## Antenna environment processing

## brief summary

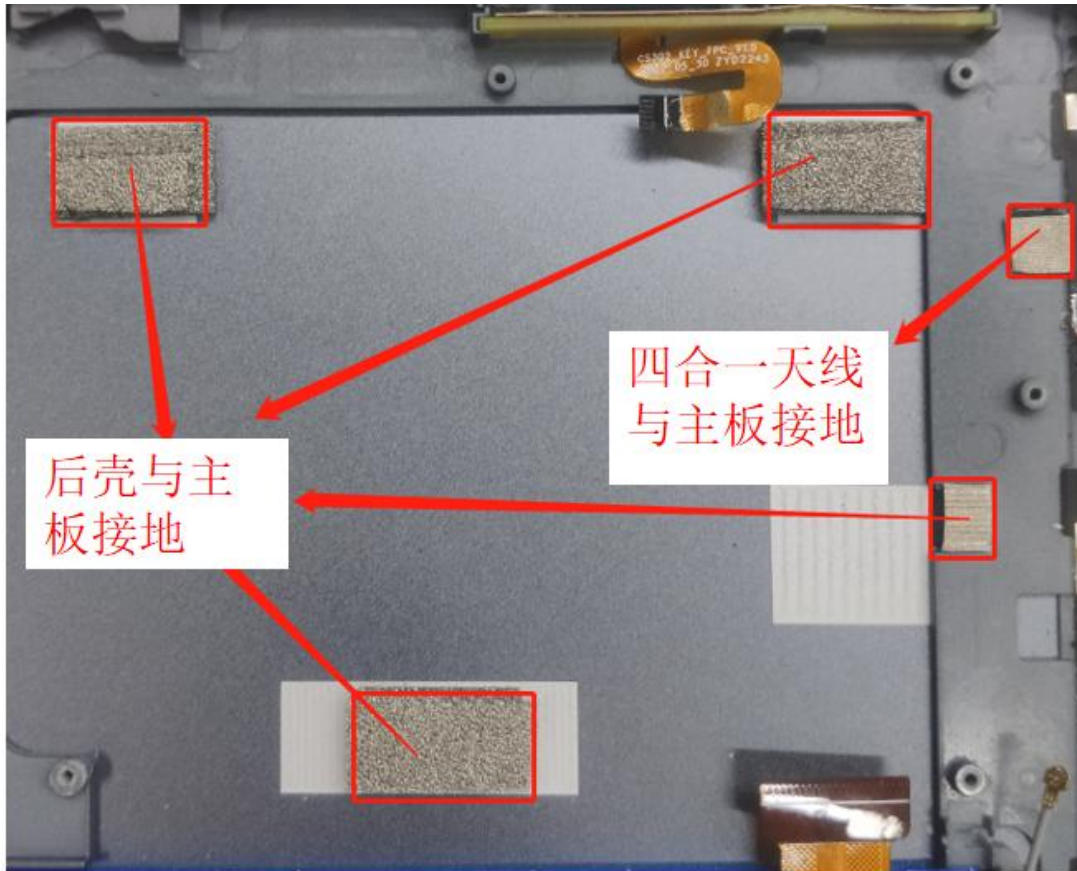
此处接地需用合适泡棉没接好地会影响天线性能

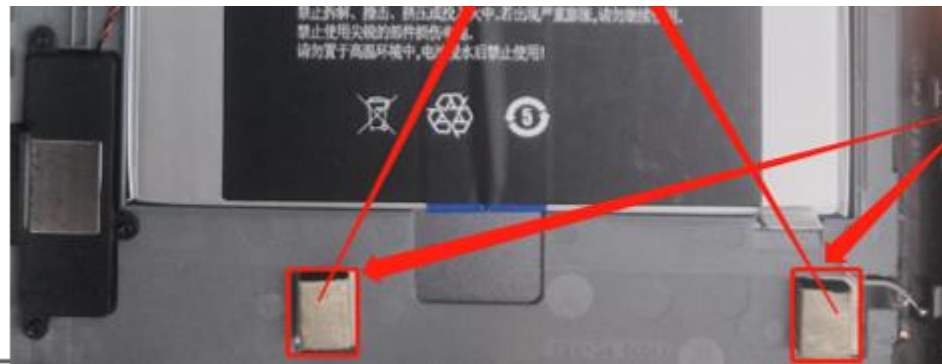
Note: The main antennas original condition test was abnormal, after disassembling it was found that the sponge grounding effect at the screen connection below the main antenna was poor, then it was regrounded and the test was repeated, which was normal. The diversity antenna was optimized to improve sensitivity. The difference in screen brightness is still relatively large at low frequencies, further environmental processing will be done to see if it helps with screen brightness.

Note: These two need to be grounded with a high enough grounding foam, not properly connected will affect the performance of the main antenna
