**Issue Date :****17<sup>th</sup> November 2012****Product :****Car2Go Head unit****Subject :****Hardware changes description****Revision history table**

# 1. List of changes

Following are listed all the changes on the Car2Go HU system to improve system reliability and fix bugs discovered during product validation phase.

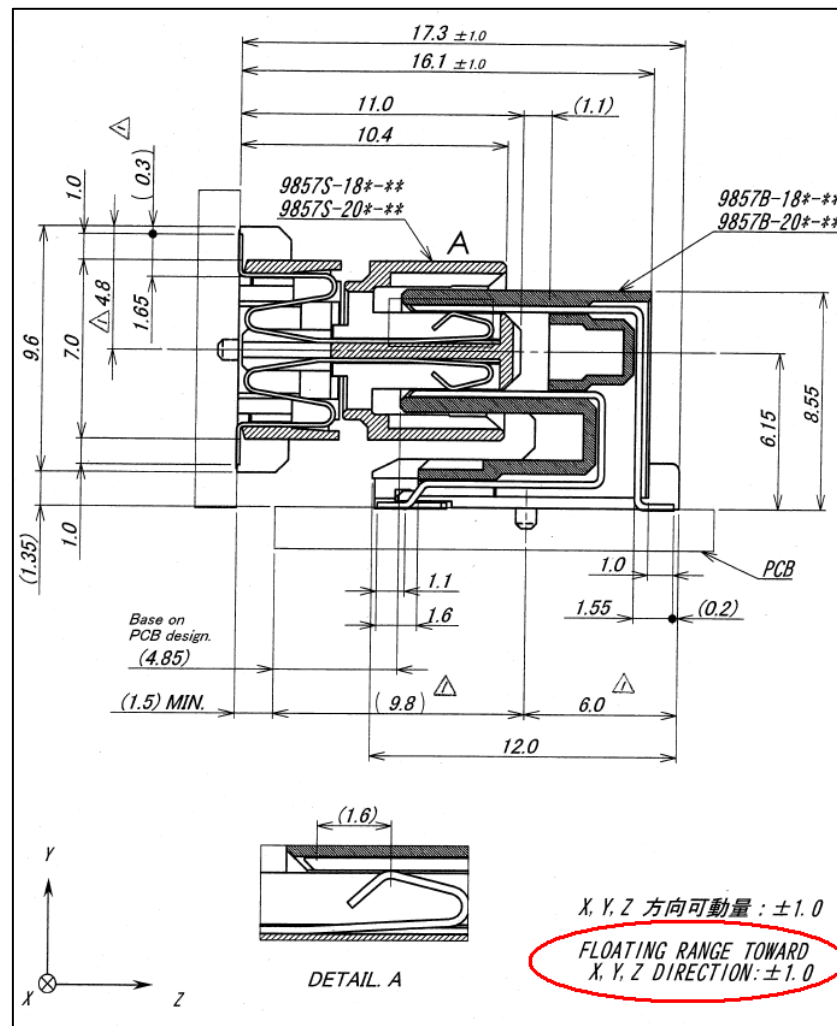
Kyocera connector (P/N 24\_5078\_050\_100\_861) has been replaced with Iriso (P/N 9857S-52A-GF) floating connector to prevent disconnection due to Z-axis vibration:

Figure 1 Floating mating up to 1 mm

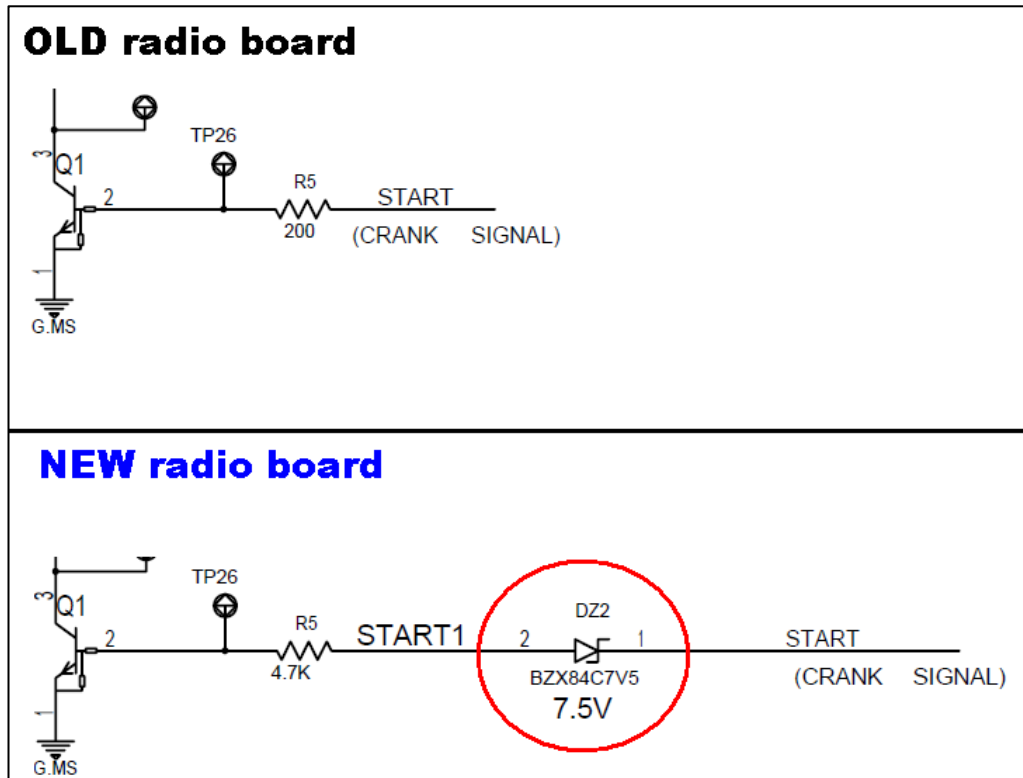
First release of radio board was not able to properly manage the START line signal of 2011 vehicles. This input was designed to properly manage an “off” state of START line close to 0 volt. Unfortunately on 2011 vehicle, the START line have a different behavior when not active, and the “off” state is no more close to 0 volt: this was the root cause of audio noise/mute on the FordWork audio amplifier.

Figure 2 Crank line improvement for 2011 vehicles

On the new radio board a series Zener diode has been introduced to avoid unwanted “mute” of the audio amplifier due to different input voltage level on START line, while vehicle is not cranking.

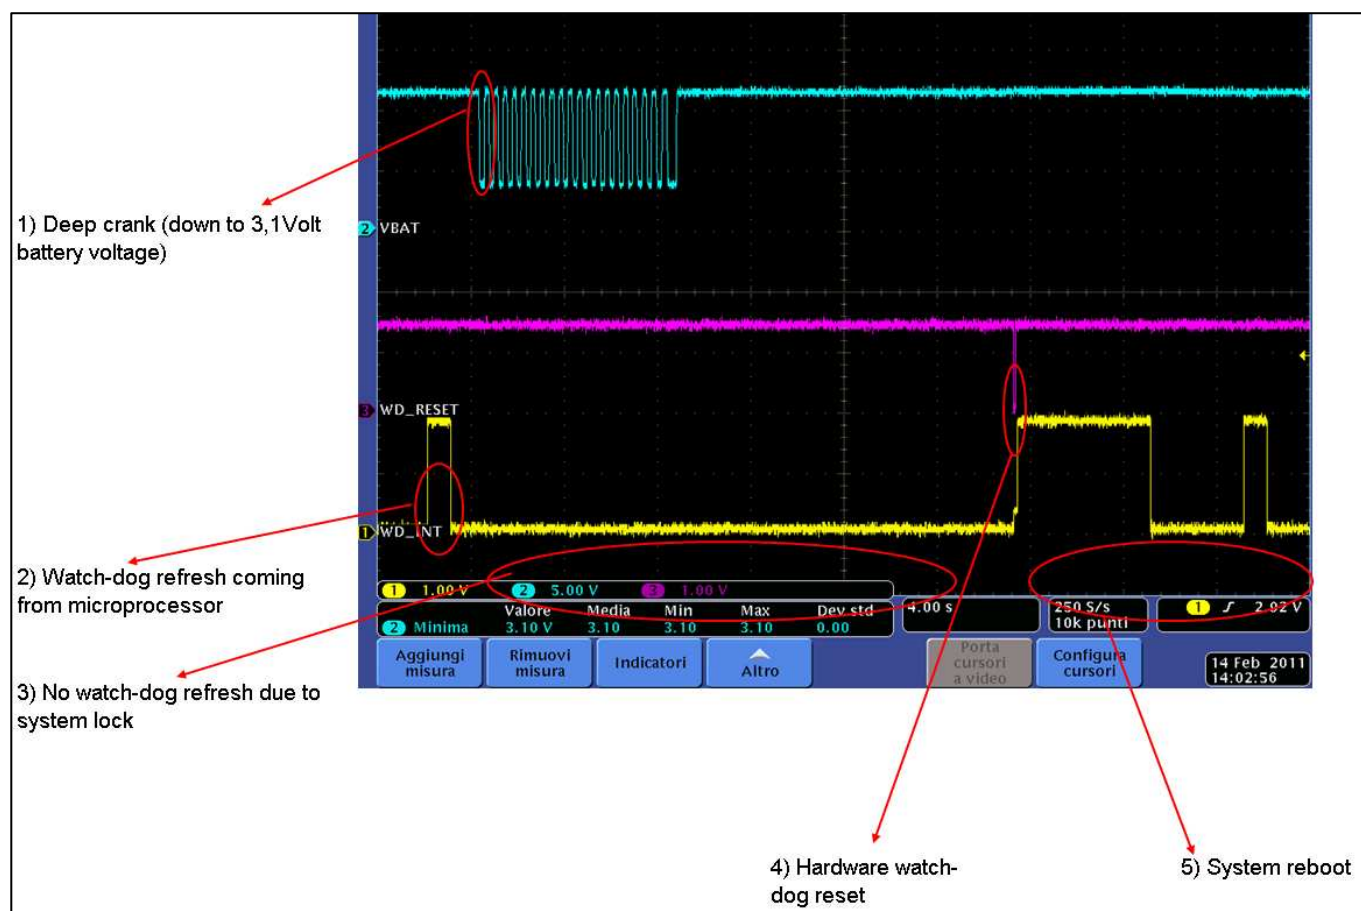
During low-battery crank, battery voltage can drop below 5 volt.

If this event happens on a PV1 system, the power mosfet who feed the microprocessor do not close completely and the core supply voltage can be out of range. This could generate a system hang-up with no system reset.

The system do not boot again and stay permanently with the screen in dark mode.

Figure 3 External watch-dog functionality

In the picture above a deep-crank has been simulated (on the bench) to reproduce system hang-up and show the external watch dog intervention:

1. battery voltage (VBAT) falls repetitively down to 3,1 volt
2. the signal coming from the microprocessor to refresh the external watch-dog (WD\_INT) stops since the microprocessors hangs-up
3. the watch-dog internal counter elapses after about 25 seconds
4. a reset (WD\_RESET) is asserted from the watch-dog to the system
5. system reboot

- a pull down resistor has been introduced on the interrupt pin of the system power supply IC (Daisy) to prevent from false boot condition due to leakage current
- an external hardware watch-dog has been enabled to prevent from unwanted system hang up

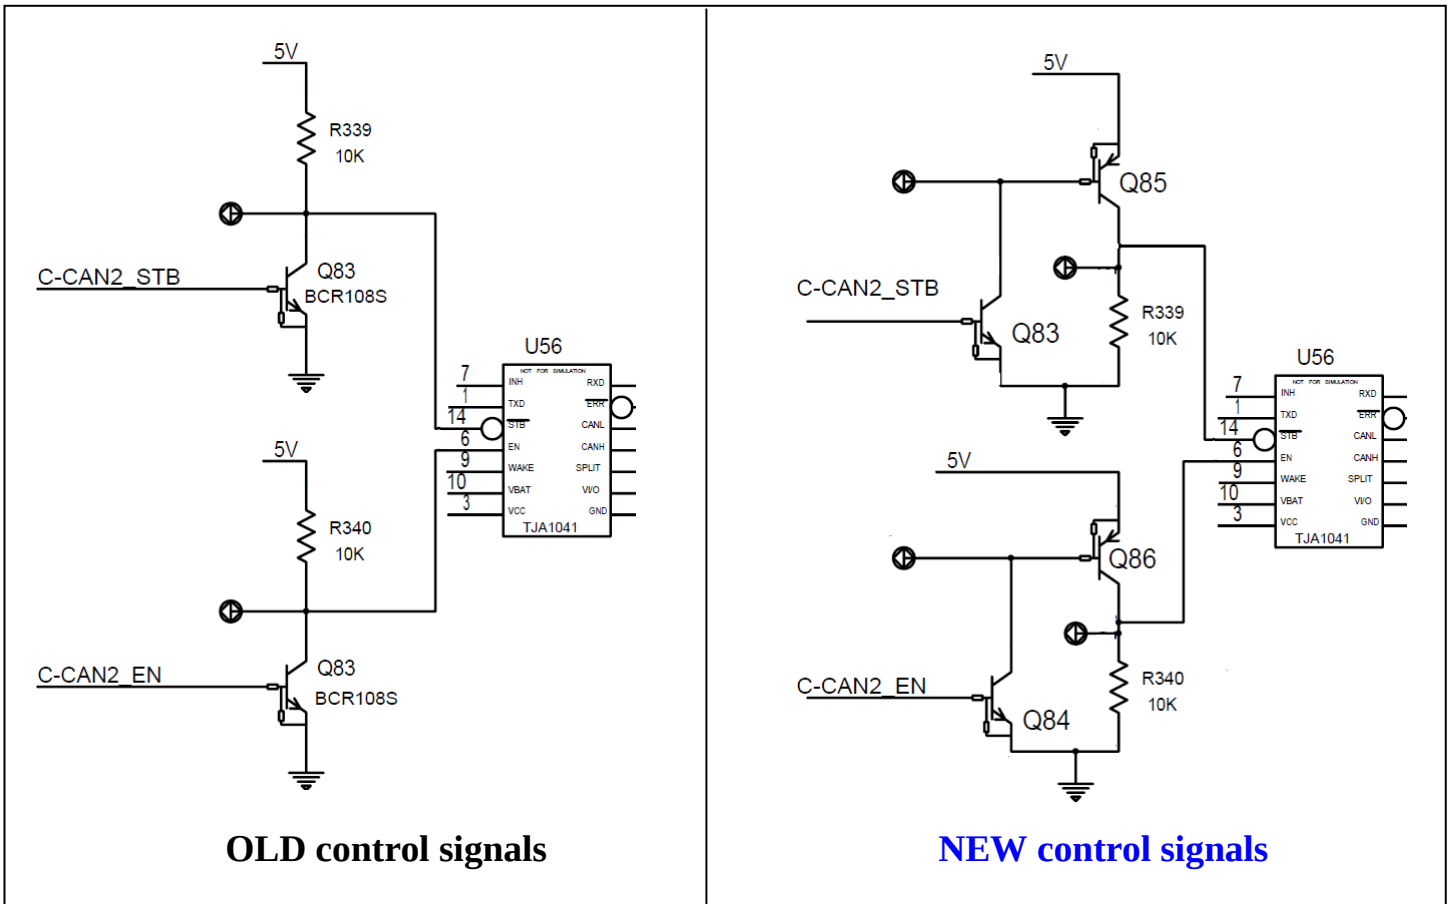
CAN transceiver control signals have been reversed on PRS3 as depicted in the picture below:

- old control: TJA1041 is active when C-CAN2\_STB and C-CAN2\_EN are low
- new control: TJA1041 is active when C-CAN2\_STB and C-CAN2\_EN are high

Figure 4 CAN transceiver control comparison

In the old architecture, when system is booting (5V is high) C-CAN2\_STB and C-CAN2\_EN are low then EN and nSTB pin of TJA1041 are high: the transceiver is “on”.

This means that messages on the CAN bus go to the input of the microprocessor CAN cell, while it is booting.

Robust design rules require to properly initialize the CAN driver before receive any message from the CAN bus.

The improvement gained with the new control is that transceiver is “off” while system is booting because Q85 and Q86 are “off” then EN and nSTB pin are low also if 5V is high.

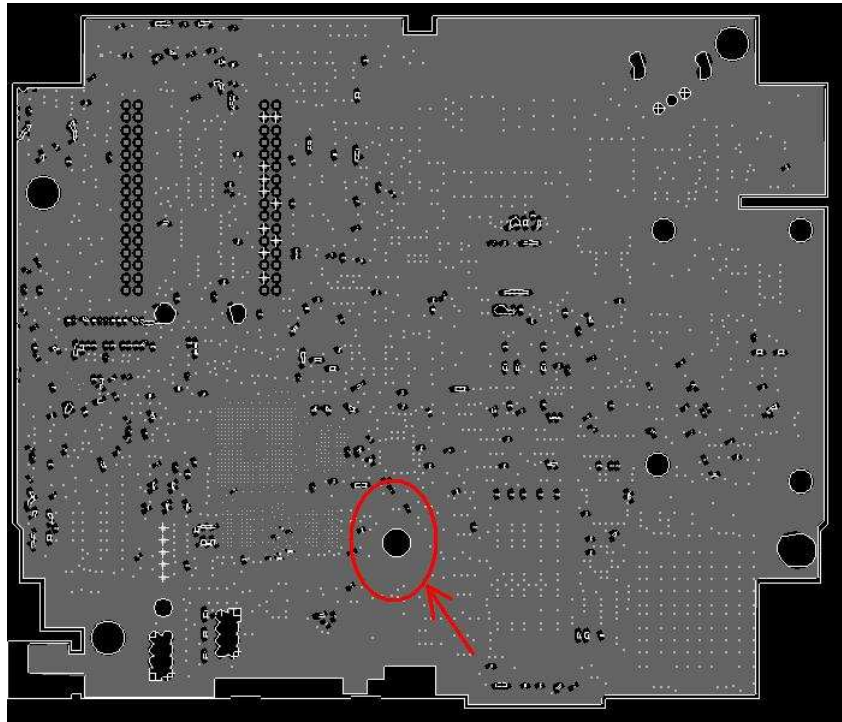
An additional hole has been introduced on (Lauberhorn C3 PRS4) mainboard to improve assembly/testing process reliability.

*Figure 5 Additional motherboard locating hole*
