Roke Manor Research Limited  
Roke Manor  
Romsey  
Hampshire  
SO51 0ZN  
UK

Working paper no: WP\_0050

Title: Dustin Hardware Delta's B2.1-2 to B2.1-5

Issue & Date: Issue 1 – June 2006

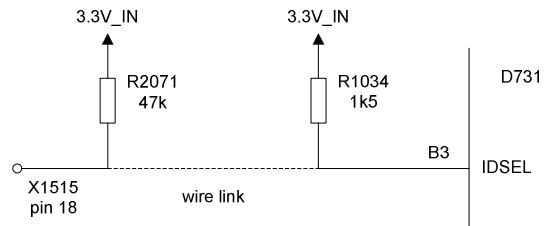
| <b>Reason For Change: (e.g. list of associated Problem Reports)</b><br><br>4G have allocated pin 18 of the Cardbus connector (Vpp1) to the function IDSEL. This pin must therefore be routed to the IDSEL line on the NEC USB Host Controller chip.<br><br>This has no Affect on the Radio Performance. | | |

Figure 1: present arrangement

| <b>Details of Change: (e.g. sections of document that have changed)</b><br><br>Disconnect R2071 pin 2 from the net 3.3V_IN and route instead to pin B3 (92) of D731 (NEC µPD720101 USB Host Controller).<br><br>Change R2071 from 47k to 0R 0201<br><br>R2071 is No Build for the PC card Variant and fitted for the Router Variant (Variant A) as shown in the figures on the following page. | | |

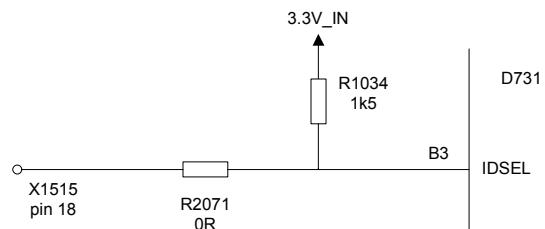
Figure 2: Router variant (variant A): R2071 fitted

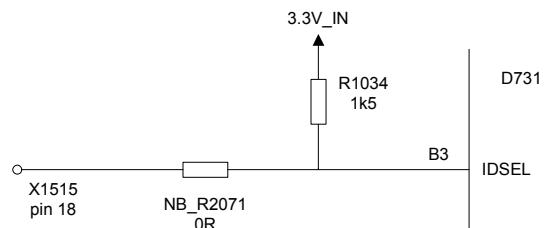
Figure 3: PC card variant: R2071 not fitted (NB)
