Document number  
BGLI08:494  
Date  
2008-06-05  
Remarks

## HW change description for

**Mobile Station Type:**  
**AAD-3252041-BV W760i**  
**HW (B)**

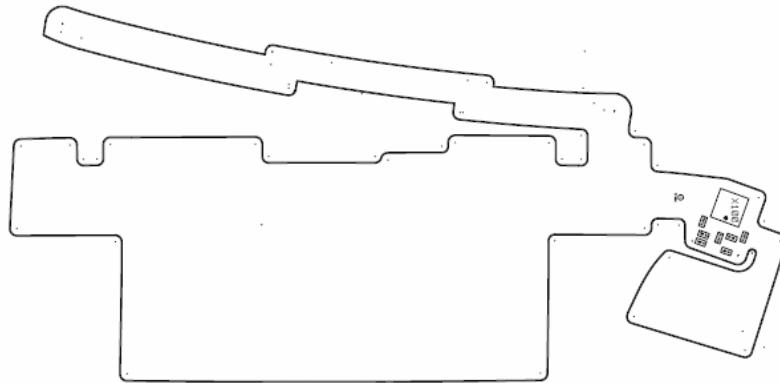
#### HW-A

Note the array of components surrounding the larger coax connector. These were intended to be used for a “pre-distortion” matching circuit between the antenna element and the coax cable.

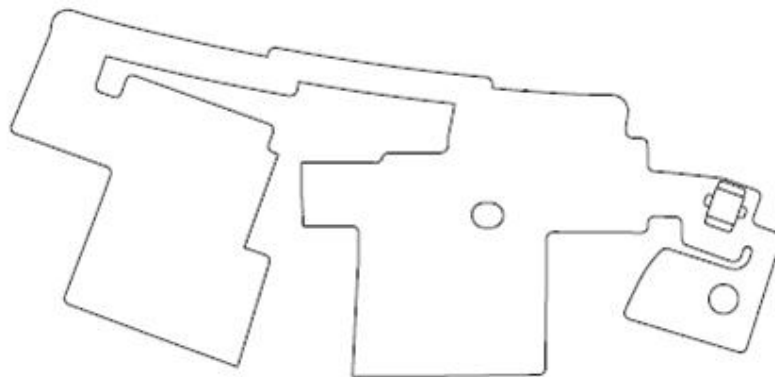
#### HW-B

For HW-B, the element shape has changed and the pre-distortion matching circuit has been eliminated.

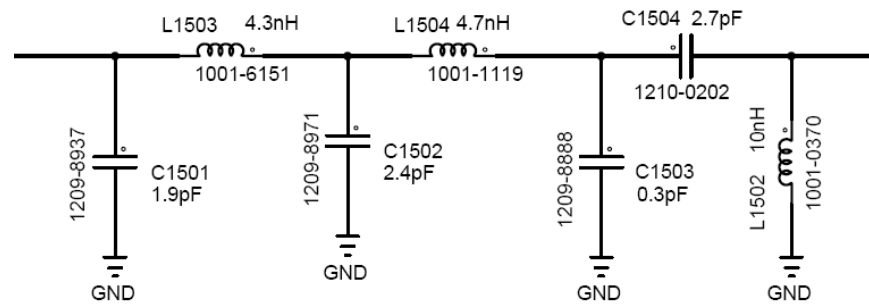
**HW-A**

HW-A used a 7 component LCCLCLC matching circuit. HW-B uses only a 2 component CL circuit. For HW-B, C1501 through C1503 are no-mounted (<NM>) and L1503 and L1504 are replaced with 0 ohm resistors. C1504 is replaced with a 2.2nH inductor and L1502 is replaced with a 0.5pF capacitor.
