## Appendix B: photographs of test setup

## Appendix C: photographs of EUT

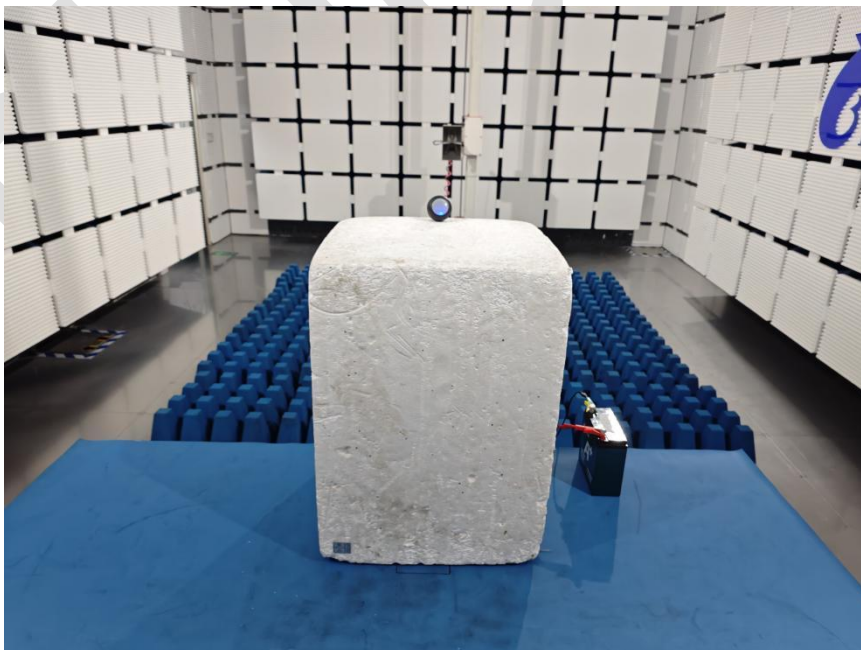
Radiated Emissions (above 1GHz)

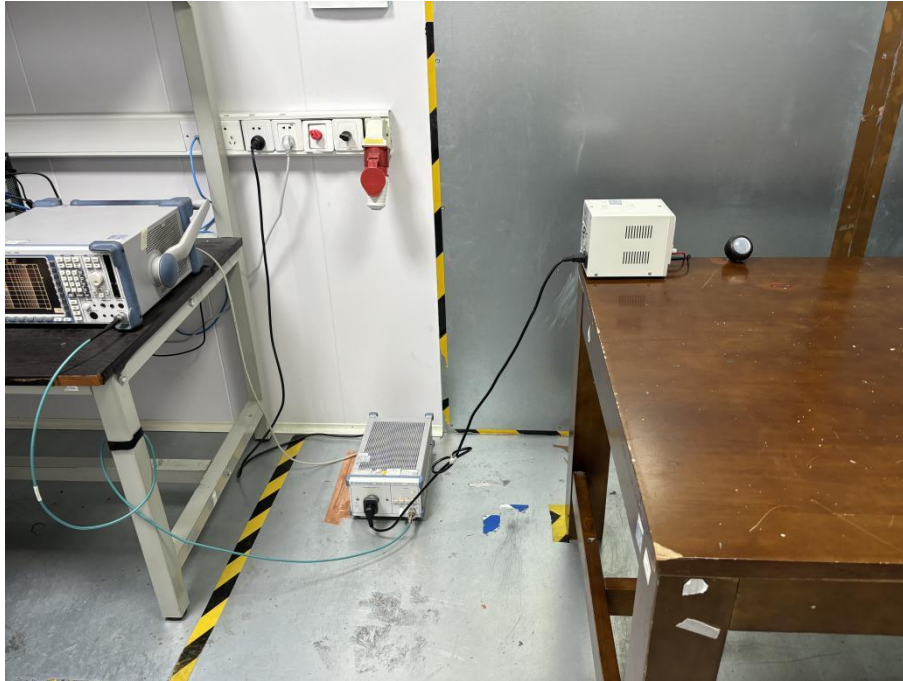
Conducted Emissions at Mains Terminals (150 kHz-30MHz)
