## PHOTOGRAPHS OF TEST SETUP

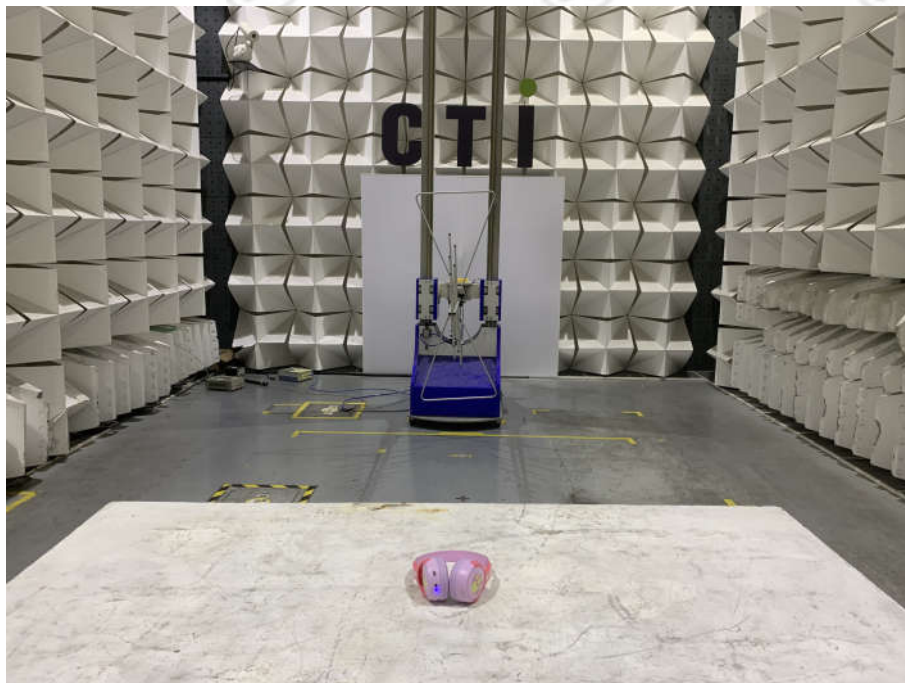
**Radiated spurious emission Test Setup-1 (Below 1GHz)**

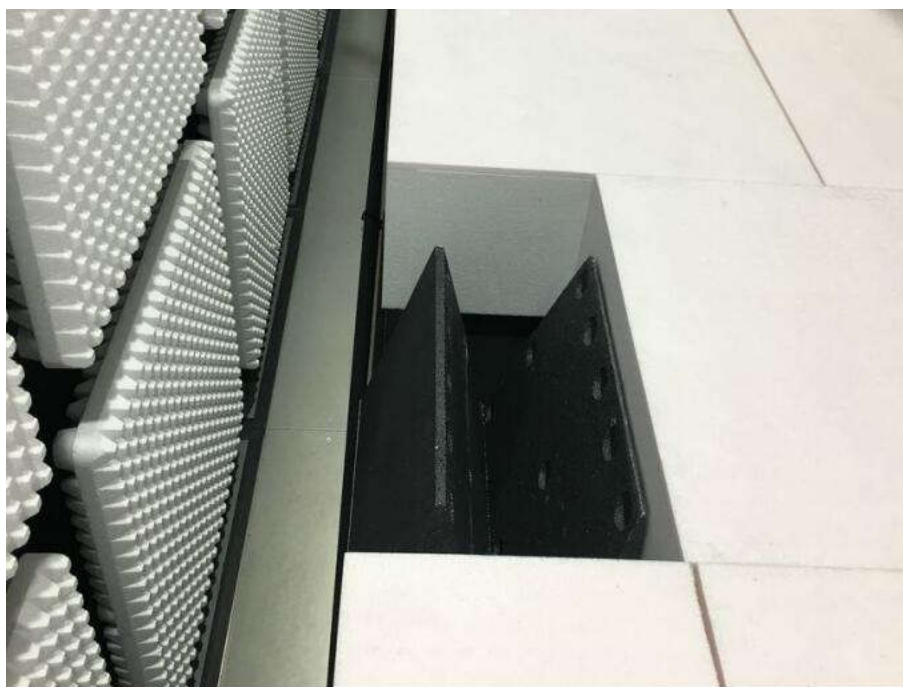
**Radiated spurious emission Test Setup-3(Above 1GHz)  
There are absorbing materials under the ground.**
