PHOTOGRAPHS OF TEST SETUP

Test Model No.: S988

Report No.:EED32N80998106

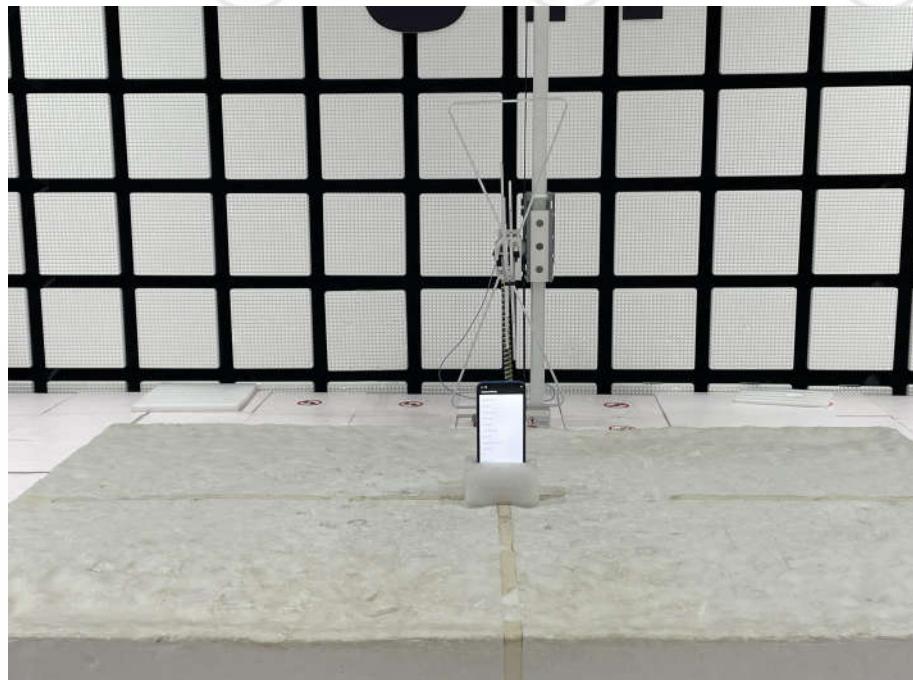
Radiated spurious emission Test Setup-1(Below 1GHz)

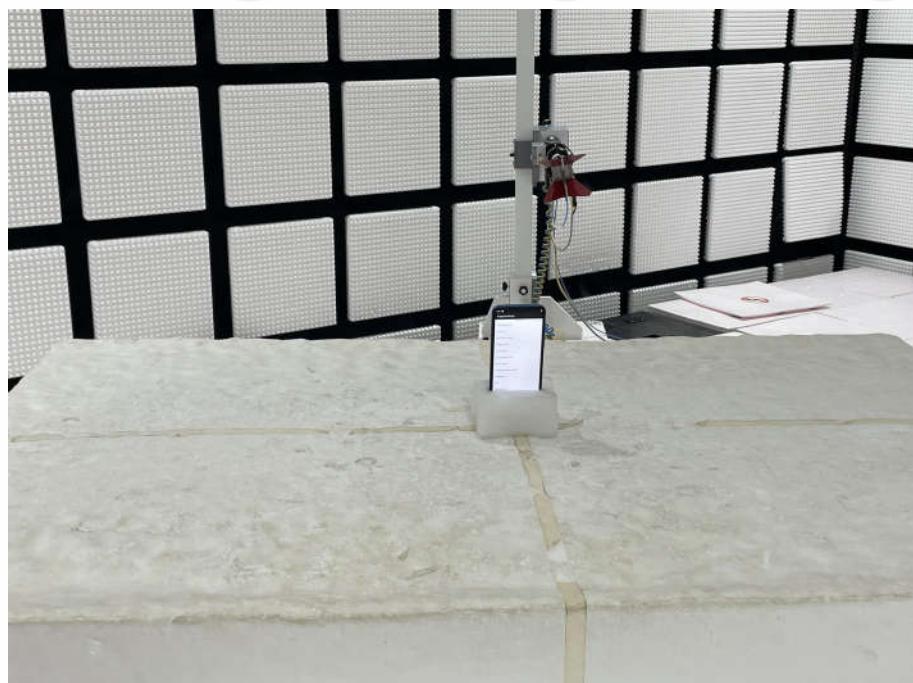
Radiated spurious emission Test Setup-2(Above 1GHz)

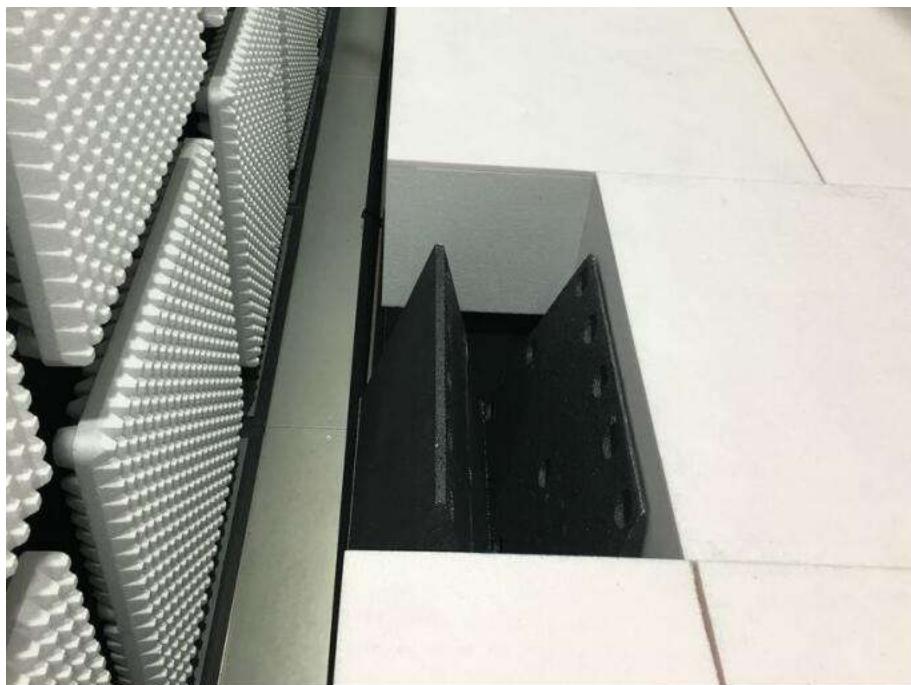
Radiated spurious emission Test Setup-3Above 1GHz
There are absorbing materials under the ground.
