## Appendix E: Reference level measurement

## Appendix F: Band edge measurements

## Appendix G: Conducted Spurious Emission

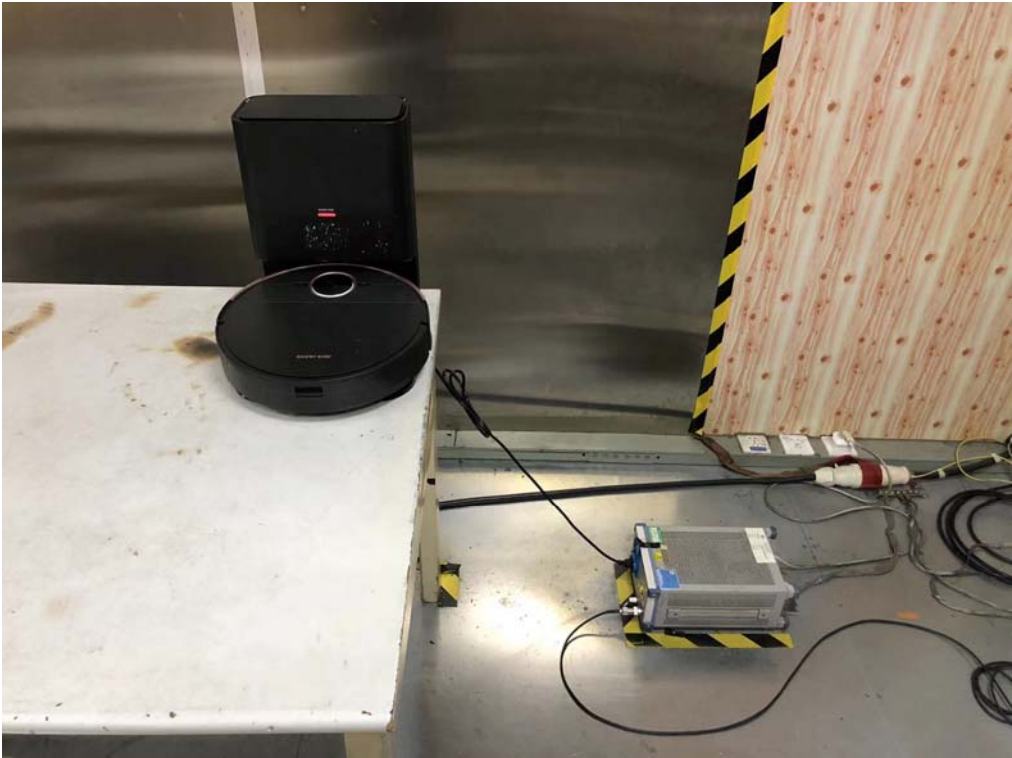
Conducted Test

12. TEST SETUP PHOTO
