## Appendix B: photographs of test setup

Reference to the test report no. BLA-EMC-202506-A10401

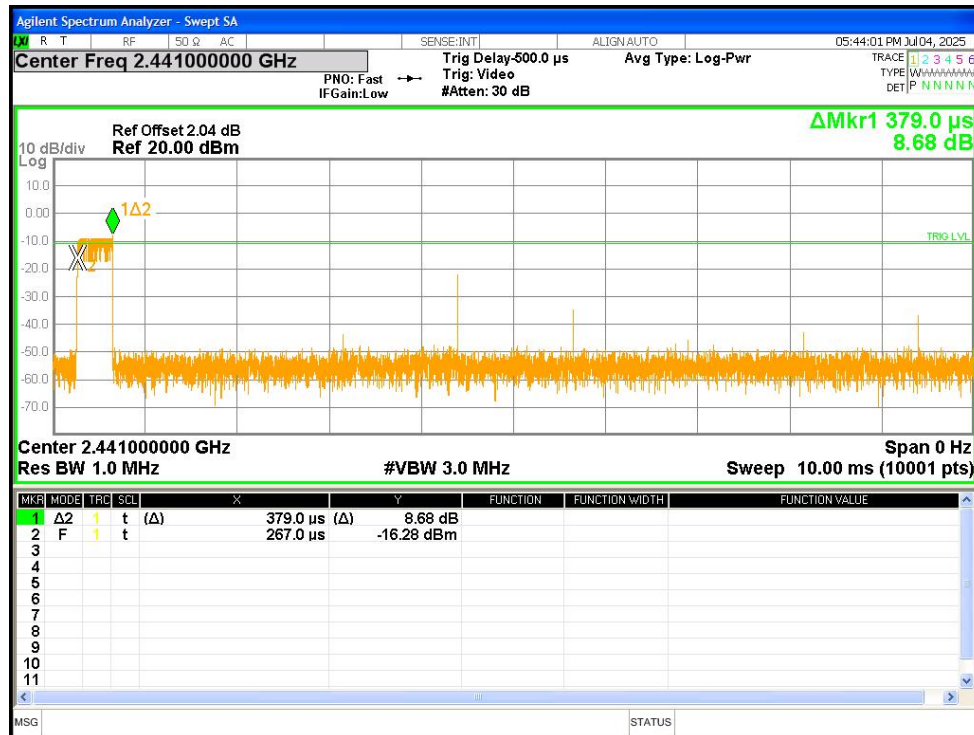
### Dwell NVNT 1-DH1 2441MHz Ant1 One Burst

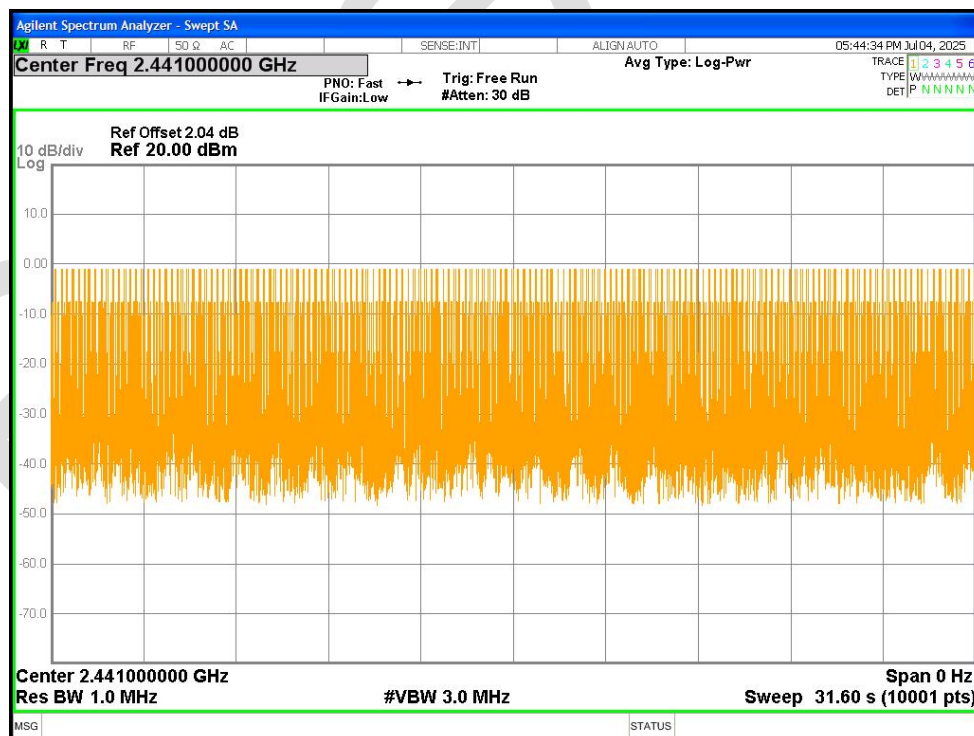
### Dwell NVNT 1-DH1 2441MHz Ant1 Accumulated

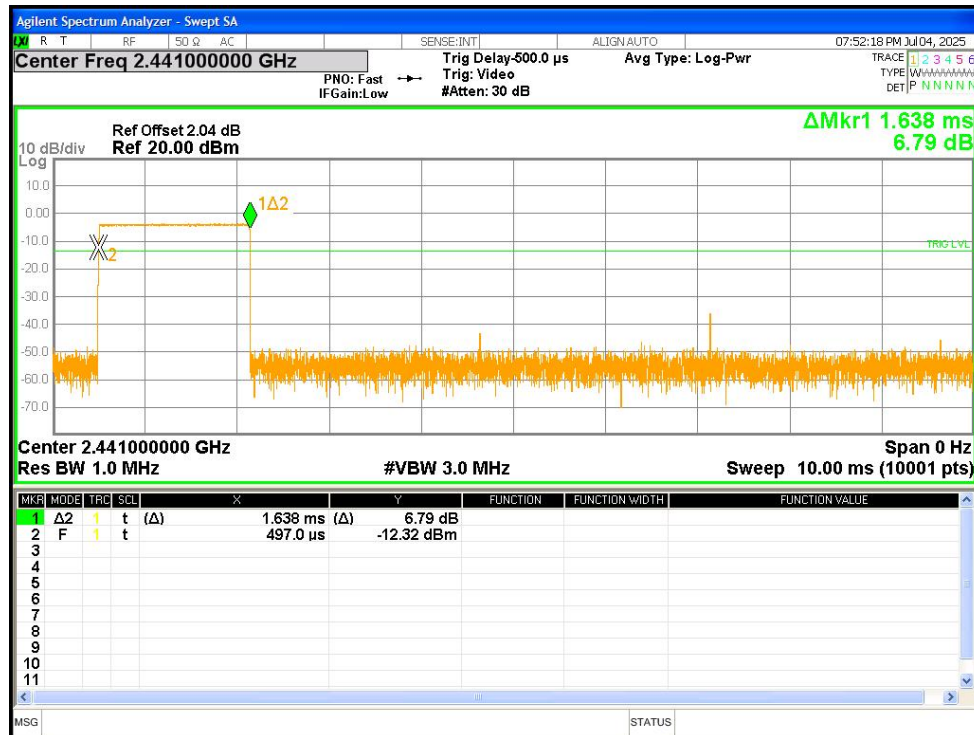
### Dwell NVNT 1-DH3 2441MHz Ant1 One Burst

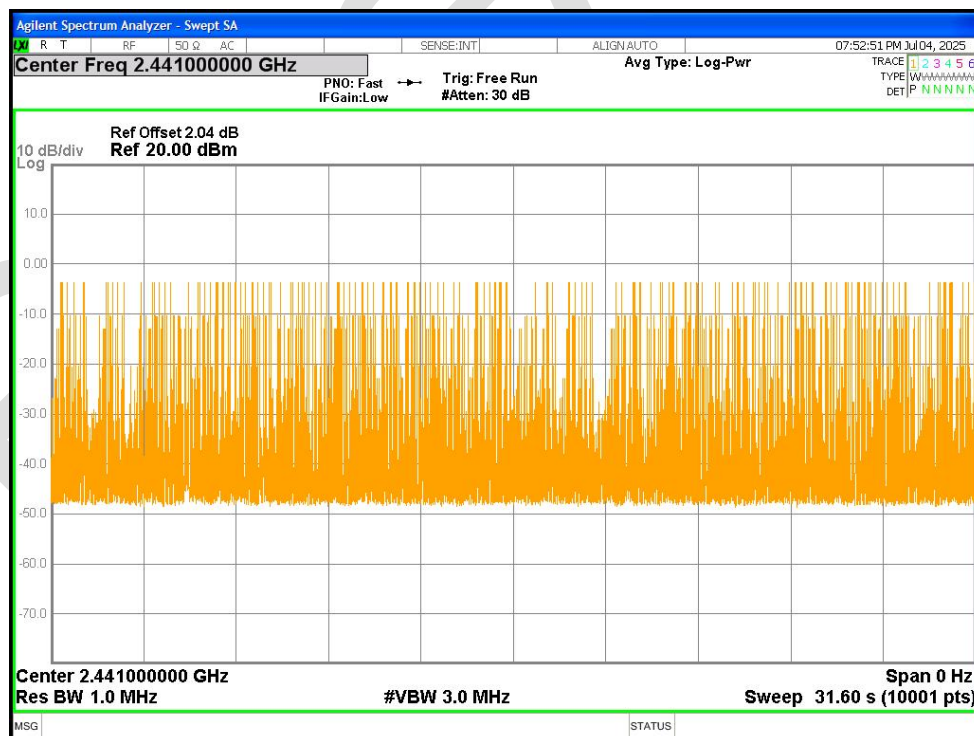
### Dwell NVNT 1-DH3 2441MHz Ant1 Accumulated

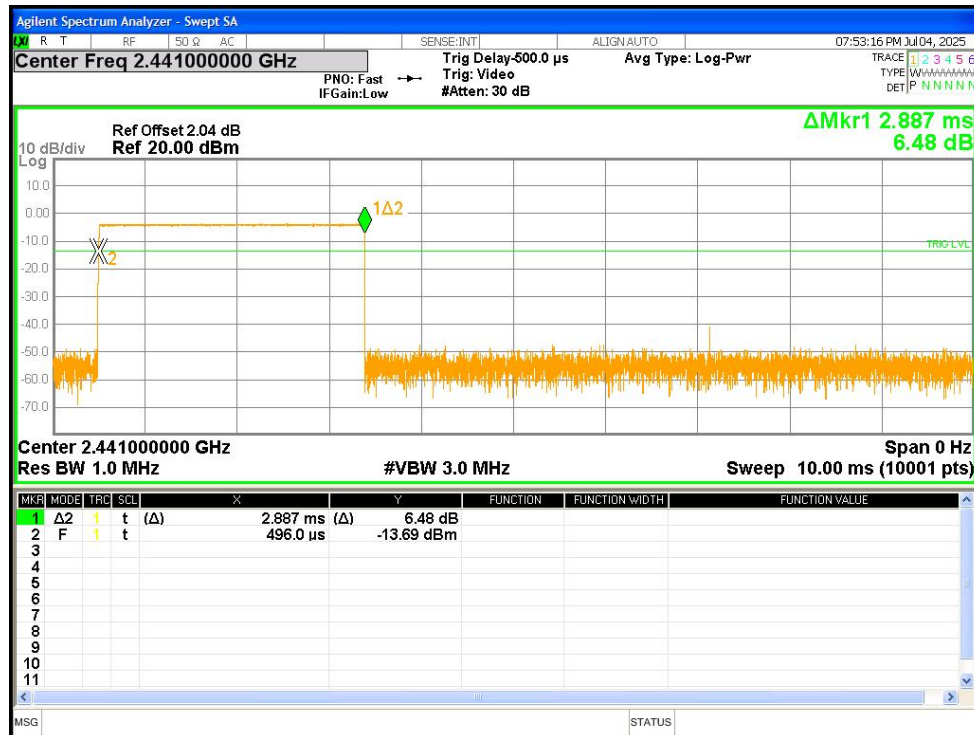
### Dwell NVNT 1-DH5 2441MHz Ant1 One Burst

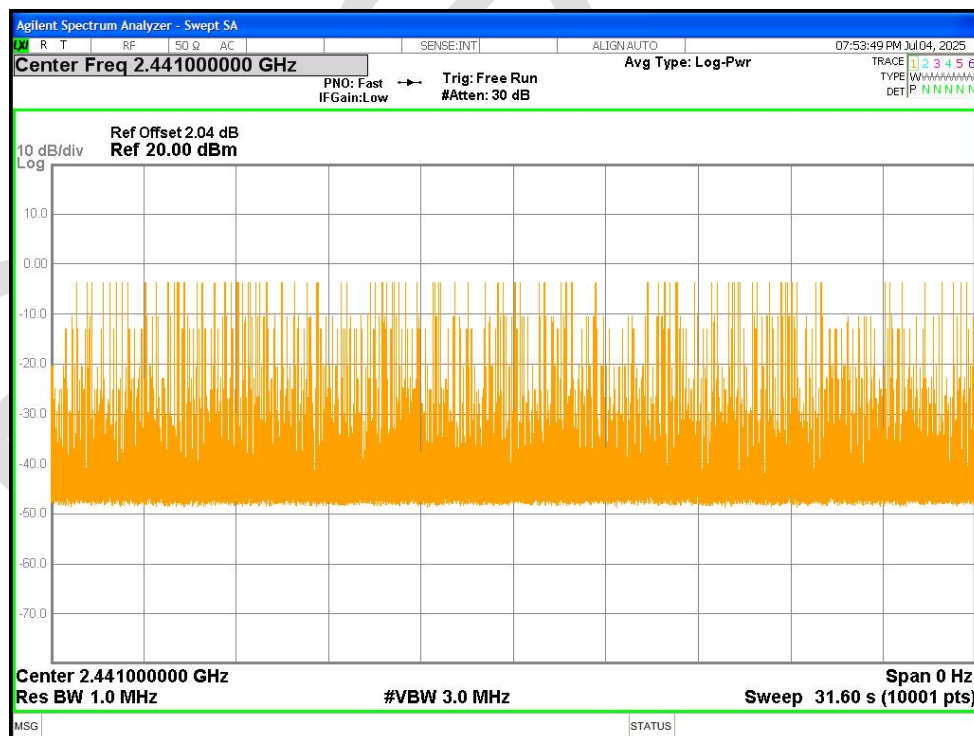
### Dwell NVNT 1-DH5 2441MHz Ant1 Accumulated

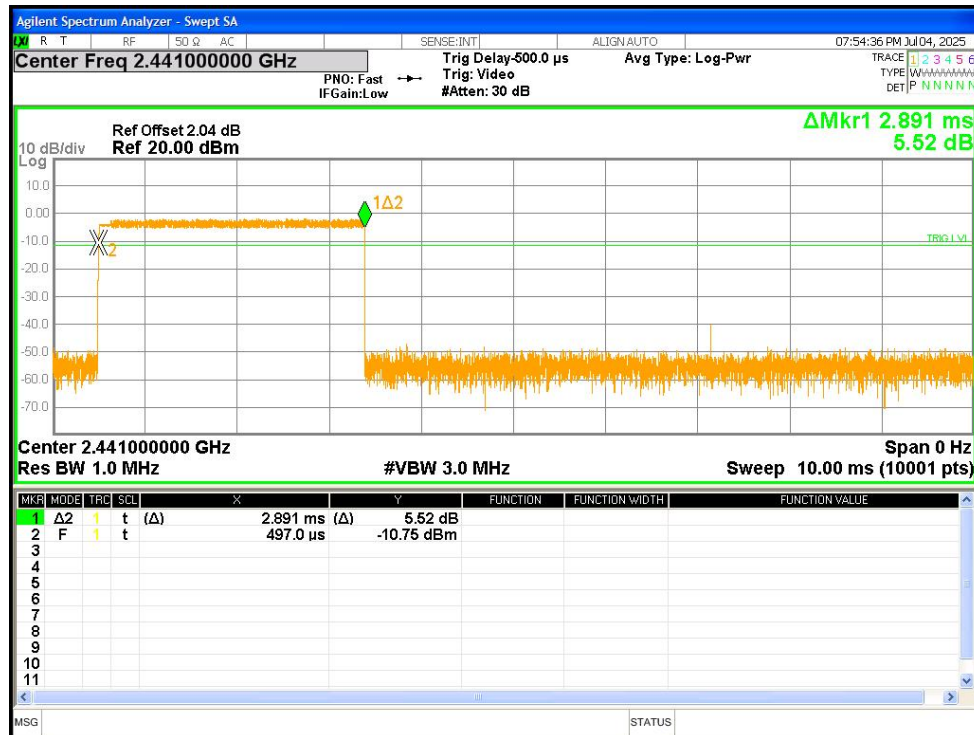
### Dwell NVNT 2-DH5 2441MHz Ant1 One Burst

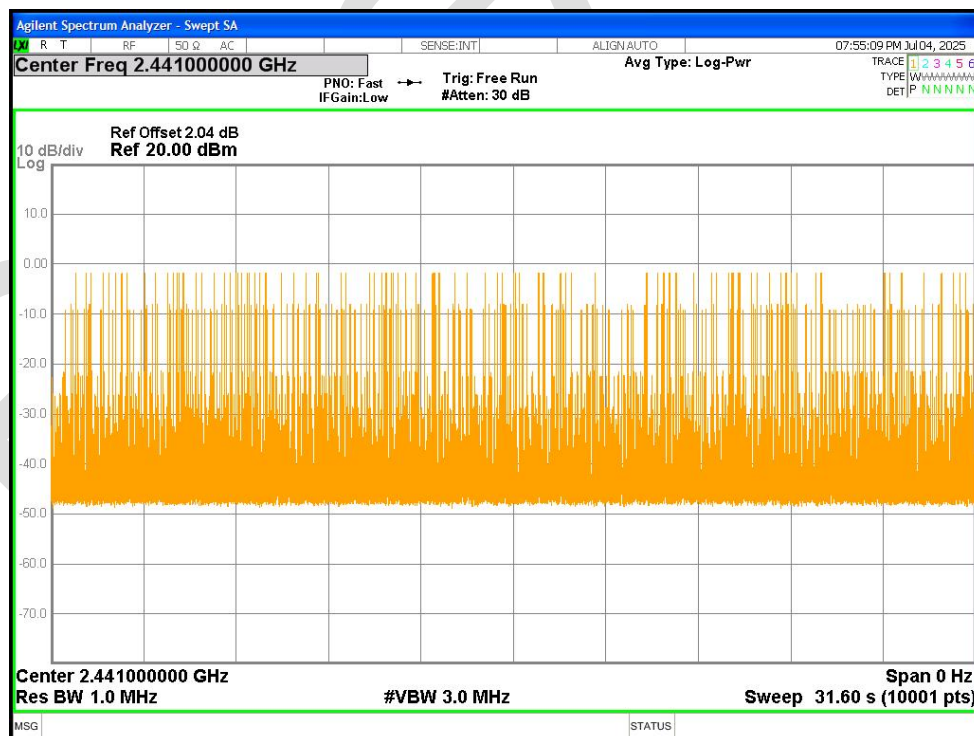
### Dwell NVNT 2-DH5 2441MHz Ant1 Accumulated

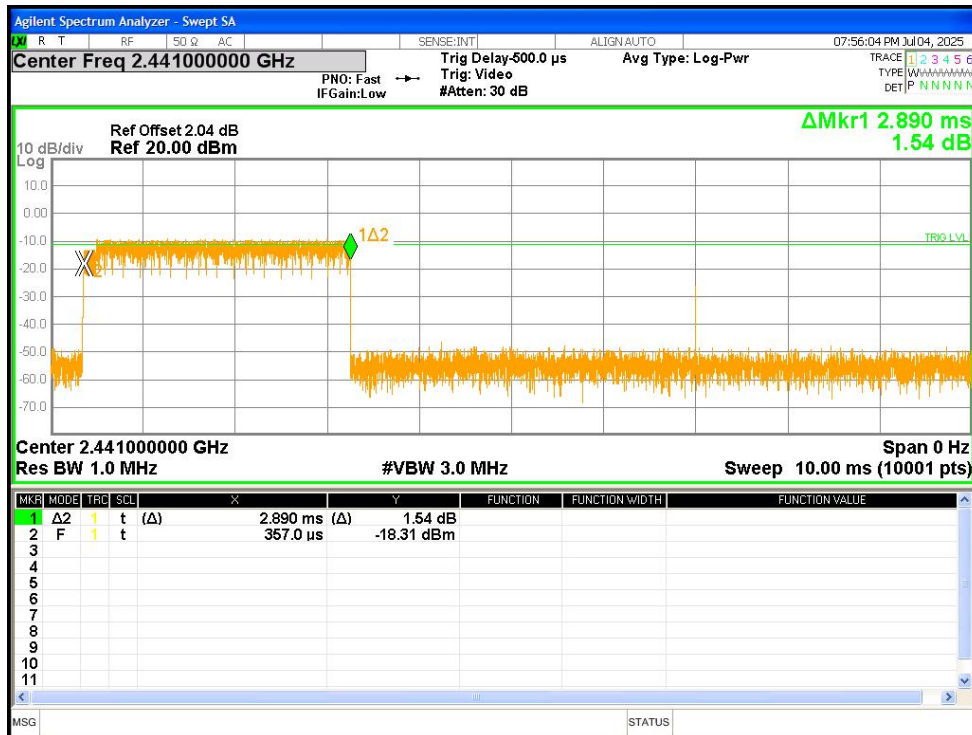
### Dwell NVNT 3-DH5 2441MHz Ant1 One Burst

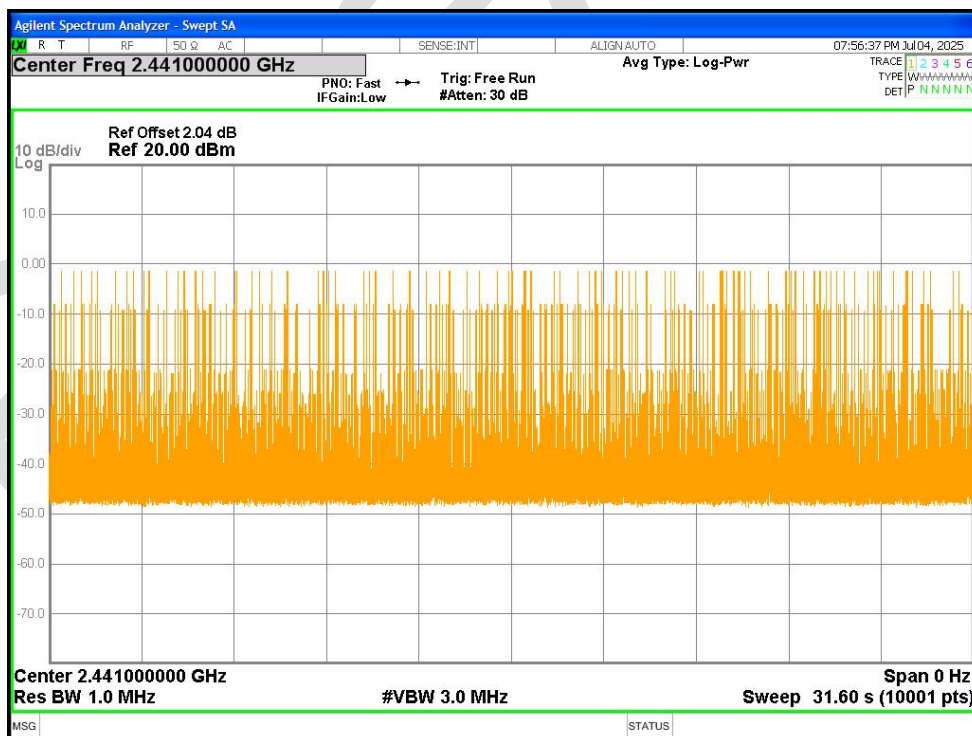
### Dwell NVNT 3-DH5 2441MHz Ant1 Accumulated

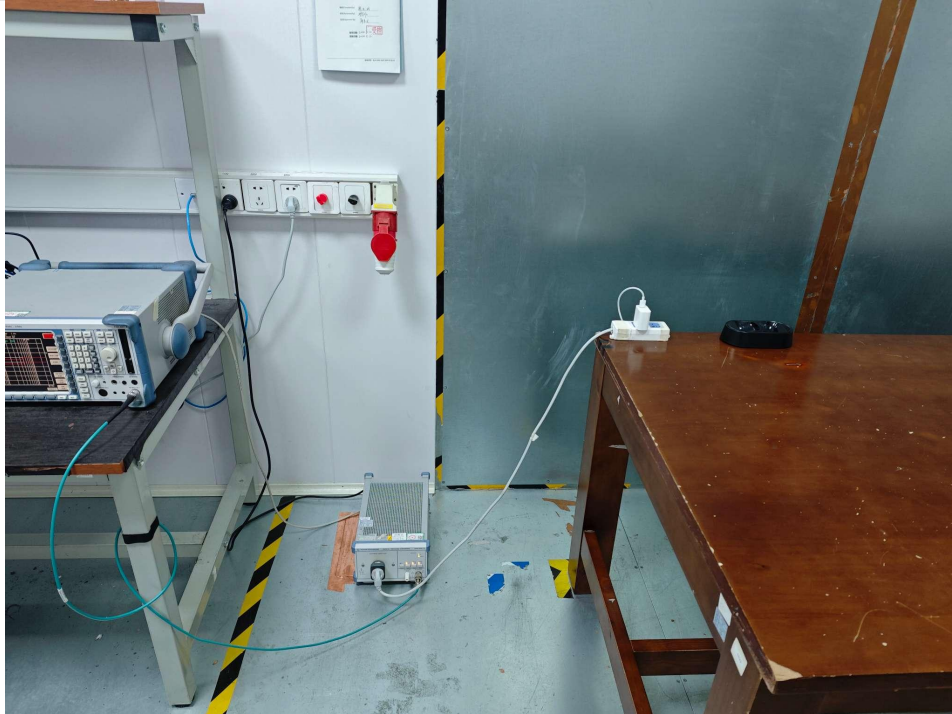
Conducted emissions at AC power line (150kHz-30MHz)

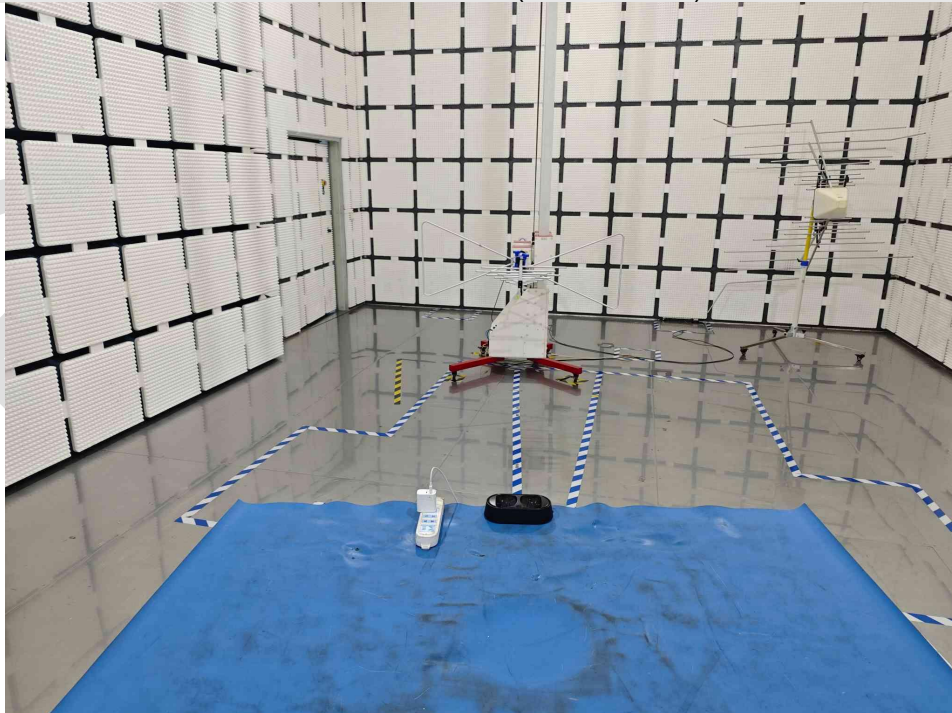
Radiated Emissions (30MHz-1GHz)

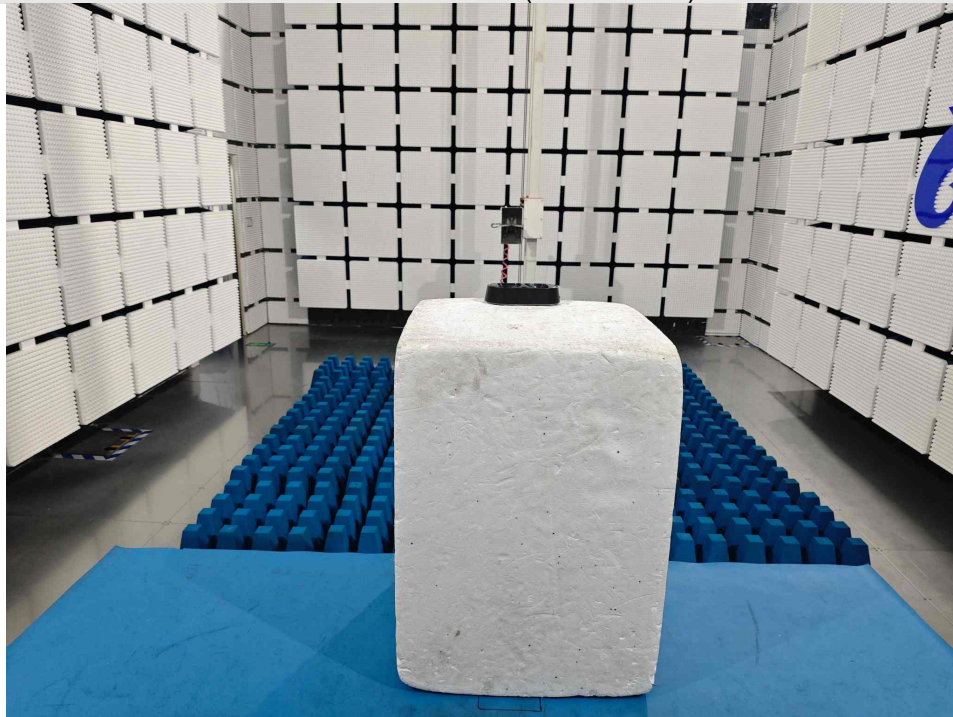
Radiated Emissions (above 1GHz)
