Antenna Debugging Report

Customer: Duoke
Project: DK103
Structure: Xiaoxiang-13316888409
RF: Long Yaobin -15874137313
Date: 2025-4-29

Version number: V5.0

Machine status: PVT trial production machine

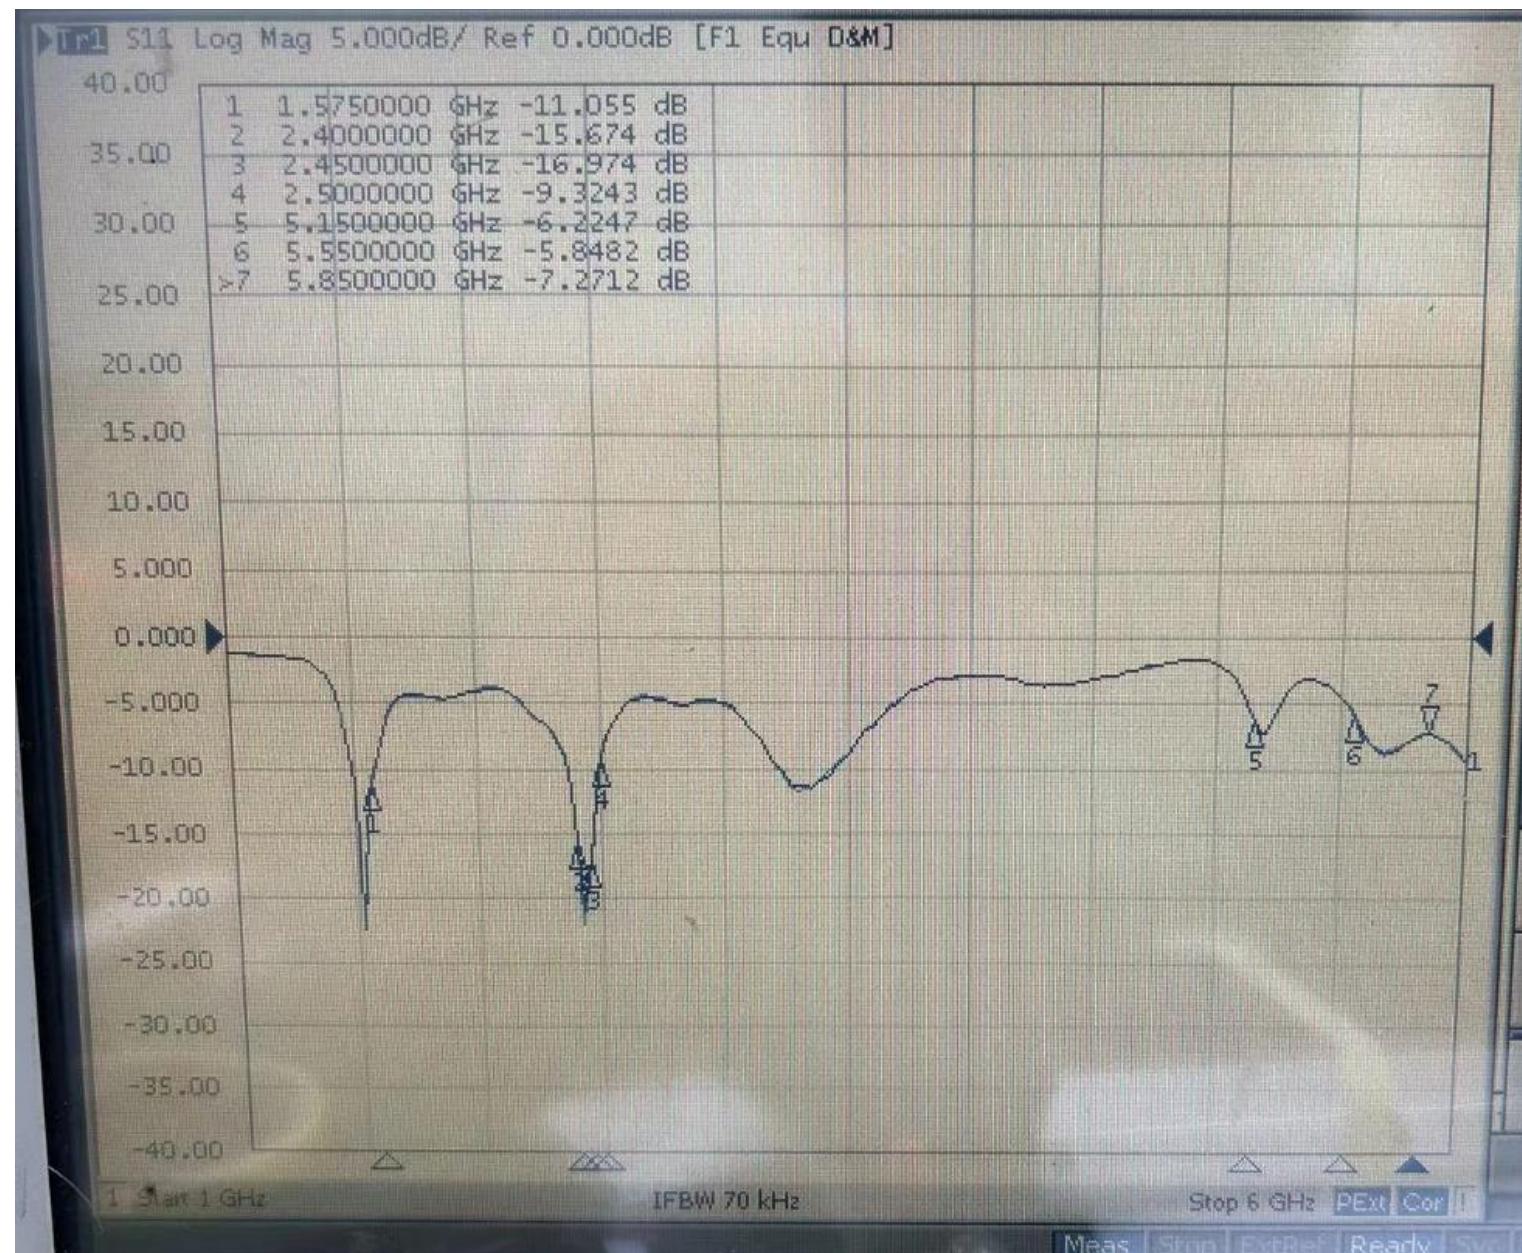
GPS/Wifi/BT antenna LOG MAG

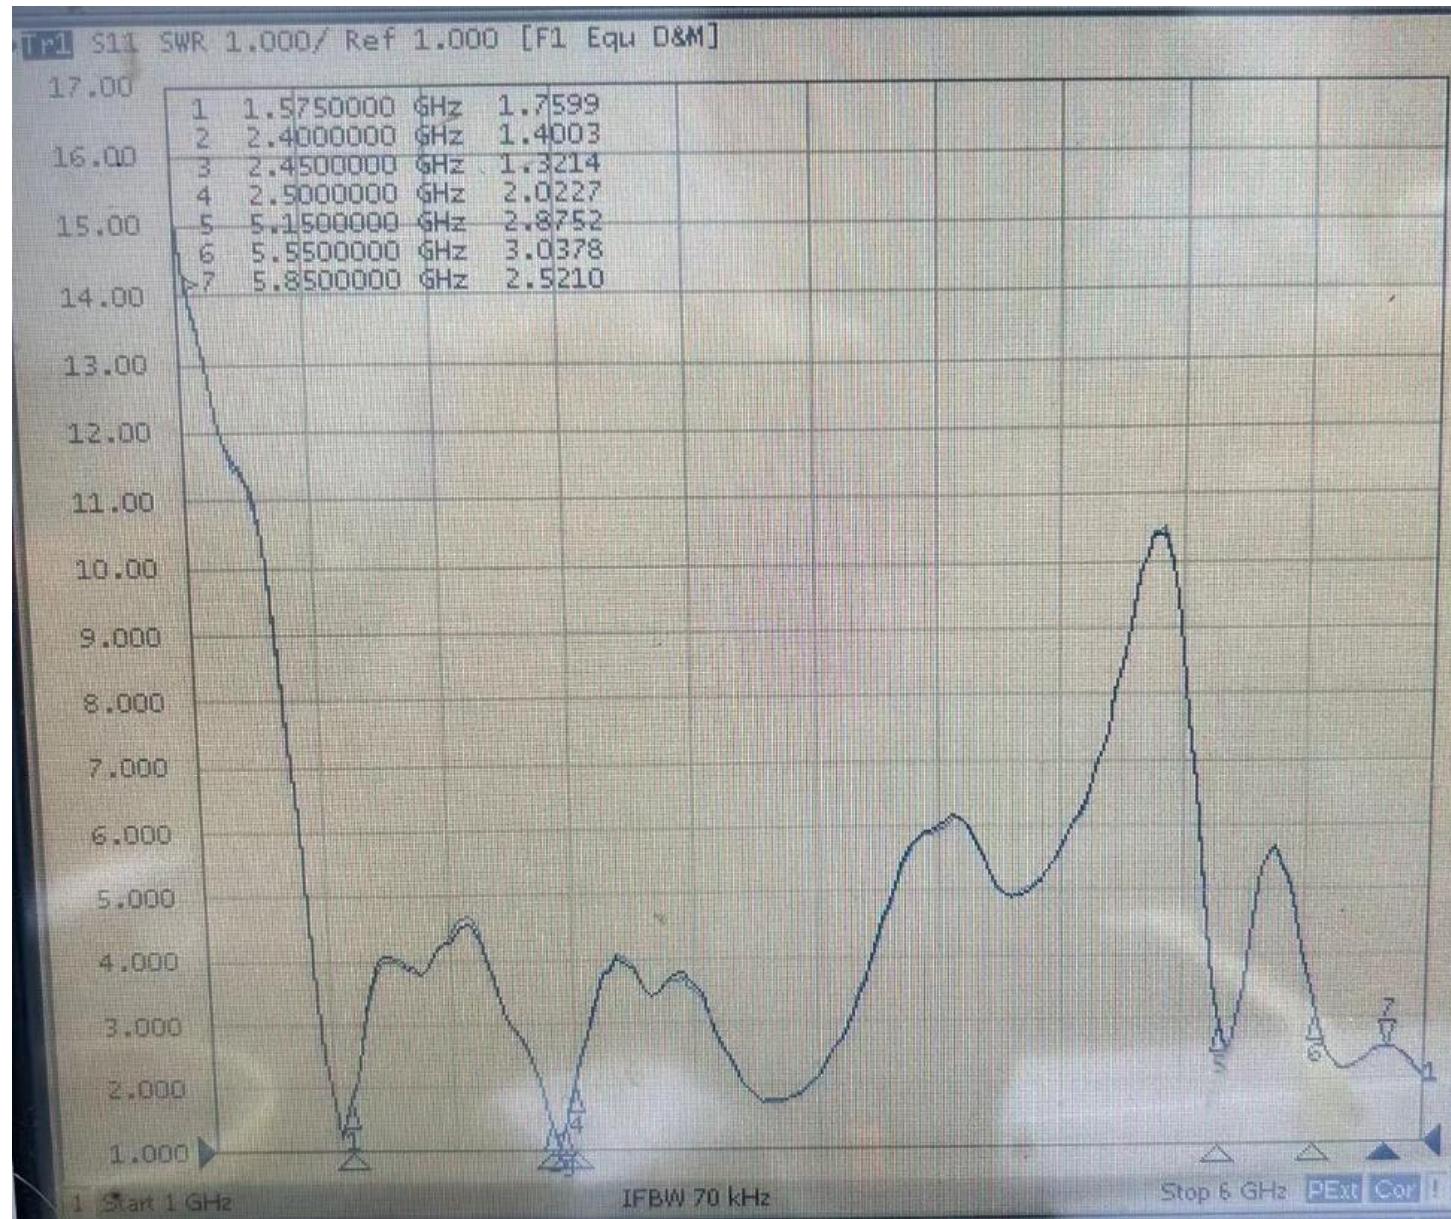
GPS/Wifi/BT antenna SWR

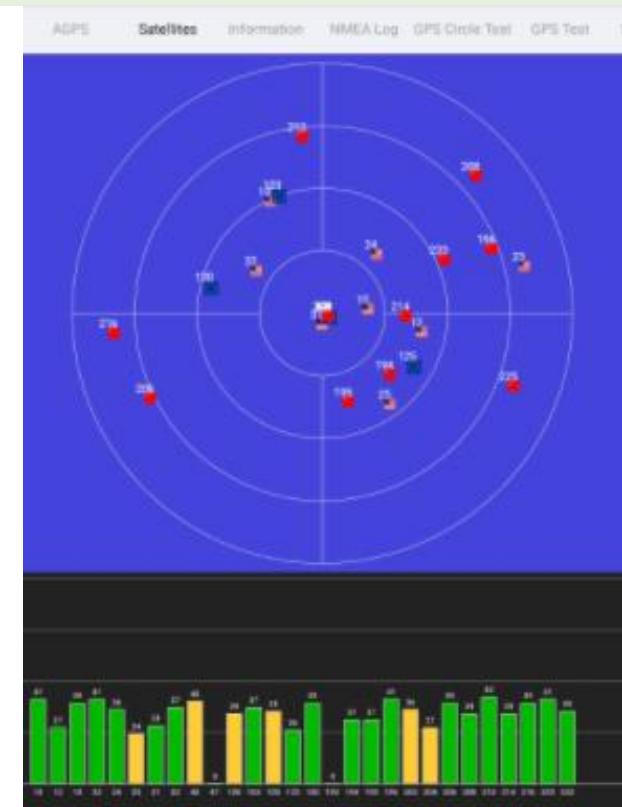
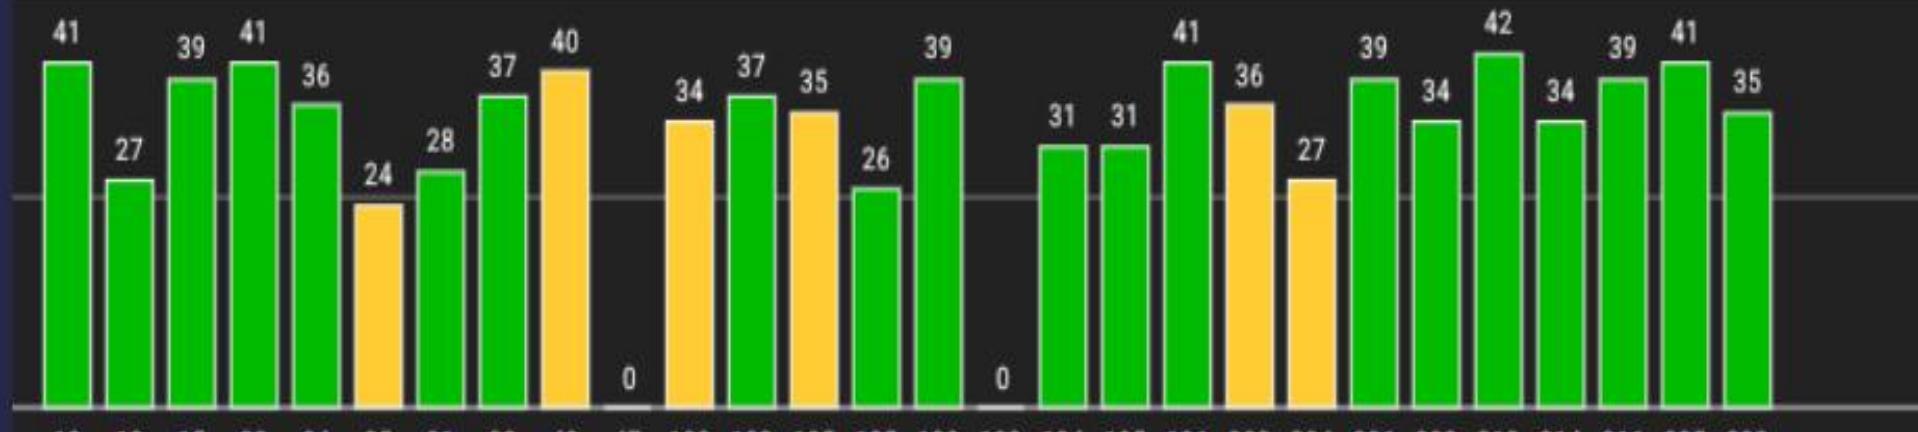
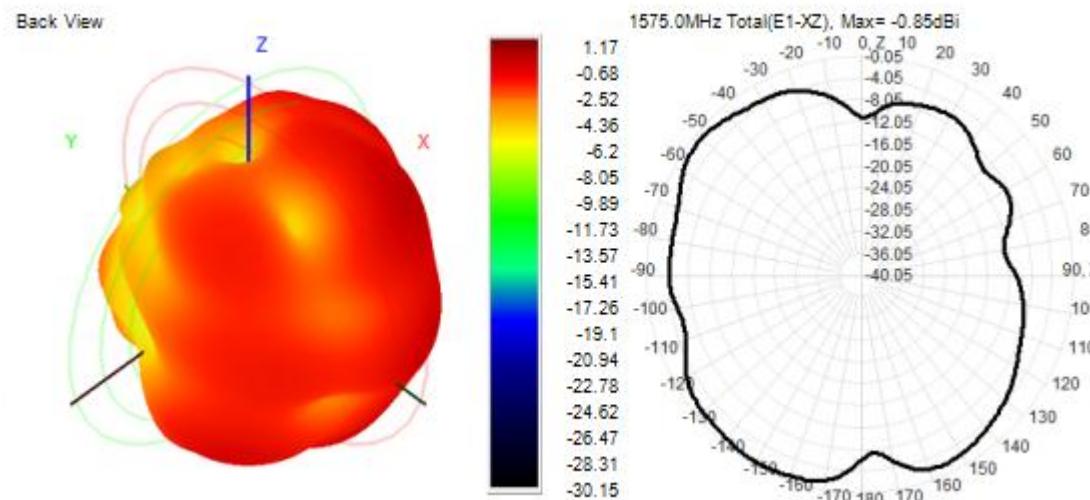
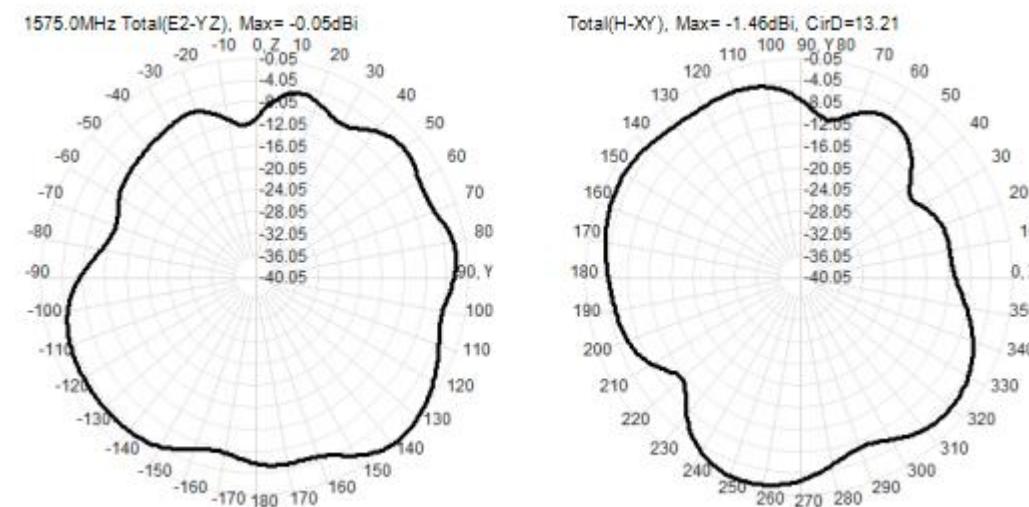
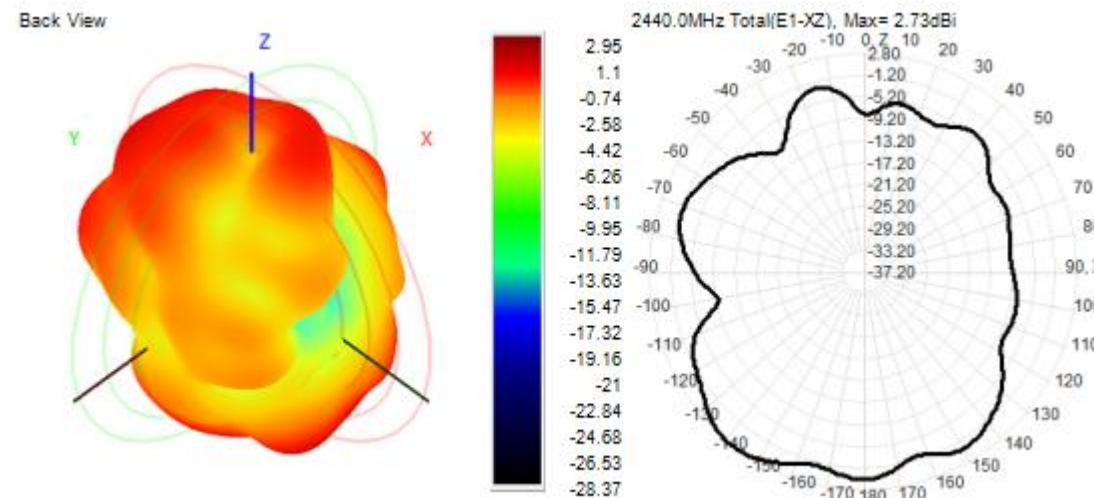
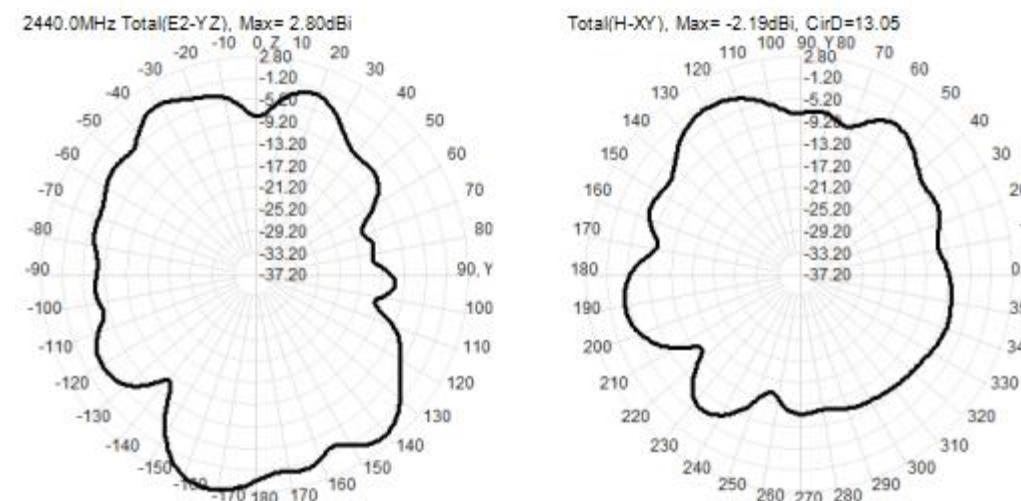
GPS antenna measurement, location:
Intersection of Ping'an Avenue
Weather: Sunny

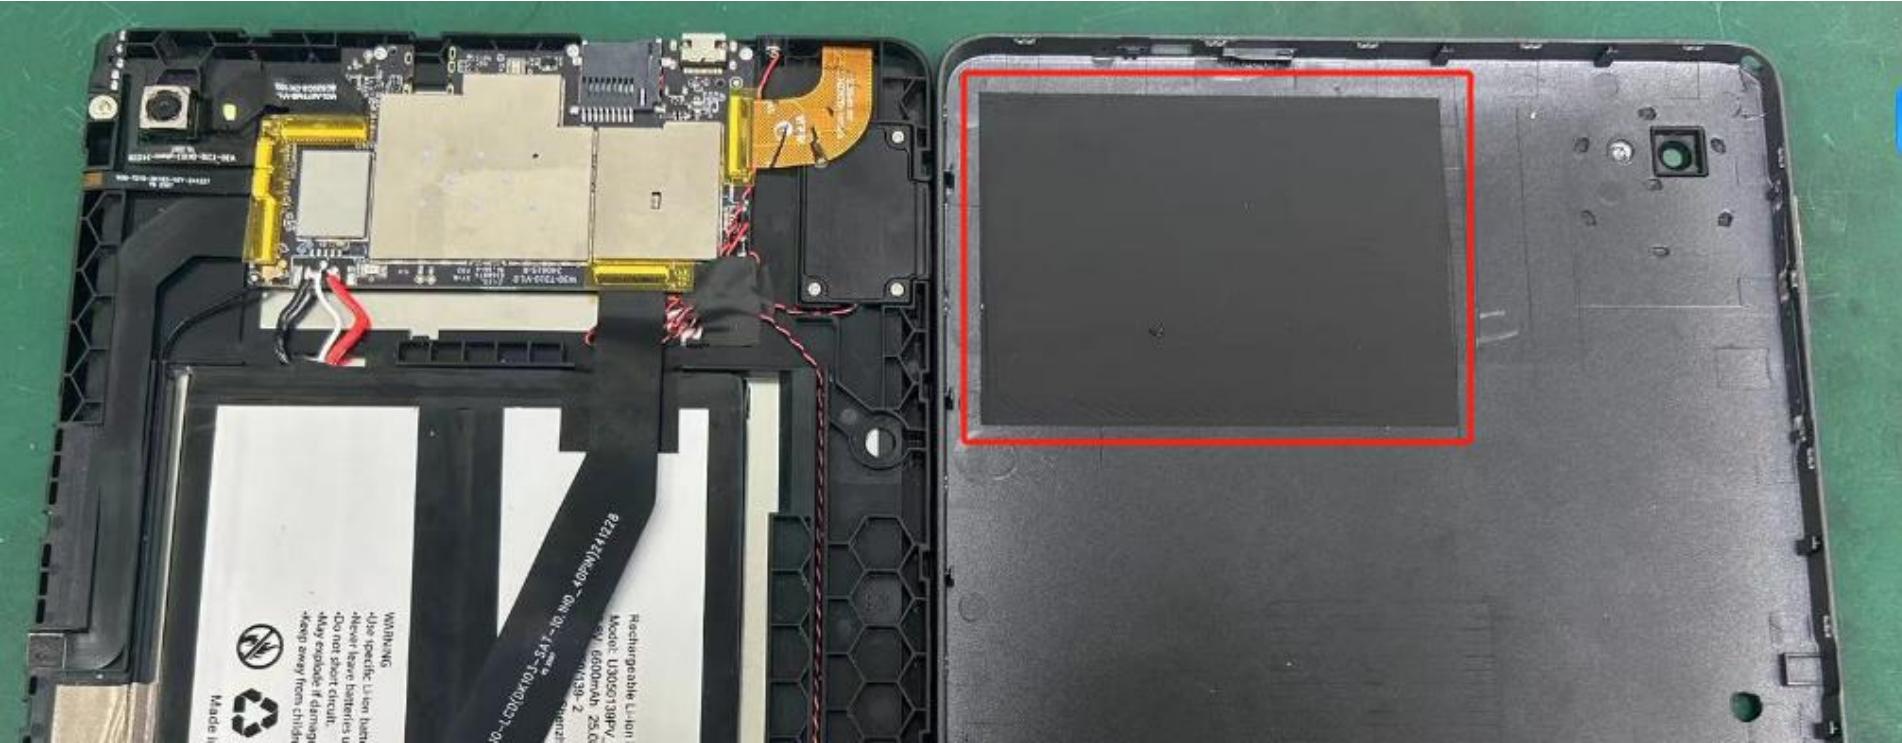
As shown in the red box in the figure: The newly added graphite sheet in the red box cannot extend above the motherboard RF chip.

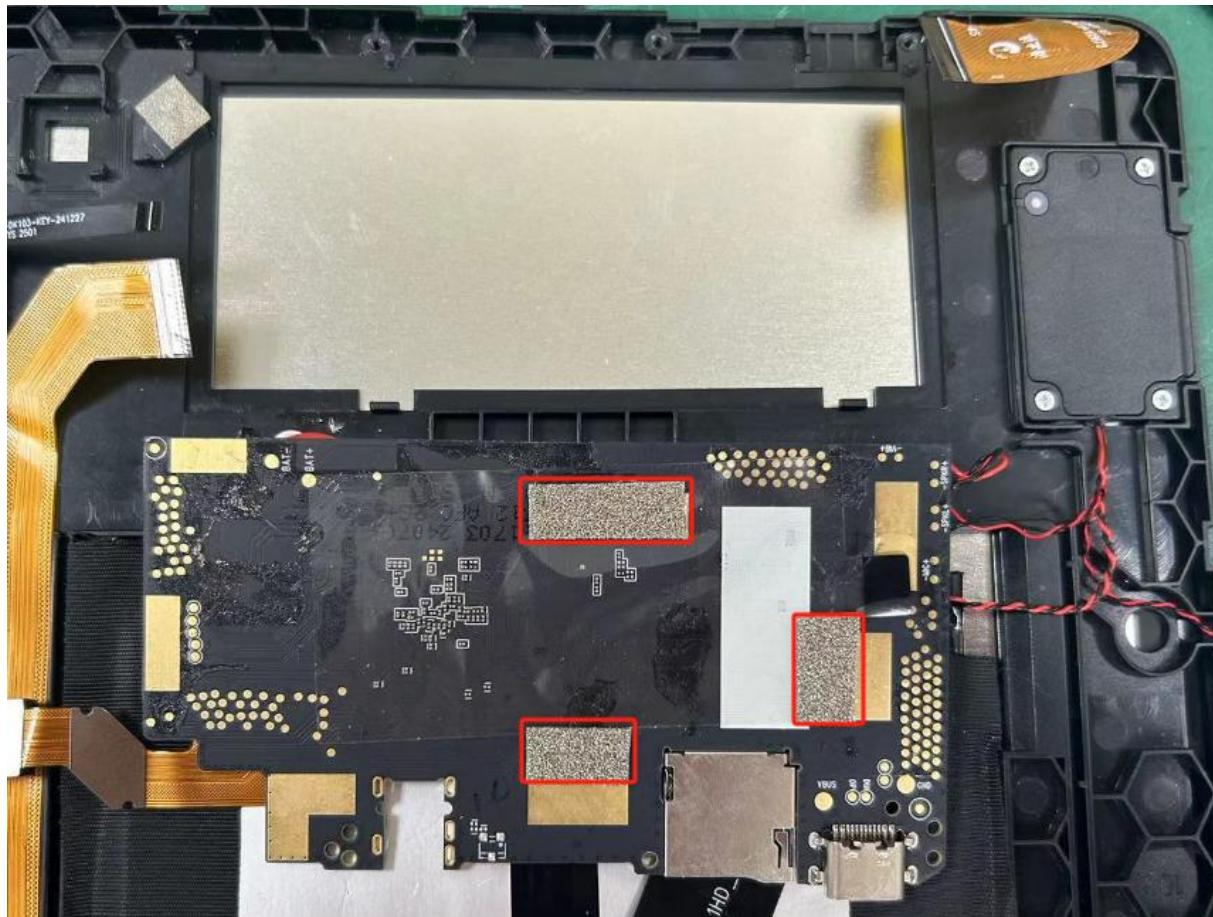
As shown in the red box in the figure: Increase the height of the back of the motherboard enough for the conductive sponge to be grounded to the screen metal. (Note: The exposed copper area on the back of the motherboard overlaps with the plastic bracket, and the conductive sponge should avoid the overlapping area.)

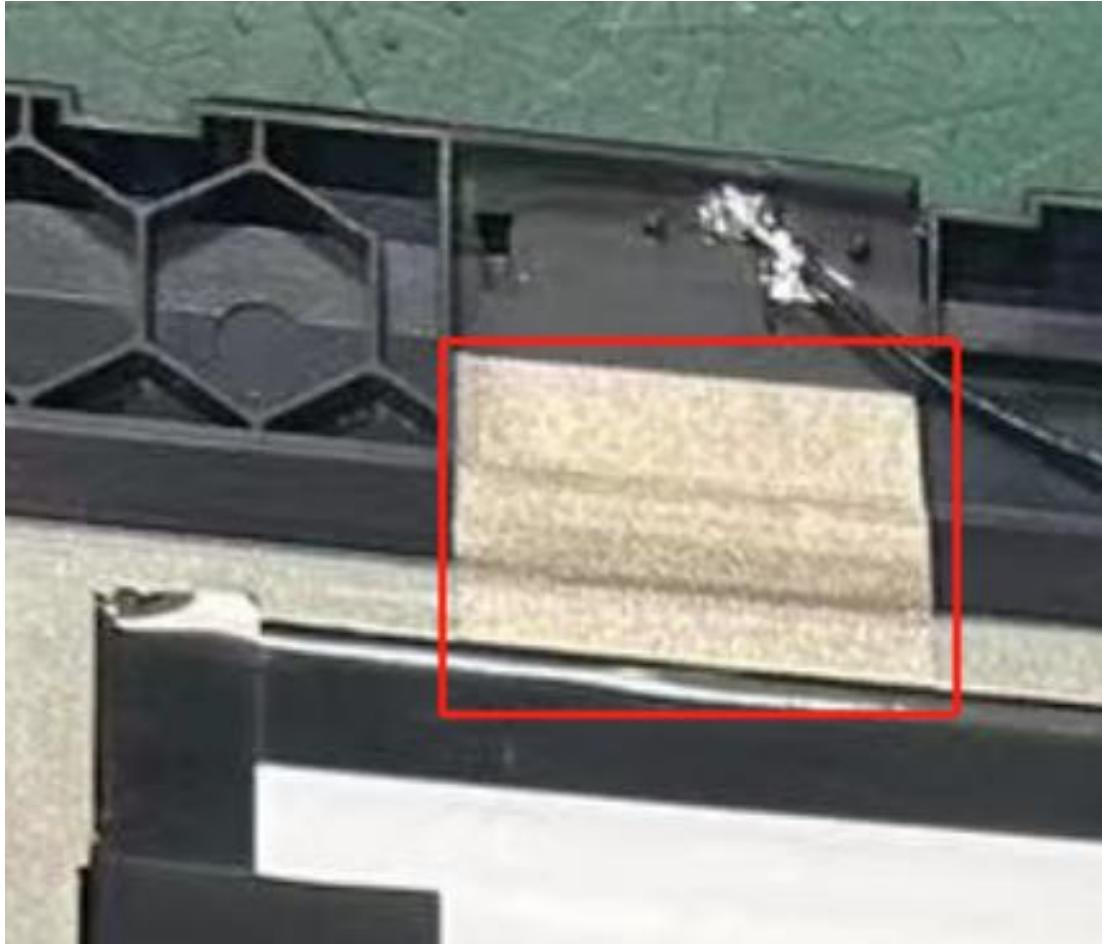
As shown in the red box in the figure, a large strip of conductive cloth is attached to the exposed copper area of the antenna and extended to the grounding of the screen metal area.

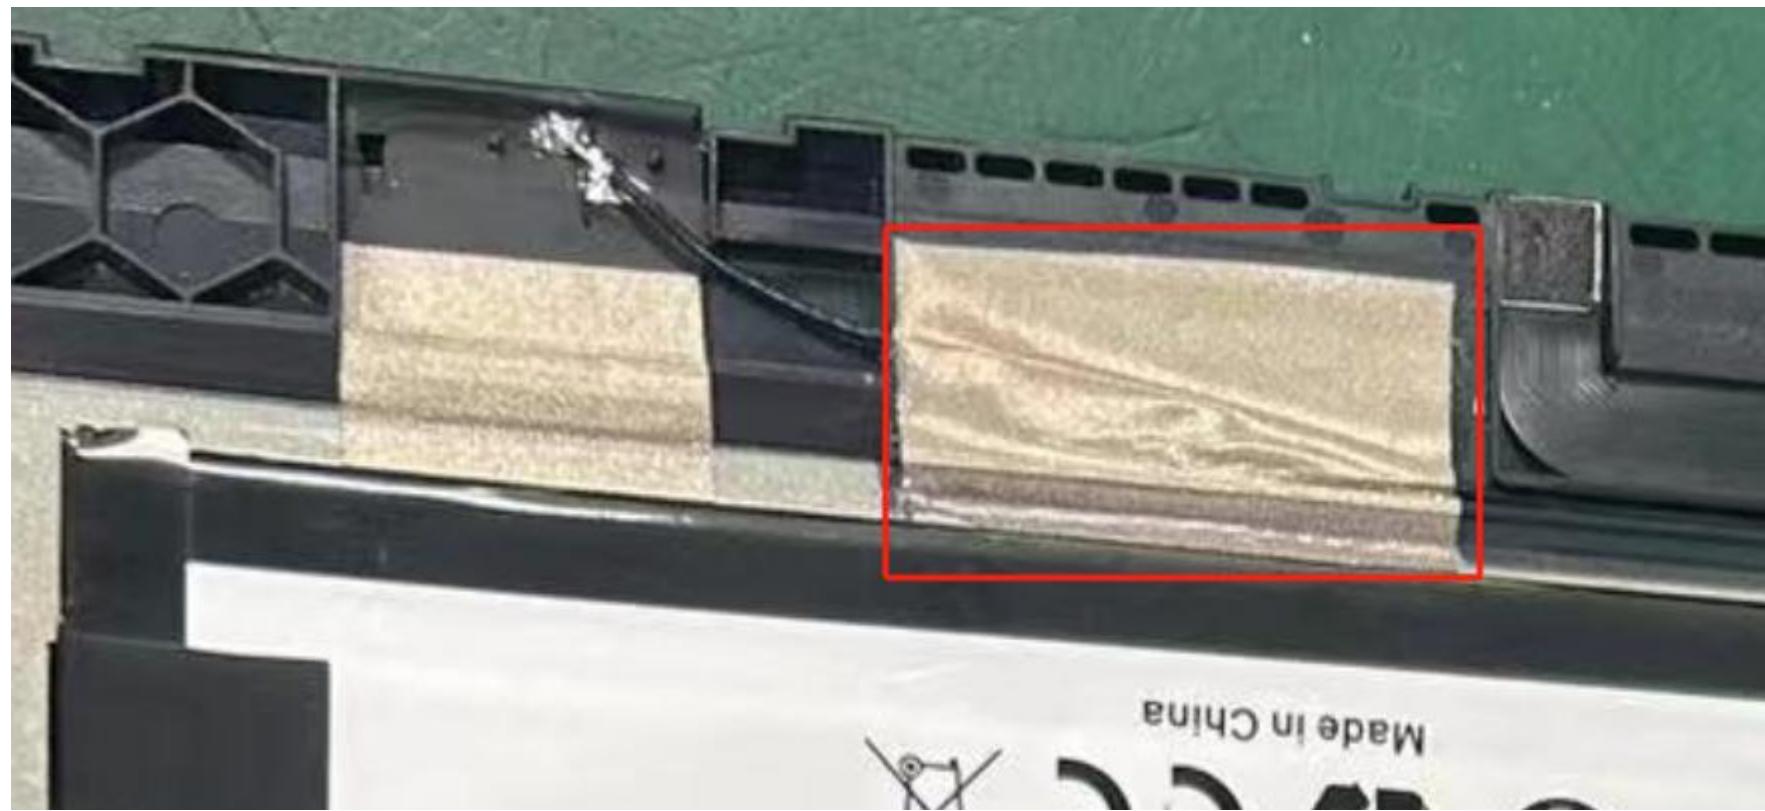
As shown in the red box in the figure, a large conductive cloth is added next to the antenna to cover the coaxial line and extend to the grounding point of the screen metal.

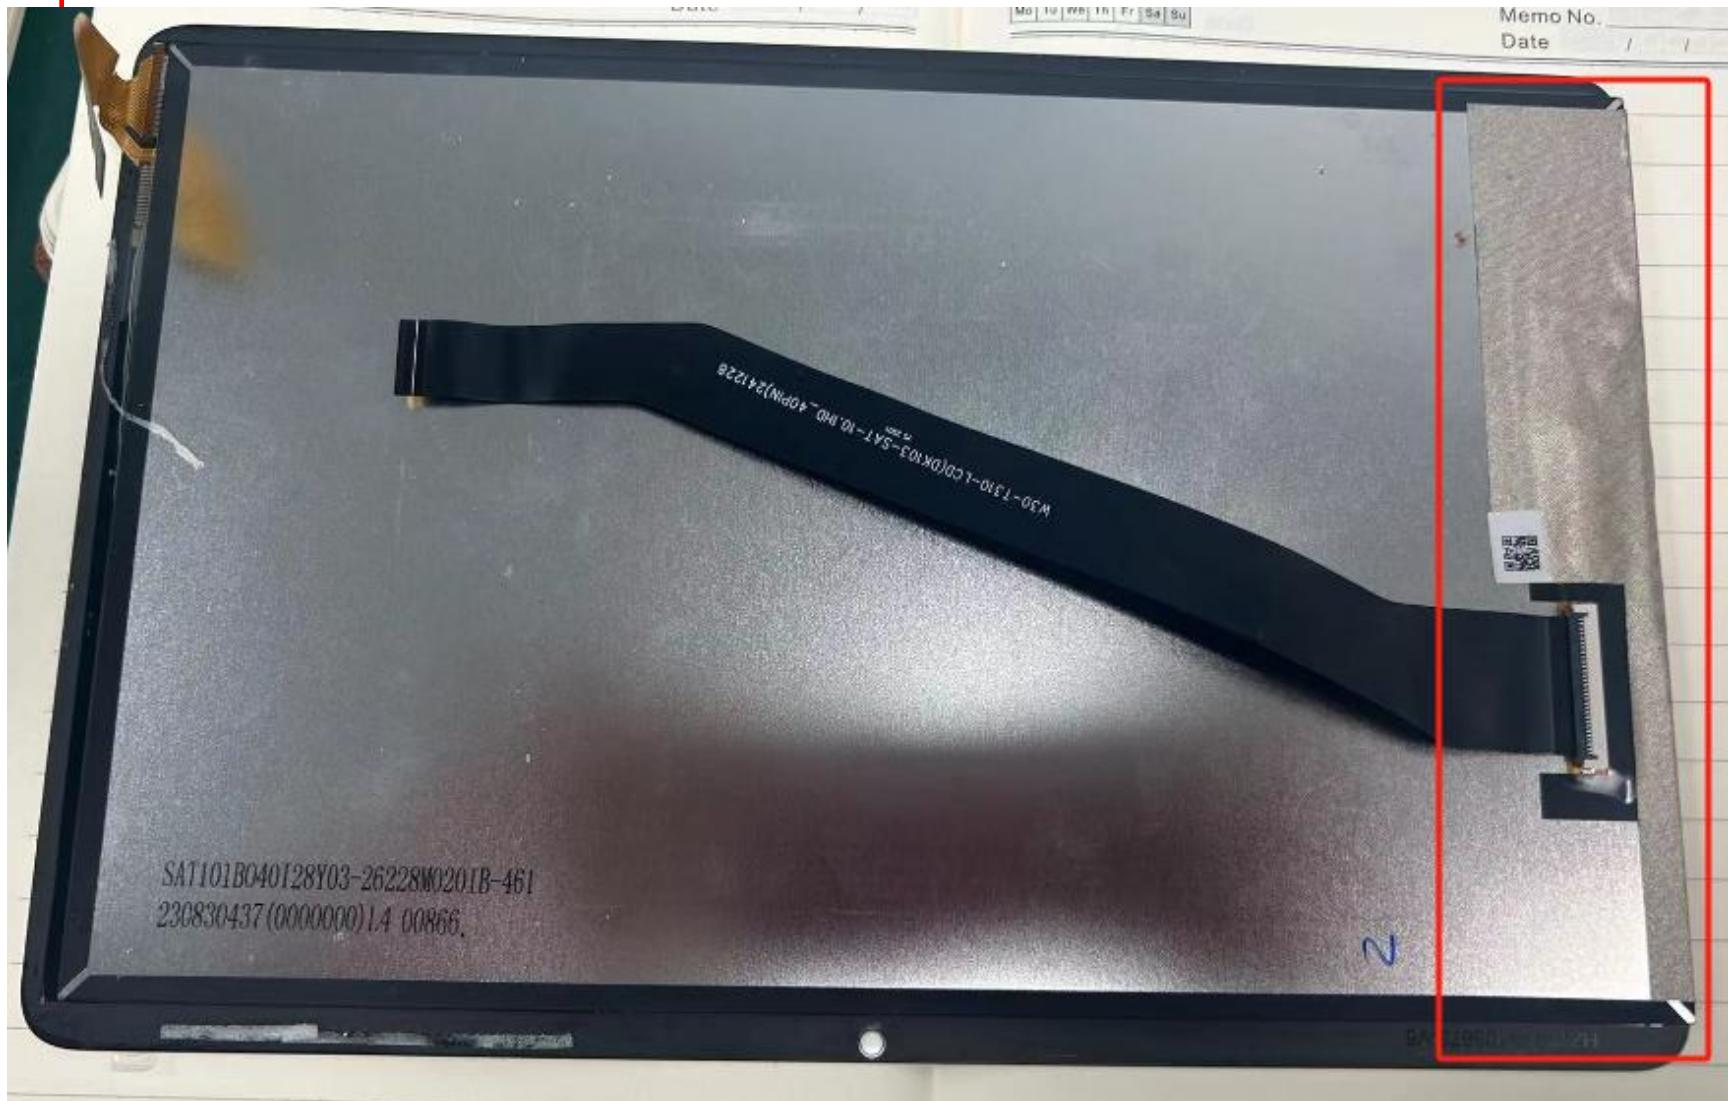
As shown in the red box in the figure, the screen cable, IC, etc. are covered with large conductive cloth for shielding, and the conductive cloth is extended and pasted back to the back.
