## APPENDIX A: PHOTOGRAPHS OF TEST SETUP

**APPENDIX B: PHOTOGRAPHS OF EUT**

Reference to the test report No. BLA-EMC-202301-A0101

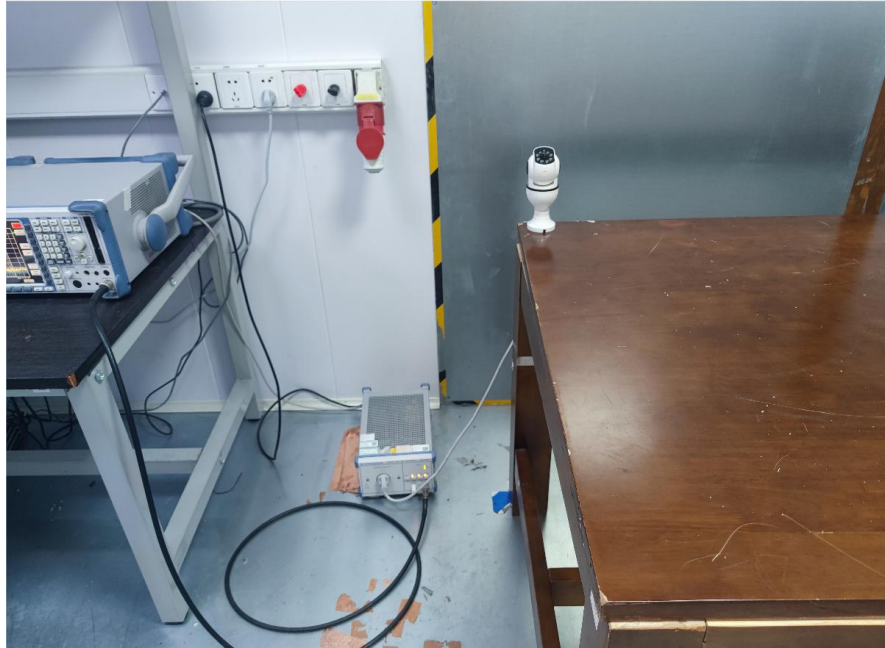
**Conducted Emissions at AC Power Line (150kHz-30MHz)**
