## Line Conducted Emission Test Line 2-N

**APPENDIX A: PHOTOGRAPHS OF TEST SETUP****RADIATED EMISSION TEST SETUP BELOW 1GHZ**

## APPENDIX B: PHOTOGRAPHS OF EUT

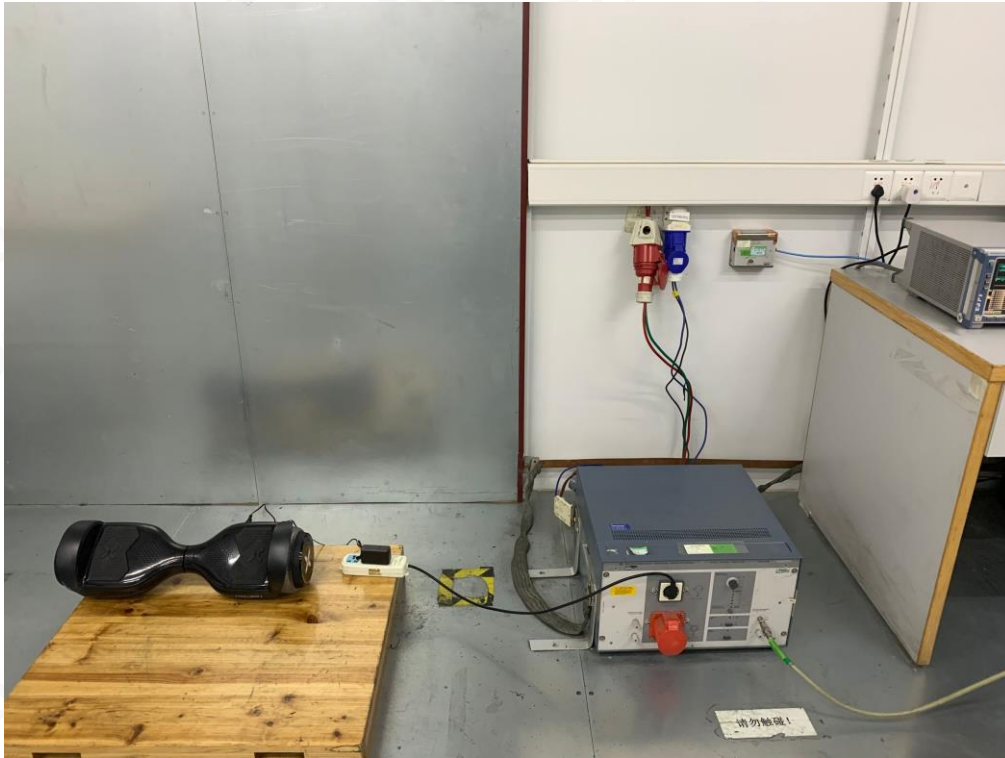
CONDUCTED EMISSION TEST SETUP
