Report No.: EED32P82119601 Page 32 of 45

9 PHOTOGRAPHS OF TEST SETUP

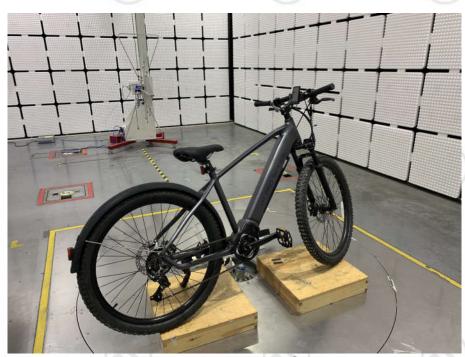
Radiated spurious emission Test Setup-1(Below 1GHz)

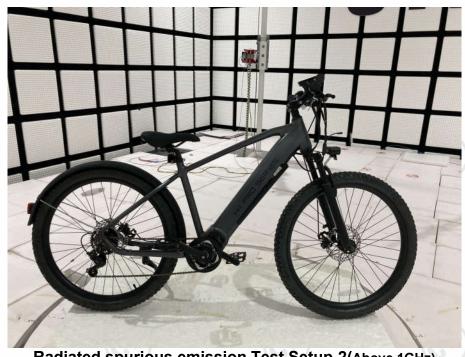
Radiated spurious emission Test Setup-2(Above 1GHz)

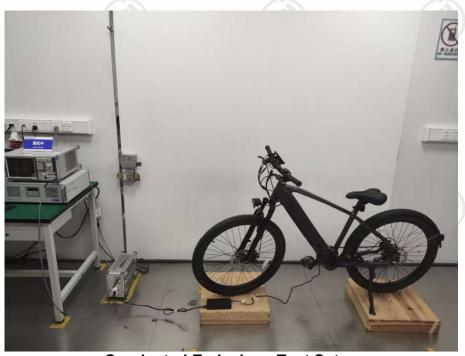
Conducted Emissions Test Setup
