ENVIRONMENTAL TEST REPORT NO. 4857-1

**MARINE RESCUE TECHNOLOGIES LTD
MARSHALL HOUSE
ZARYA COURT
GROVEHILL ROAD
BEVERLEY
YORKSHIRE
HU17 0JG**

3 off personal locator beacons, Model No AU10

Test Performed:		
Process 1	Altitude	UKAS
Process 2	Temperature variation	UKAS
Process 3	Operational vibration	UKAS
Process 4	Operational shock & crash safety (Impulse)	UKAS
Process 5	Icing	UKAS
Process 6	Crash safety (Sustained)	UKAS
Process 7	Functional Test	Non UKAS

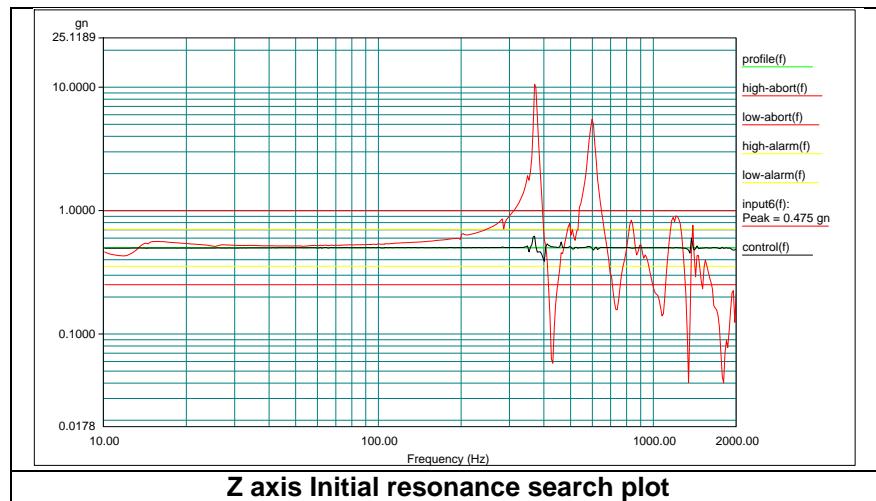
Resonance search test details	
Frequency (Hz)	Acceleration (g)
10	0.5
2000	0.5
Sweep rate 1 oct/min

Z axis Initial resonance search plot
