7. Test Setup Photos

Report No.: DDT-15Q00730-1E6

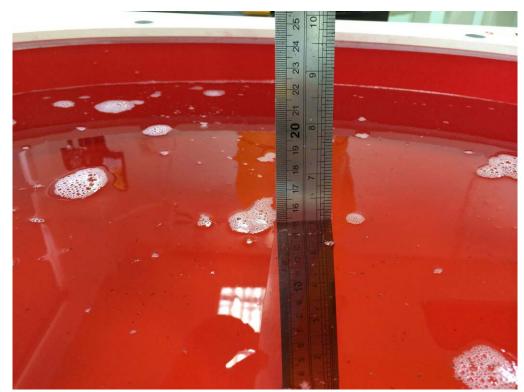
Photograph of the depth in the Head Phantom (450MHz)

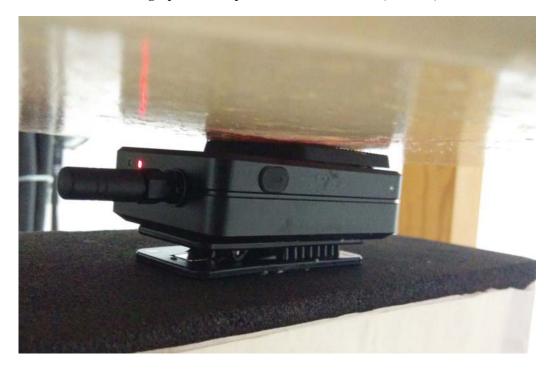
the front of the EUT towards phantom (The distance was 0mm)

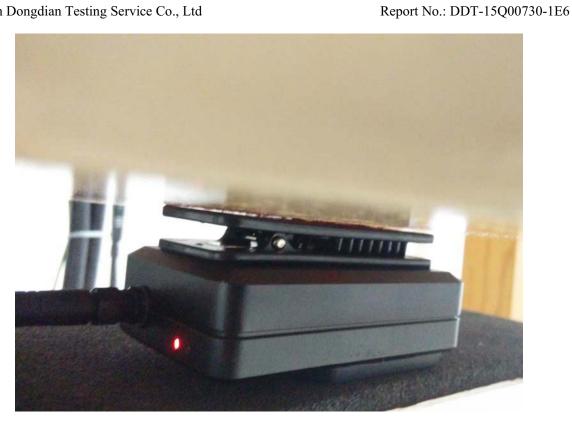
the Back of the EUT towards phantom (The distance was 0mm)

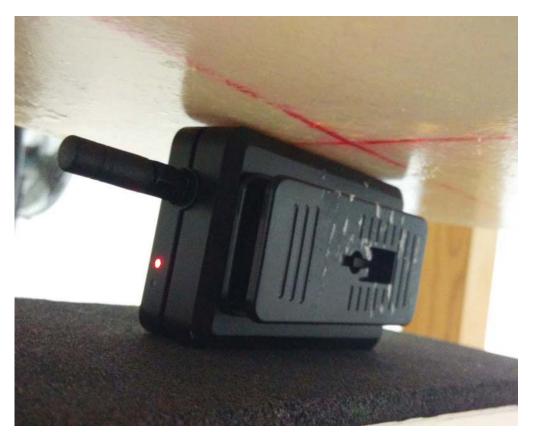
the Left of the EUT towards phantom (The distance was 0mm)

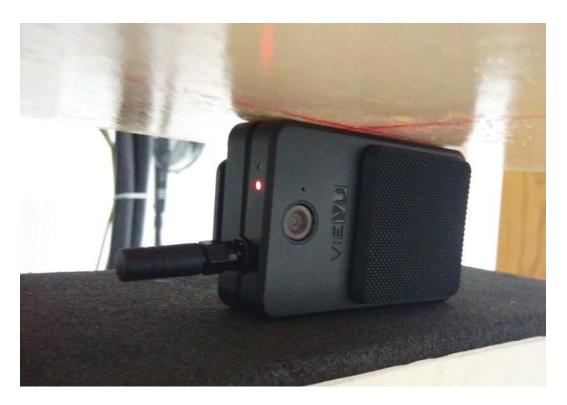
the Right of the EUT towards phantom (The distance was 0mm)

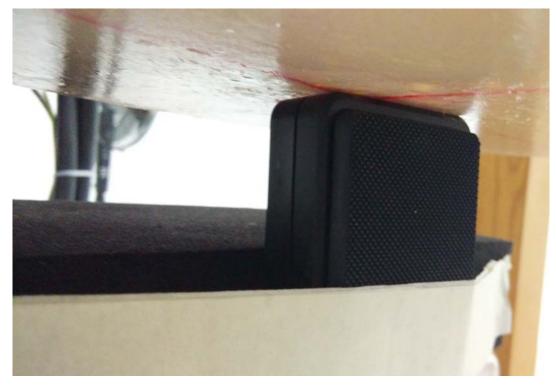
the Bottom of the EUT towards phantom (The distance was 0mm)
