*Title:* AIR 10 INTERNAL PHOTOGRAPHS -  
COMPARISON

*Project/Product* AIR 10

This document contains the comparison of internal photographs of the below Air 10 models.

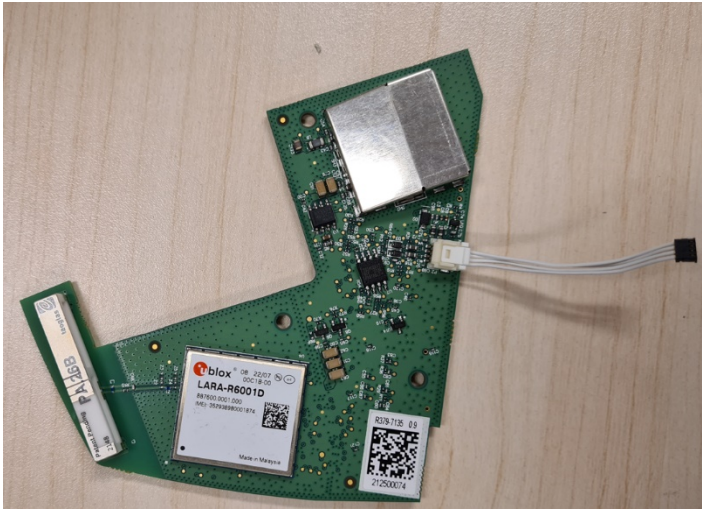
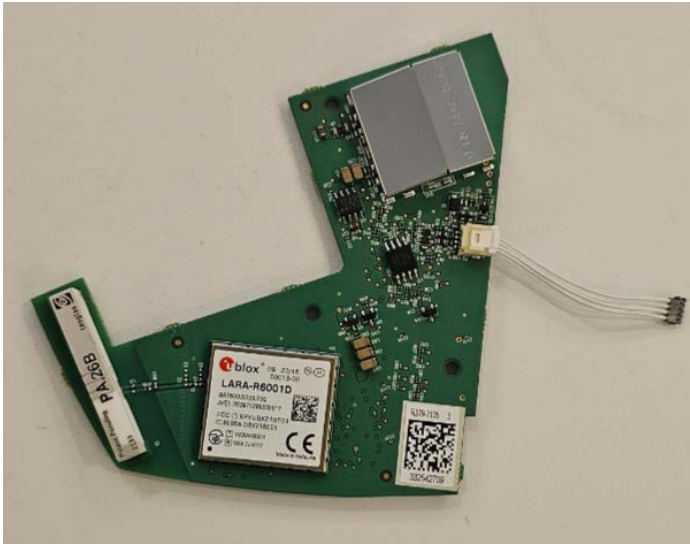
| View | Photographs applicable to 37158, 37159, 37160, 37161, 37162, 37163, 37164, 37165 | Photographs applicable to 28541, 28542, 28405 | Remark |
|---|---|---|---|
| CAM<br>PCBA<br>Top<br>View | | | Both boards are identical. |

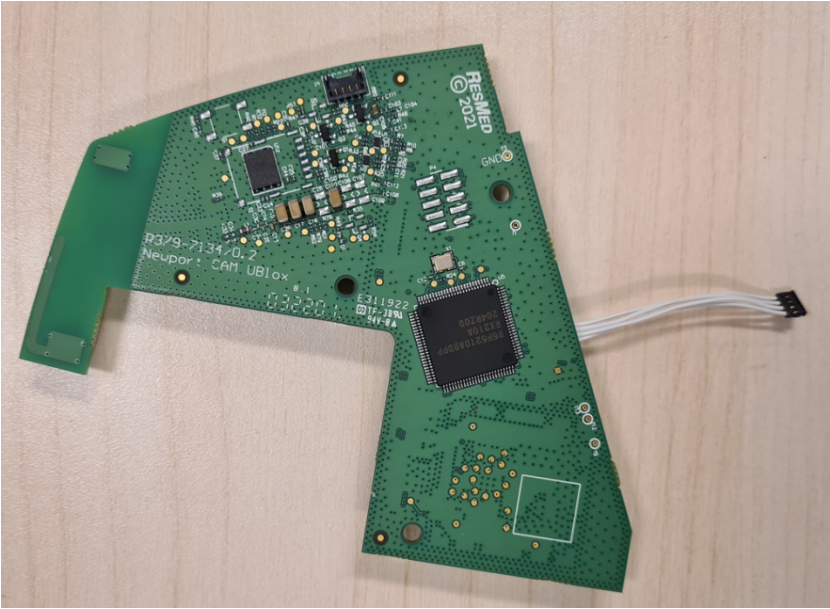
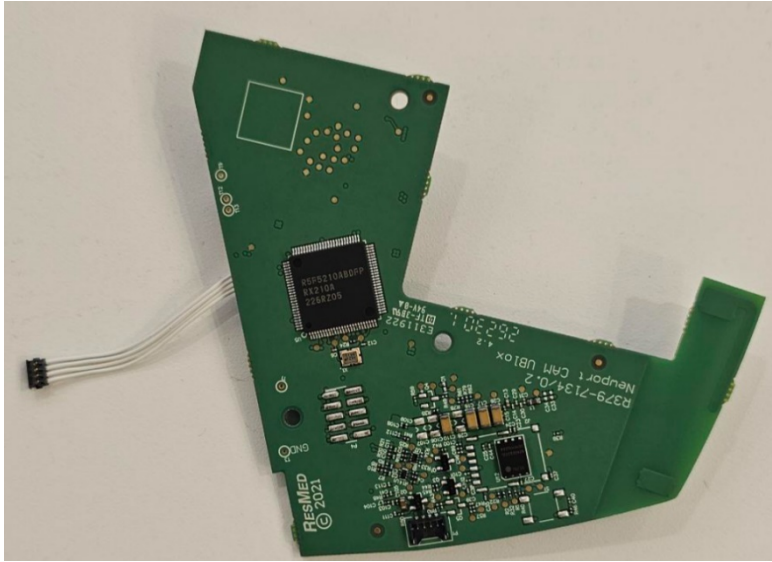
| View | Photographs applicable to 37158, 37159, 37160, 37161, 37162, 37163, 37164, 37165 | Photographs applicable to 28541, 28542, 28405 | Remark |
|---|---|---|---|
| CAM<br>PCBA<br>Bottom<br>View | | | Both boards<br>are identical |

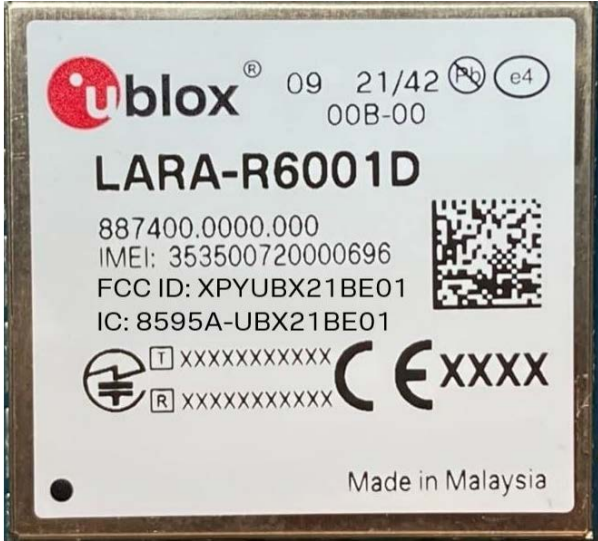
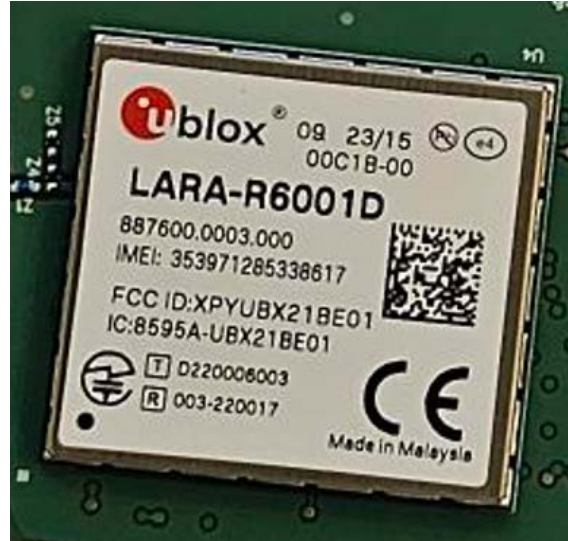
| View | Photographs applicable to 37158, 37159, 37160, 37161, 37162, 37163, 37164, 37165 | Photographs applicable to 28541, 28542, 28405 | Remark |
|---|---|---|---|
| Cellular Module | | | Cellular module is identical |

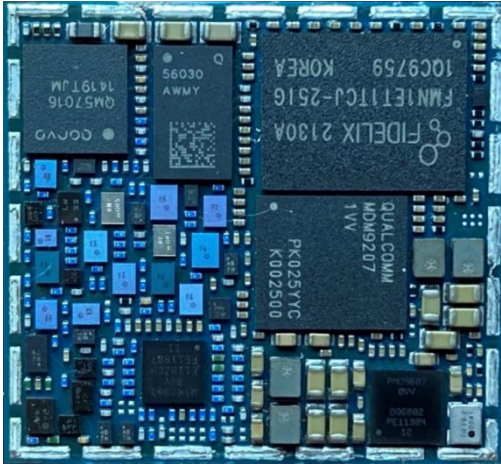
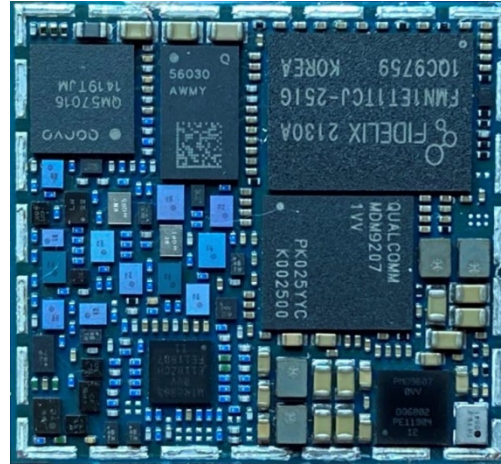
| View | Photographs applicable to 37158, 37159, 37160, 37161, 37162, 37163, 37164, 37165 | Photographs applicable to 28541, 28542, 28405 | Remark |
|---|---|---|---|
| Cellular Module without shield | | | Cellular module is identical |

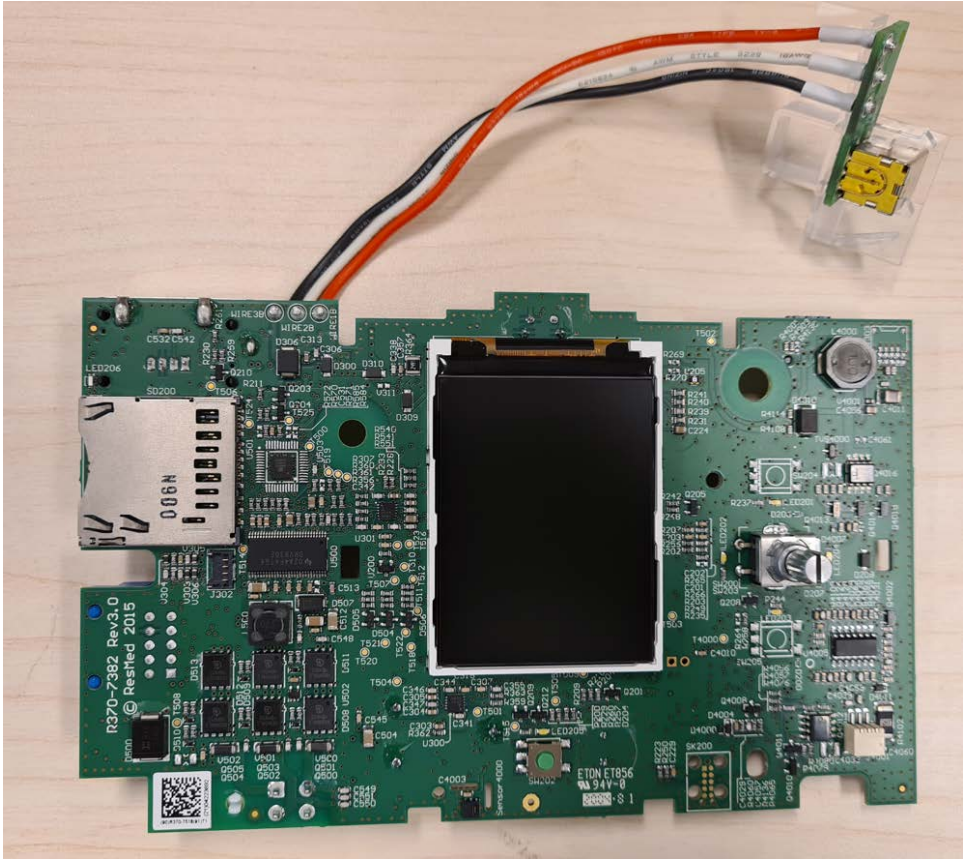
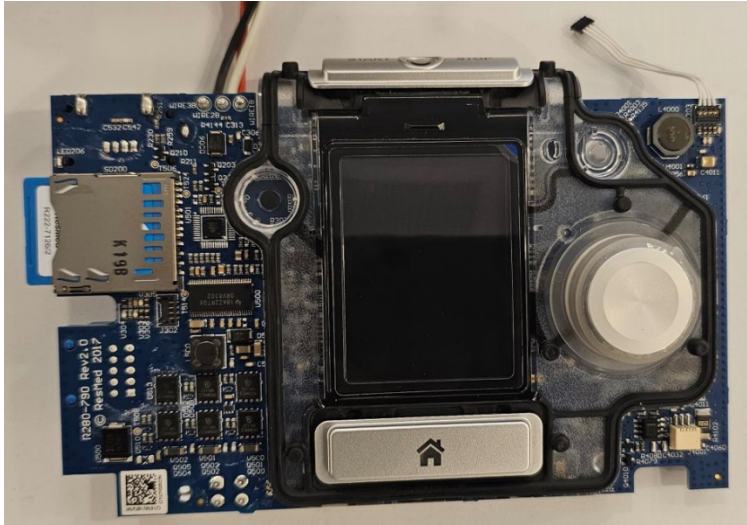
| View | Photographs applicable to 37158, 37159, 37160, 37161, 37162, 37163, 37164, 37165 | Photographs applicable to 28541, 28542, 28405 | Remark |
|---|---|---|---|
| Main PCBA Top View | | | Top view of the boards are identical |

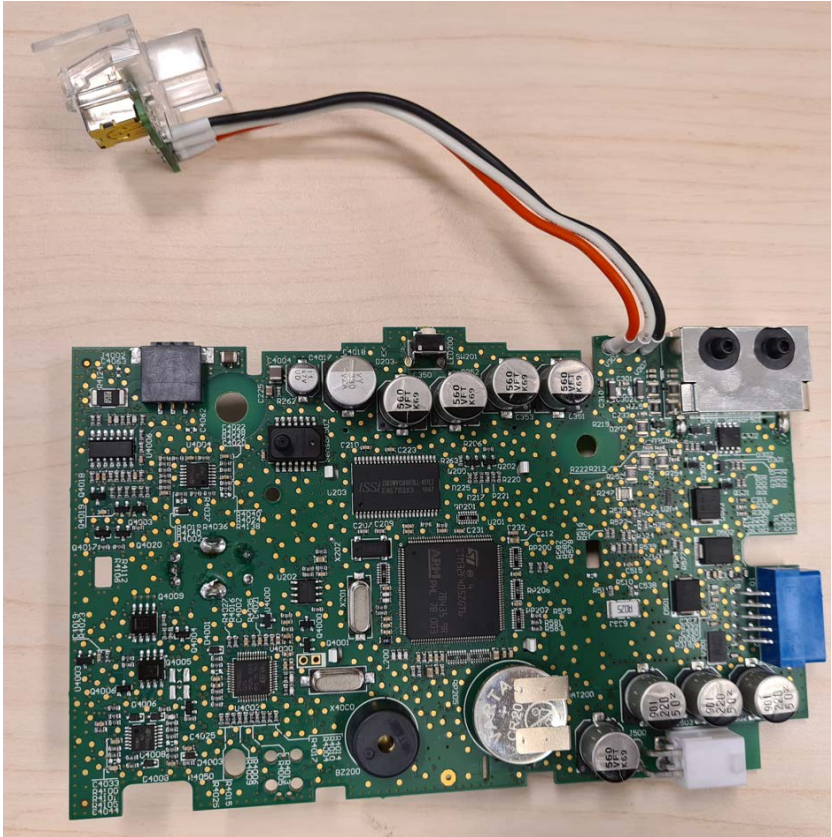
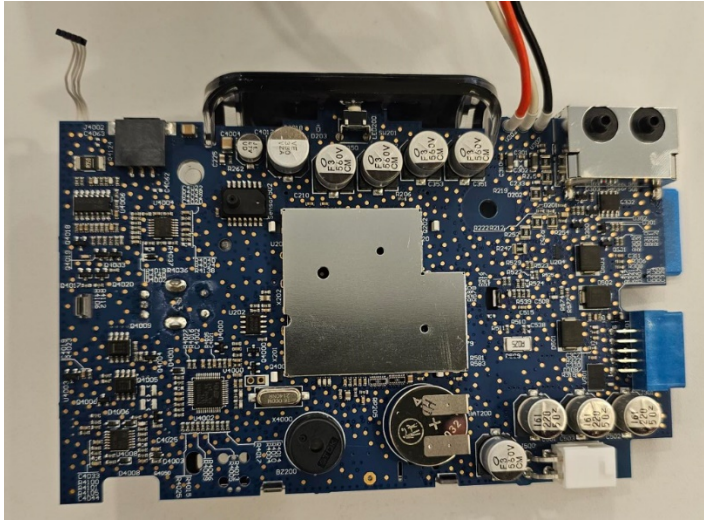
| View | Photographs applicable to 37158, 37159, 37160, 37161, 37162, 37163, 37164, 37165 | Photographs applicable to 28541, 28542, 28405 | Remark |
|---|---|---|---|
| Main PCBA Bottom View | | | The only difference is the shield on main microcontroller. |

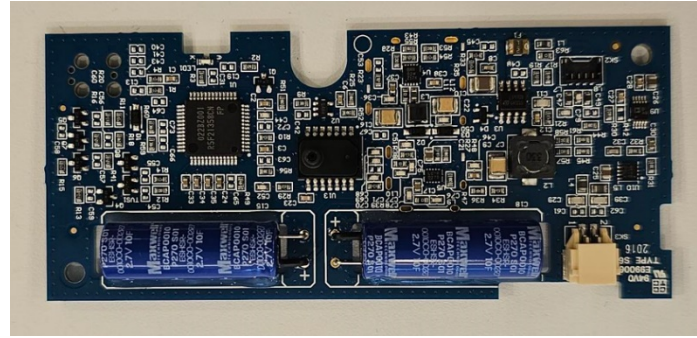
| View | Photographs applicable to 37158, 37159, 37160, 37161, 37162, 37163, 37164, 37165 | Photographs applicable to 28541, 28542, 28405 | Remark |
|---|---|---|---|
| Alarms PCBA Top View | Not present | | Additional PCBA on 28541, 28542 and 28405 for alarm purposes. |

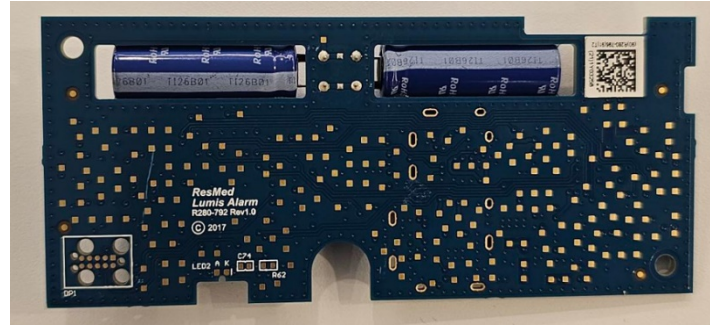
| View | Photographs applicable to 37158, 37159, 37160, 37161, 37162, 37163, 37164, 37165 | Photographs applicable to 28541, 28542, 28405 | Remark |
|---|---|---|---|
| Alarms PCBA Bottom View | Not present | | |

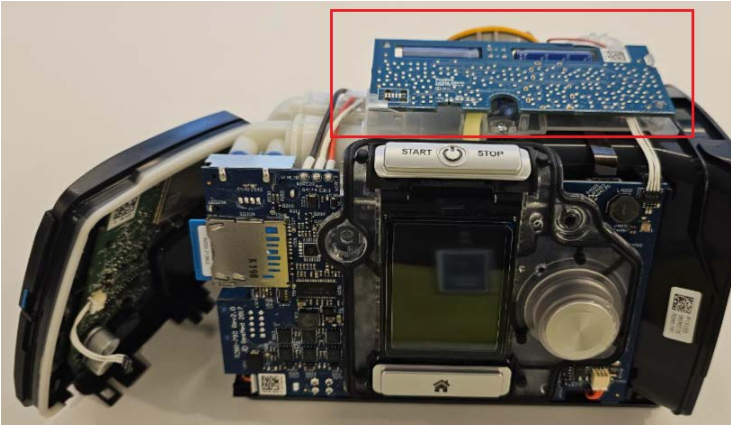
| View | Photographs applicable to 37158, 37159, 37160, 37161, 37162, 37163, 37164, 37165 | Photographs applicable to 28541, 28542, 28405 | Remark |
|---|---|---|---|
| Location of Alarms PCBA | Alarms PCBA not present. | | Image provided for location identification. |
