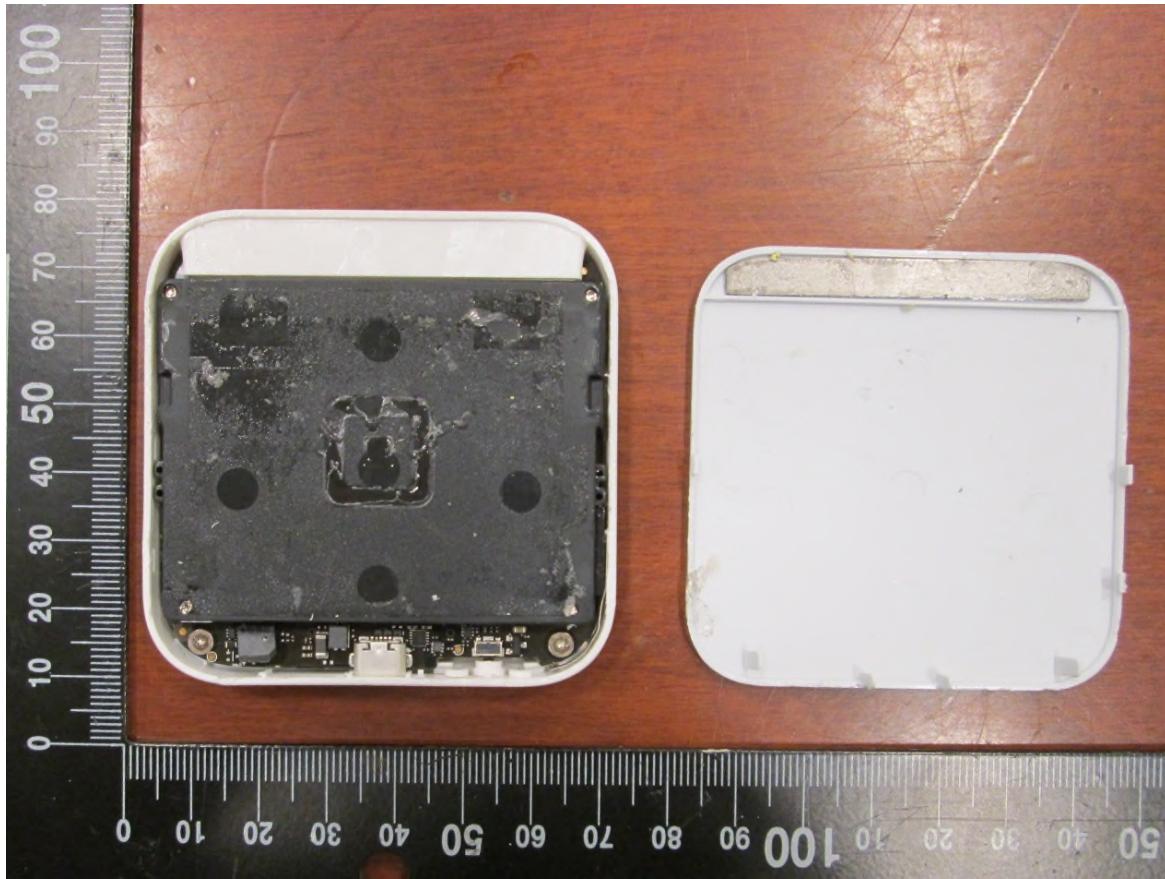
EUT – Internal view 1
Back cover removed.

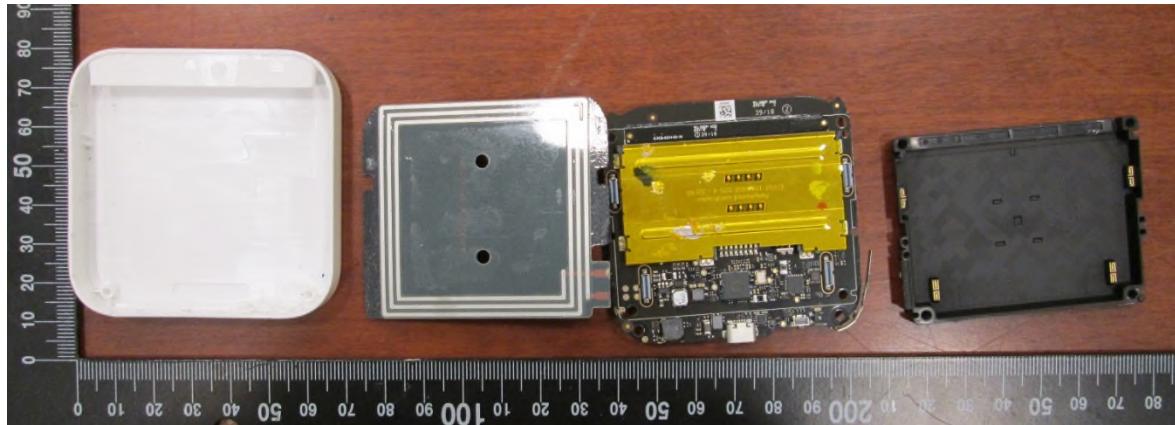
EUT – Internal view 3
Cage removed.
Cover removed over 13.56 MHz antenna.

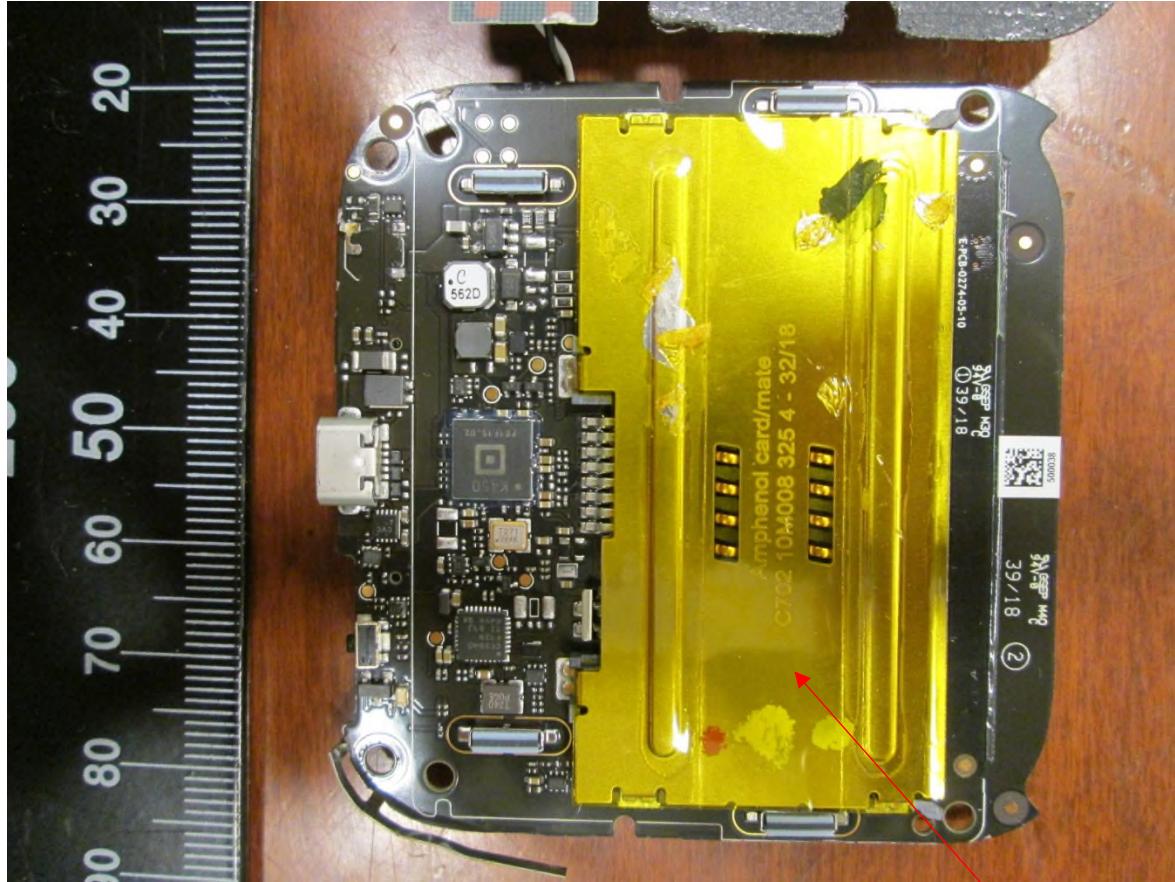
EUT – Internal view 5
Close-up of PCB side 1, alternate view

Contact card socket
soldered directly onto the
PCB. Not a shield. No
components under this part.
