## Appendix G: Band edge measurements

## Appendix H: Conducted Spurious Emission Test Result

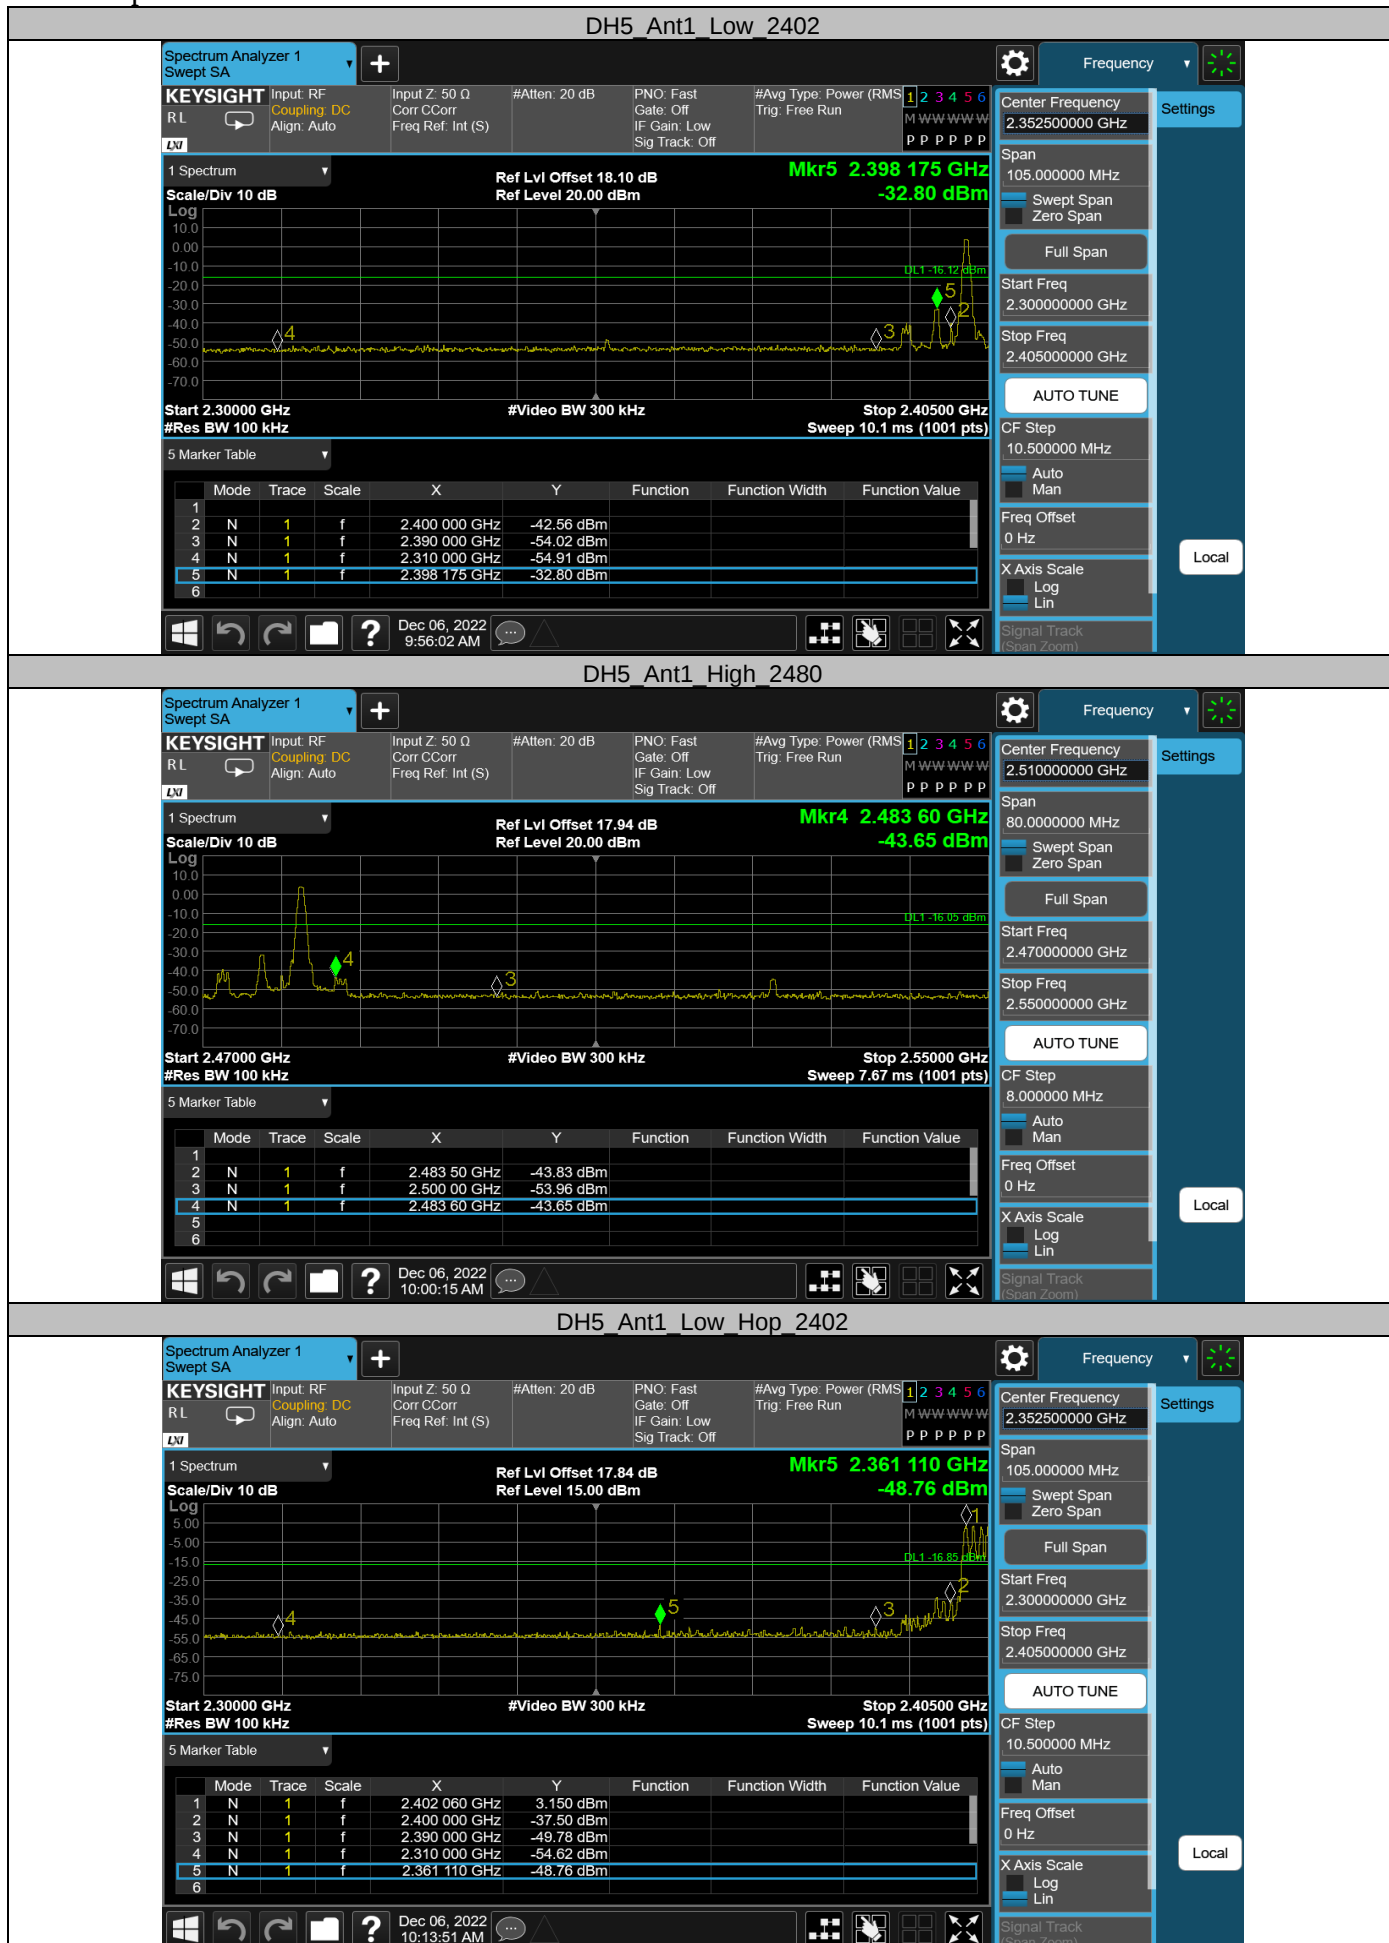
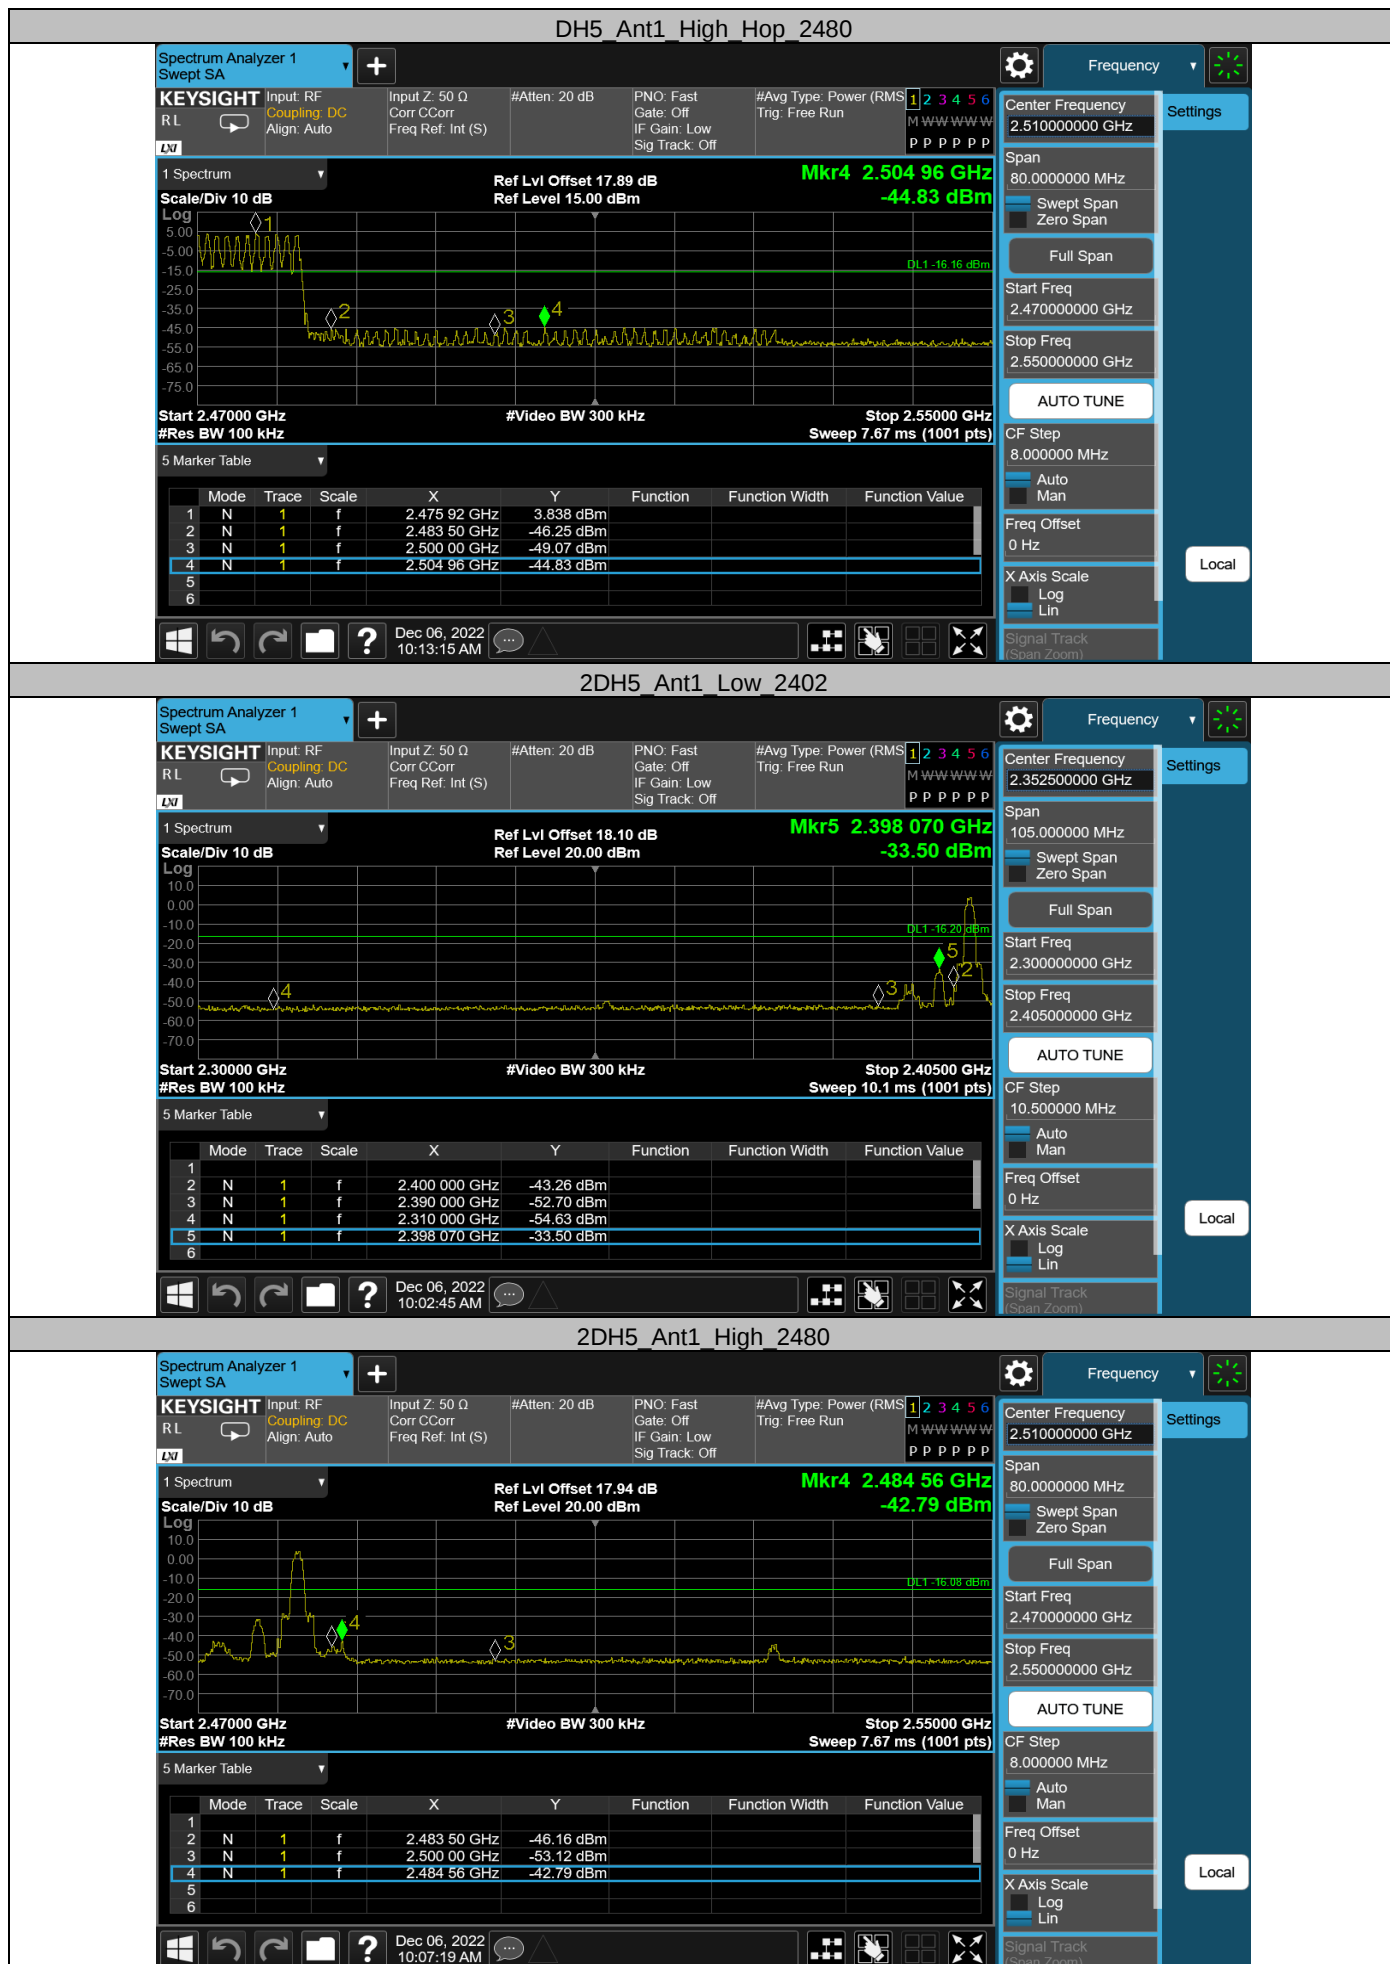
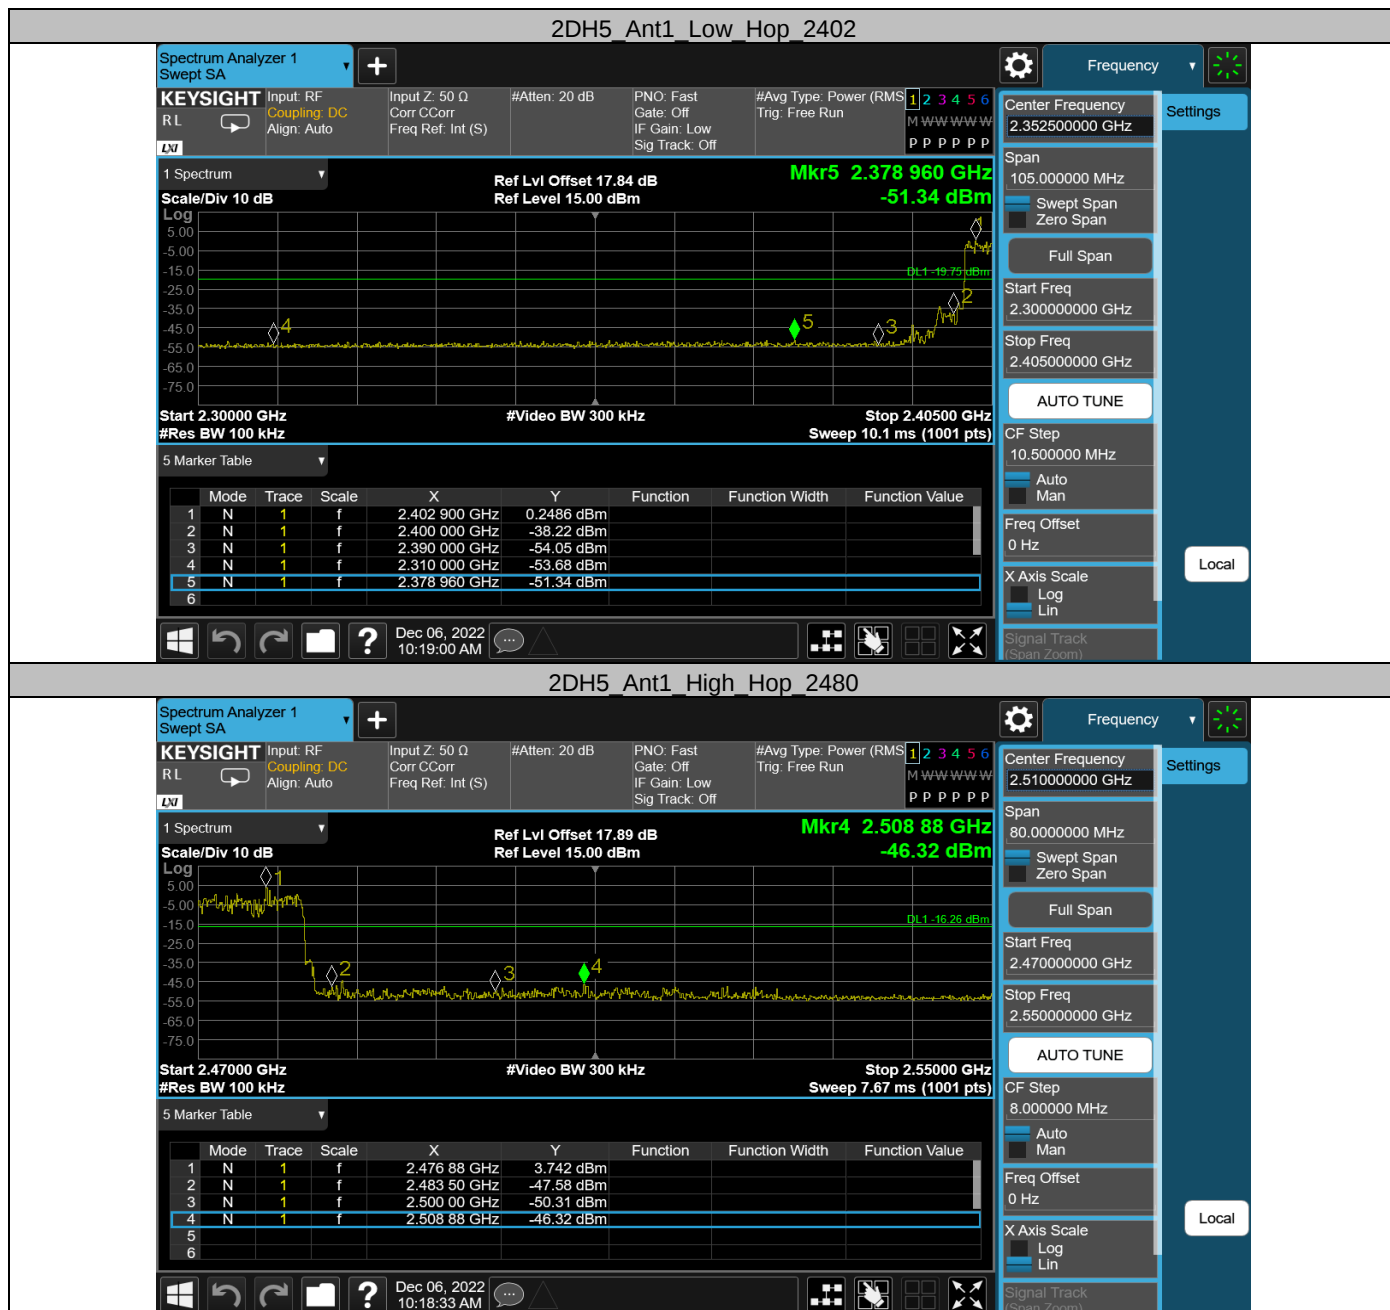
## Test Graphs

| Test Mode | Antenna | Ch Name | Freq(MHz) | Ref Level [dBm] | Result [dBm] | Limit [dBm] | Verdict |

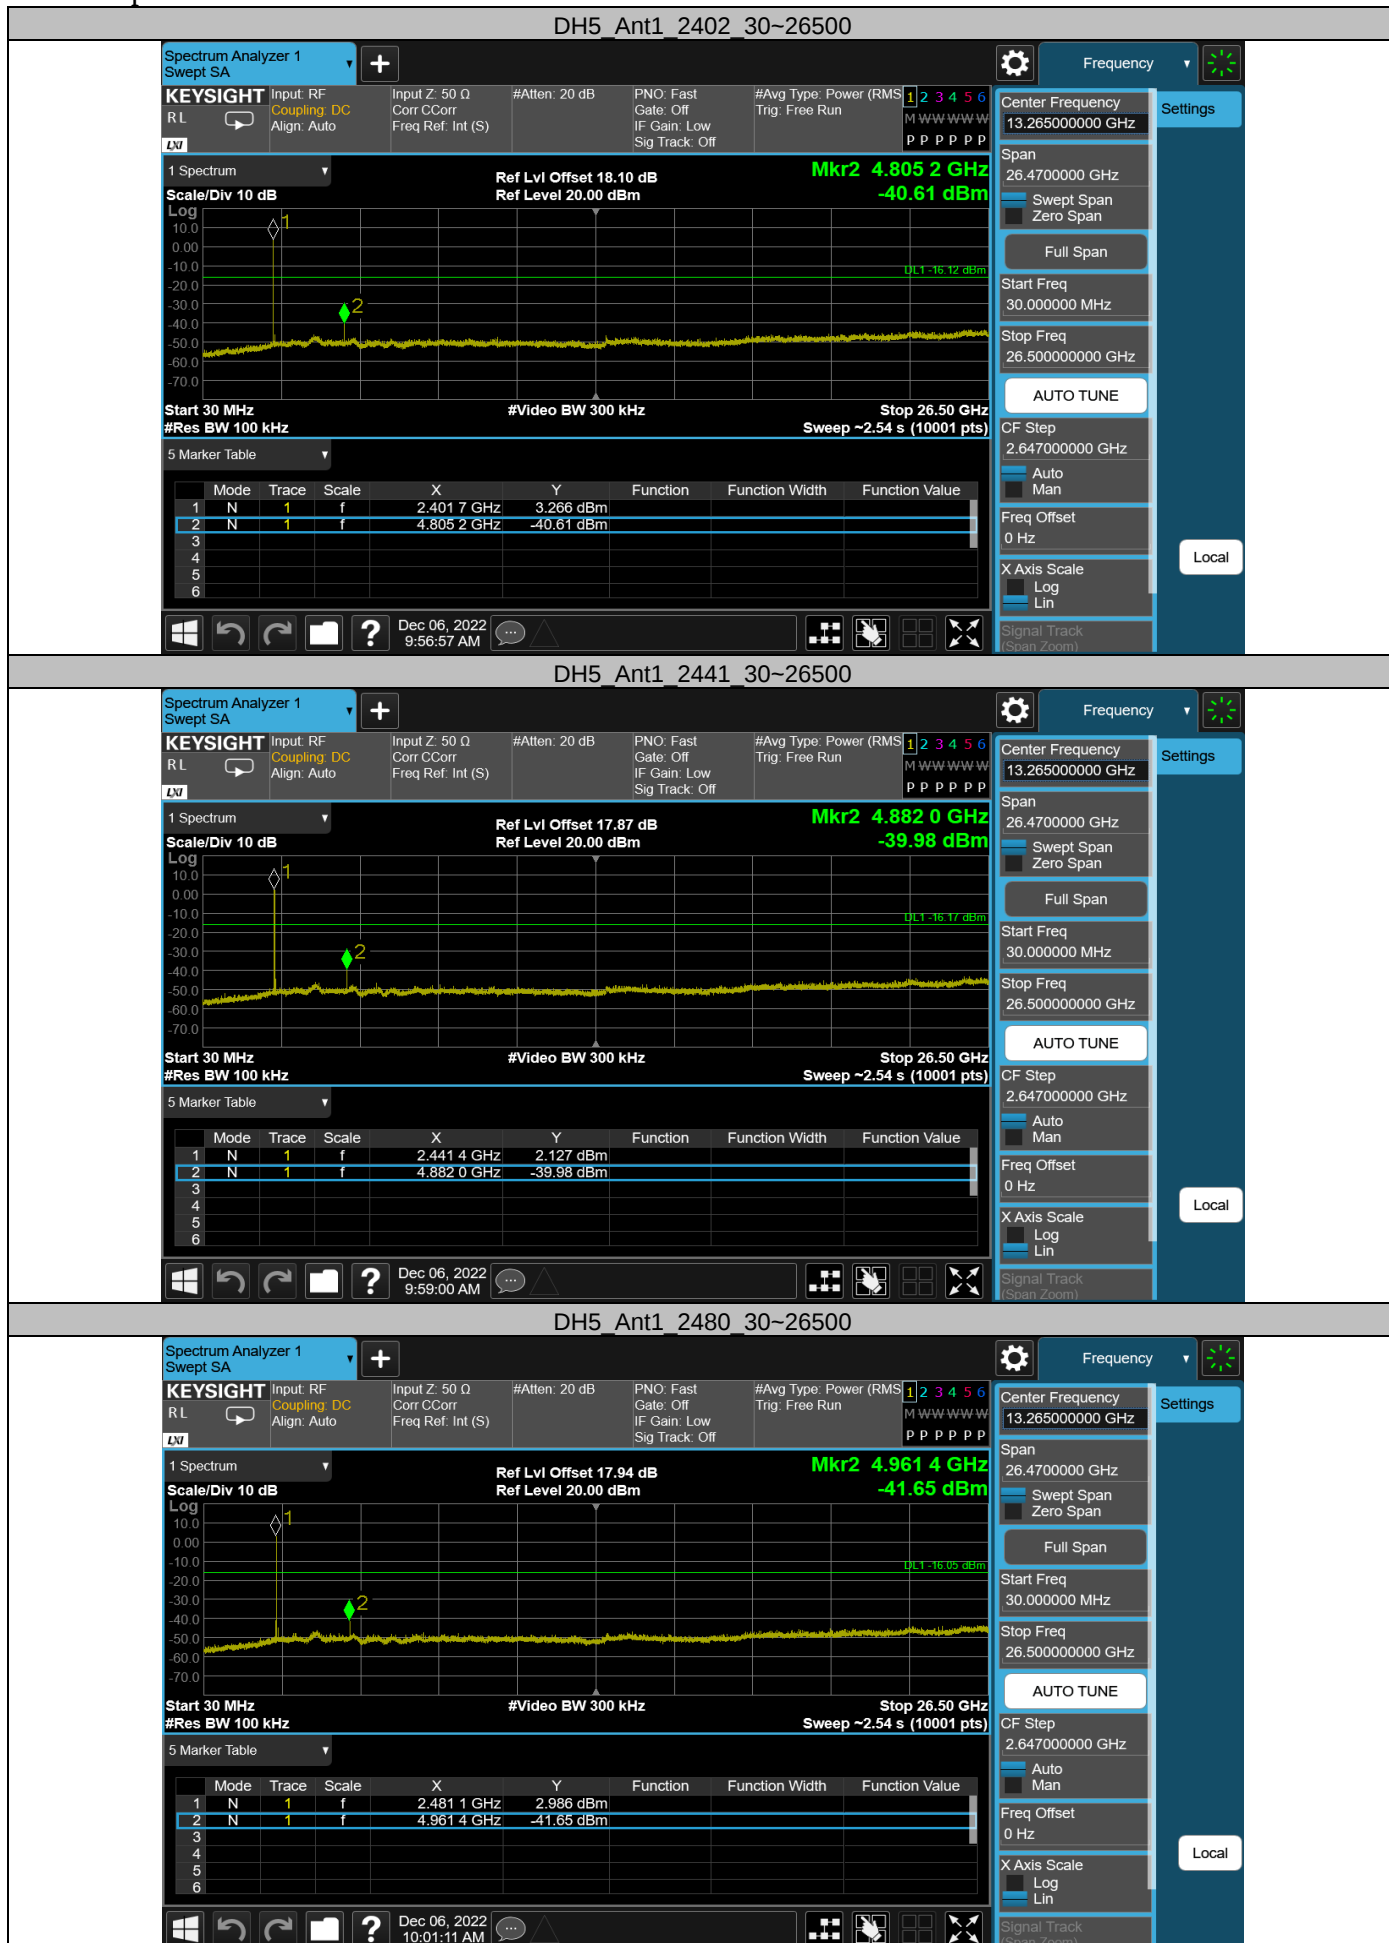
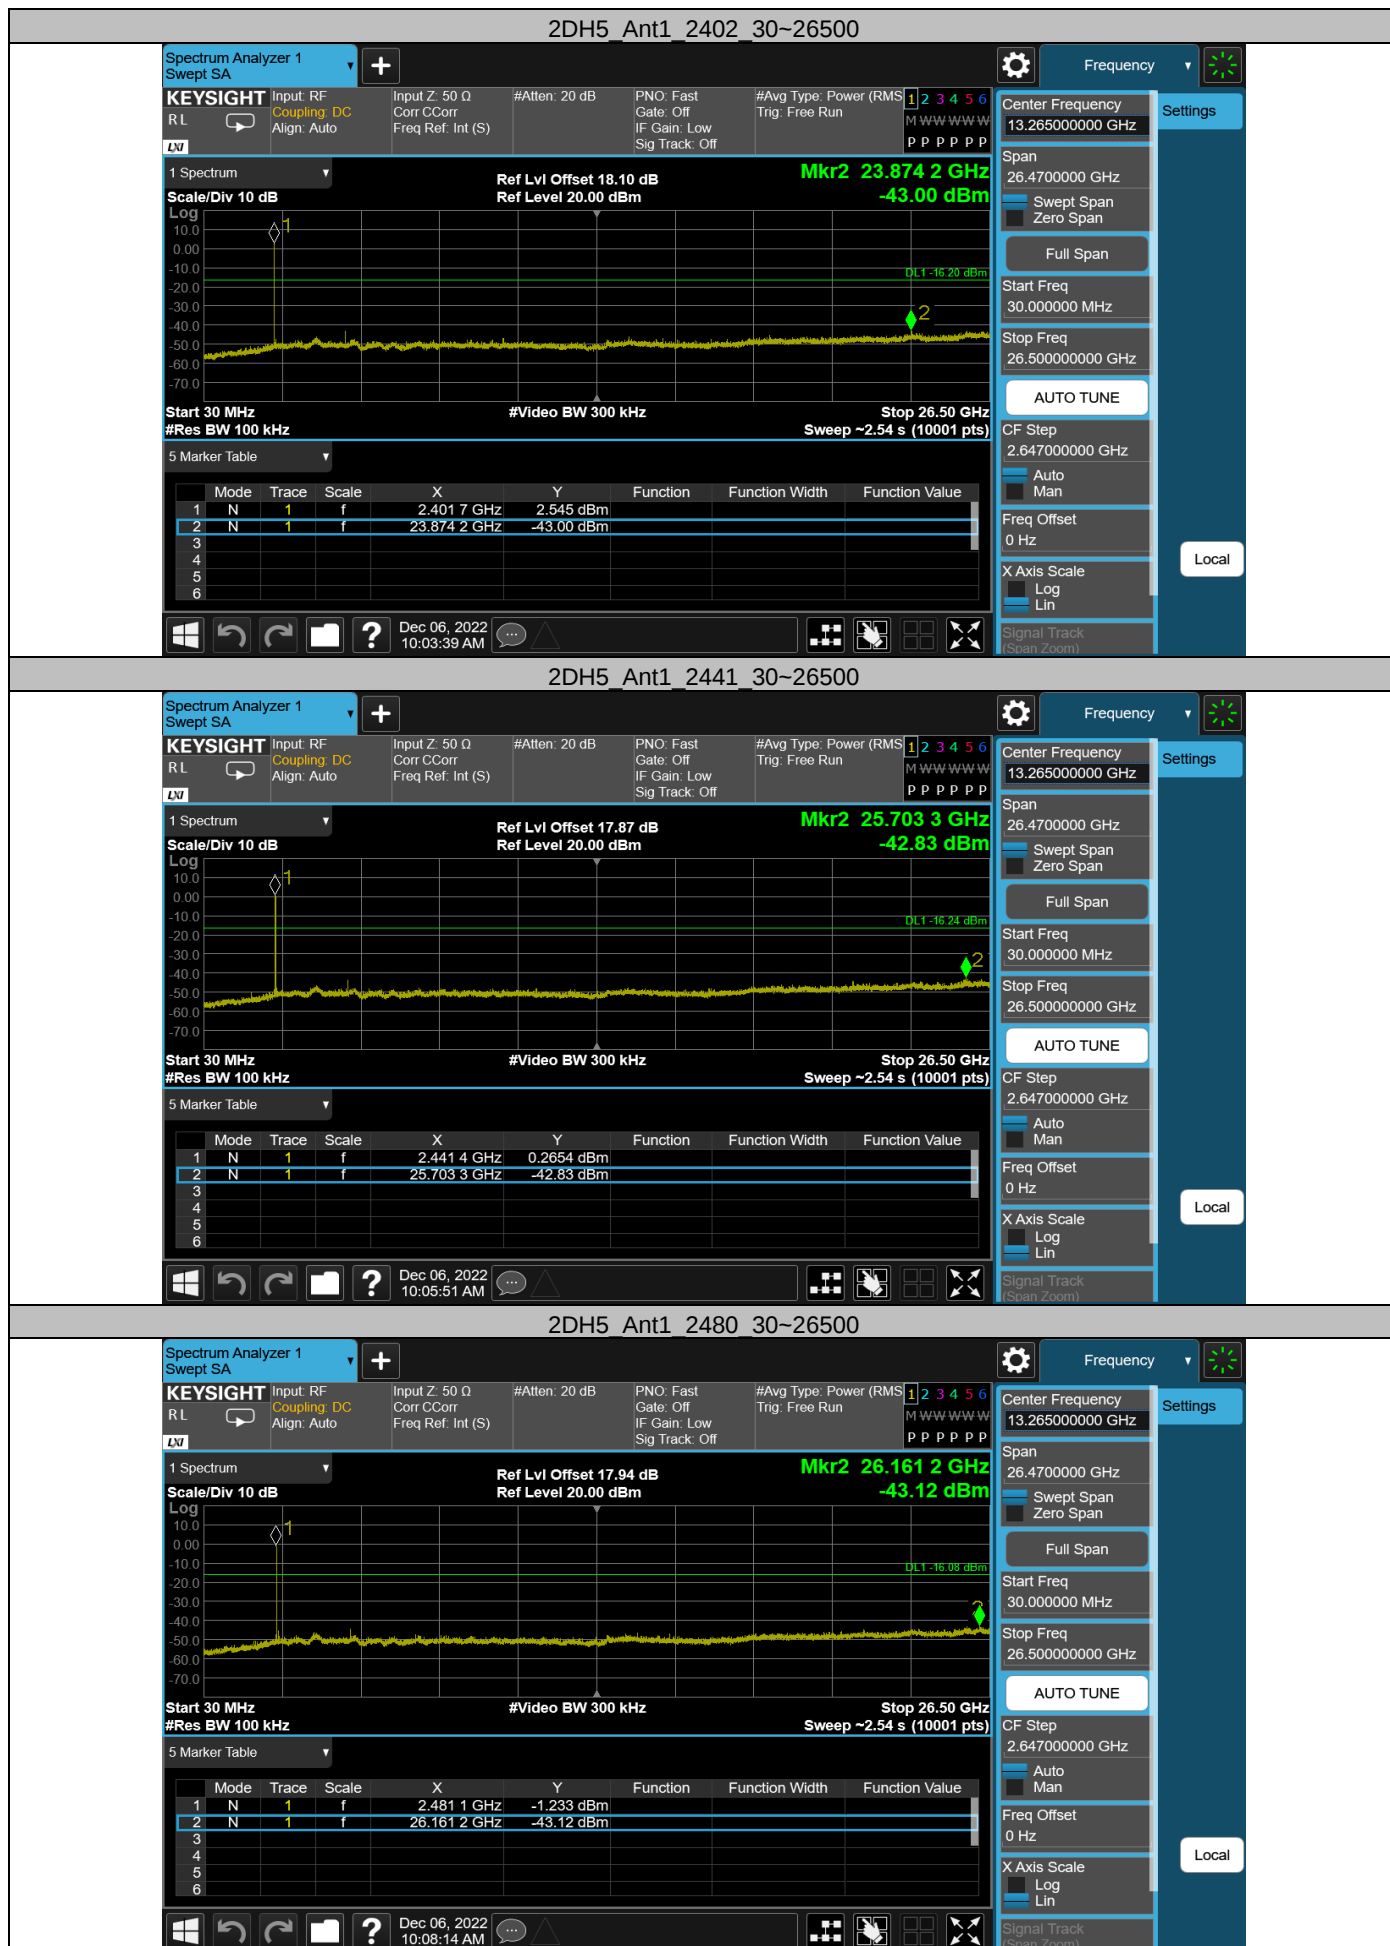
## Test Graphs

| Test Mode | Antenna | Freq(MHz) | Freq Range<br>[MHz] | Ref Level<br>[dBm] | Result<br>[dBm] | Limit<br>[dBm] | Verdict |

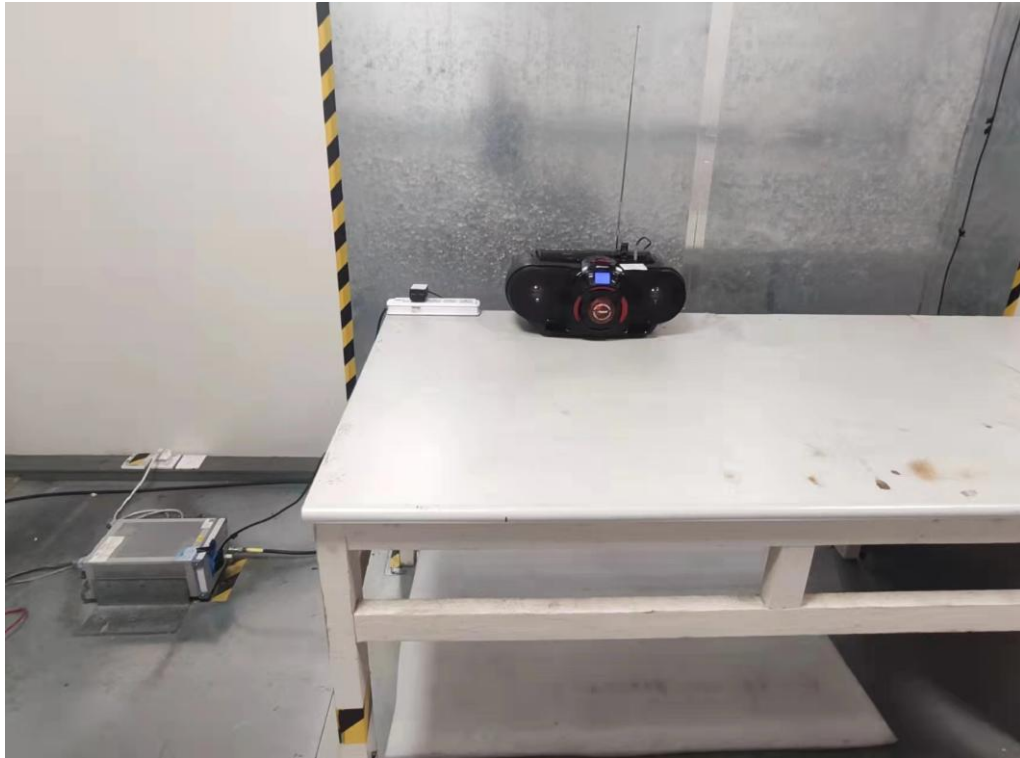
**Conducted Test**

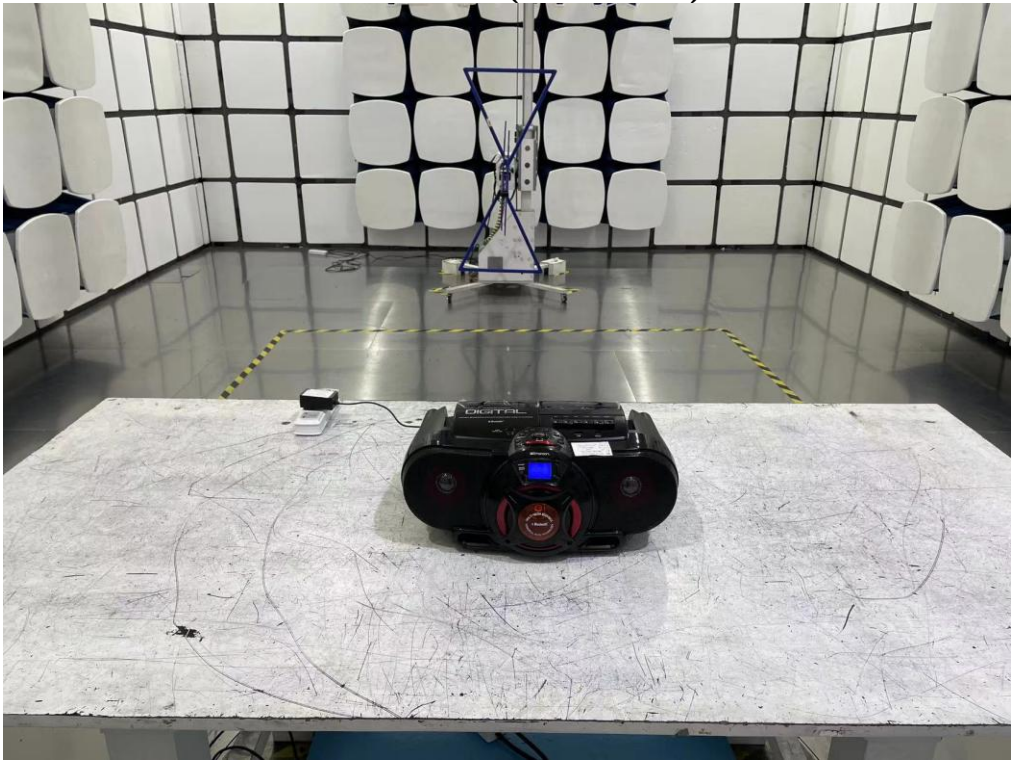
**Radiated Test (Below 1GHz)**

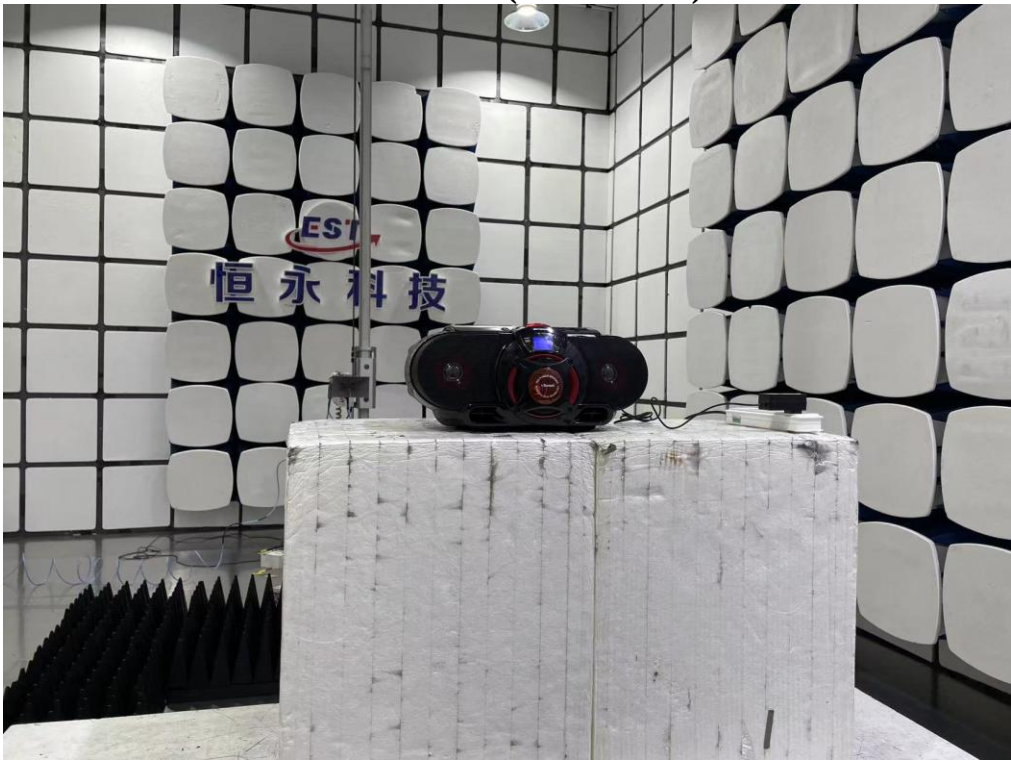
**Radiated Test (Above 1GHz)**
