## Appendix B: photographs of test setup

## Appendix C: photographs of EUT

Reference to the test report no. BLA-EMC-202505-A2301

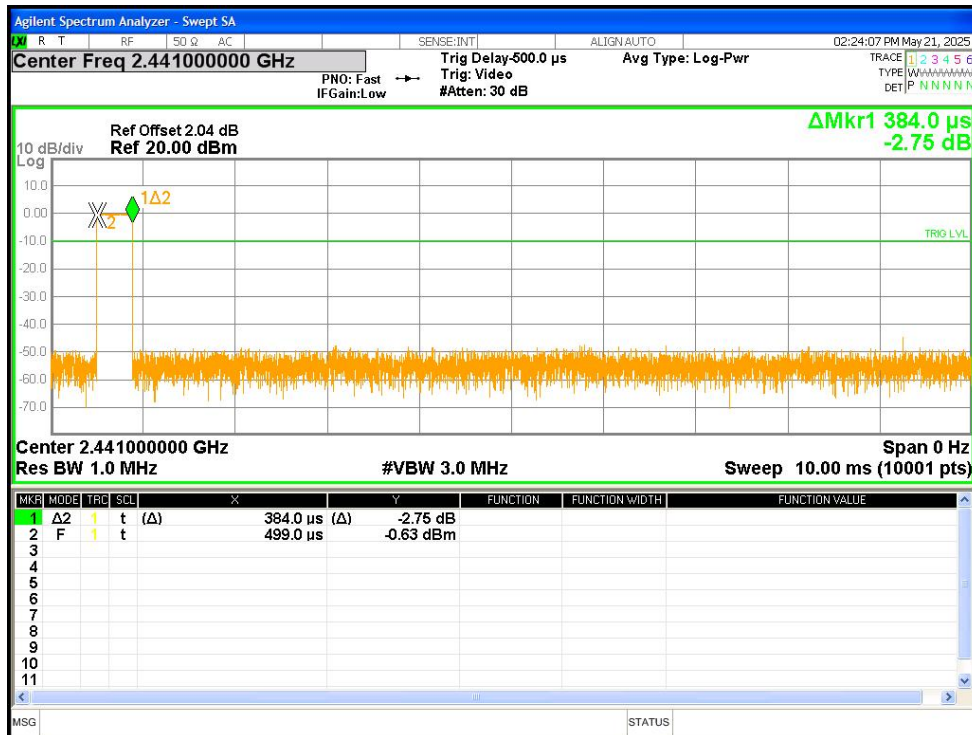
### Dwell NVNT 1-DH1 2441MHz Ant1 One Burst

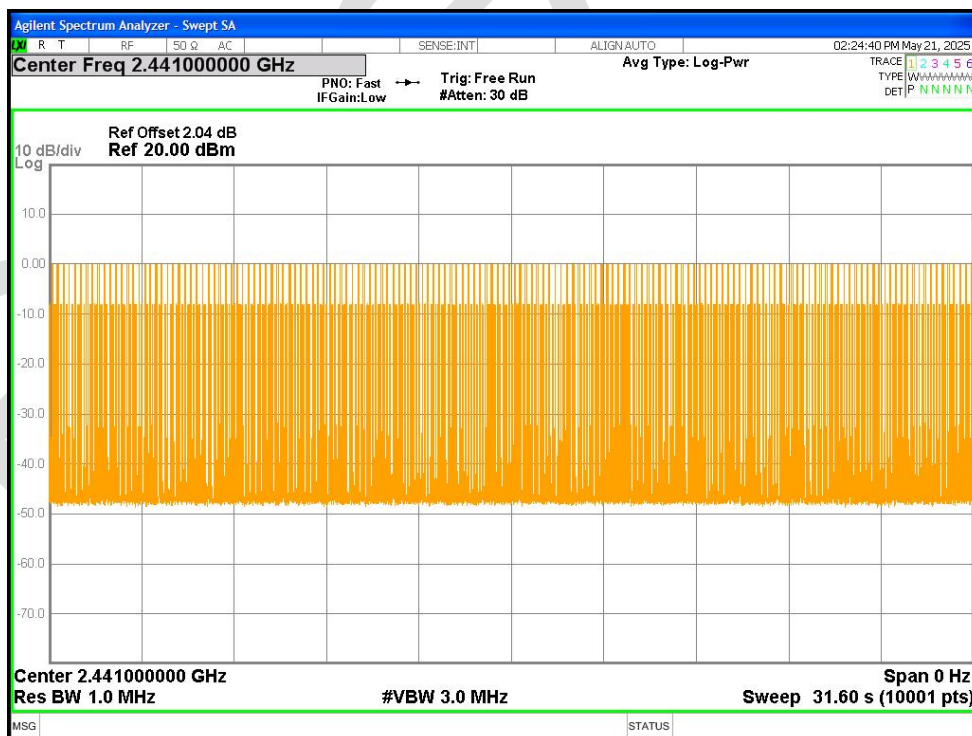
### Dwell NVNT 1-DH1 2441MHz Ant1 Accumulated

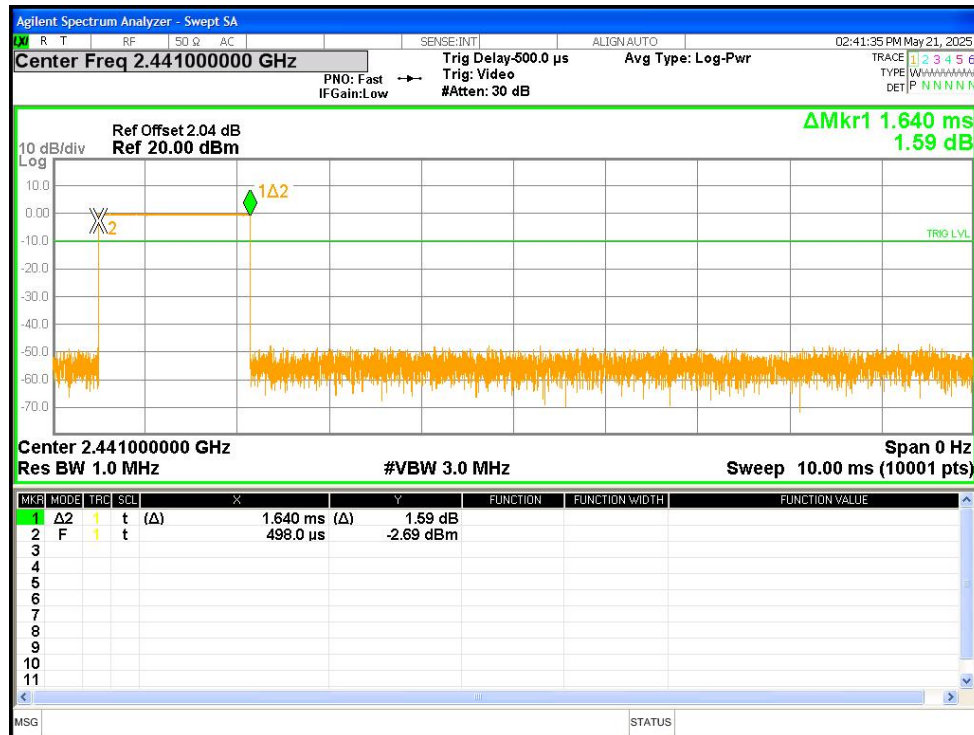
### Dwell NVNT 1-DH3 2441MHz Ant1 One Burst

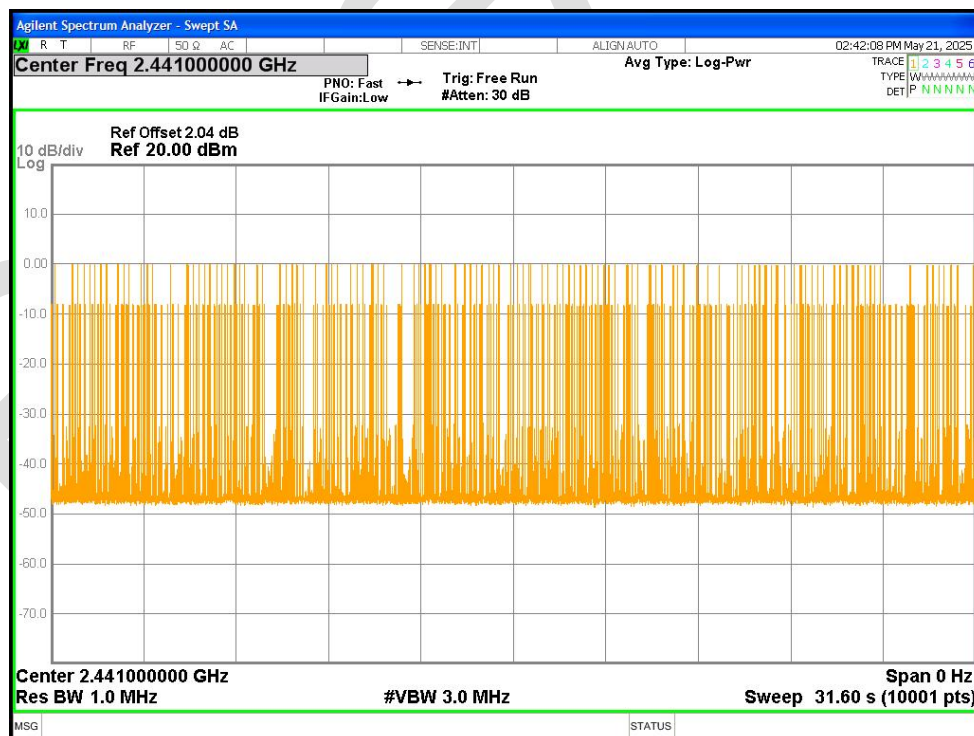
### Dwell NVNT 1-DH3 2441MHz Ant1 Accumulated

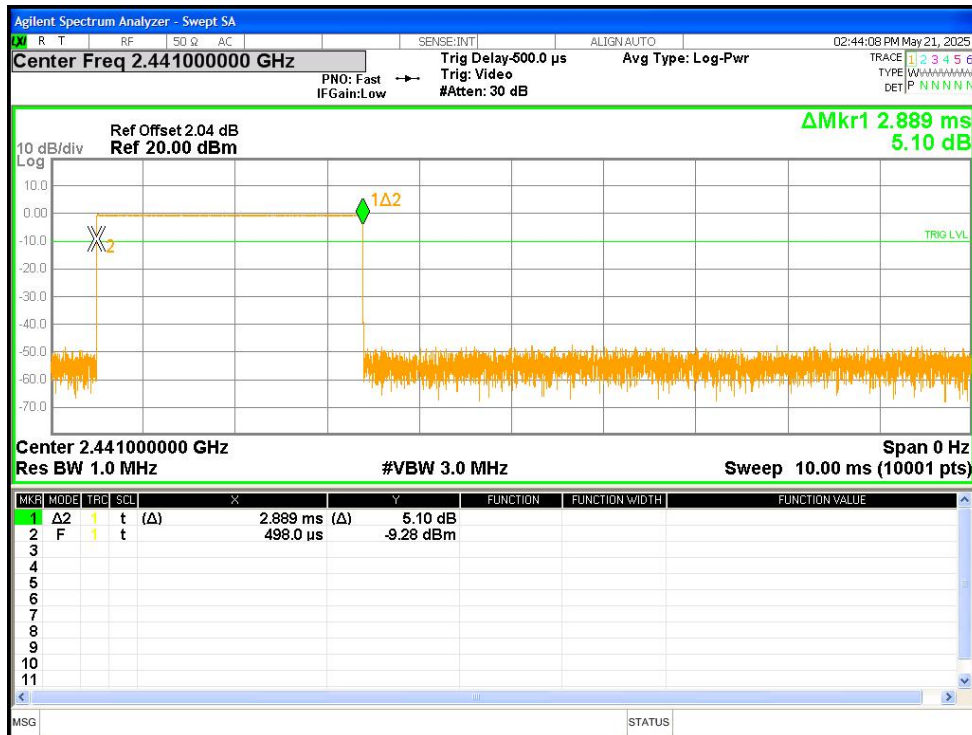
### Dwell NVNT 1-DH5 2441MHz Ant1 One Burst

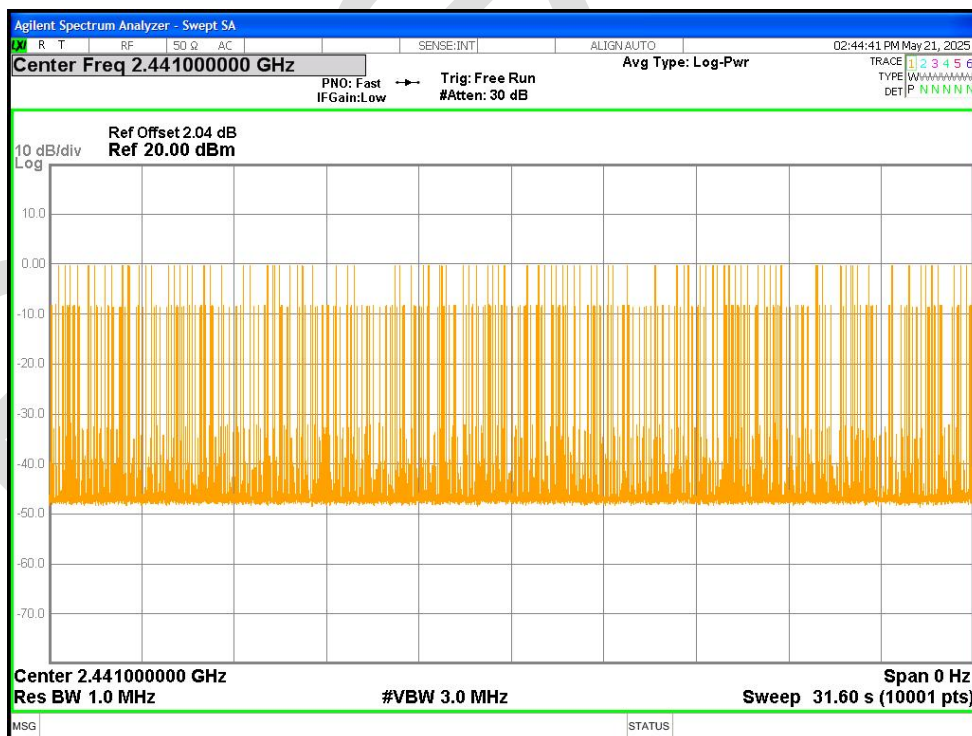
### Dwell NVNT 1-DH5 2441MHz Ant1 Accumulated

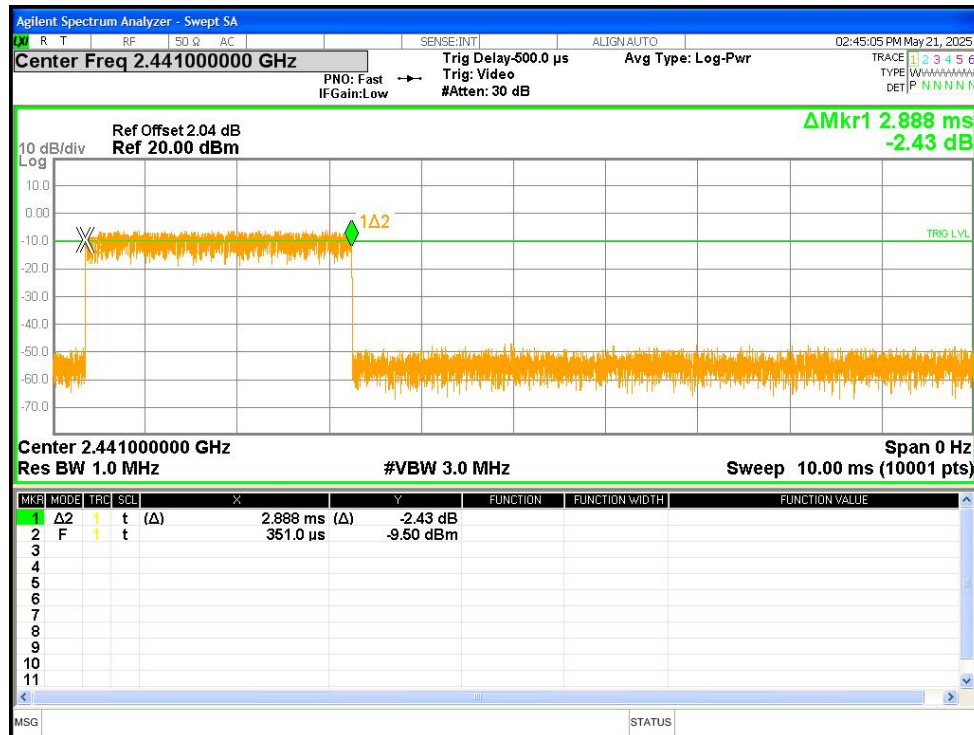
### Dwell NVNT 2-DH5 2441MHz Ant1 One Burst

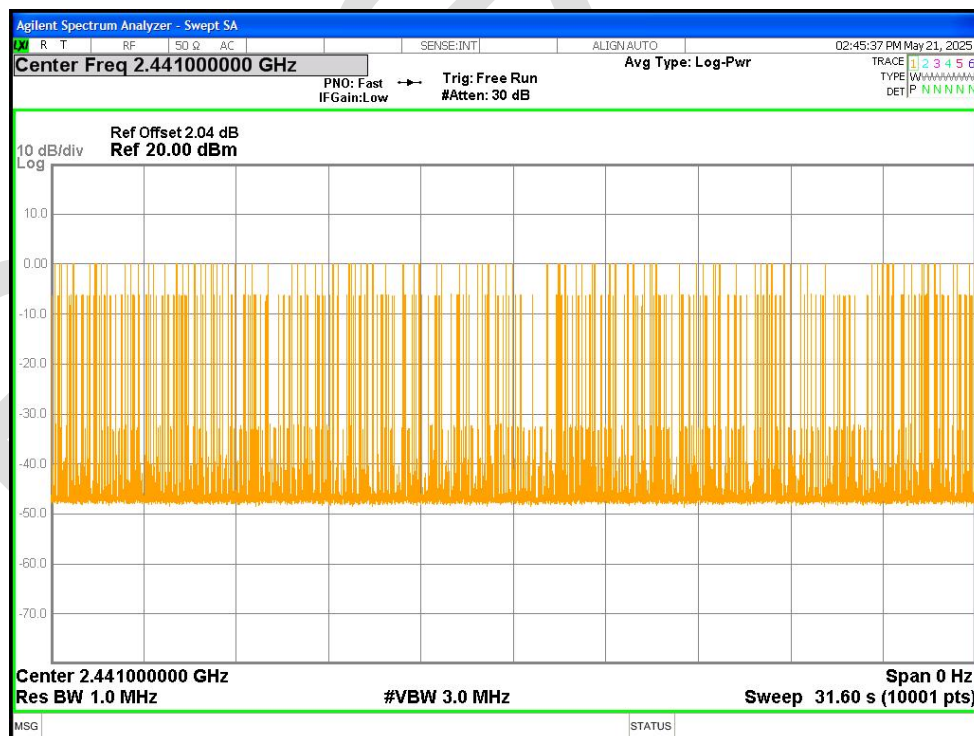
### Dwell NVNT 2-DH5 2441MHz Ant1 Accumulated

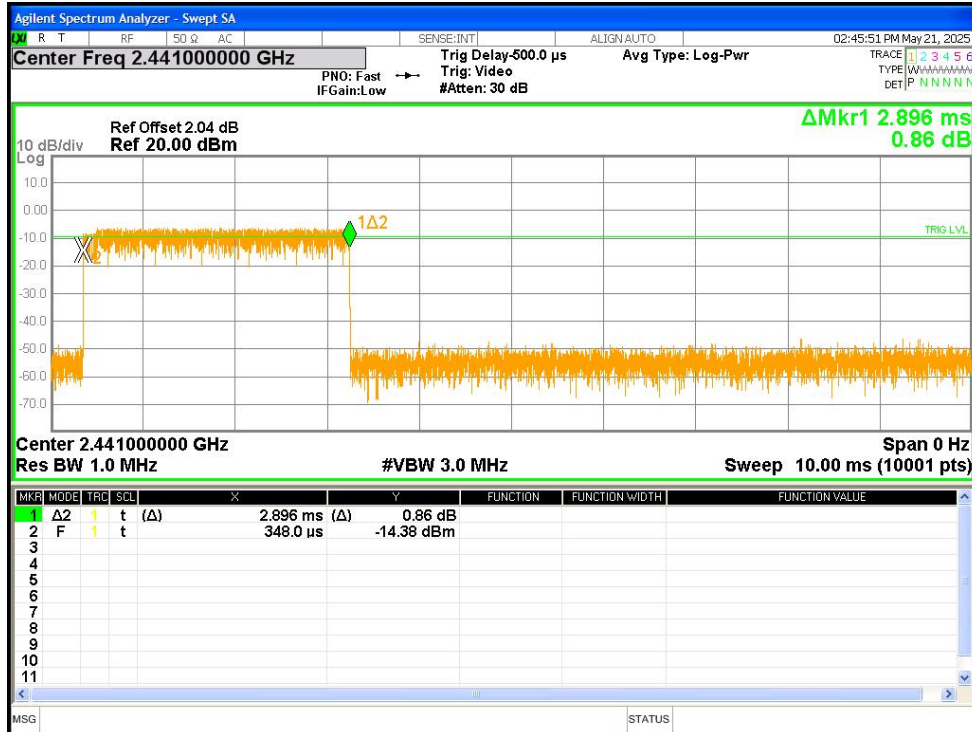
### Dwell NVNT 3-DH5 2441MHz Ant1 One Burst

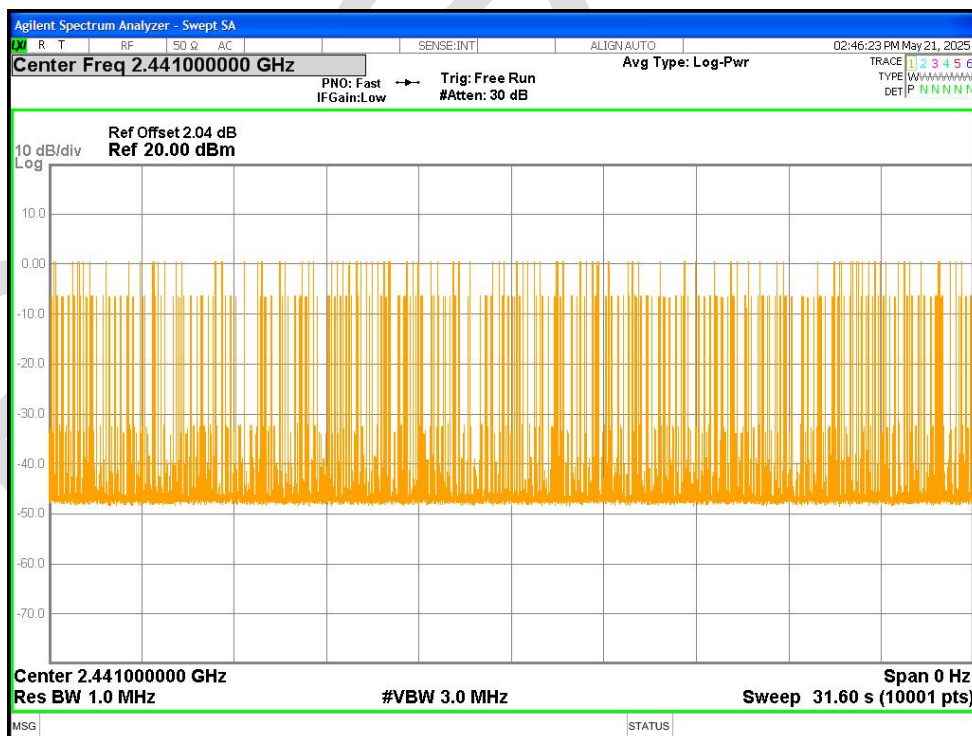
### Dwell NVNT 3-DH5 2441MHz Ant1 Accumulated

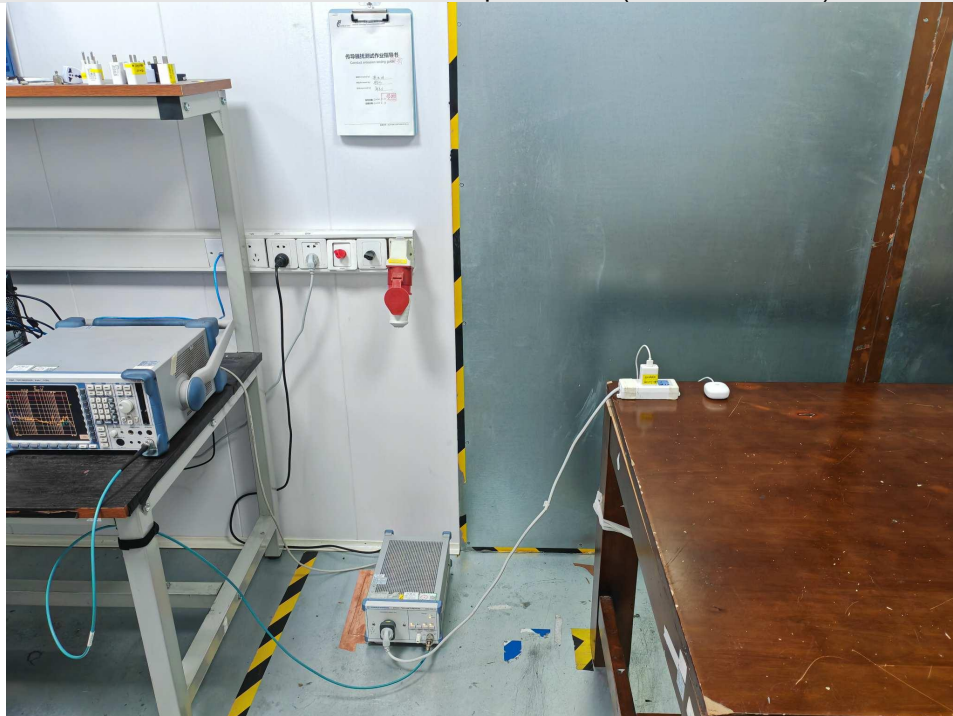
Conducted emissions at AC power line (150kHz-30MHz)

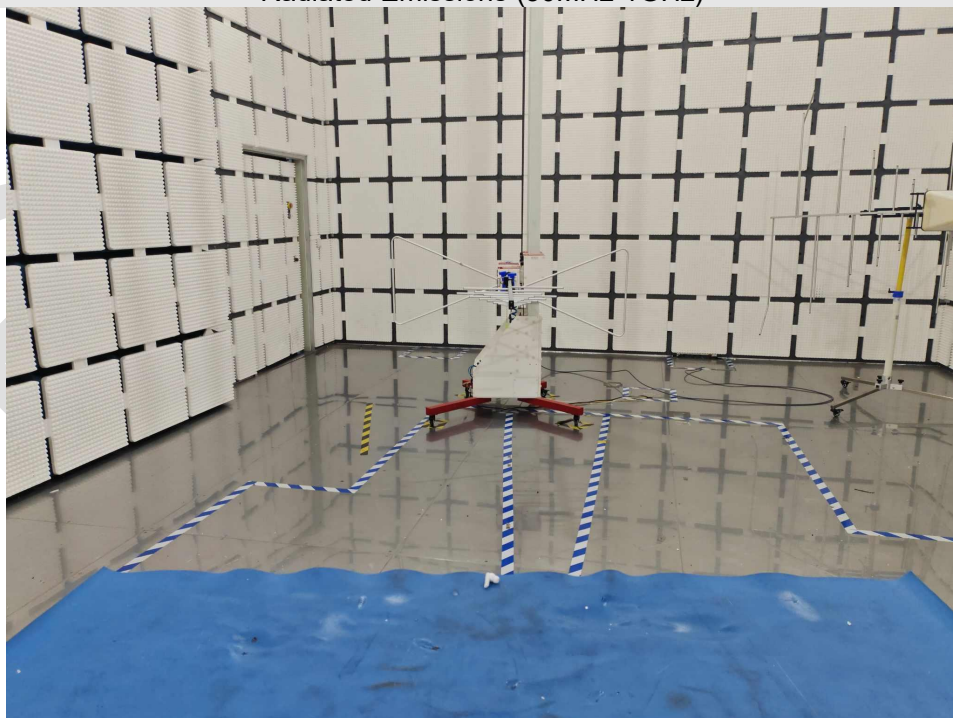
Radiated Emissions (30MHz-1GHz)

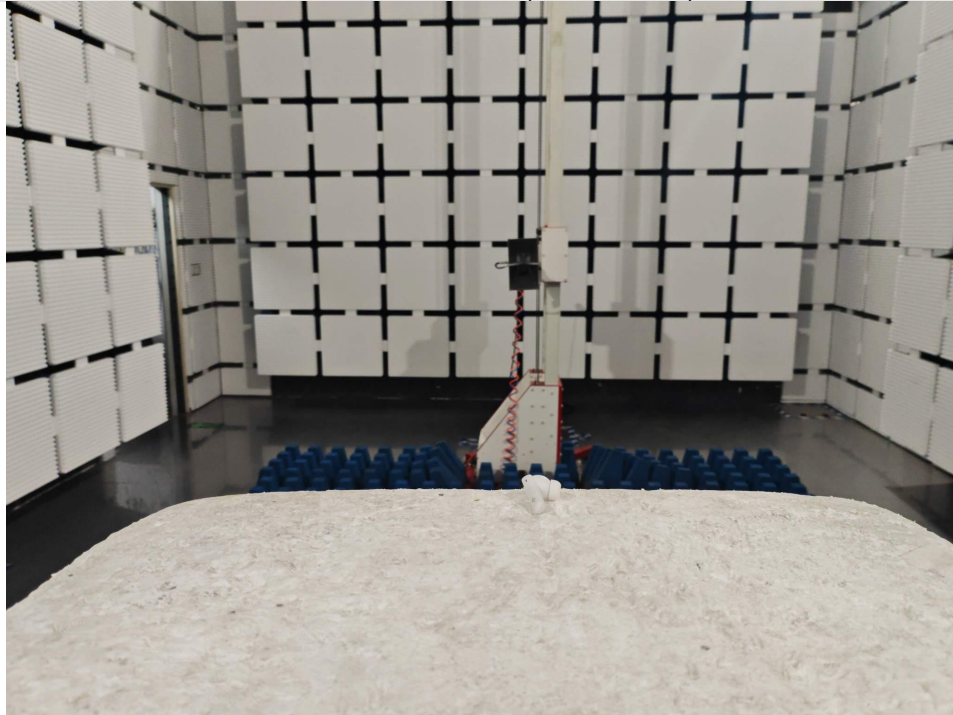
Radiated Emissions (above 1GHz)
