## Appendix B: photographs of test setup

## Appendix C: photographs of EUT

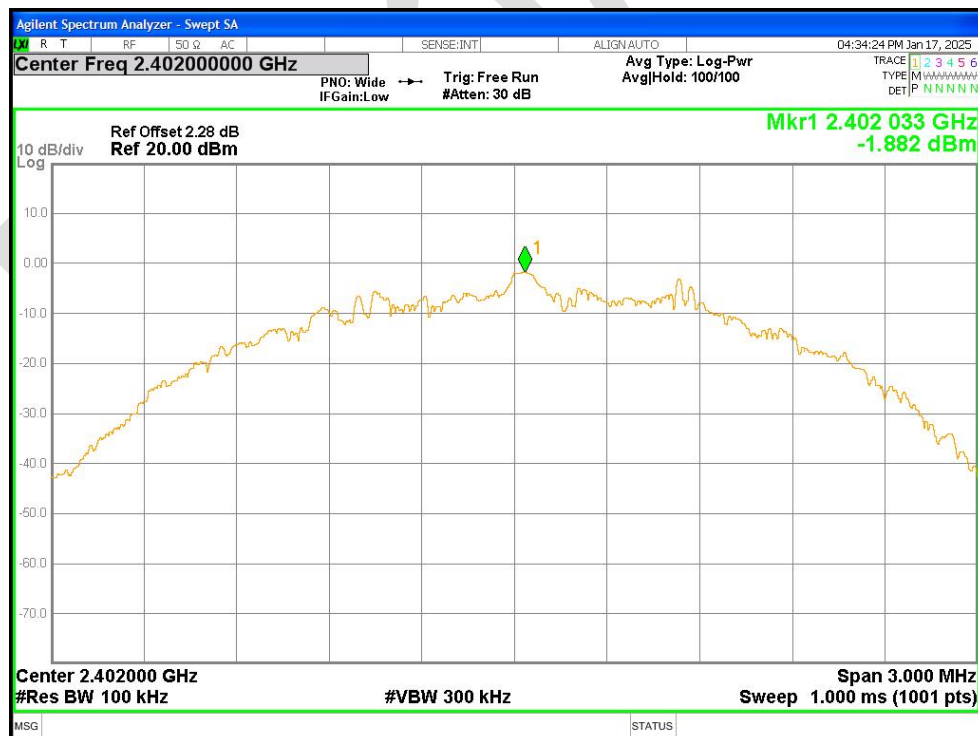
Tx. Spurious NVNT BLE 2M 2402MHz Ant1 Emission

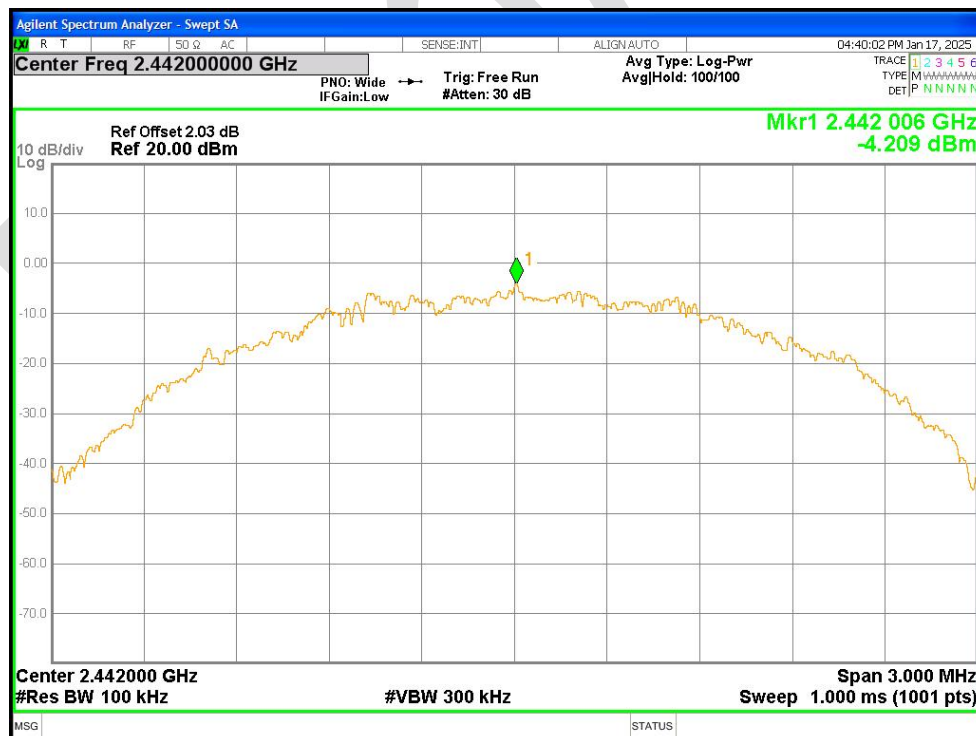
Tx. Spurious NVNT BLE 2M 2442MHz Ant1 Emission

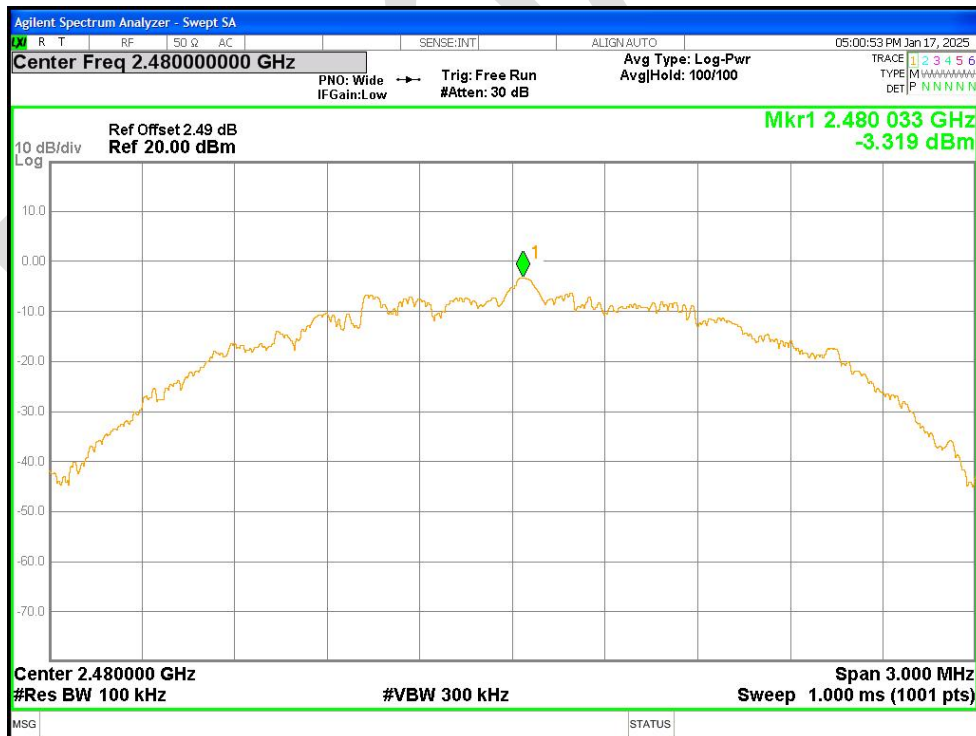
Tx. Spurious NVNT BLE 2M 2480MHz Ant1 Emission

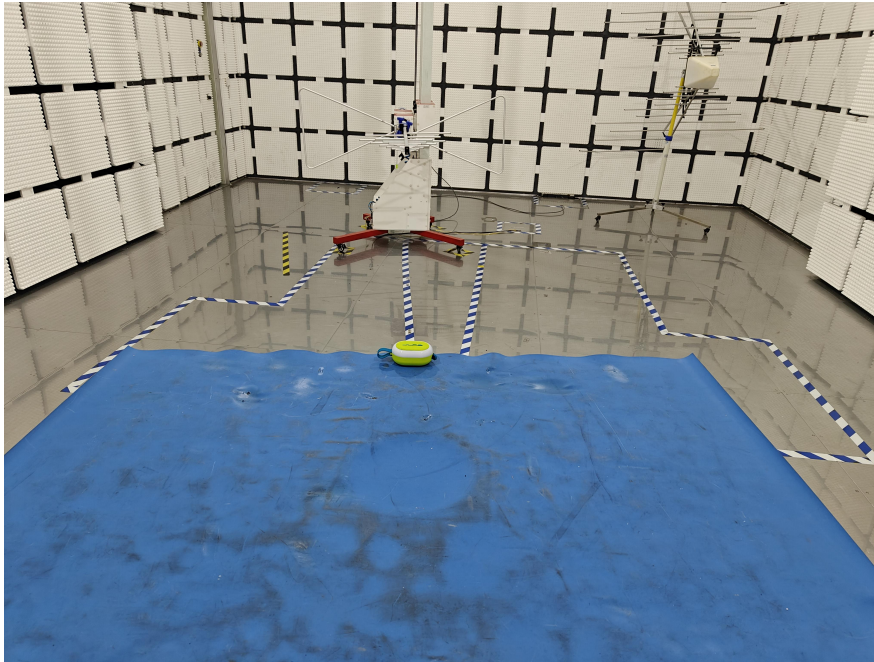
Radiated Emissions (30MHz-1GHz)

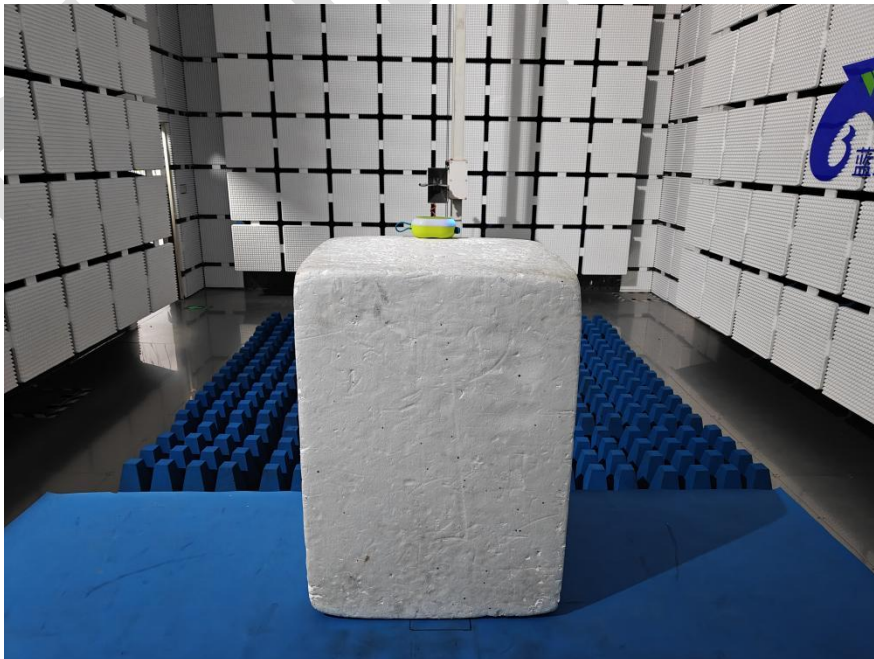
Radiated Emissions (above 1GHz)

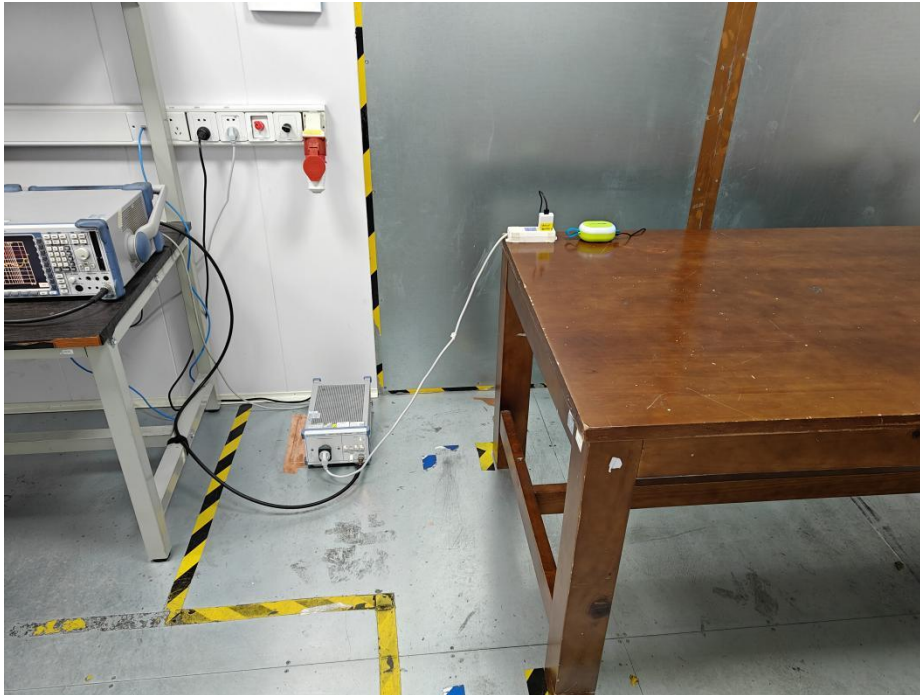
Conducted Emissions at Mains Terminals (150 kHz-30MHz)
