Tx. Spurious NVNT BLE 1M 2442MHz Ant1 Ref

## Appendix B: photographs of test setup

Reference to the test report no. BLA-EMC-202412-A2701

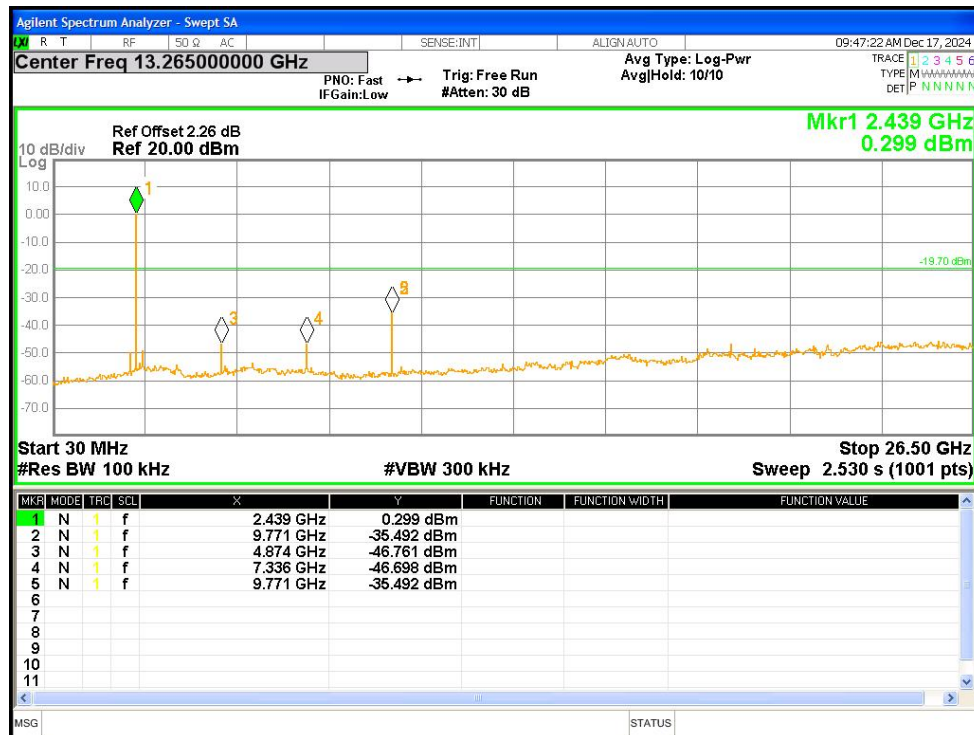
Tx. Spurious NVNT BLE 1M 2480MHz Ant1 Ref

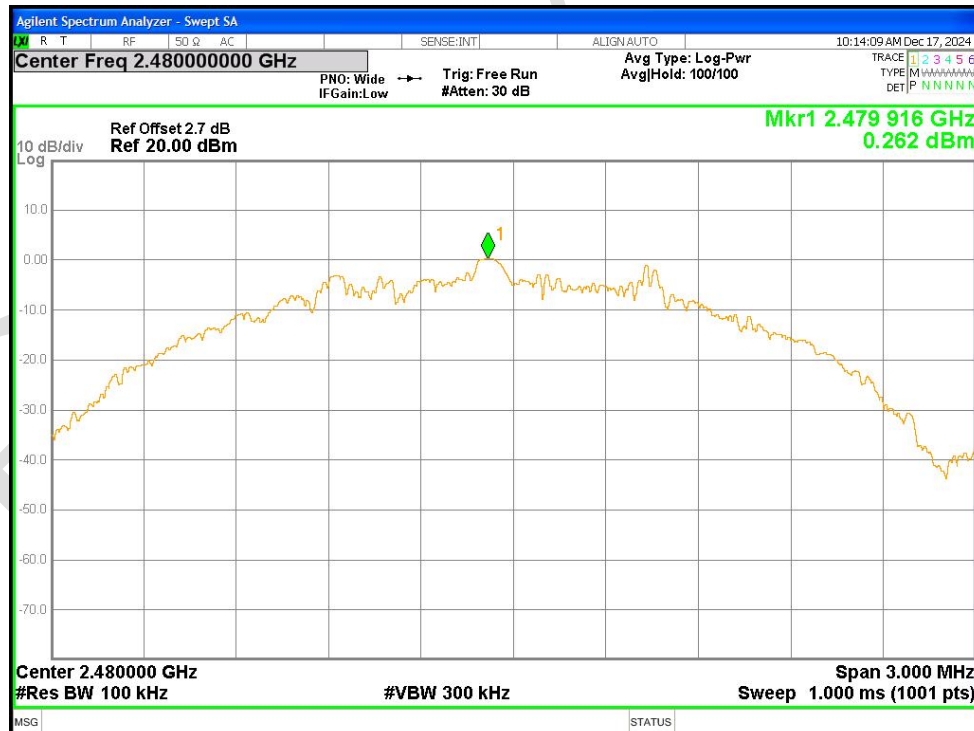
Tx. Spurious NVNT BLE 2M 2480MHz Ant1 Emission

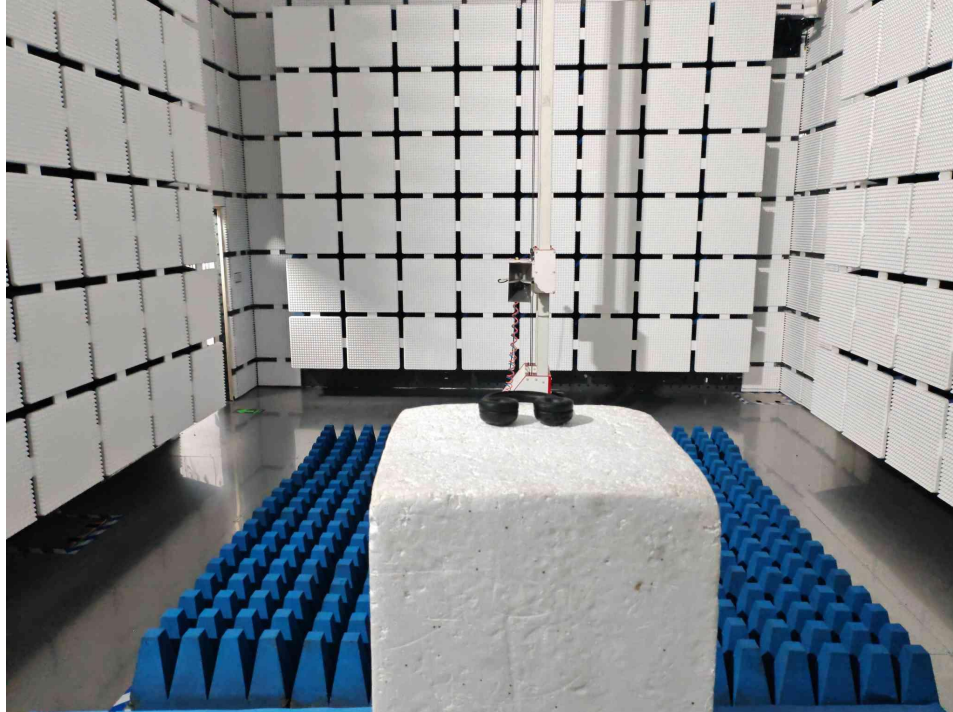
Radiated Emissions (above 1GHz)
