Report No.:FA182305

Appendix D. SAR Test Setup Photos

Issued Date: Oct. 13, 2021 Form version. : 200414 FCC ID: 2AJOR2101GAA Page D1 of D3

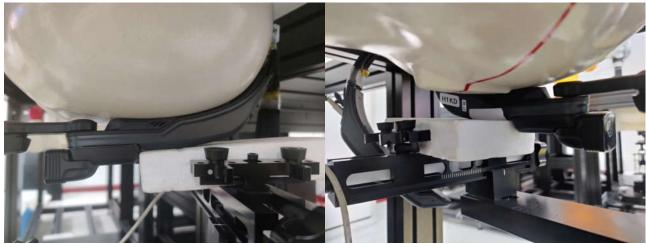
Left Cheek, Test Separation 0 mm with front view

Left Cheek, Test Separation 0 mm with side view

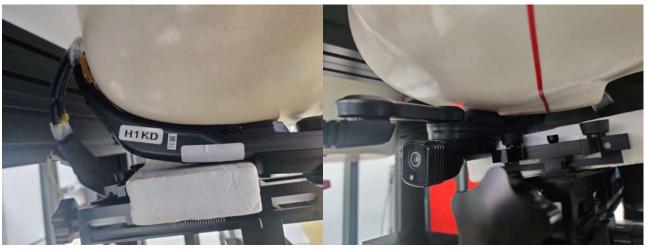
Right Cheek, Test Separation 0 mm with front view

Right Cheek, Test Separation 0 mm with side view

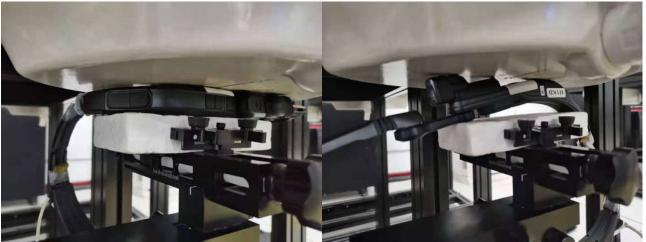
Edge1, Test Separation 0 mm

Edge2a, Test Separation 0 mm

Note: Due to the raised camera near the antenna area, in order to get the antenna area closer to the Phantom, the camera was removed for Edge 2b, while for Edge 2a, the camera was not removed. For details, please refer to test setup photo.

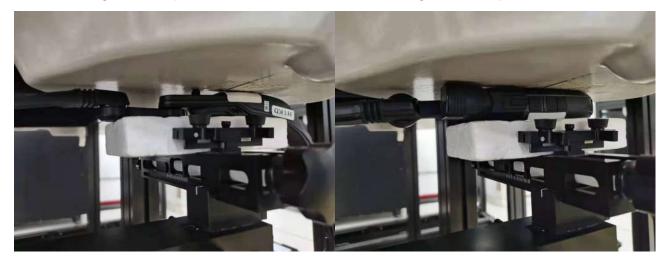
Edge2b, Test Separation 0 mm

Edge3, Test Separation 0 mm
