## 17. EUT Photographs

## 19. EUT Test Setup Photographs

**Body mode Exposure Conditions**  
**Test distance: 10mm**

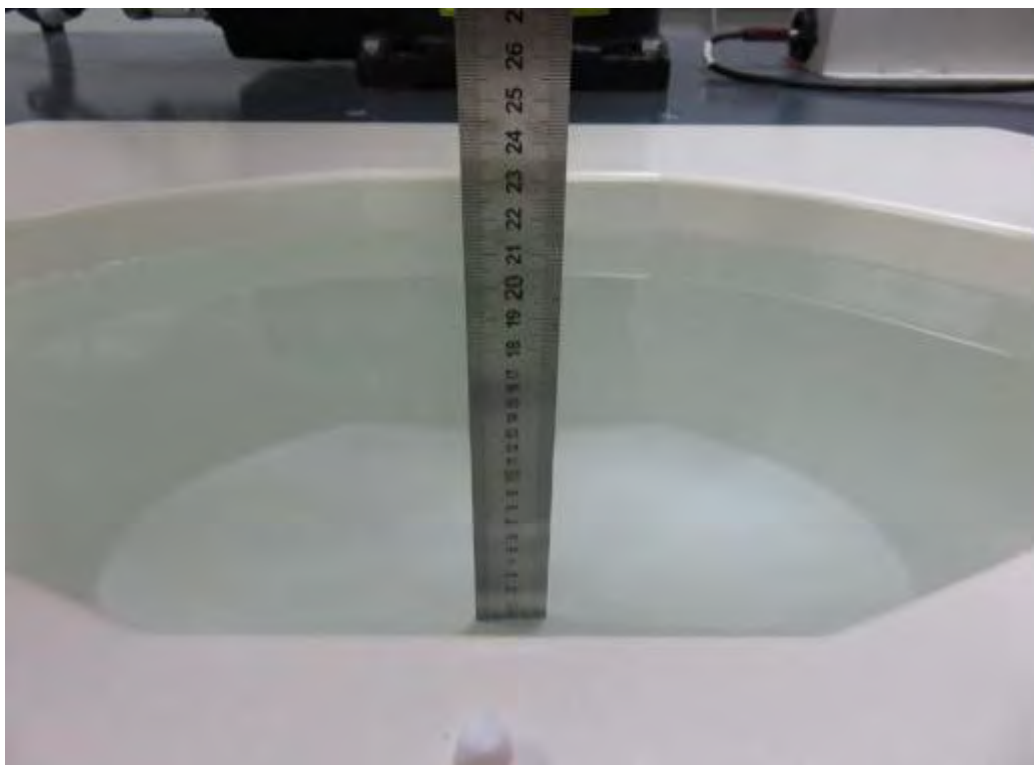
**Photograph of the depth in the Body Phantom (600-10000MHz, depth >15cm)**

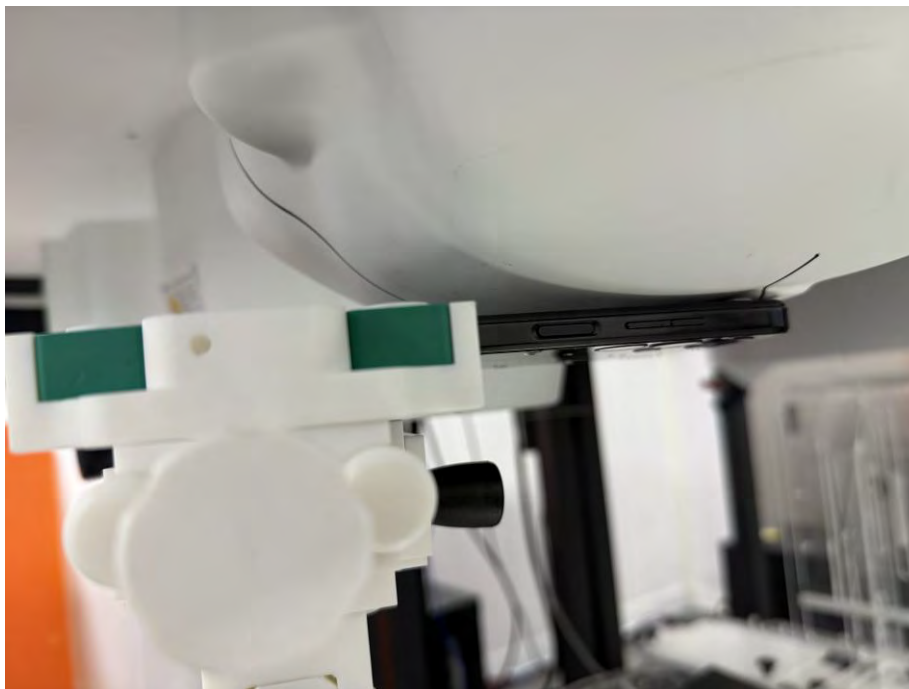
Left Cheek

### Head mode Exposure Conditions
