# **TEST PHOTOS REPORT**

**Report Number. :** R12373455- EP1

**Model :** 807211

**EUT Description :** Wireless Network Control

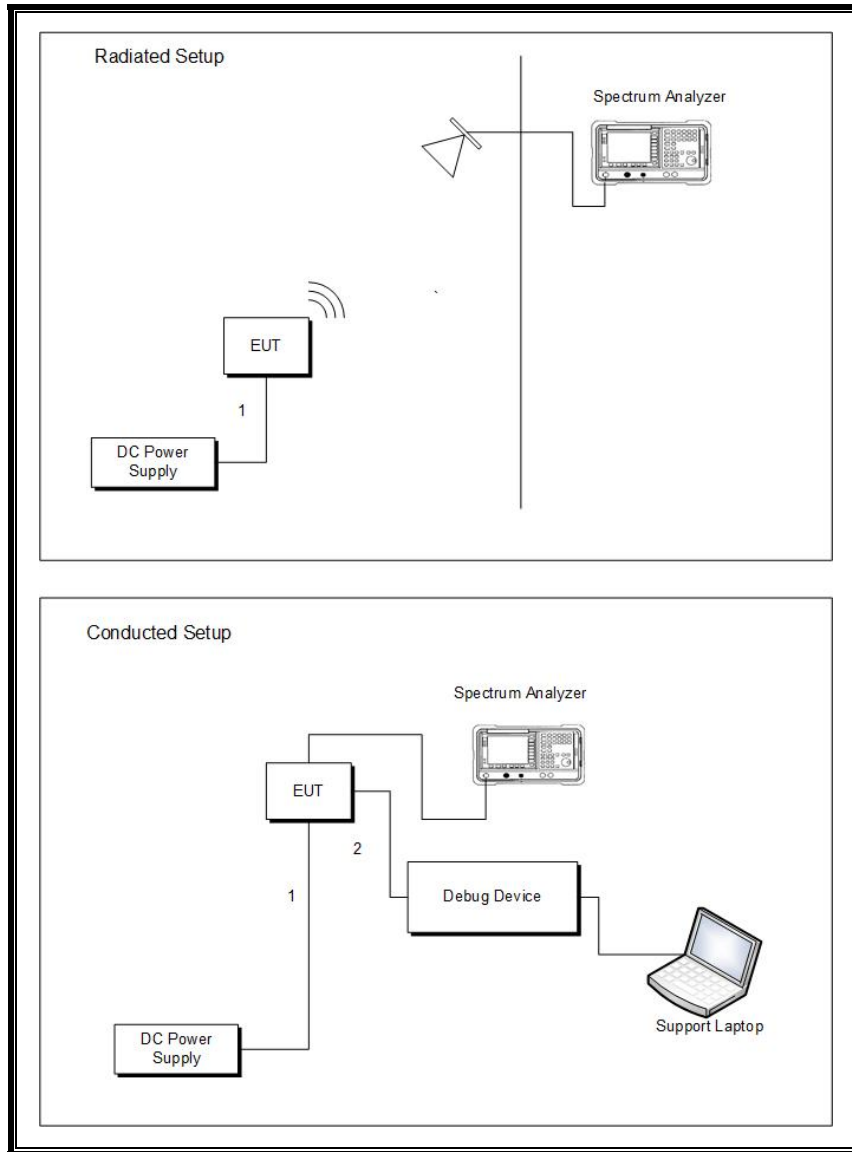
## **SETUP DIAGRAM**

The EUT is installed in as a standalone device. Test software exercised the radio card.

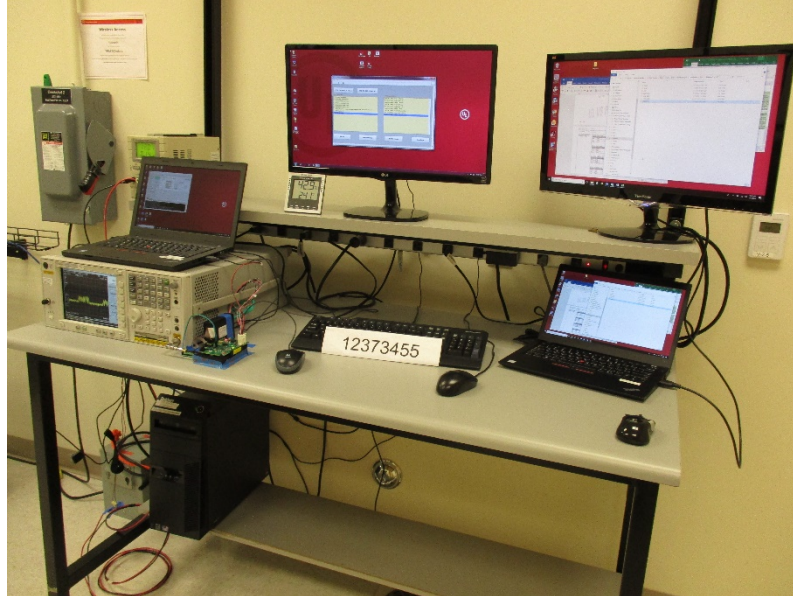
ANTENNA PORT CONDUCTED PHOTO (FULL)

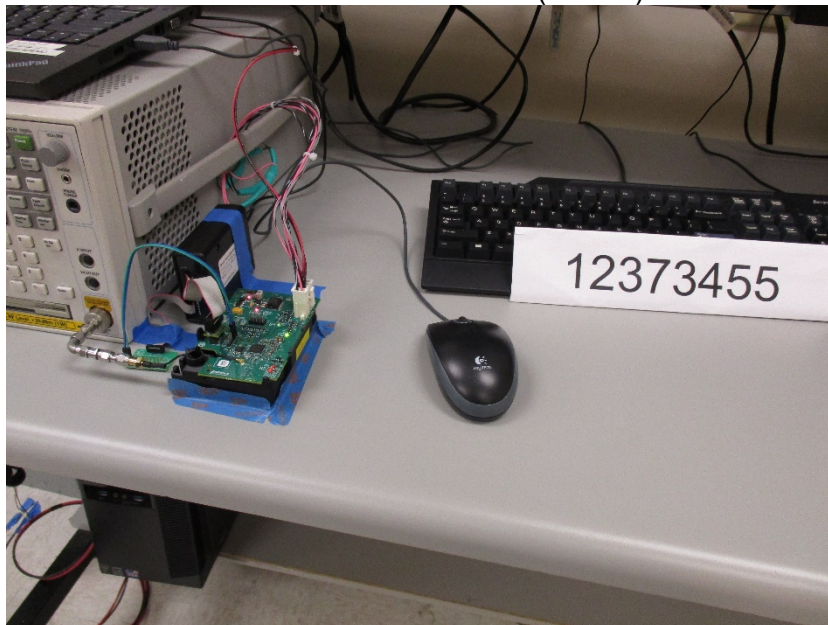
ANTENNA PORT CONDUCTED PHOTO (ZOOM)

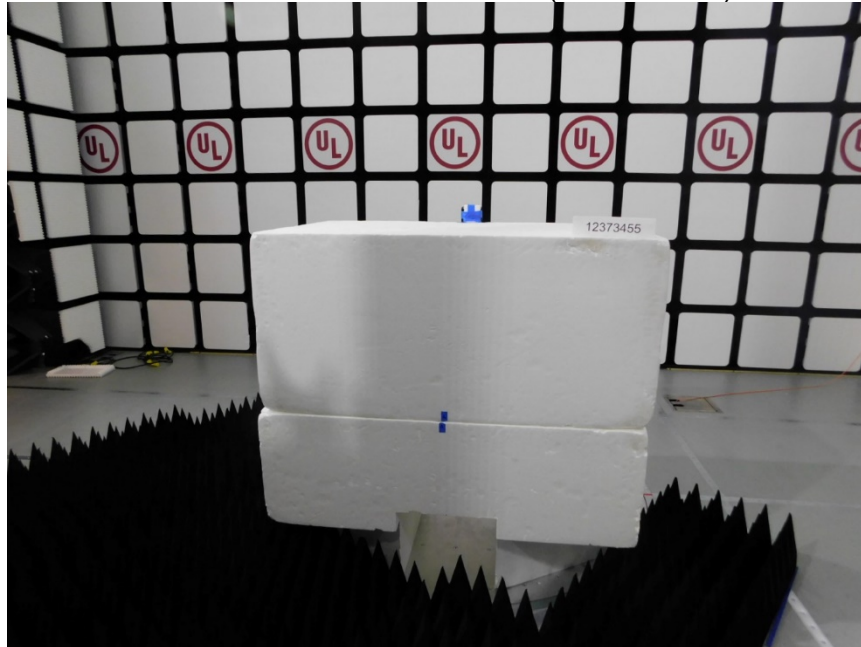
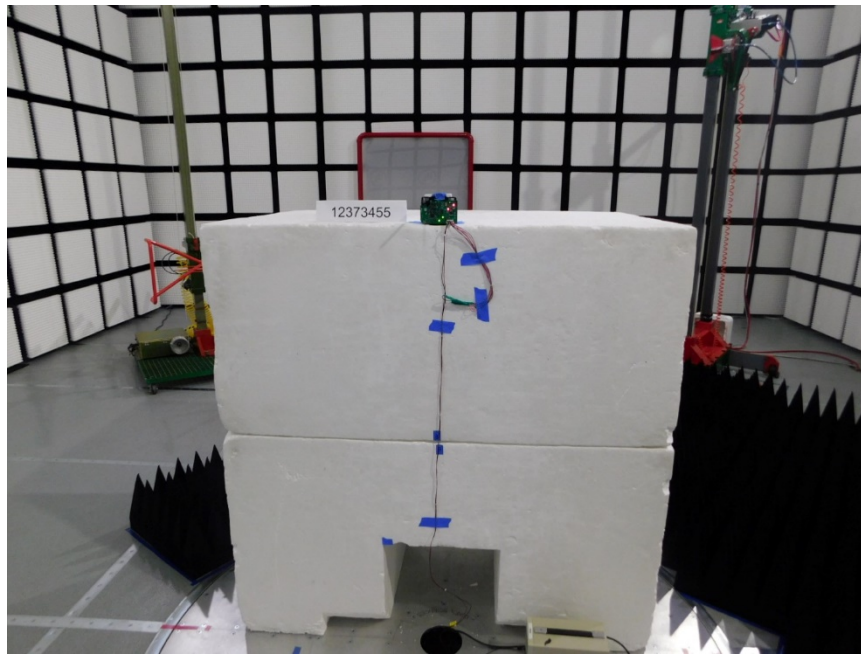
RADIATED SPURIOUS FRONT PHOTO (Above 1GHz)

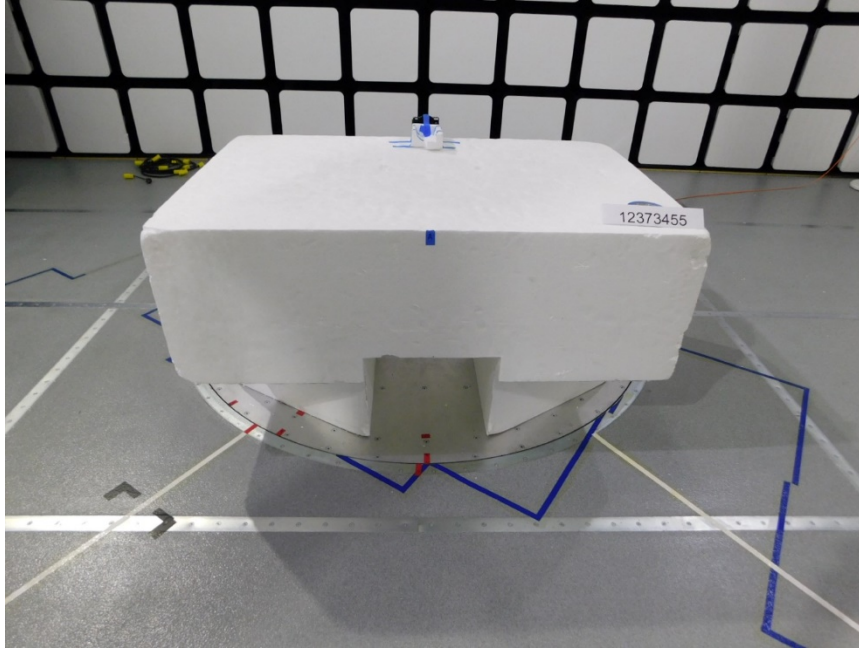
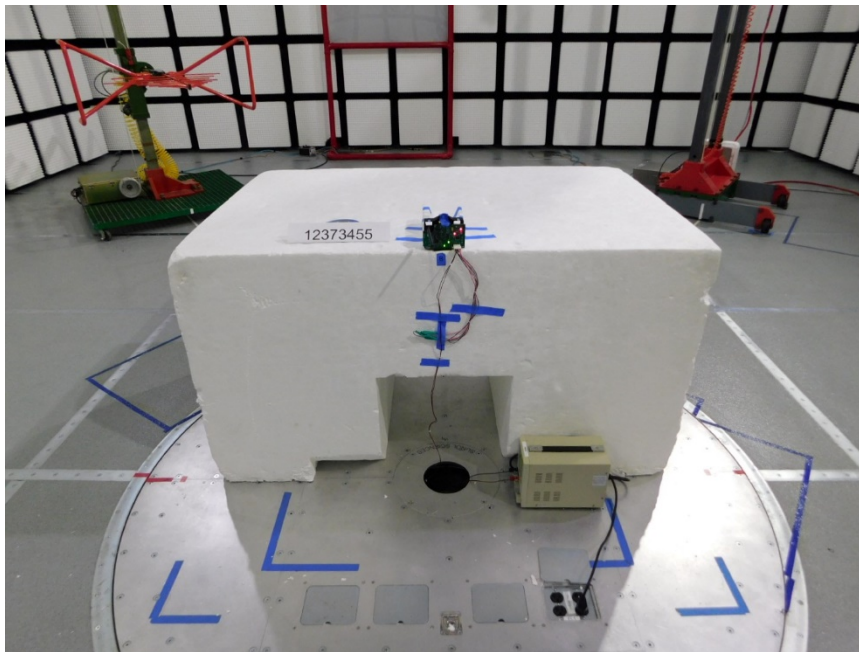
RADIATED SPURIOUS FRONT PHOTO (Below 1GHz)

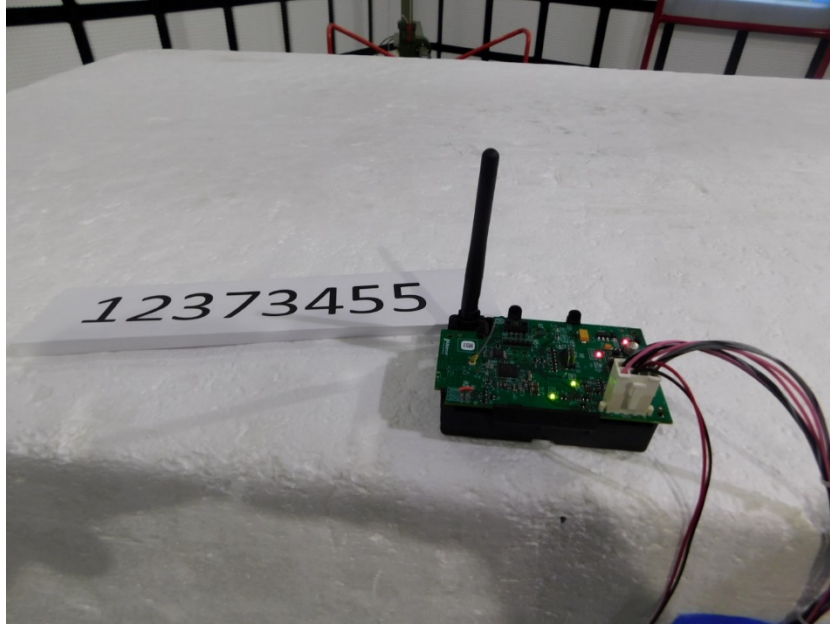
RADIATED SPURIOUS PHOTO (X Orientation)

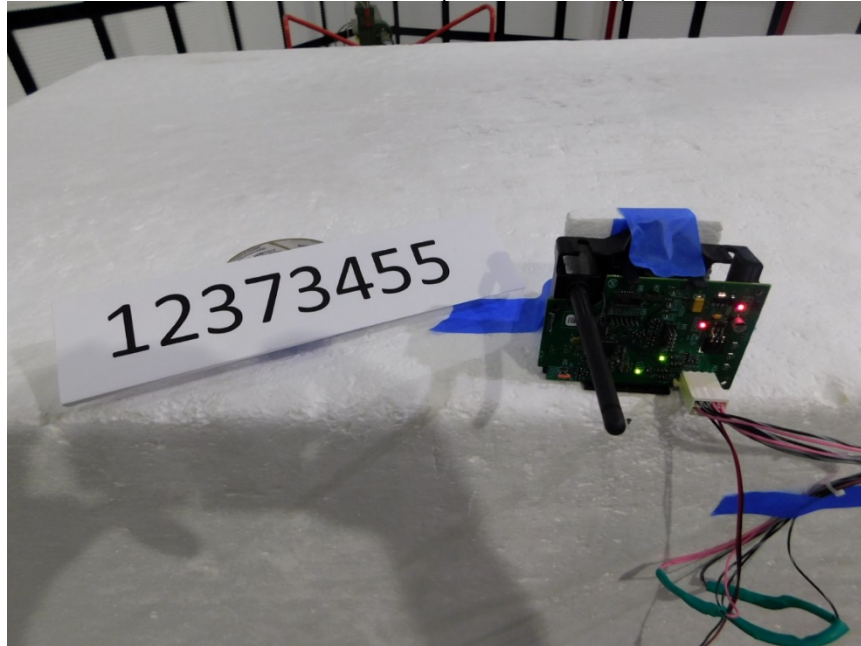
RADIATED SPURIOUS PHOTO (Y Orientation)
