Radiated Emission Measurement

Condition : FCC\_part 15 RE-Class C\_Above 1GHz\_PK

EUT : W6M22311-23090

Test Mode : TX 802.11b CH6

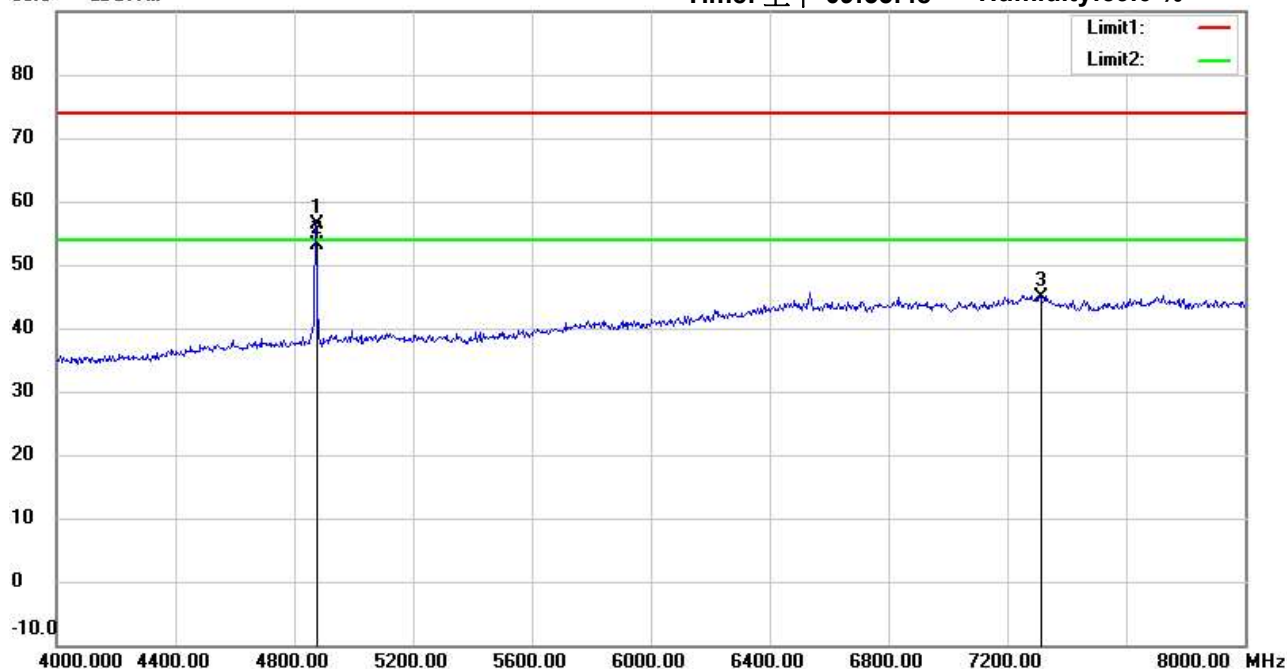
Data :#2

Polarization: **Horizontal**

| Mk. | Frequency (MHz) | Reading (dBuV) | Detector | Corr. factor (dB/m) | Result (dBuV/m) | Limit (dBuV/m) | Ant.Pos (cm) | Tab.Pos (deg.) | Margin (dB) | Comment |
|---|---|---|---|---|---|---|---|---|---|---|
| | 4874.000 | 51.17 | peak | 5.21 | 56.38 | 74.00 | 150 | 26 | -17.62 | |
| * | 4874.000 | 47.96 | AVG | 5.21 | 53.17 | 54.00 | 150 | 26 | -0.83 | |
| | 7311.000 | 33.25 | peak | 11.70 | 44.95 | 74.00 | 150 | 91 | -29.05 | |

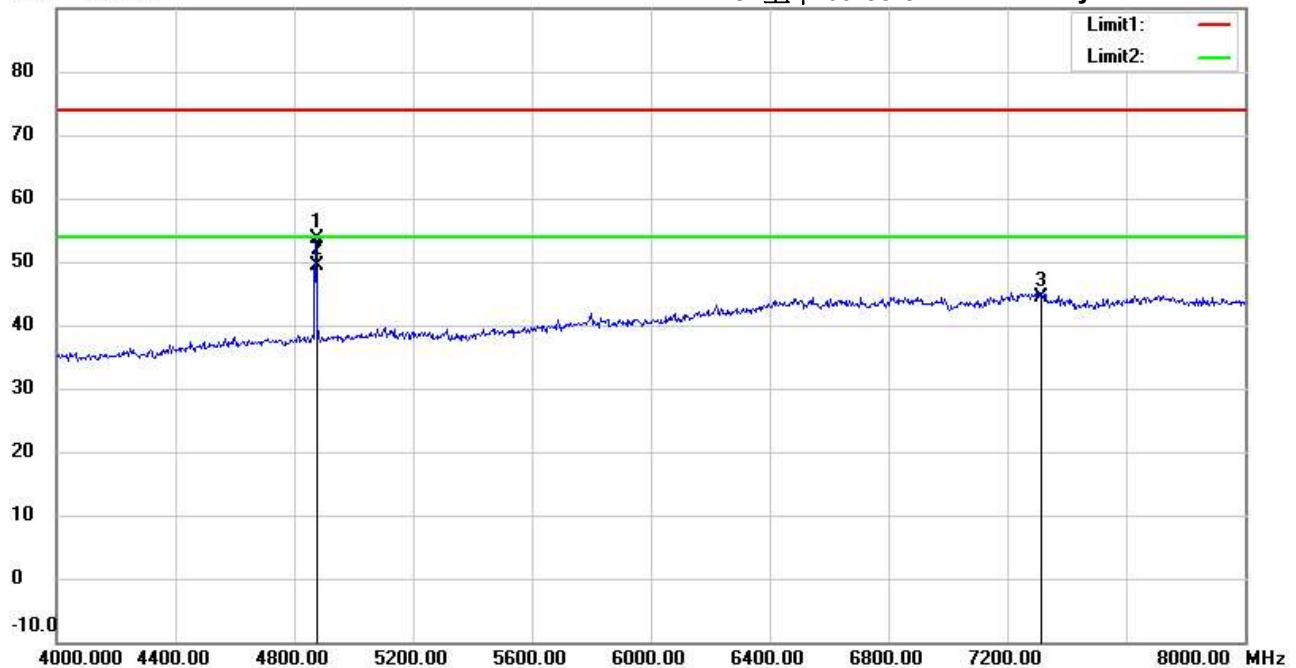
Data :#7

Test Mode : TX 802.11b CH6

Polarization: Vertical

| Mk. | Frequency (MHz) | Reading (dBuV) | Detector | Corr. factor (dB/m) | Result (dBuV/m) | Limit (dBuV/m) | Ant.Pos (cm) | Tab.Pos (deg.) | Margin (dB) | Comment |
|---|---|---|---|---|---|---|---|---|---|---|
| | 4874.000 | 48.41 | peak | 5.21 | 53.62 | 74.00 | 150 | 117 | -20.38 | |
| * | 4874.000 | 44.09 | AVG | 5.21 | 49.30 | 54.00 | 150 | 117 | -4.70 | |
| | 7311.000 | 32.59 | peak | 11.70 | 44.29 | 74.00 | 150 | 60 | -29.71 | |

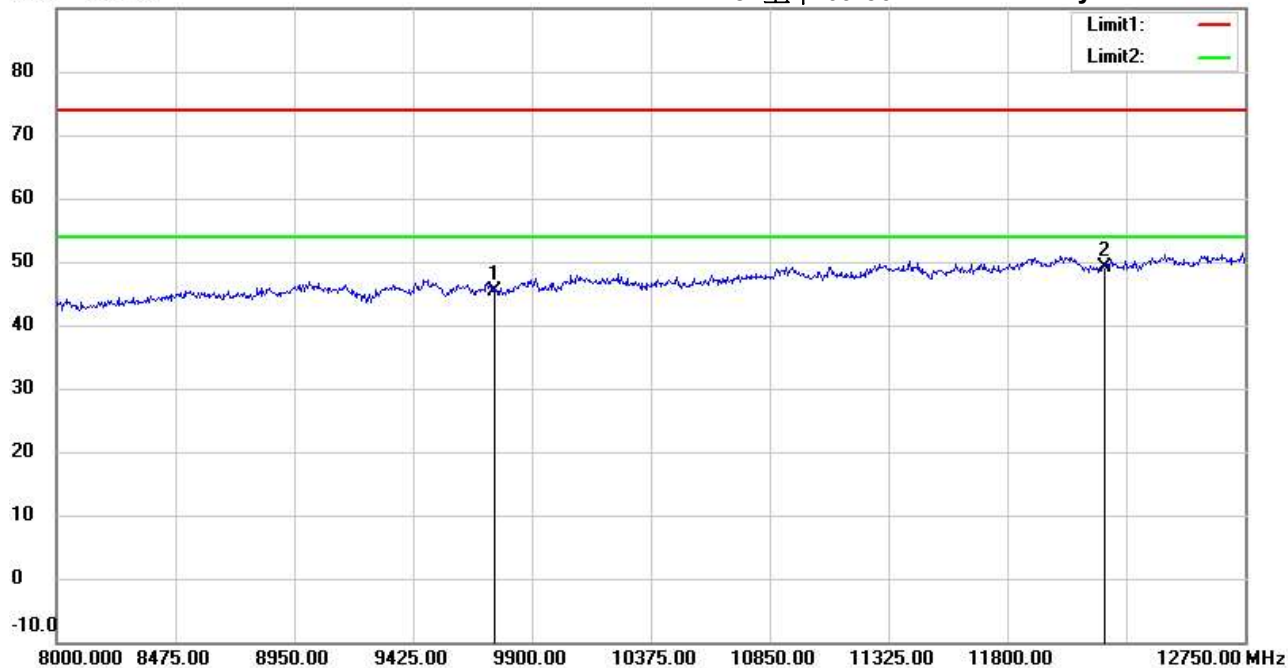
Data : #3

Test Mode : TX 802.11b CH6

Polarization: **Horizontal**

| Mk. | Frequency (MHz) | Reading (dBuV) | Detector | Corr. factor (dB/m) | Result (dBuV/m) | Limit (dBuV/m) | Ant.Pos (cm) | Tab.Pos (deg.) | Margin (dB) | Comment |
|---|---|---|---|---|---|---|---|---|---|---|
| | 9748.000 | 31.64 | peak | 13.70 | 45.34 | 74.00 | 150 | 293 | -28.66 | |
| * | 12185.000 | 32.13 | peak | 17.02 | 49.15 | 74.00 | 150 | 359 | -24.85 | |

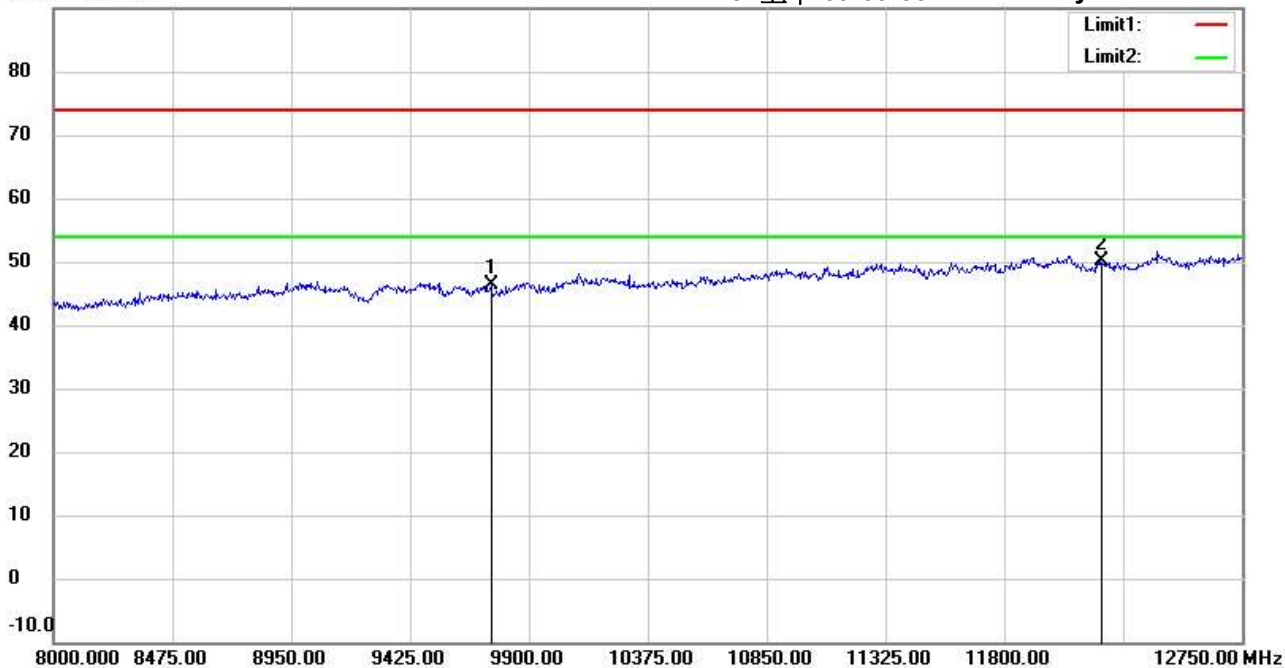
Data : #8

Test Mode : TX 802.11b CH6

Polarization: Vertical

| Mk. | Frequency (MHz) | Reading (dBuV) | Detector | Corr. factor (dB/m) | Result (dBuV/m) | Limit (dBuV/m) | Ant.Pos (cm) | Tab.Pos (deg.) | Margin (dB) | Comment |
|---|---|---|---|---|---|---|---|---|---|---|
| | 9748.000 | 32.56 | peak | 13.70 | 46.26 | 74.00 | 150 | 214 | -27.74 | |
| * | 12185.000 | 33.18 | peak | 17.02 | 50.20 | 74.00 | 150 | 21 | -23.80 | |

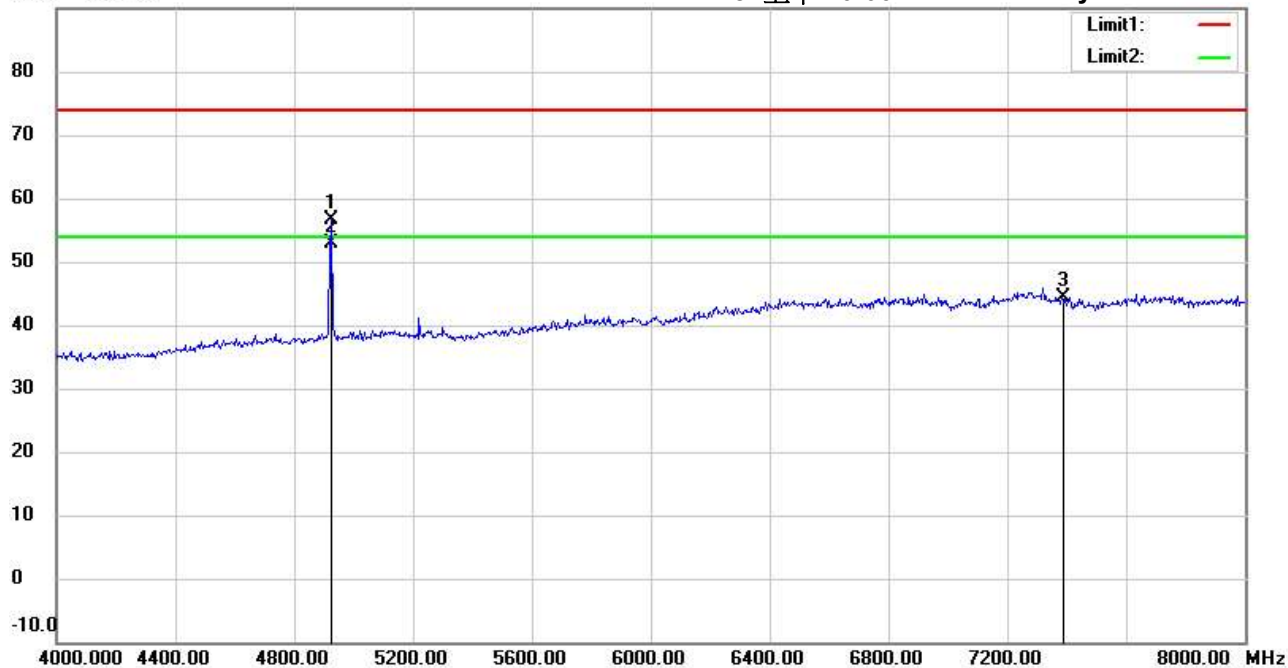
Data :#2

Test Mode : TX 802.11b CH11

Polarization: **Horizontal**

| Mk. | Frequency (MHz) | Reading (dBuV) | Detector | Corr. factor (dB/m) | Result (dBuV/m) | Limit (dBuV/m) | Ant.Pos (cm) | Tab.Pos (deg.) | Margin (dB) | Comment |
|---|---|---|---|---|---|---|---|---|---|---|
| | 4924.000 | 51.28 | peak | 5.38 | 56.66 | 74.00 | 150 | 35 | -17.34 | |
| * | 4924.000 | 47.52 | AVG | 5.38 | 52.90 | 54.00 | 150 | 35 | -1.10 | |
| | 7386.000 | 32.90 | peak | 11.39 | 44.29 | 74.00 | 150 | 23 | -29.71 | |

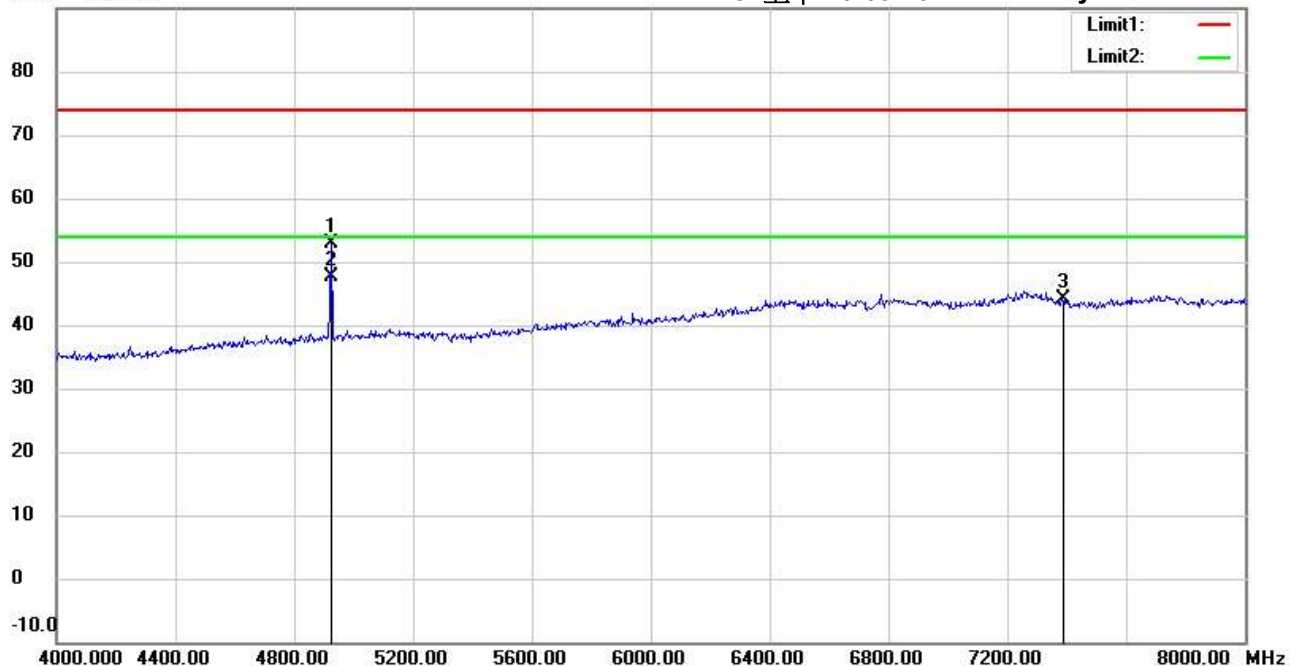
Data : #7

Test Mode : TX 802.11b CH11

Polarization: Vertical

| Mk. | Frequency (MHz) | Reading (dBuV) | Detector | Corr. factor (dB/m) | Result (dBuV/m) | Limit (dBuV/m) | Ant.Pos (cm) | Tab.Pos (deg.) | Margin (dB) | Comment |
|---|---|---|---|---|---|---|---|---|---|---|
| | 4924.000 | 47.38 | peak | 5.38 | 52.76 | 74.00 | 150 | 291 | -21.24 | |
| * | 4924.000 | 42.17 | AVG | 5.38 | 47.55 | 54.00 | 150 | 291 | -6.45 | |
| | 7386.000 | 32.71 | peak | 11.39 | 44.10 | 74.00 | 150 | 286 | -29.90 | |

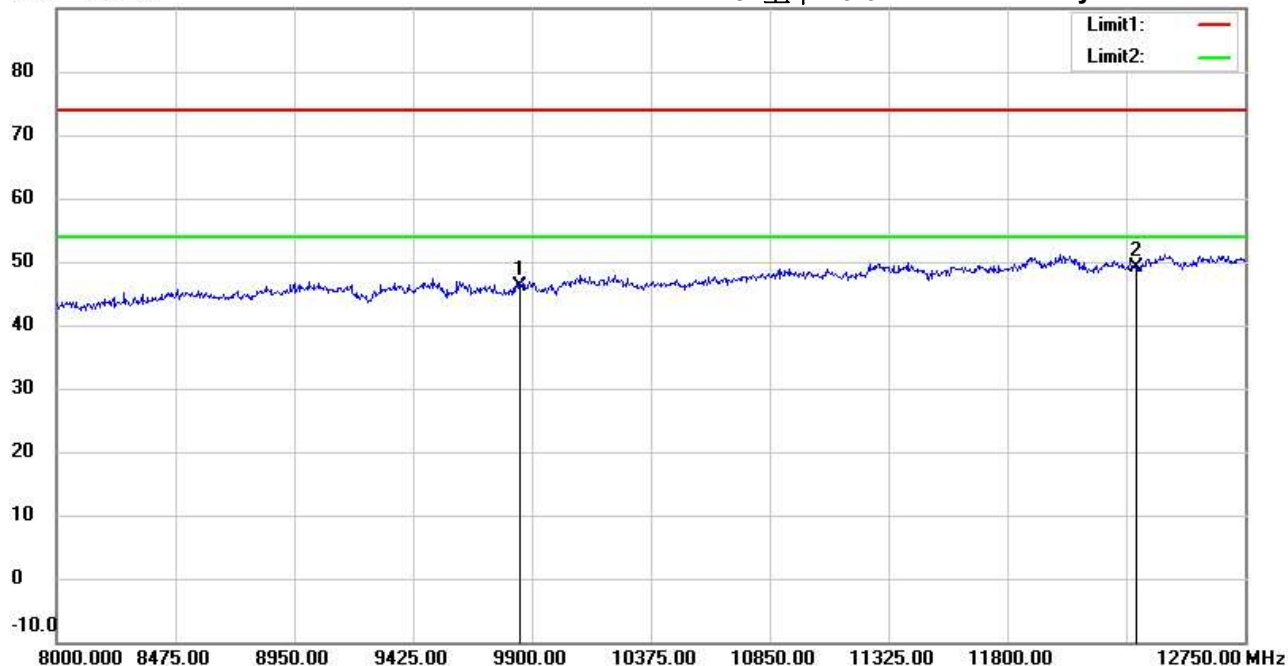
Data : #3

Test Mode : TX 802.11b CH11

Polarization: **Horizontal**

| Mk. | Frequency (MHz) | Reading (dBuV) | Detector | Corr. factor (dB/m) | Result (dBuV/m) | Limit (dBuV/m) | Ant.Pos (cm) | Tab.Pos (deg.) | Margin (dB) | Comment |
|---|---|---|---|---|---|---|---|---|---|---|
| | 9848.000 | 32.15 | peak | 13.97 | 46.12 | 74.00 | 150 | 295 | -27.88 | |
| * | 12310.000 | 32.49 | peak | 16.62 | 49.11 | 74.00 | 150 | 102 | -24.89 | |

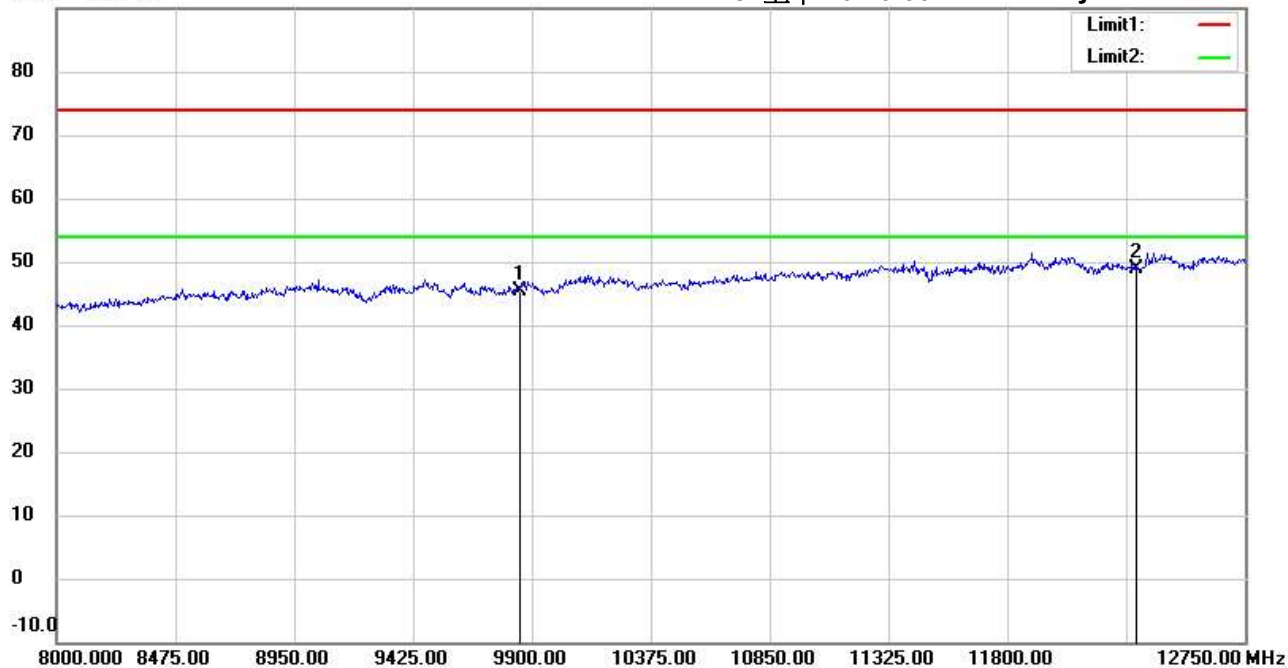
Data : #8

Test Mode : TX 802.11b CH11

Polarization: Vertical

| Mk. | Frequency (MHz) | Reading (dBuV) | Detector | Corr. factor (dB/m) | Result (dBuV/m) | Limit (dBuV/m) | Ant.Pos (cm) | Tab.Pos (deg.) | Margin (dB) | Comment |
|---|---|---|---|---|---|---|---|---|---|---|
| | 9848.000 | 31.40 | peak | 13.97 | 45.37 | 74.00 | 150 | 238 | -28.63 | |
| * | 12310.000 | 32.23 | peak | 16.62 | 48.85 | 74.00 | 150 | 74 | -25.15 | |

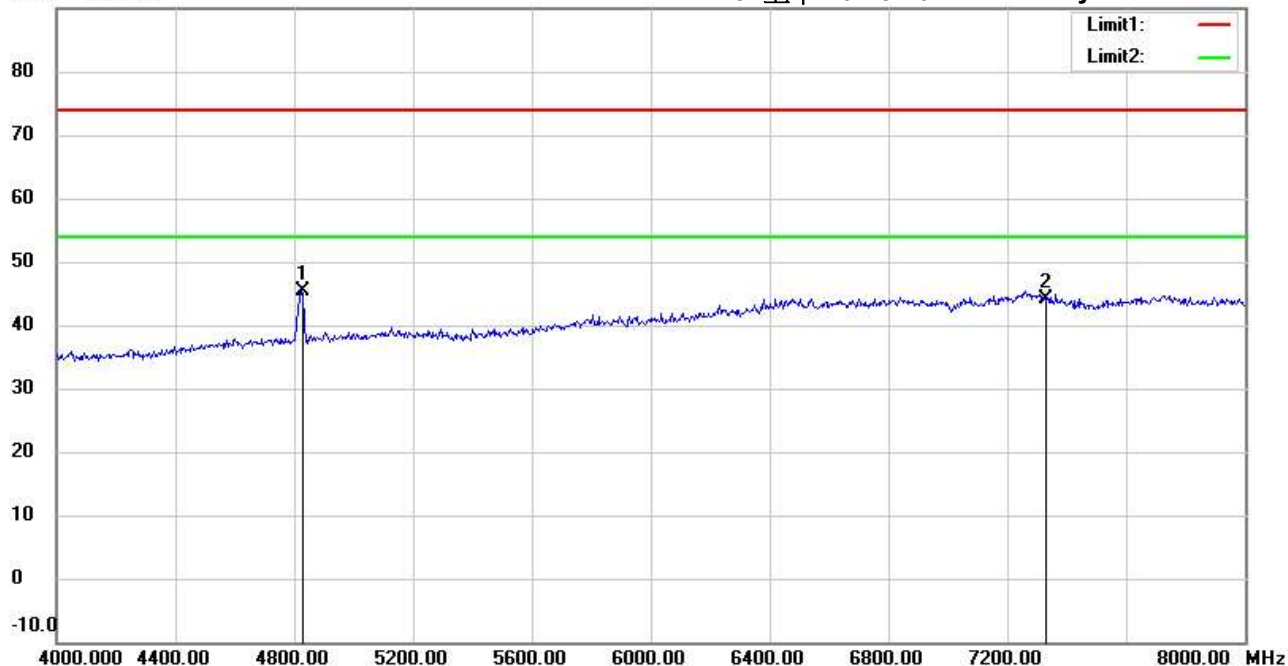
Data : #2

Test Mode : TX 802.11g CH1

Polarization: **Horizontal**

| Mk. | Frequency (MHz) | Reading (dBuV) | Detector | Corr. factor (dB/m) | Result (dBuV/m) | Limit (dBuV/m) | Ant.Pos (cm) | Tab.Pos (deg.) | Margin (dB) | Comment |
|---|---|---|---|---|---|---|---|---|---|---|
| * | 4826.000 | 40.34 | peak | 5.09 | 45.43 | 74.00 | 150 | 271 | -28.57 | |
| | 7326.000 | 32.59 | peak | 11.64 | 44.23 | 74.00 | 150 | 145 | -29.77 | |

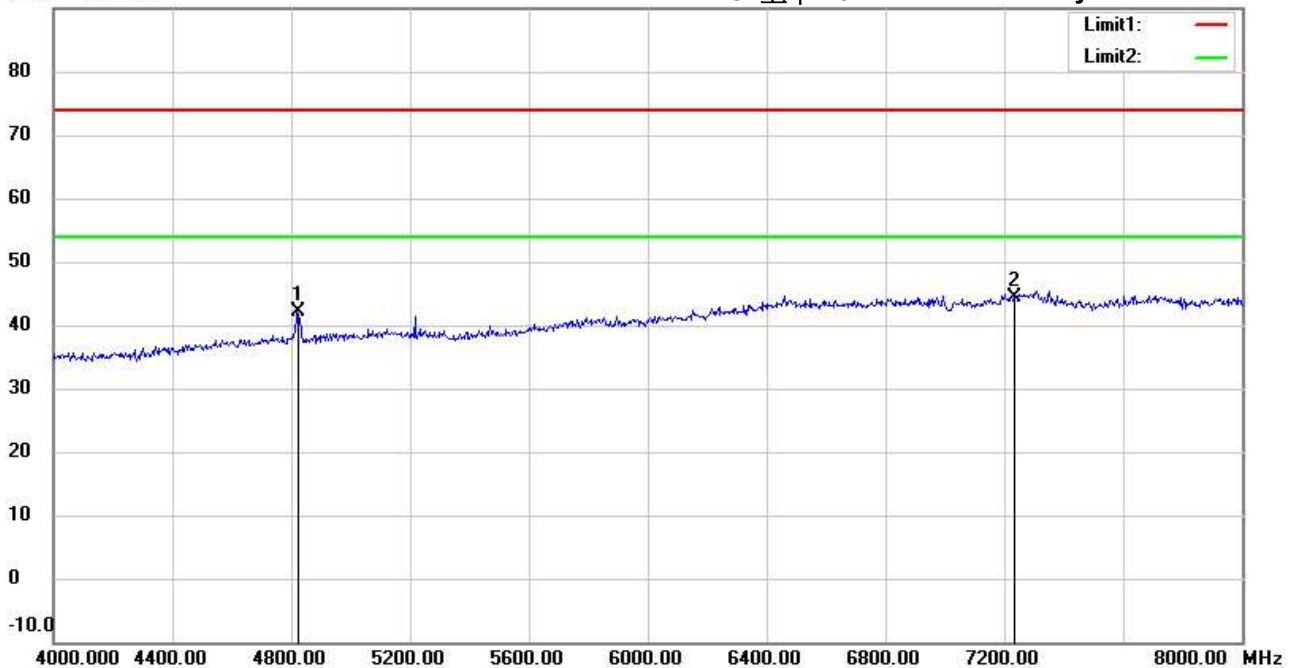
Data : #7

Test Mode : TX 802.11g CH1

Polarization: Vertical

| Mk. | Frequency (MHz) | Reading (dBuV) | Detector | Corr. factor (dB/m) | Result (dBuV/m) | Limit (dBuV/m) | Ant.Pos (cm) | Tab.Pos (deg.) | Margin (dB) | Comment |
|---|---|---|---|---|---|---|---|---|---|---|
| | 4822.000 | 37.15 | peak | 5.08 | 42.23 | 74.00 | 150 | 305 | -31.77 | |
| * | 7236.000 | 32.96 | peak | 11.50 | 44.46 | 74.00 | 150 | 173 | -29.54 | |

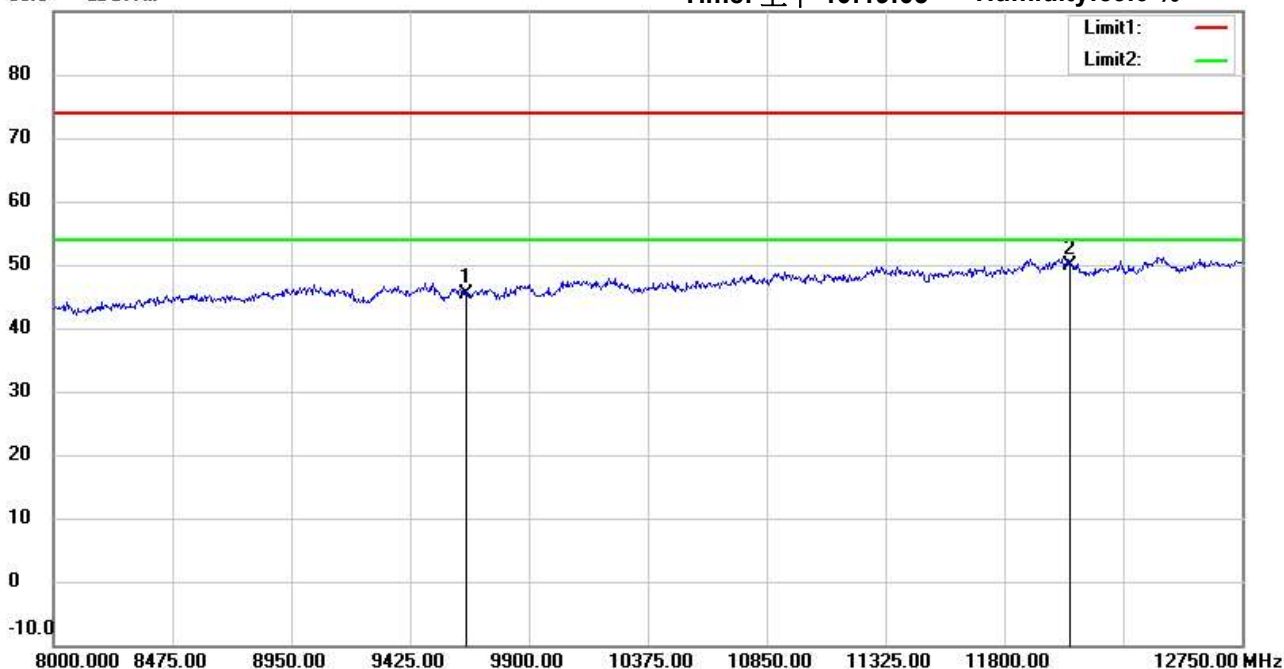
Data : #3

Test Mode : TX 802.11g CH1

Polarization: **Horizontal**

| Mk. | Frequency (MHz) | Reading (dBuV) | Detector | Corr. factor (dB/m) | Result (dBuV/m) | Limit (dBuV/m) | Ant.Pos (cm) | Tab.Pos (deg.) | Margin (dB) | Comment |
|---|---|---|---|---|---|---|---|---|---|---|
| | 9648.000 | 31.86 | peak | 13.44 | 45.30 | 74.00 | 150 | 135 | -28.70 | |
| * | 12060.000 | 32.87 | peak | 17.10 | 49.97 | 74.00 | 150 | 203 | -24.03 | |

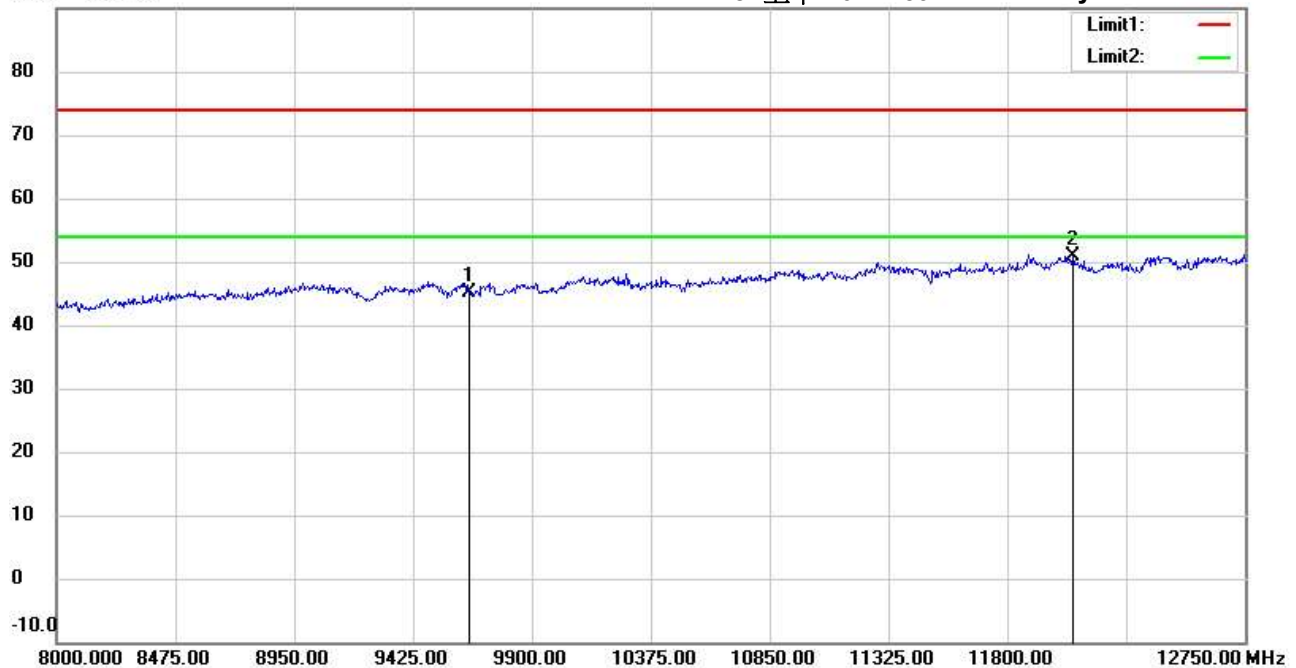
Data : #8

Test Mode : TX 802.11g CH1

Polarization: Vertical

| Mk. | Frequency (MHz) | Reading (dBuV) | Detector | Corr. factor (dB/m) | Result (dBuV/m) | Limit (dBuV/m) | Ant.Pos (cm) | Tab.Pos (deg.) | Margin (dB) | Comment |
|---|---|---|---|---|---|---|---|---|---|---|
| | 9648.000 | 31.64 | peak | 13.44 | 45.08 | 74.00 | 150 | 315 | -28.92 | |
| * | 12060.000 | 33.75 | peak | 17.10 | 50.85 | 74.00 | 150 | 279 | -23.15 | |
