# Radiated Emission Measurement

Condition : FCC\_part 15 RE-Class C\_Above 1GHz\_PK

EUT : W6M22311-23090

Test Mode : TX 802.11n20 CH1

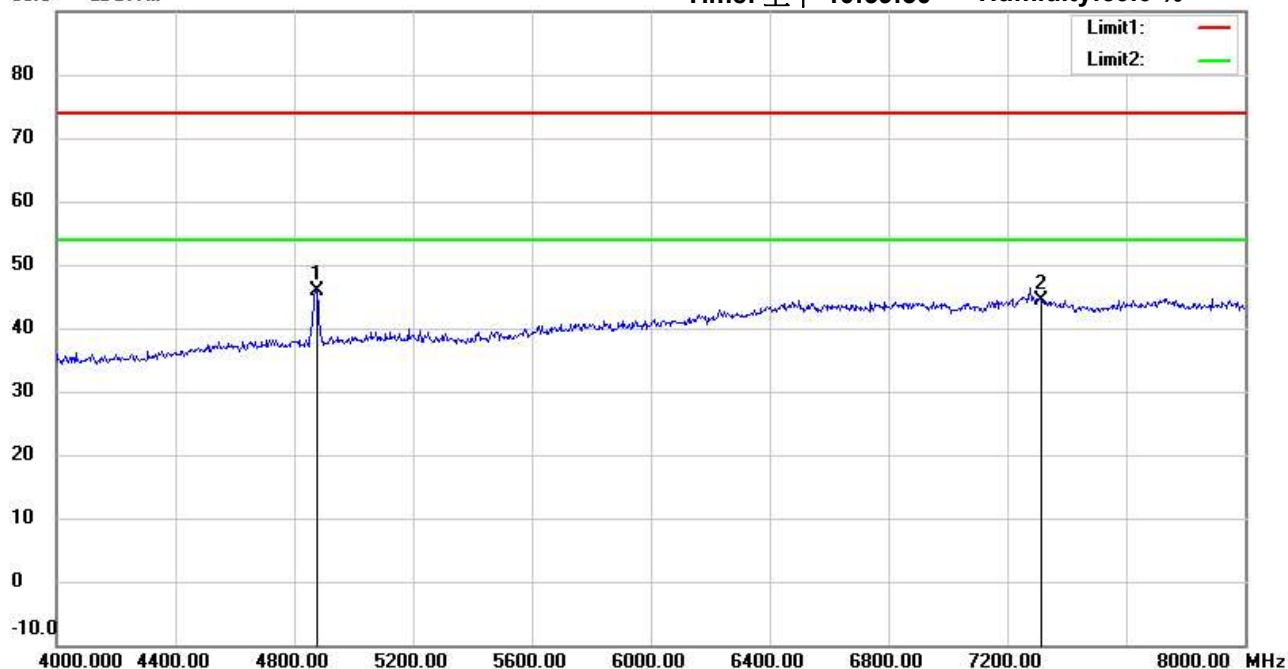
Test Mode : TX 802.11n20 CH6

Polarization: **Horizontal**

| Mk. | Frequency (MHz) | Reading (dBuV) | Detector | Corr. factor (dB/m) | Result (dBuV/m) | Limit (dBuV/m) | Ant.Pos (cm) | Tab.Pos (deg.) | Margin (dB) | Comment |
|---|---|---|---|---|---|---|---|---|---|---|
| * | 4874.000 | 40.76 | peak | 5.21 | 45.97 | 74.00 | 150 | 24 | -28.03 | |
| | 7311.000 | 32.66 | peak | 11.70 | 44.36 | 74.00 | 150 | 274 | -29.64 | |

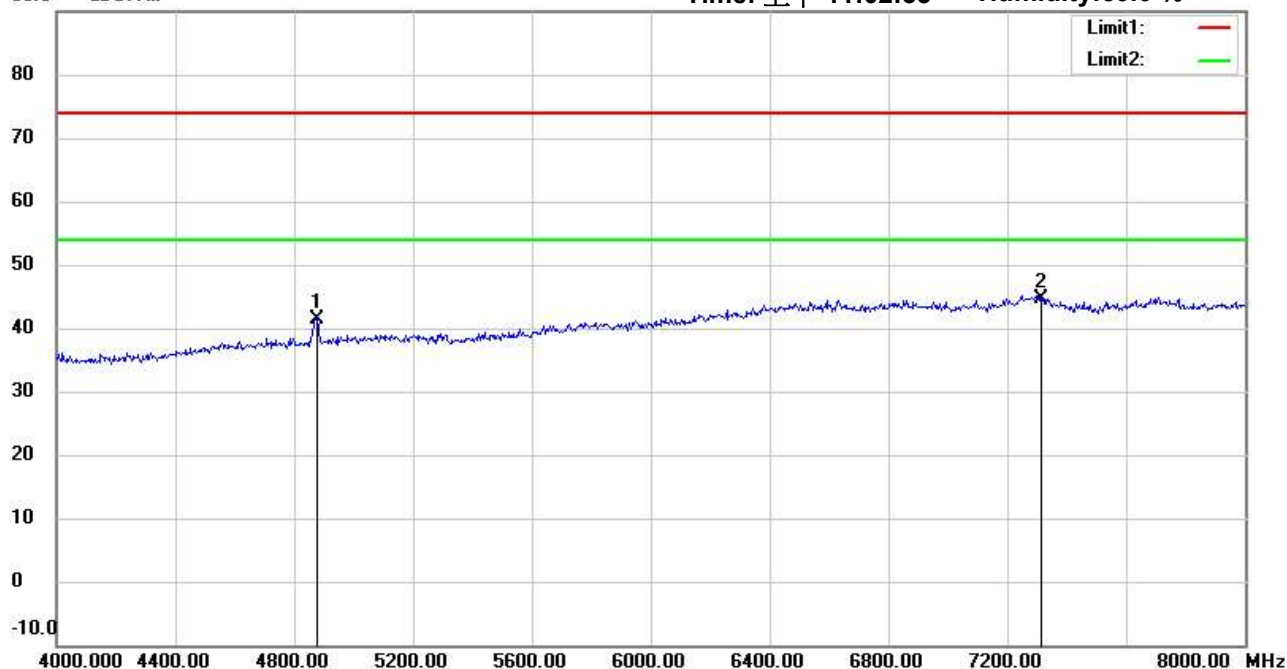
Test Mode : TX 802.11n20 CH6

Polarization: Vertical

| Mk. | Frequency (MHz) | Reading (dBuV) | Detector | Corr. factor (dB/m) | Result (dBuV/m) | Limit (dBuV/m) | Ant.Pos (cm) | Tab.Pos (deg.) | Margin (dB) | Comment |
|---|---|---|---|---|---|---|---|---|---|---|
| | 4874.000 | 36.23 | peak | 5.21 | 41.44 | 74.00 | 150 | 119 | -32.56 | |
| * | 7311.000 | 32.88 | peak | 11.70 | 44.58 | 74.00 | 150 | 285 | -29.42 | |

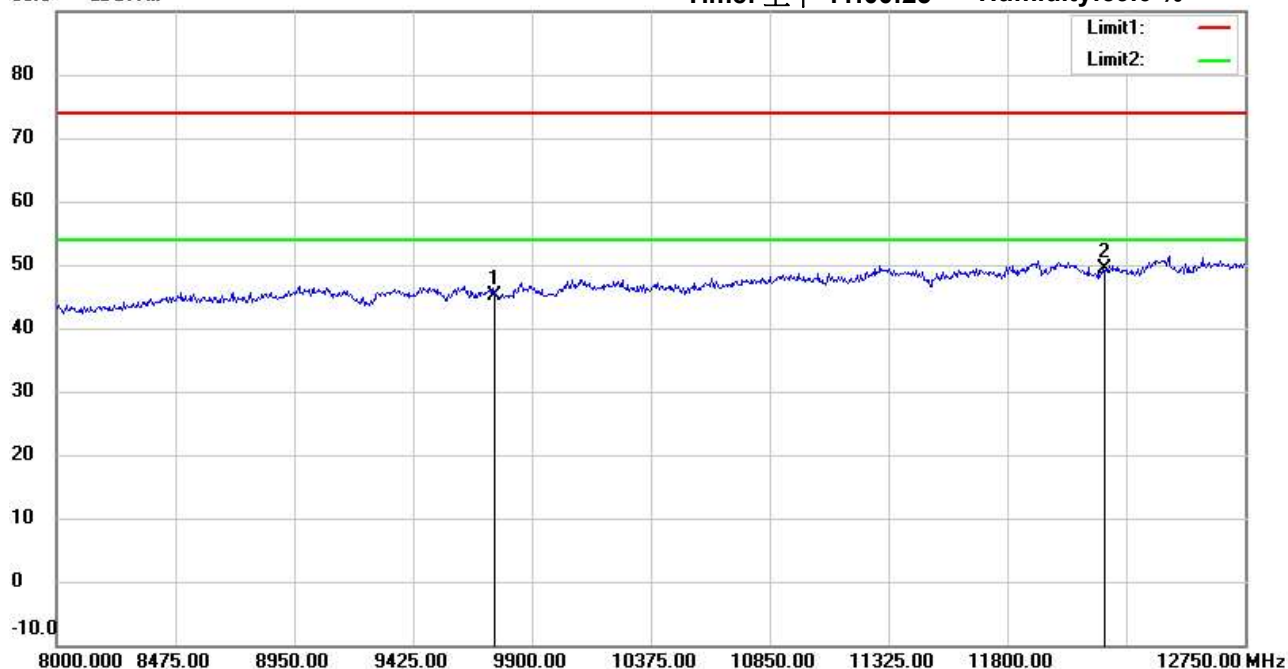
Test Mode : TX 802.11n20 CH6

Polarization: **Horizontal**

| Mk. | Frequency (MHz) | Reading (dBuV) | Detector | Corr. factor (dB/m) | Result (dBuV/m) | Limit (dBuV/m) | Ant.Pos (cm) | Tab.Pos (deg.) | Margin (dB) | Comment |
|---|---|---|---|---|---|---|---|---|---|---|
| | 9748.000 | 31.52 | peak | 13.70 | 45.22 | 74.00 | 150 | 280 | -28.78 | |
| * | 12185.000 | 32.27 | peak | 17.02 | 49.29 | 74.00 | 150 | 178 | -24.71 | |

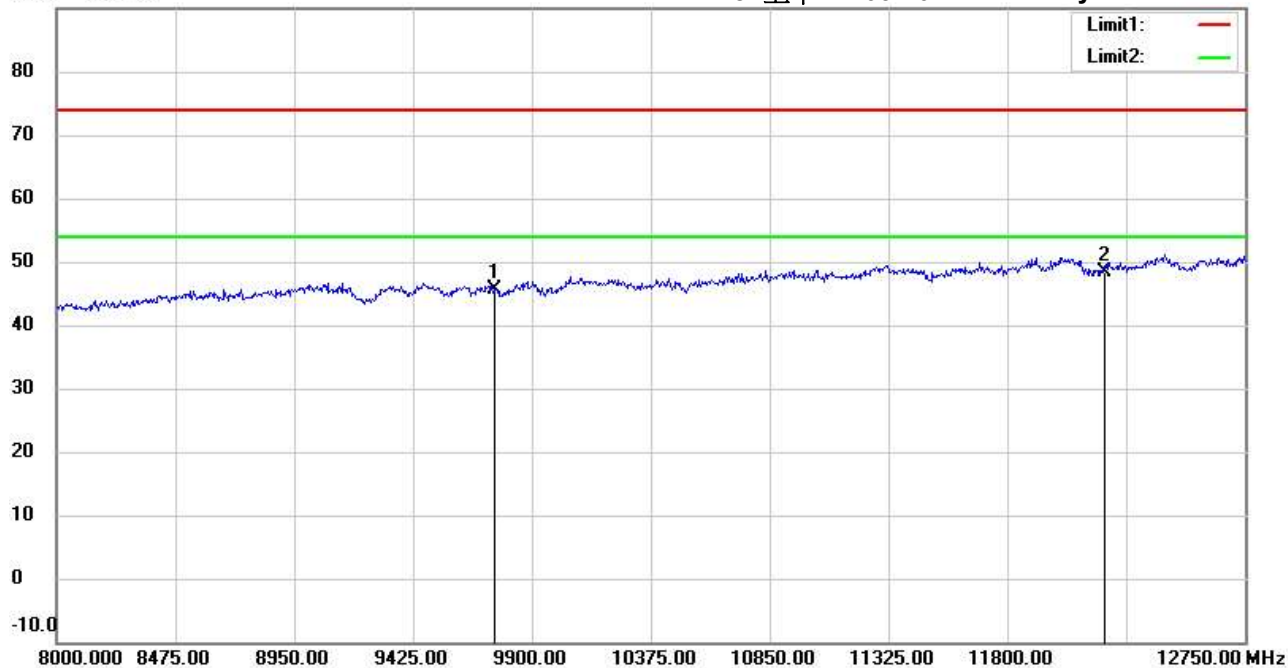
Test Mode : TX 802.11n20 CH6

Polarization: Vertical

| Mk. | Frequency (MHz) | Reading (dBuV) | Detector | Corr. factor (dB/m) | Result (dBuV/m) | Limit (dBuV/m) | Ant.Pos (cm) | Tab.Pos (deg.) | Margin (dB) | Comment |
|---|---|---|---|---|---|---|---|---|---|---|
| | 9748.000 | 32.01 | peak | 13.70 | 45.71 | 74.00 | 150 | 280 | -28.29 | |
| * | 12185.000 | 31.48 | peak | 17.02 | 48.50 | 74.00 | 150 | 78 | -25.50 | |

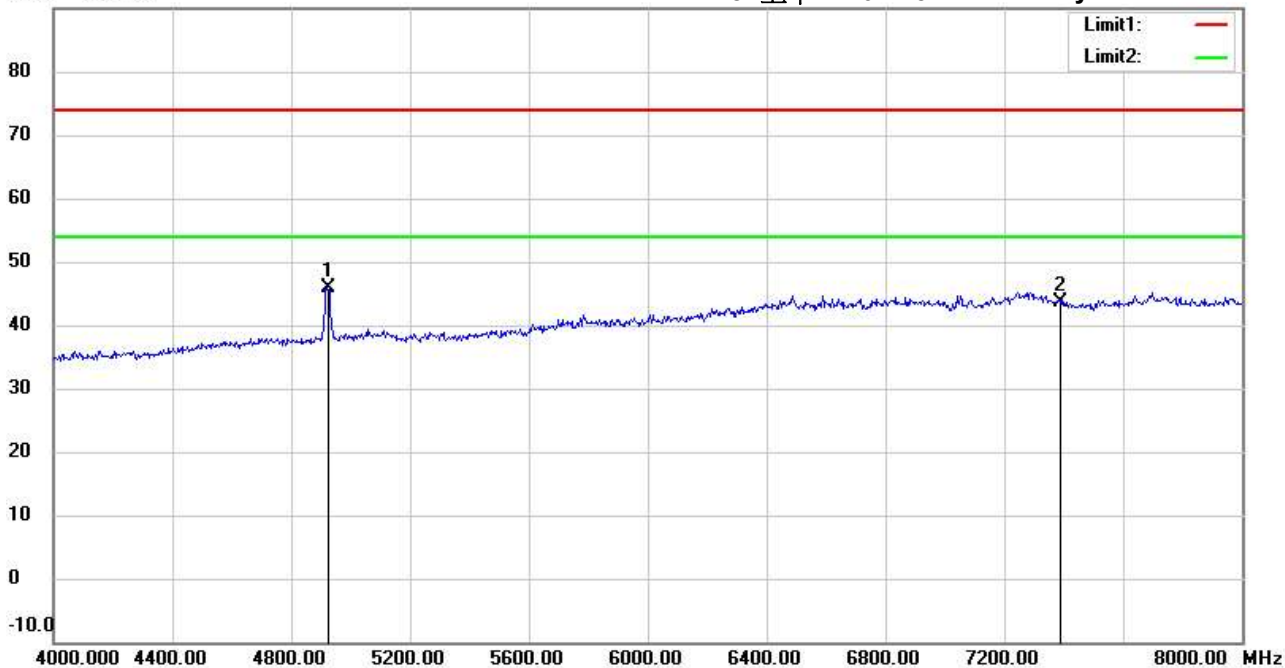
Test Mode : TX 802.11n20 CH11

Polarization: **Horizontal**

| Mk. | Frequency (MHz) | Reading (dBuV) | Detector | Corr. factor (dB/m) | Result (dBuV/m) | Limit (dBuV/m) | Ant.Pos (cm) | Tab.Pos (deg.) | Margin (dB) | Comment |
|---|---|---|---|---|---|---|---|---|---|---|
| * | 4922.000 | 40.63 | peak | 5.37 | 46.00 | 74.00 | 150 | 41 | -28.00 | |
| | 7386.000 | 32.29 | peak | 11.39 | 43.68 | 74.00 | 150 | 344 | -30.32 | |

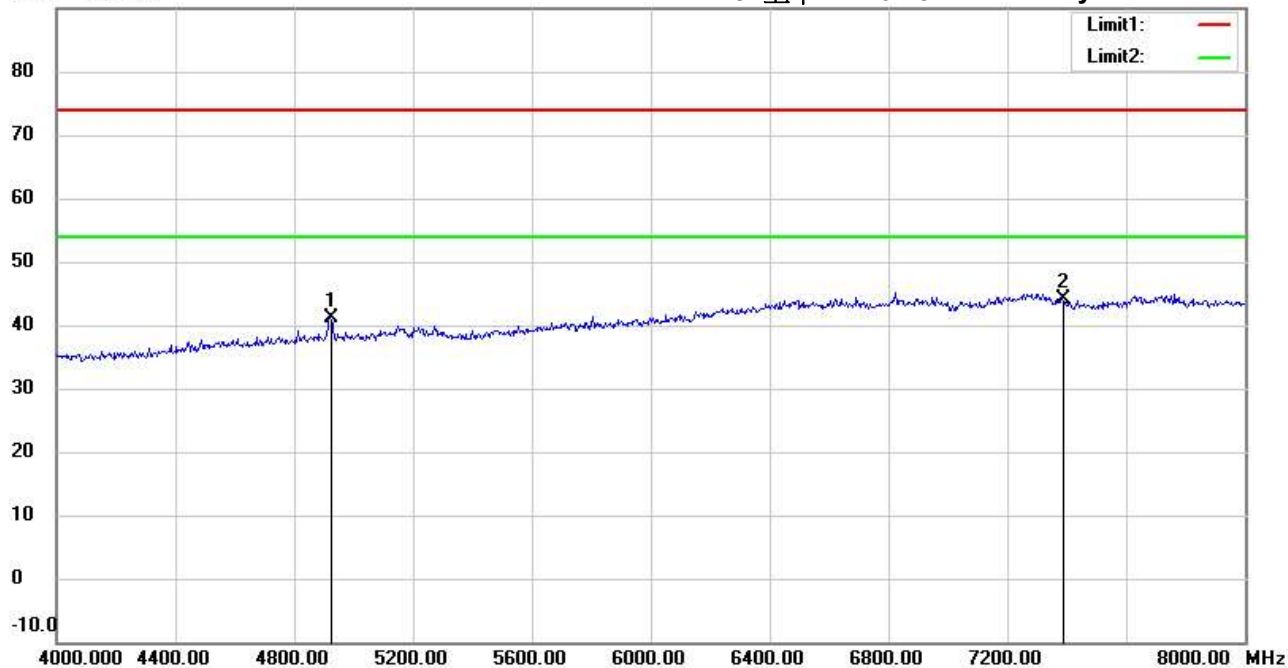
Test Mode : TX 802.11n20 CH11

Polarization: **Vertical**

| Mk. | Frequency (MHz) | Reading (dBuV) | Detector | Corr. factor (dB/m) | Result (dBuV/m) | Limit (dBuV/m) | Ant.Pos (cm) | Tab.Pos (deg.) | Margin (dB) | Comment |
|---|---|---|---|---|---|---|---|---|---|---|
| | 4922.000 | 35.79 | peak | 5.37 | 41.16 | 74.00 | 150 | 112 | -32.84 | |
| * | 7386.000 | 32.77 | peak | 11.39 | 44.16 | 74.00 | 150 | 127 | -29.84 | |

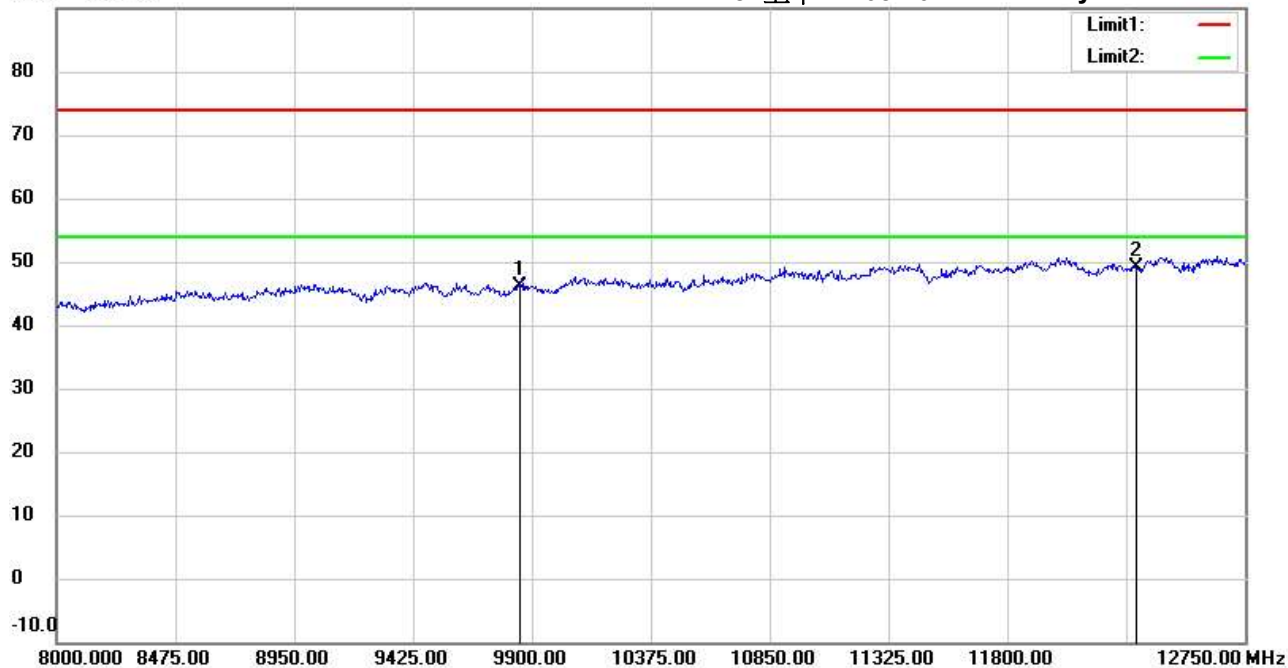
Test Mode : TX 802.11n20 CH11

Polarization: **Horizontal**

| Mk. | Frequency (MHz) | Reading (dBuV) | Detector | Corr. factor (dB/m) | Result (dBuV/m) | Limit (dBuV/m) | Ant.Pos (cm) | Tab.Pos (deg.) | Margin (dB) | Comment |
|---|---|---|---|---|---|---|---|---|---|---|
| | 9848.000 | 32.21 | peak | 13.97 | 46.18 | 74.00 | 150 | 295 | -27.82 | |
| * | 12310.000 | 32.39 | peak | 16.62 | 49.01 | 74.00 | 150 | 44 | -24.99 | |

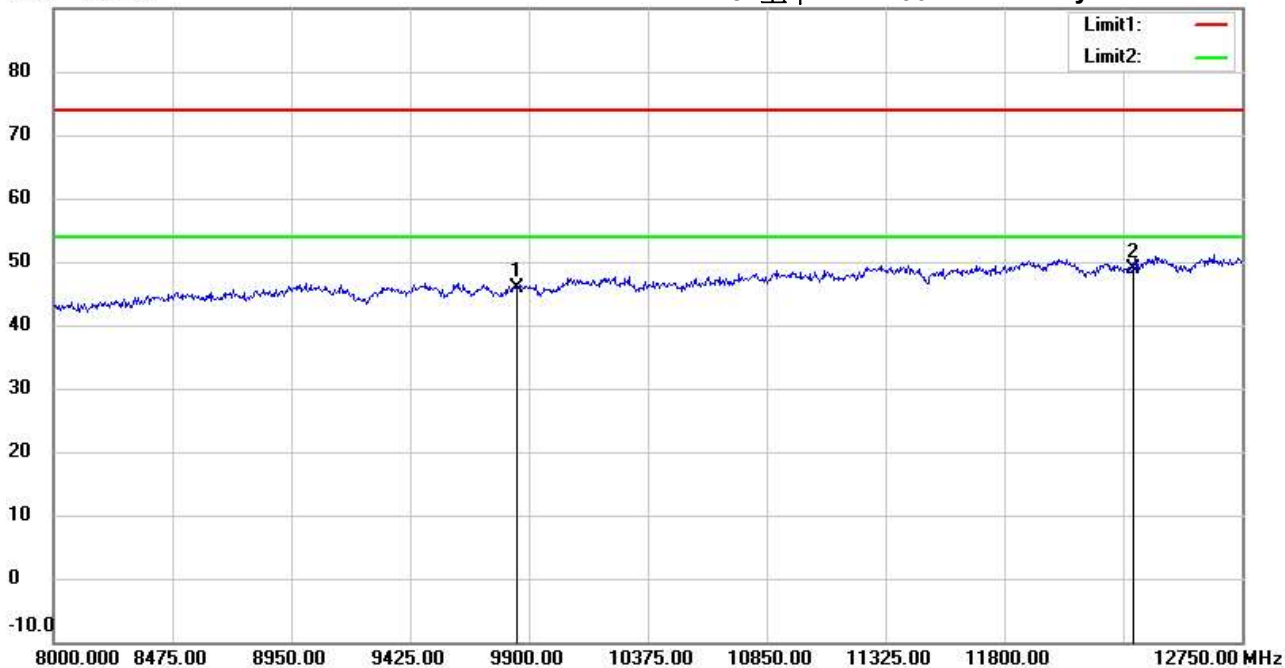
Test Mode : TX 802.11n20 CH11

Polarization: Vertical

| Mk. | Frequency (MHz) | Reading (dBuV) | Detector | Corr. factor (dB/m) | Result (dBuV/m) | Limit (dBuV/m) | Ant.Pos (cm) | Tab.Pos (deg.) | Margin (dB) | Comment |
|---|---|---|---|---|---|---|---|---|---|---|
| | 9848.000 | 31.93 | peak | 13.97 | 45.90 | 74.00 | 150 | 249 | -28.10 | |
| * | 12310.000 | 32.19 | peak | 16.62 | 48.81 | 74.00 | 150 | 221 | -25.19 | |

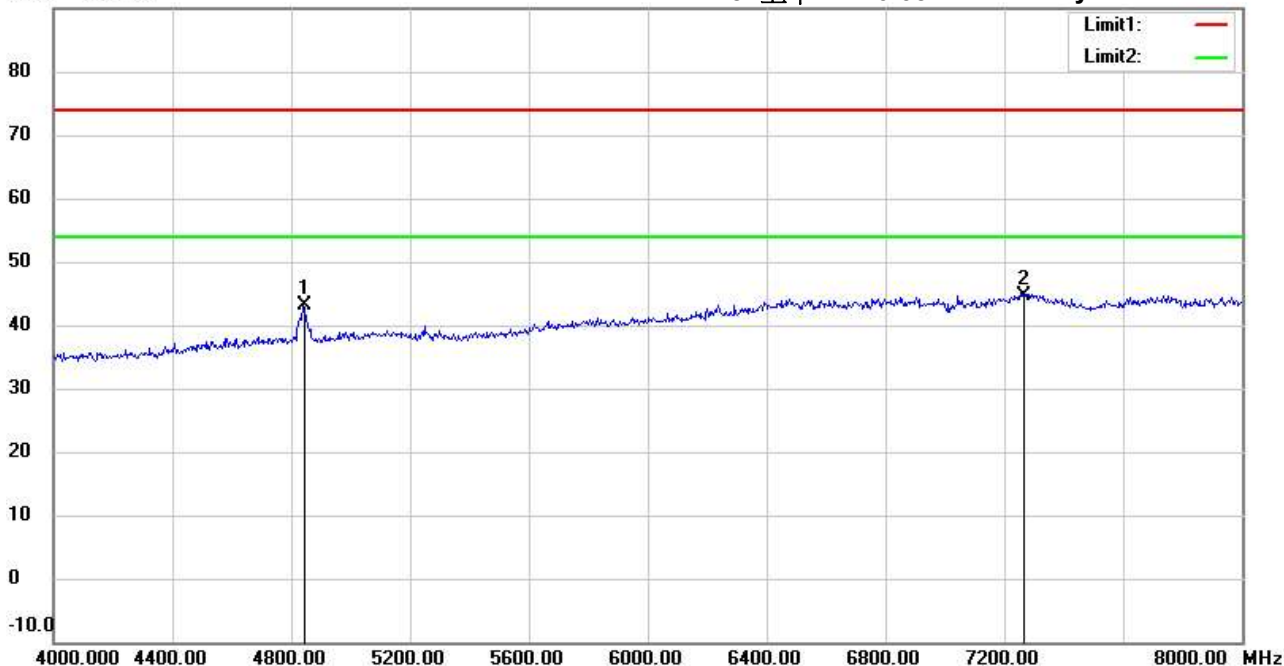
Test Mode : TX 802.11n40 CH1

Polarization: **Horizontal**

| Mk. | Frequency (MHz) | Reading (dBuV) | Detector | Corr. factor (dB/m) | Result (dBuV/m) | Limit (dBuV/m) | Ant.Pos (cm) | Tab.Pos (deg.) | Margin (dB) | Comment |
|---|---|---|---|---|---|---|---|---|---|---|
| | 4842.000 | 37.89 | peak | 5.13 | 43.02 | 74.00 | 150 | 17 | -30.98 | |
| * | 7266.000 | 32.90 | peak | 11.62 | 44.52 | 74.00 | 150 | 359 | -29.48 | |
