# Radiated Emission Measurement

Condition : FCC\_part 15 RE-Class C\_Above 1GHz\_PK

EUT : W6M22311-23090

Test Mode : TX 802.11n40 CH1

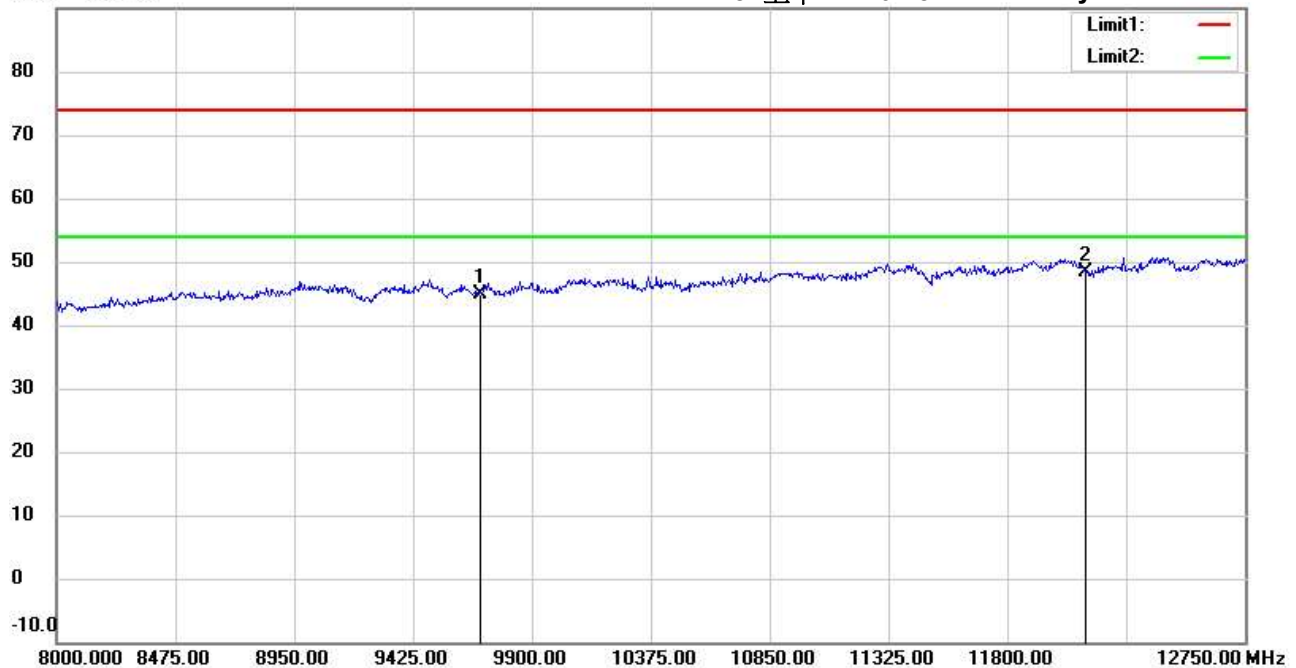
Data : #8

Test Mode : TX 802.11n40 CH1

Polarization: **Vertical**

| Mk. | Frequency (MHz) | Reading (dBuV) | Detector | Corr. factor (dB/m) | Result (dBuV/m) | Limit (dBuV/m) | Ant.Pos (cm) | Tab.Pos (deg.) | Margin (dB) | Comment |
|---|---|---|---|---|---|---|---|---|---|---|
| | 9688.000 | 31.47 | peak | 13.49 | 44.96 | 74.00 | 150 | 299 | -29.04 | |
| * | 12110.000 | 31.36 | peak | 16.97 | 48.33 | 74.00 | 150 | 263 | -25.67 | |

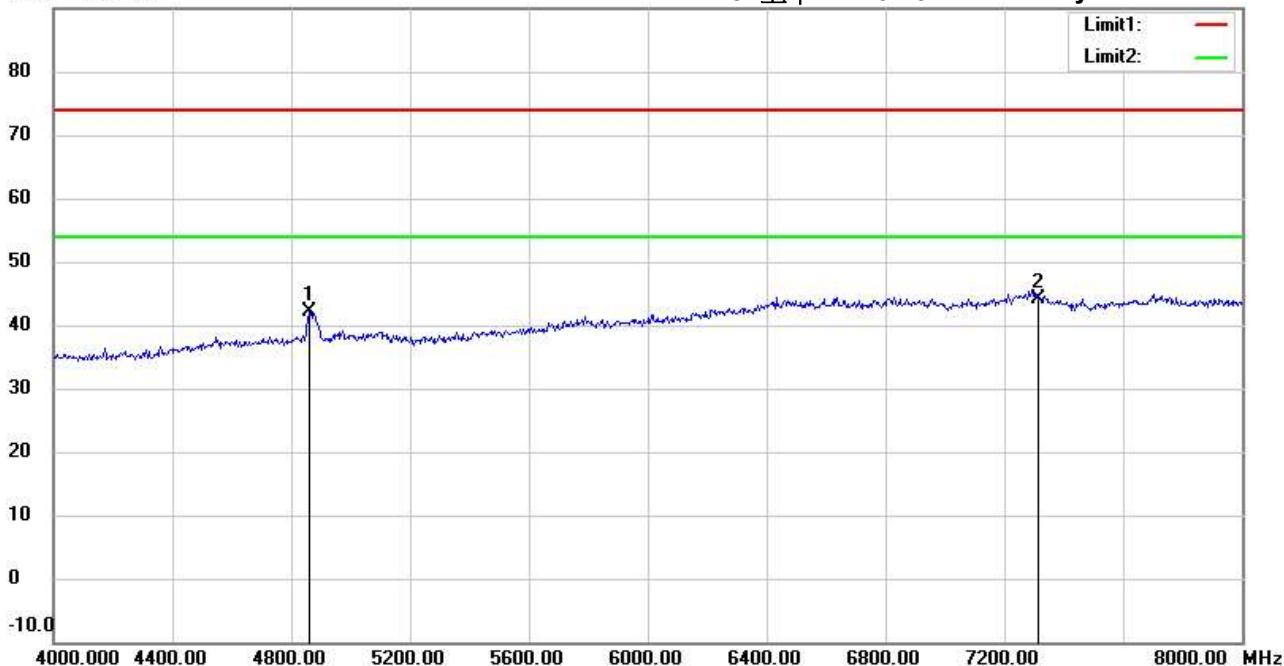
Data :#2

Test Mode : TX 802.11n40 CH4

Polarization: **Horizontal**

| Mk. | Frequency (MHz) | Reading (dBuV) | Detector | Corr. factor (dB/m) | Result (dBuV/m) | Limit (dBuV/m) | Ant.Pos (cm) | Tab.Pos (deg.) | Margin (dB) | Comment |
|---|---|---|---|---|---|---|---|---|---|---|
| | 4860.000 | 36.88 | peak | 5.18 | 42.06 | 74.00 | 150 | 150 | -31.94 | |
| * | 7311.000 | 32.54 | peak | 11.70 | 44.24 | 74.00 | 150 | 282 | -29.76 | |

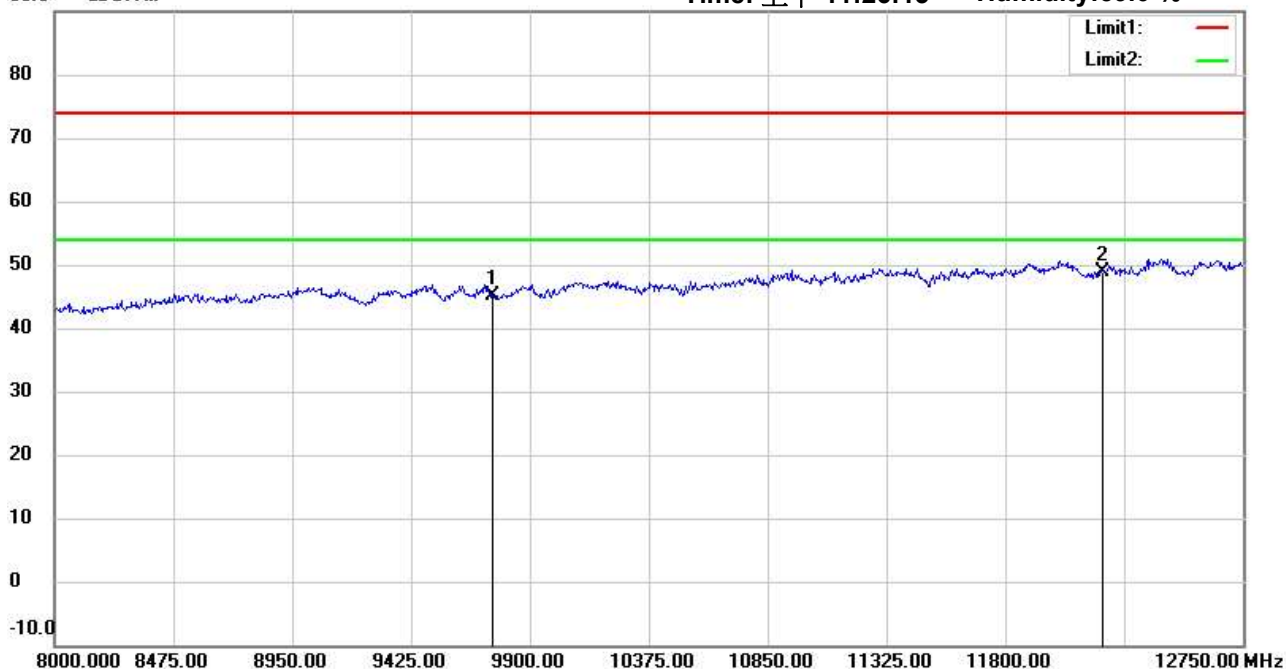
Data : #3

Test Mode : TX 802.11n40 CH4

Polarization: **Horizontal**

| Mk. | Frequency (MHz) | Reading (dBuV) | Detector | Corr. factor (dB/m) | Result (dBuV/m) | Limit (dBuV/m) | Ant.Pos (cm) | Tab.Pos (deg.) | Margin (dB) | Comment |
|---|---|---|---|---|---|---|---|---|---|---|
| | 9748.000 | 31.41 | peak | 13.70 | 45.11 | 74.00 | 150 | 71 | -28.89 | |
| * | 12185.000 | 31.97 | peak | 17.02 | 48.99 | 74.00 | 150 | 255 | -25.01 | |

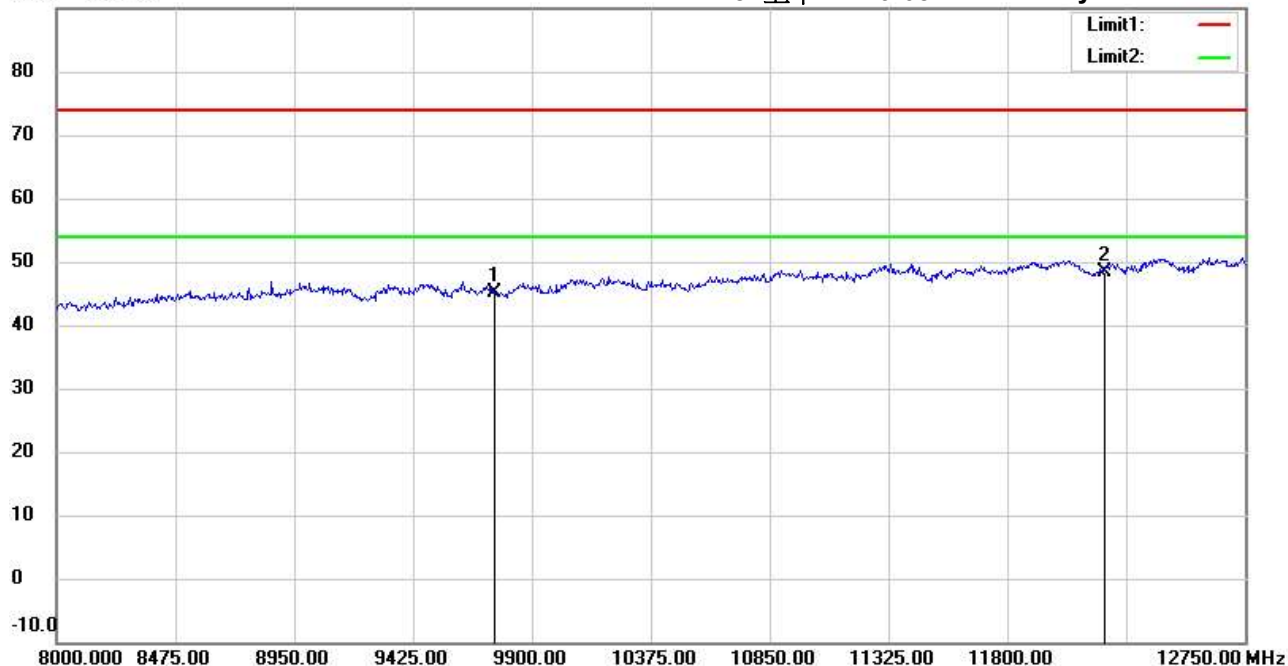
Data : #8

Test Mode : TX 802.11n40 CH4

Polarization: Vertical

| Mk. | Frequency (MHz) | Reading (dBuV) | Detector | Corr. factor (dB/m) | Result (dBuV/m) | Limit (dBuV/m) | Ant.Pos (cm) | Tab.Pos (deg.) | Margin (dB) | Comment |
|---|---|---|---|---|---|---|---|---|---|---|
| | 9748.000 | 31.51 | peak | 13.70 | 45.21 | 74.00 | 150 | 84 | -28.79 | |
| * | 12185.000 | 31.33 | peak | 17.02 | 48.35 | 74.00 | 150 | 315 | -25.65 | |

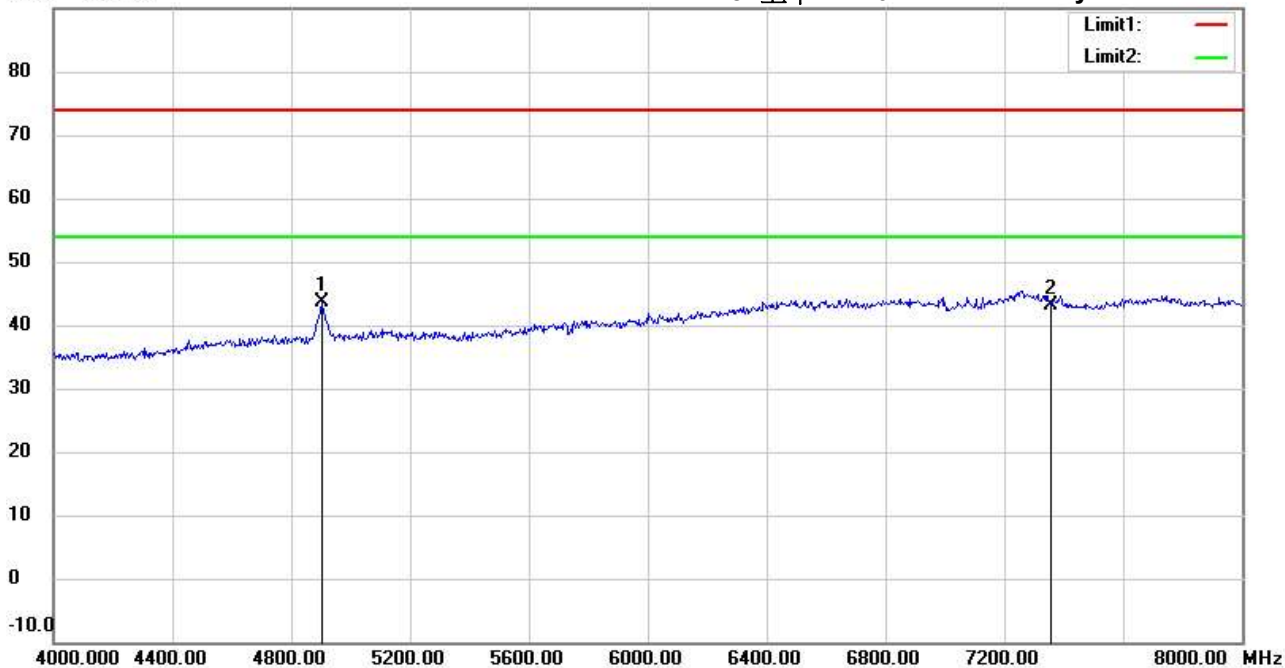
Data :#2

Test Mode : TX 802.11n40 CH7

Polarization: **Horizontal**

| Mk. | Frequency (MHz) | Reading (dBuV) | Detector | Corr. factor (dB/m) | Result (dBuV/m) | Limit (dBuV/m) | Ant.Pos (cm) | Tab.Pos (deg.) | Margin (dB) | Comment |
|---|---|---|---|---|---|---|---|---|---|---|
| * | 4904.000 | 38.29 | peak | 5.30 | 43.59 | 74.00 | 150 | 33 | -30.41 | |
| | 7356.000 | 31.71 | peak | 11.51 | 43.22 | 74.00 | 150 | 258 | -30.78 | |

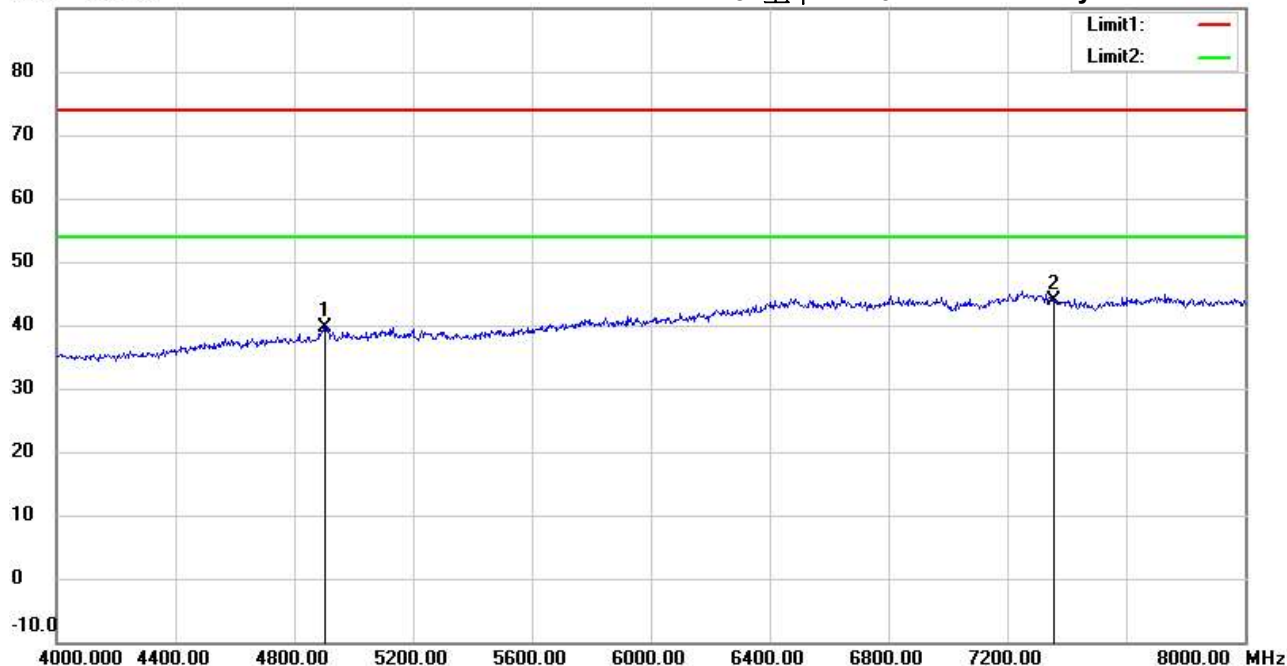
Data : #7

Test Mode : TX 802.11n40 CH7

Polarization: Vertical

| Mk. | Frequency (MHz) | Reading (dBuV) | Detector | Corr. factor (dB/m) | Result (dBuV/m) | Limit (dBuV/m) | Ant.Pos (cm) | Tab.Pos (deg.) | Margin (dB) | Comment |
|---|---|---|---|---|---|---|---|---|---|---|
| | 4904.000 | 34.22 | peak | 5.30 | 39.52 | 74.00 | 150 | 129 | -34.48 | |
| * | 7356.000 | 32.25 | peak | 11.51 | 43.76 | 74.00 | 150 | 318 | -30.24 | |

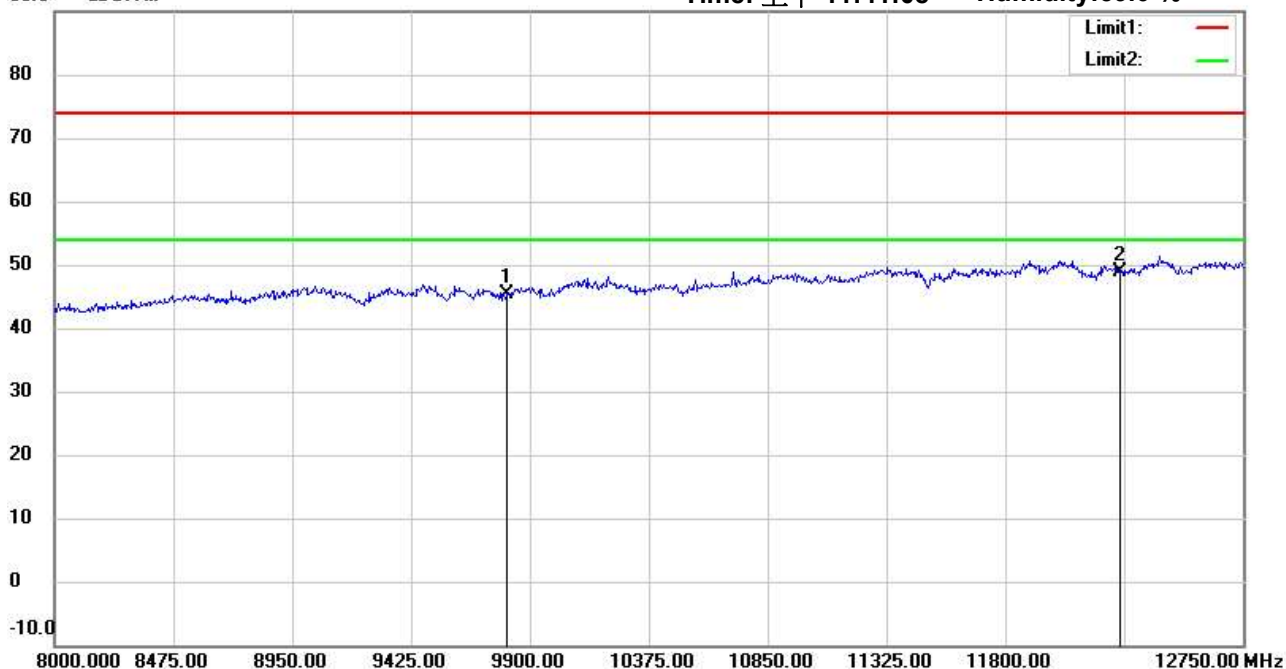
Data : #3

Test Mode : TX 802.11n40 CH7

Polarization: **Horizontal**

| Mk. | Frequency (MHz) | Reading (dBuV) | Detector | Corr. factor (dB/m) | Result (dBuV/m) | Limit (dBuV/m) | Ant.Pos (cm) | Tab.Pos (deg.) | Margin (dB) | Comment |
|---|---|---|---|---|---|---|---|---|---|---|
| | 9808.000 | 31.44 | peak | 13.92 | 45.36 | 74.00 | 150 | 272 | -28.64 | |
| * | 12260.000 | 32.04 | peak | 16.72 | 48.76 | 74.00 | 150 | 336 | -25.24 | |

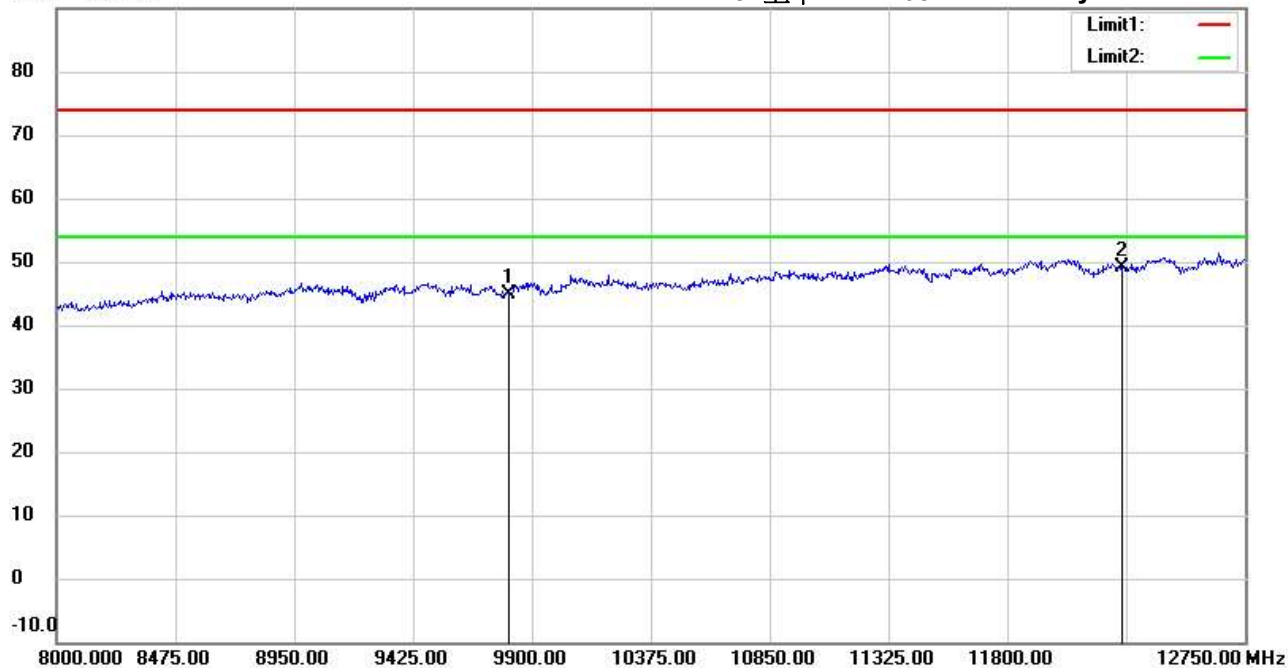
Data : #8

Test Mode : TX 802.11n40 CH7

Polarization: Vertical

| Mk. | Frequency (MHz) | Reading (dBuV) | Detector | Corr. factor (dB/m) | Result (dBuV/m) | Limit (dBuV/m) | Ant.Pos (cm) | Tab.Pos (deg.) | Margin (dB) | Comment |
|---|---|---|---|---|---|---|---|---|---|---|
| | 9808.000 | 31.02 | peak | 13.92 | 44.94 | 74.00 | 150 | 335 | -29.06 | |
| * | 12260.000 | 32.44 | peak | 16.72 | 49.16 | 74.00 | 150 | 202 | -24.84 | |
