## 6 Photographs of the Test Set-Up

**Prüfbericht - Nr.: CN23VHXX 001**  
Test Report No.:

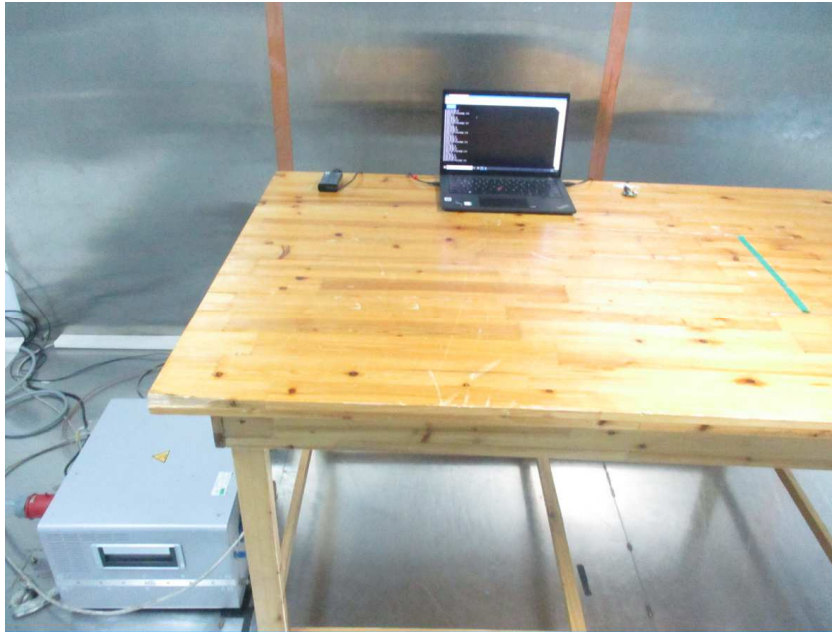
**Photograph 1: Set-up for measurement of conducted emission**

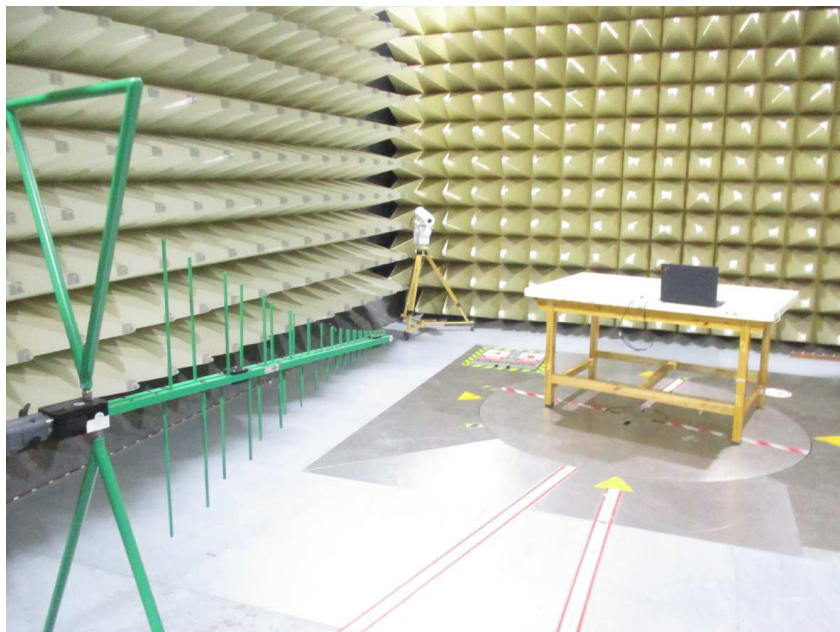
**Photograph 2: Set-up for measurement of radiated emission**

(30-1000 MHz)

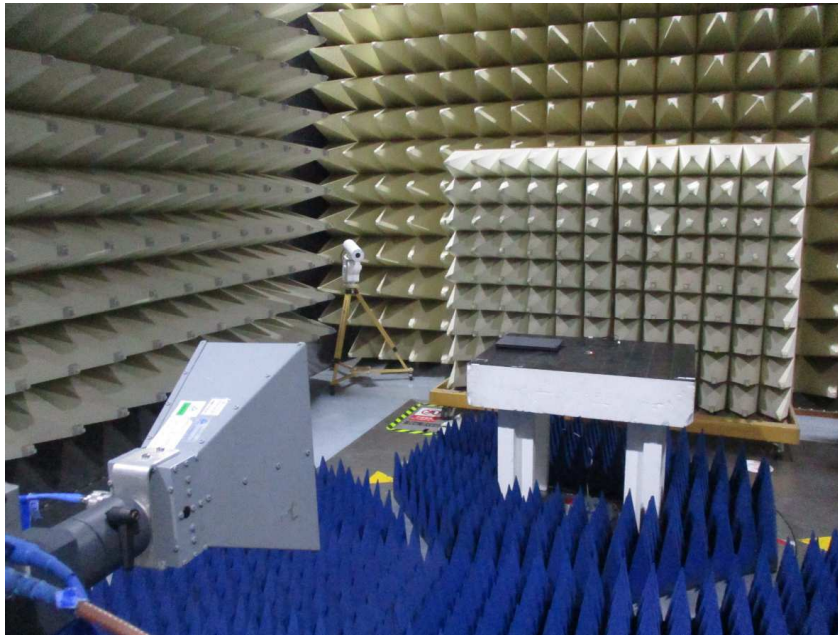
(1-18 GHz)
