### **APPENDIX 3: Photographs of test setup**

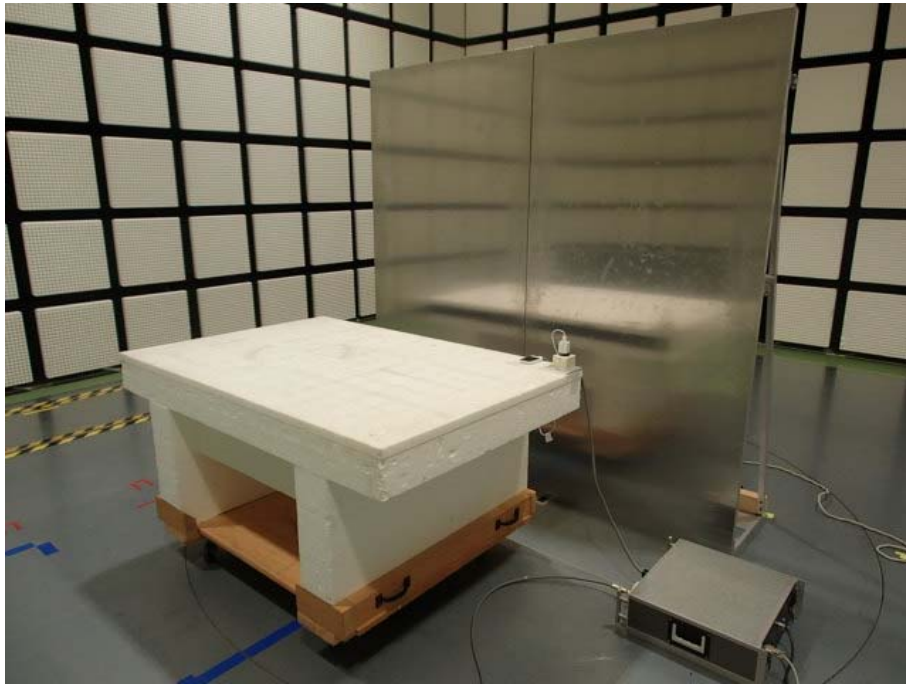
**Photo 1**

#### **Conducted Emission**

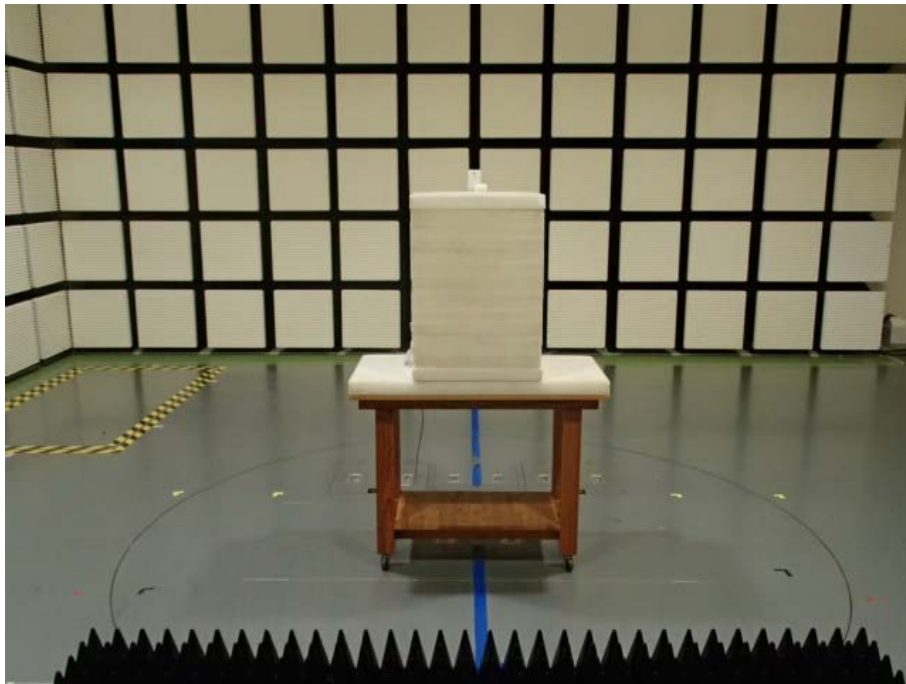
Photo 1

### Radiated Spurious Emission

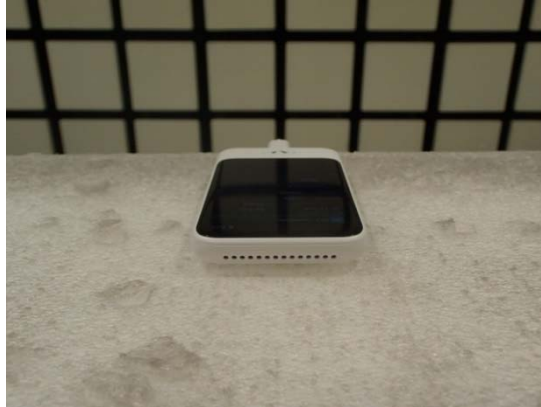
**X-axis**

**Worst Case Position**

**Below 1 GHz (Horizontal: X-axis/ Vertical: X-axis)**

**Above 1 GHz (Horizontal: X-axis/ Vertical: Y-axis)**
