IEC 60945:2002 +C1:2008 Testing of the LT-3100S GMDSS System  
on behalf of LARS THRANE A/S

Document 75946681 Report 07 Issue 1

December 2019

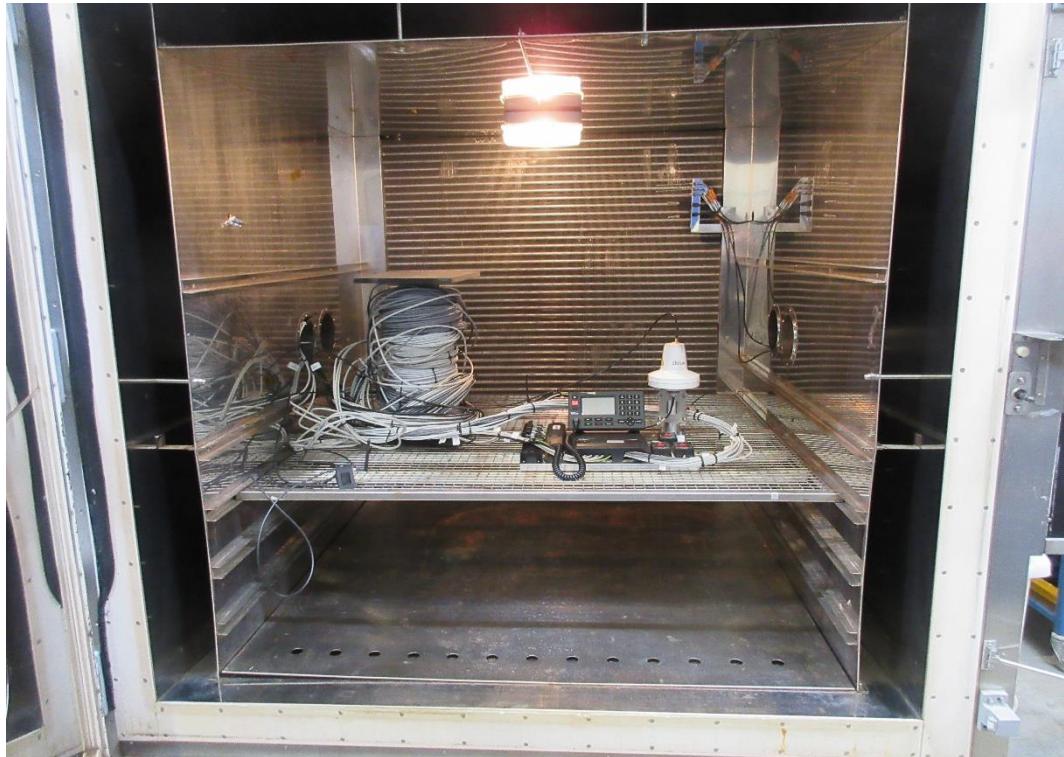
Figure 2.1.1 EUT test setup

No damage or deterioration was observed or reported. A visual examination and functional test carried out by the client's representative on completion of the test was reported as satisfactory.

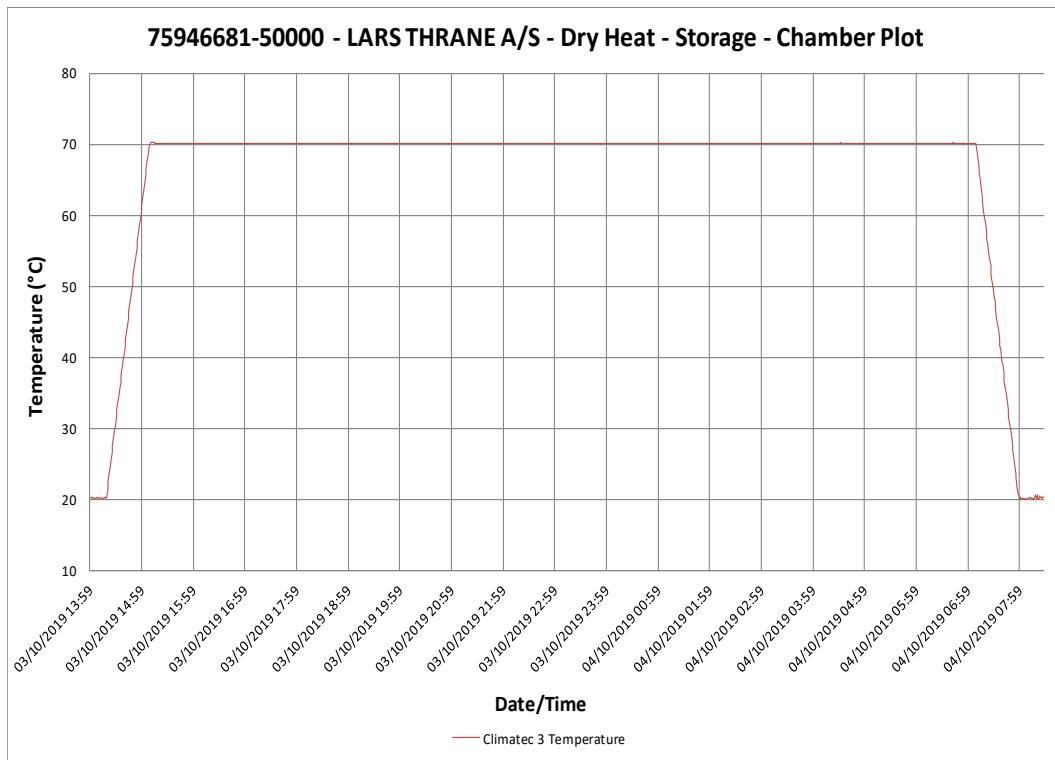
Figure 2.1.2 Dry Heat Storage Plot

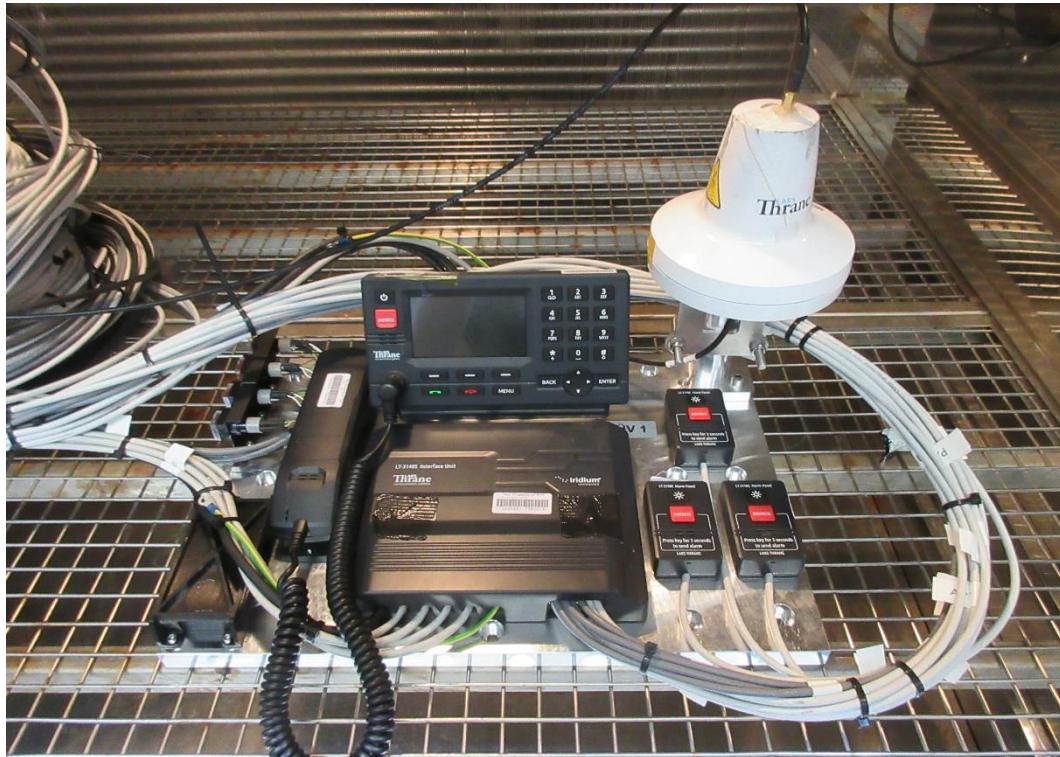
Figure 2.2.1 EUT test setup

No damage or deterioration was observed or reported. A visual examination and functional test carried out by the client's representative on completion of the test was reported as satisfactory.

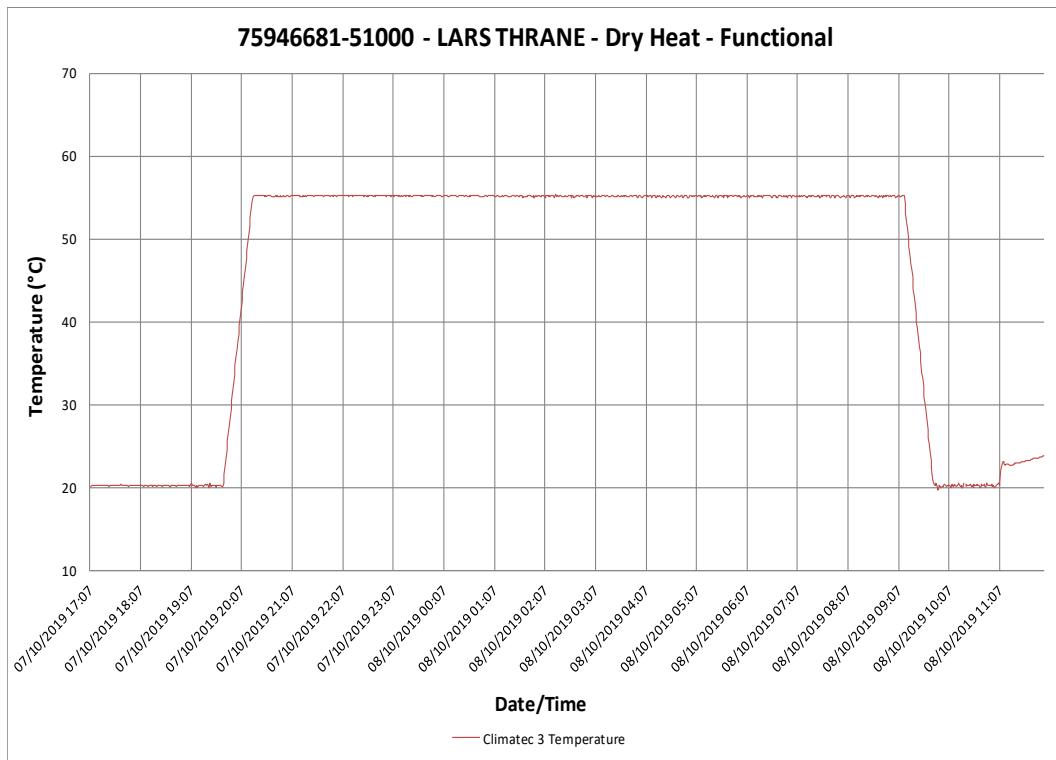
Figure 2.2.2 Dry Heat Functional Plot

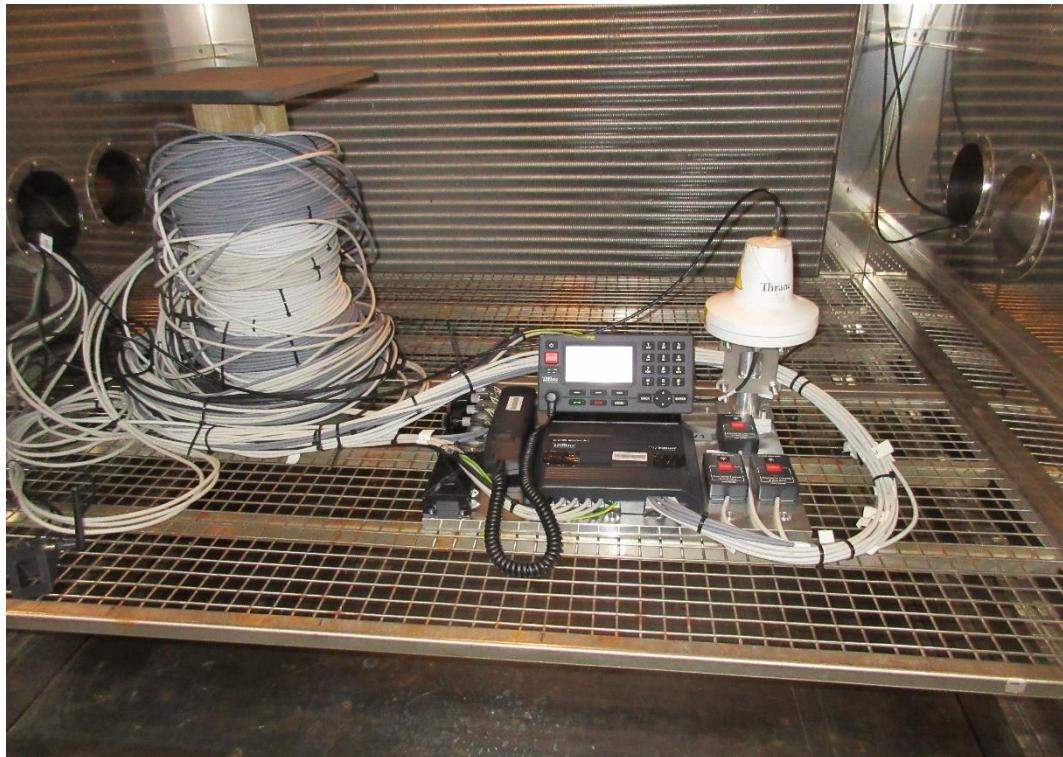
Figure 2.3.1 EUT test setup

No damage or deterioration was observed or reported. A visual examination and functional test carried out by the client's representative on completion of the test was reported as satisfactory.

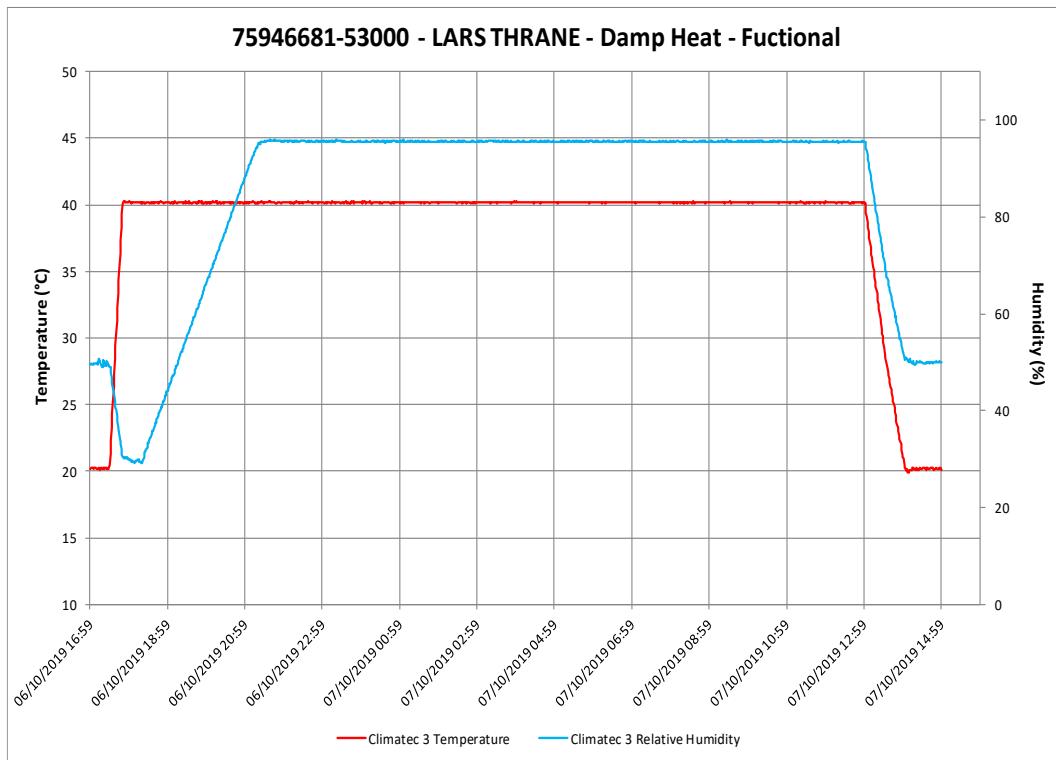
Figure 2.3.2 Damp Heat Plot

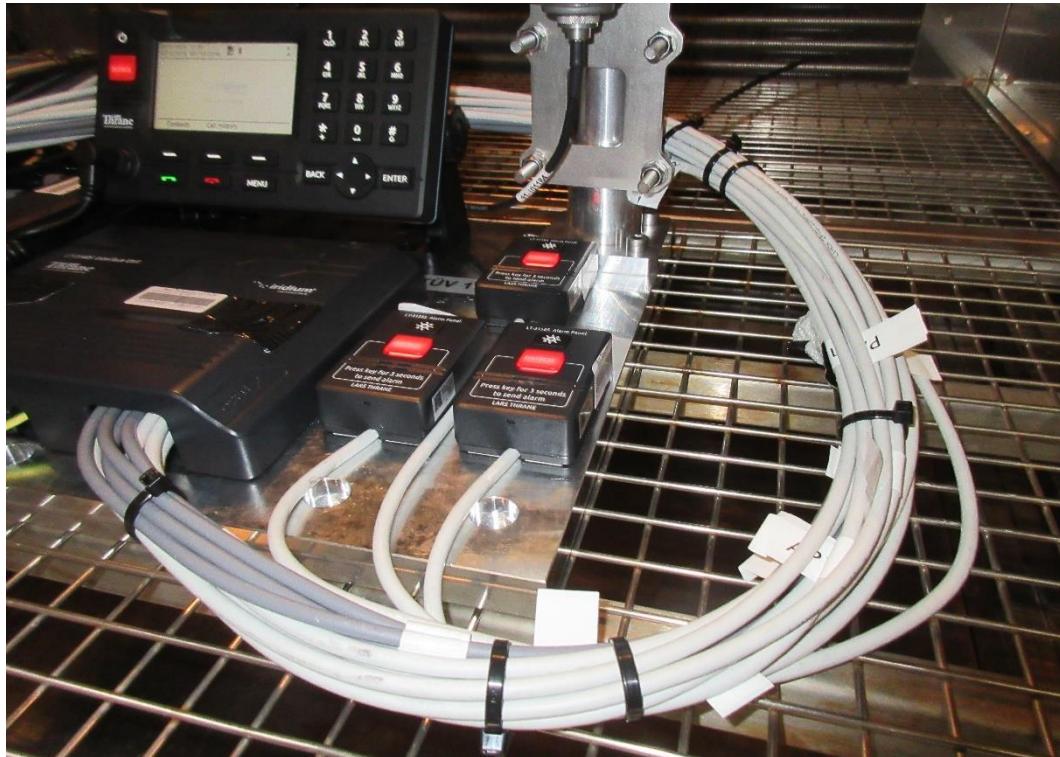
Figure 2.4.1 EUT test setup

No damage or deterioration was observed or reported. A visual examination and functional test carried out by the client's representative on completion of the test was reported as satisfactory.

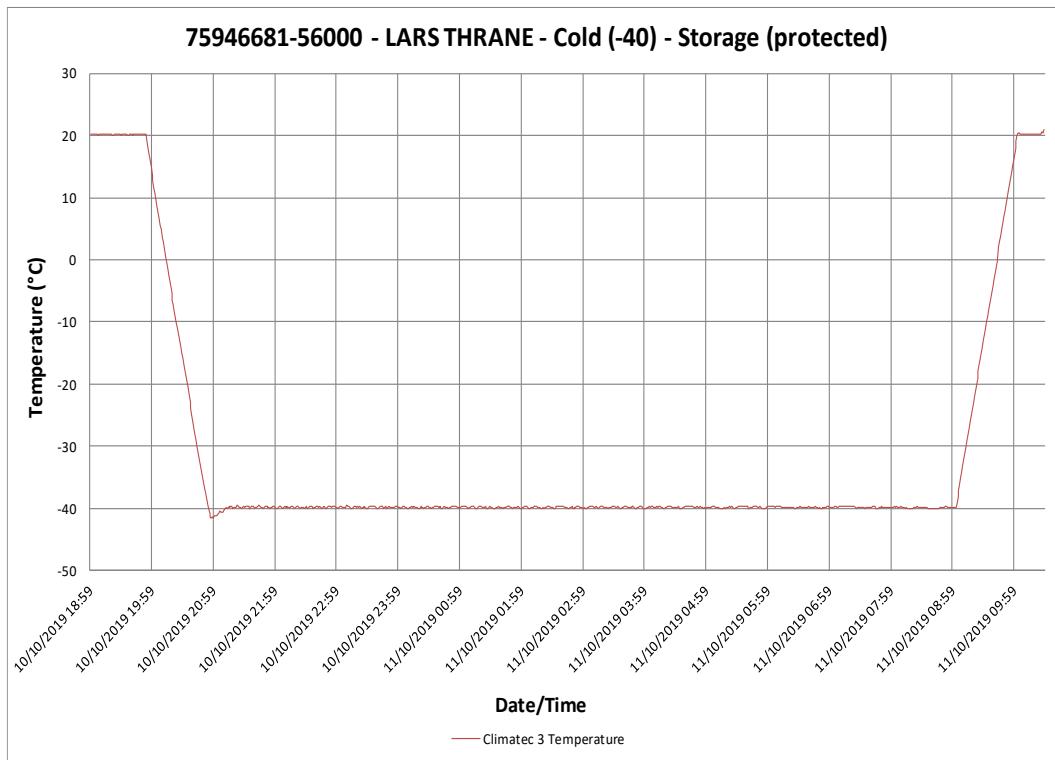
Figure 2.4.2 Low Temperature Storage (Protected)

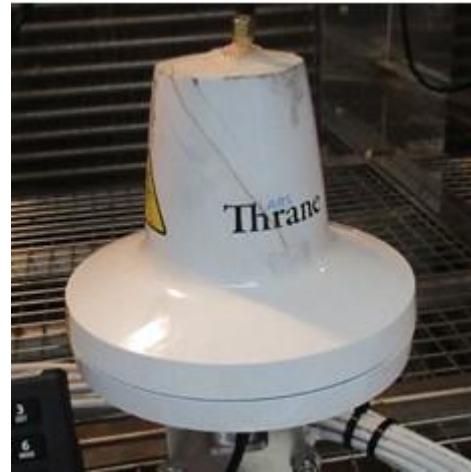
Figure 2.5.1 EUT test setup

No damage or deterioration was observed or reported. A visual examination and functional test carried out by the client's representative on completion of the test was reported as satisfactory.

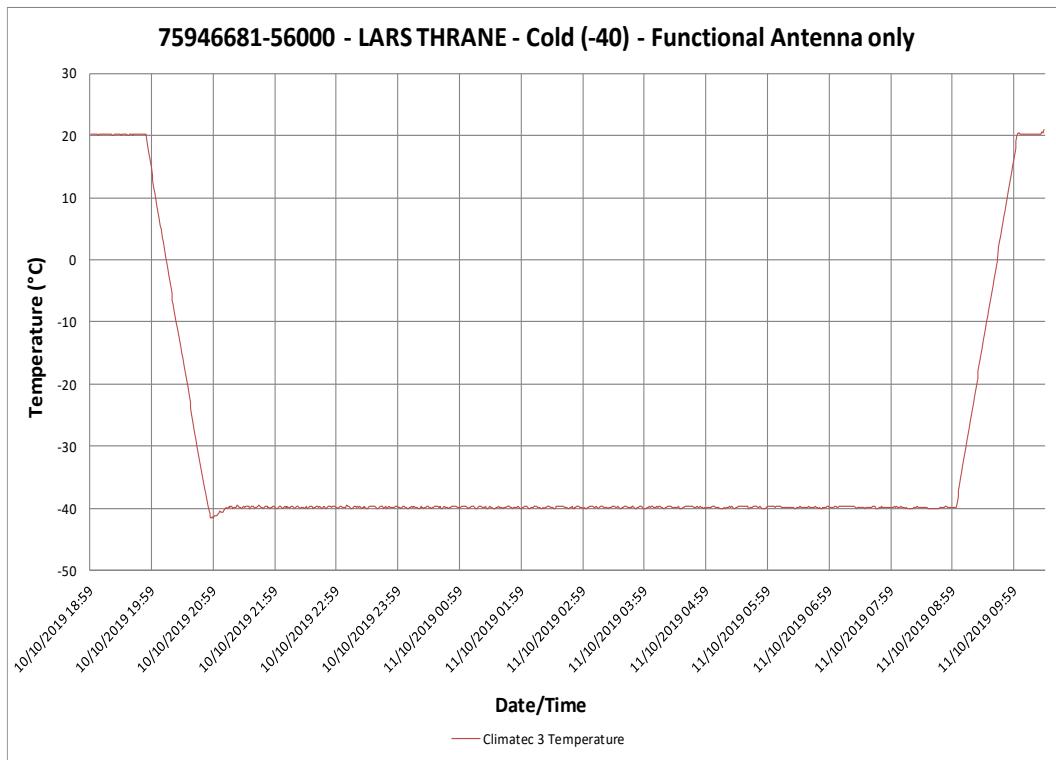
### 2.5.2 Low Temperature Antenna

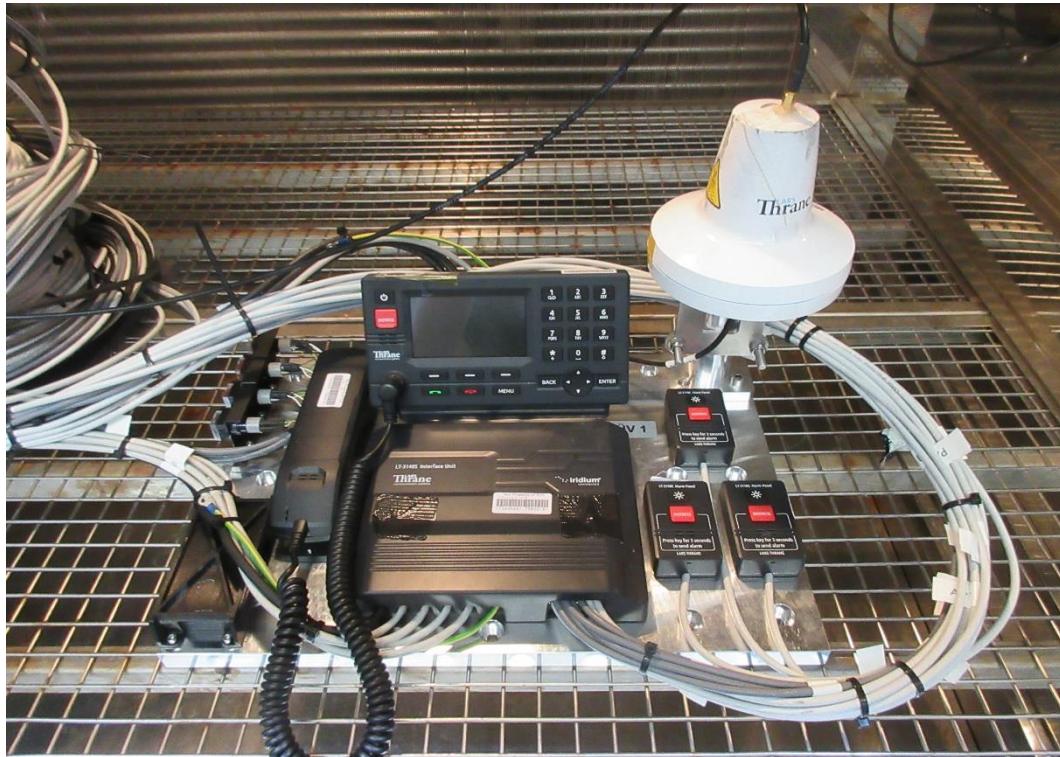
The Antenna although in the picture is not part of this test.

Figure 2.6.1 EUT test setup

No damage or deterioration was observed or reported. A visual examination and functional test carried out by the client's representative on completion of the test was reported as satisfactory.

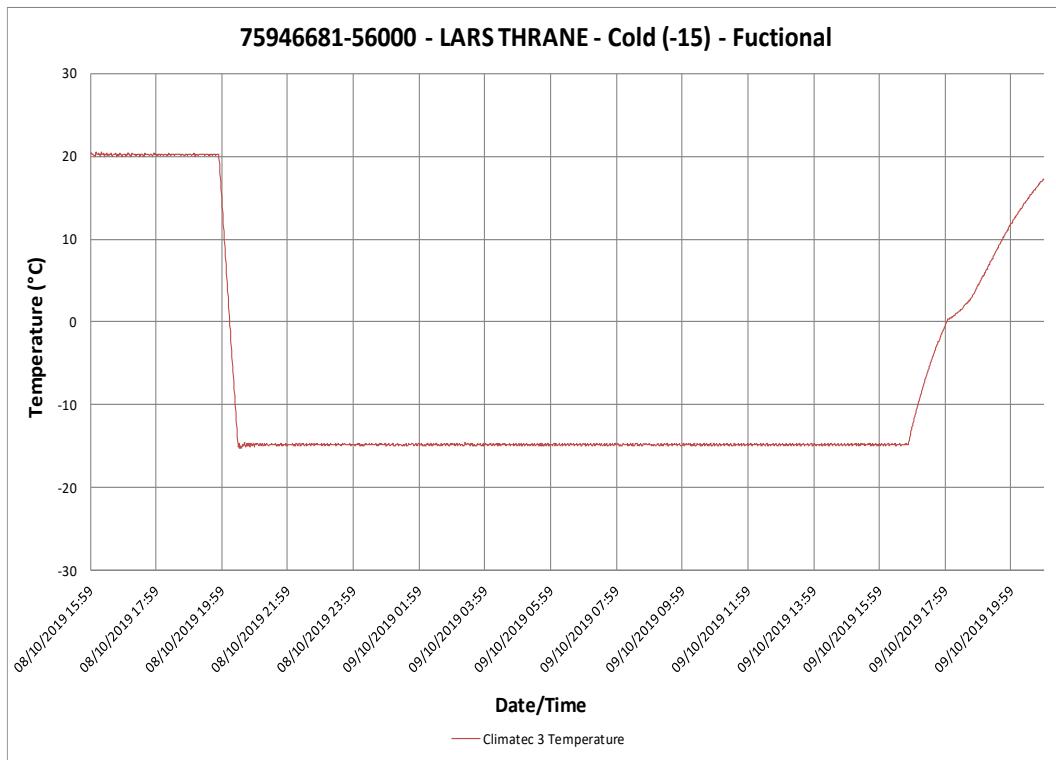
Figure 2.6.2 Low Temperature -15°C Functional

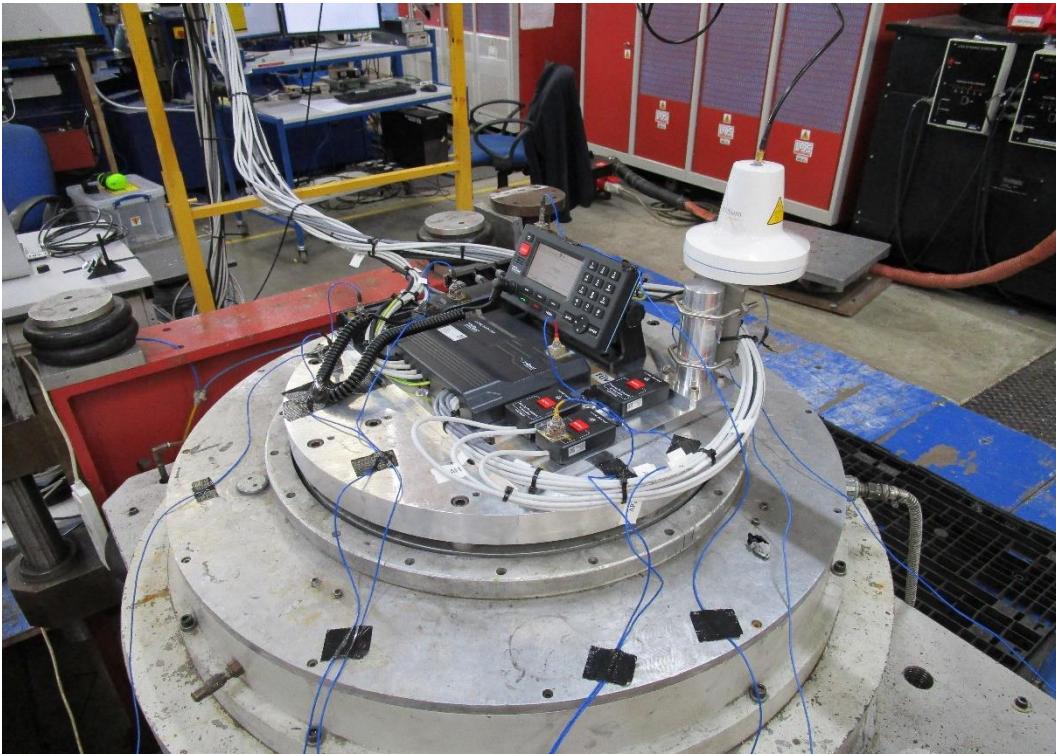
Figure 2.8.1 EUT test setup Z axis

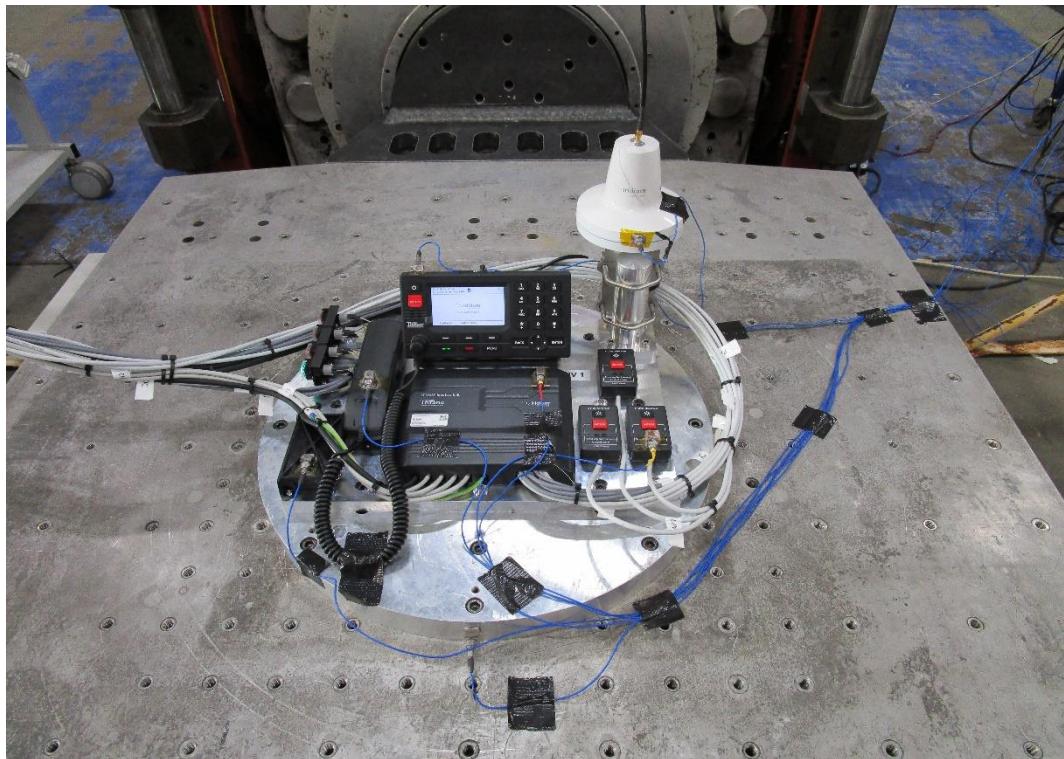
Figure 2.8.2 EUT test setup X axis

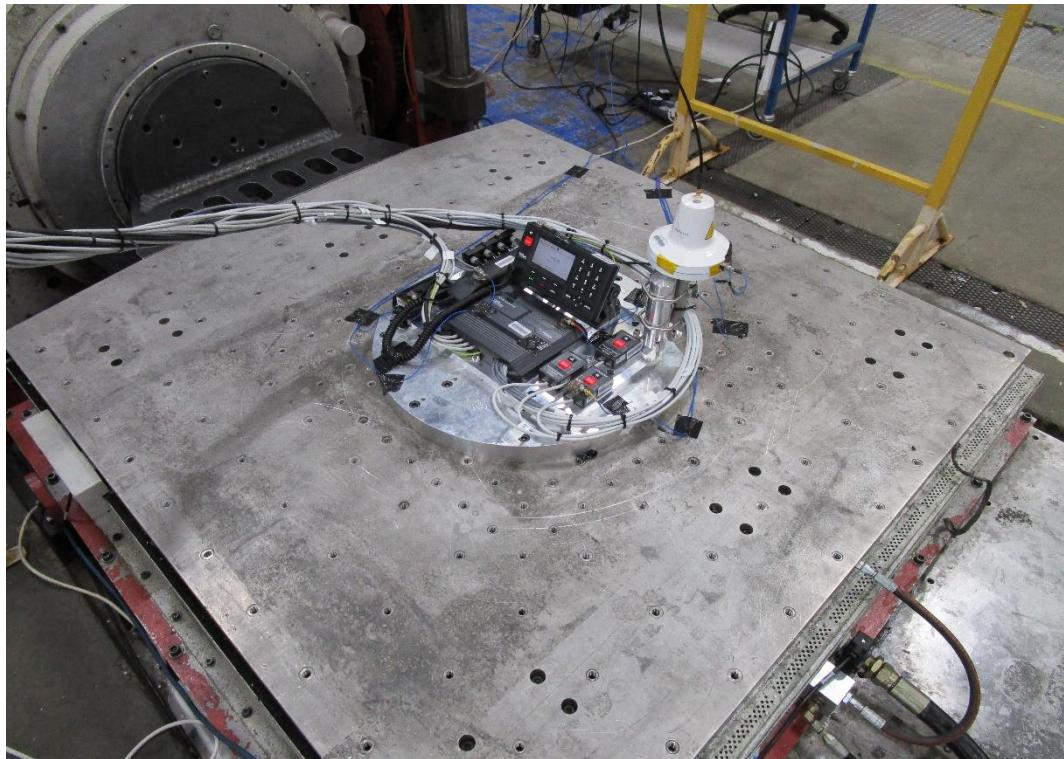
Figure 2.8.3 EUT test setup Y axis

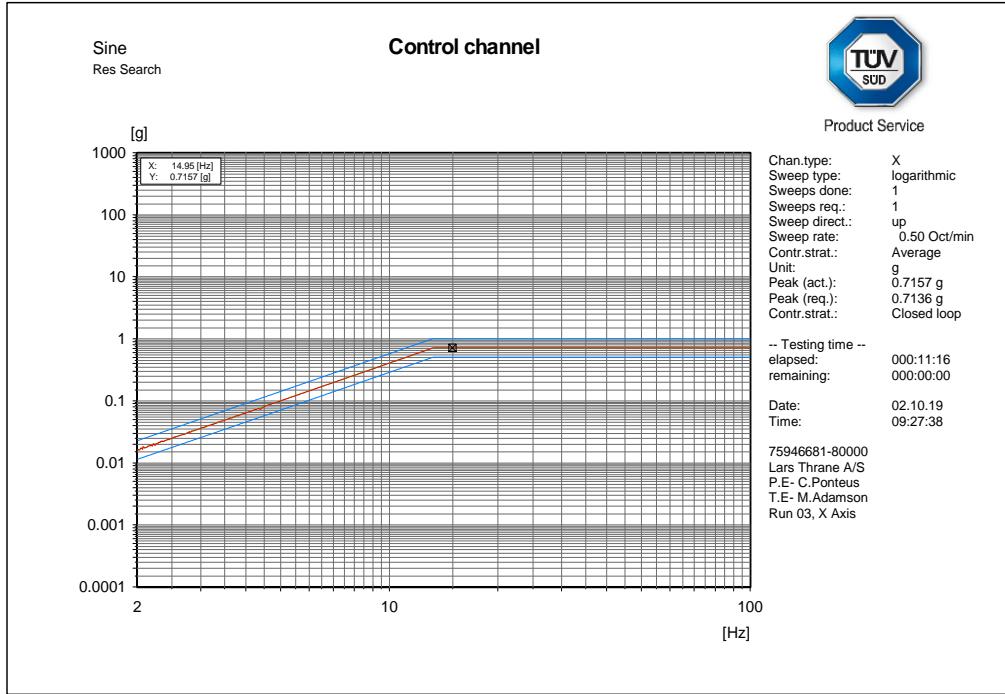
Figure 2.8.4 Run 03, X axis, Resonance sweep

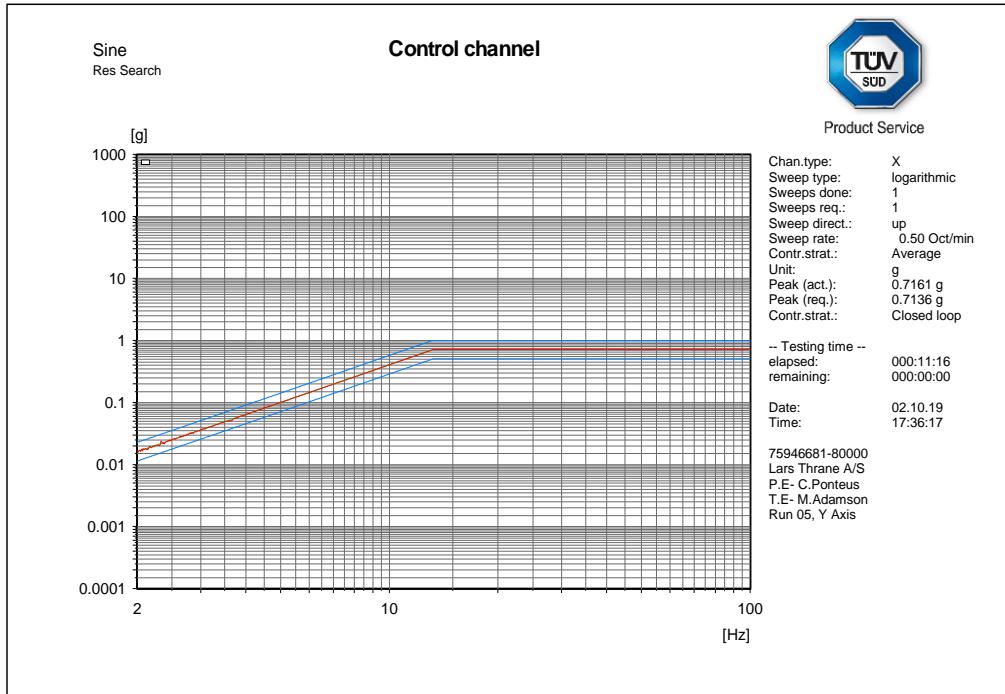
Figure 2.8.12 Run 05, Y axis, Resonance Sweep

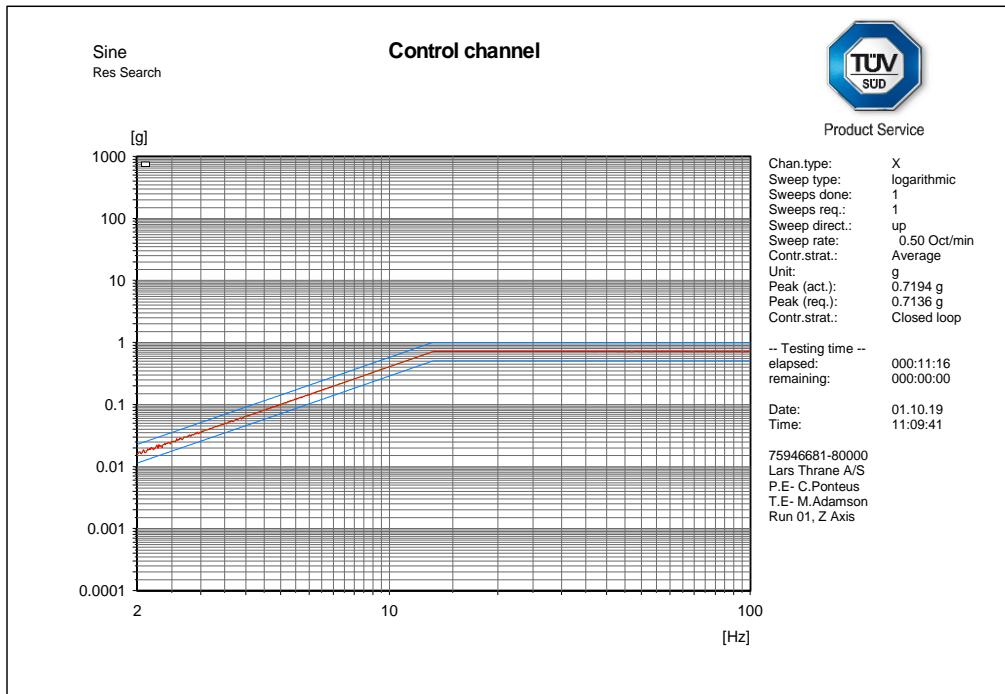
Figure 2.8.20 Run 01, Z axis, Sweep

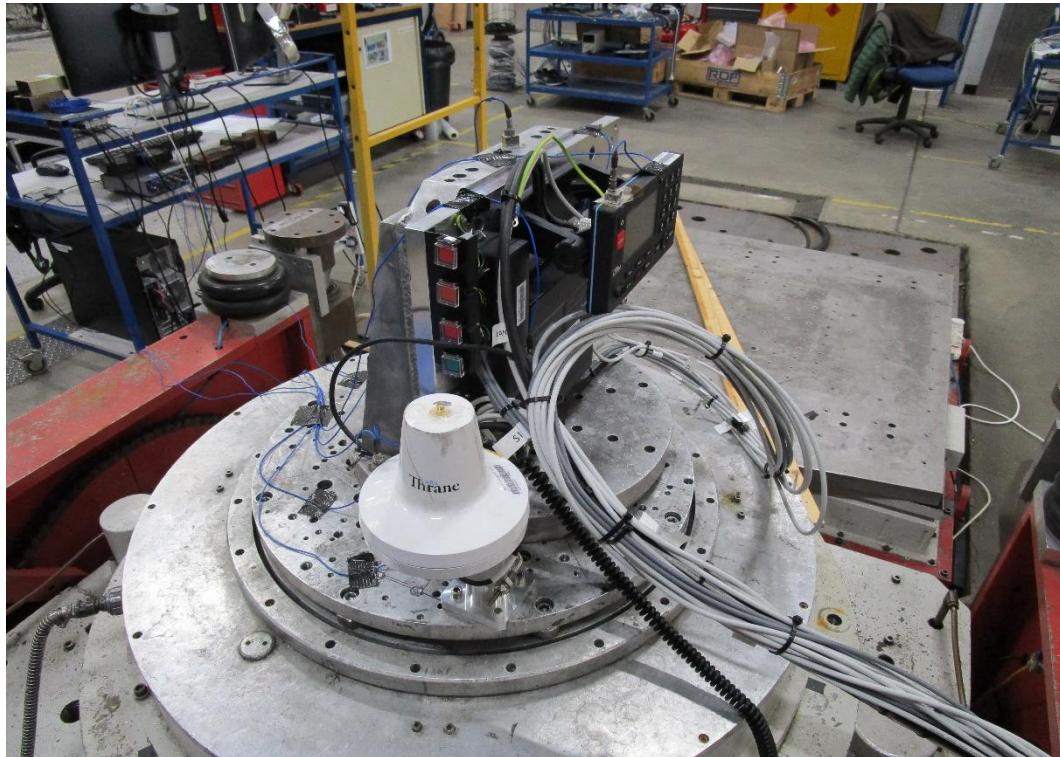
Figure 2.9.1 EUT test setup

No damage or deterioration was observed or reported. The EUT was non-operational during the test. A visual examination and functional test carried out by the client's representative on completion of the test was reported as satisfactory.

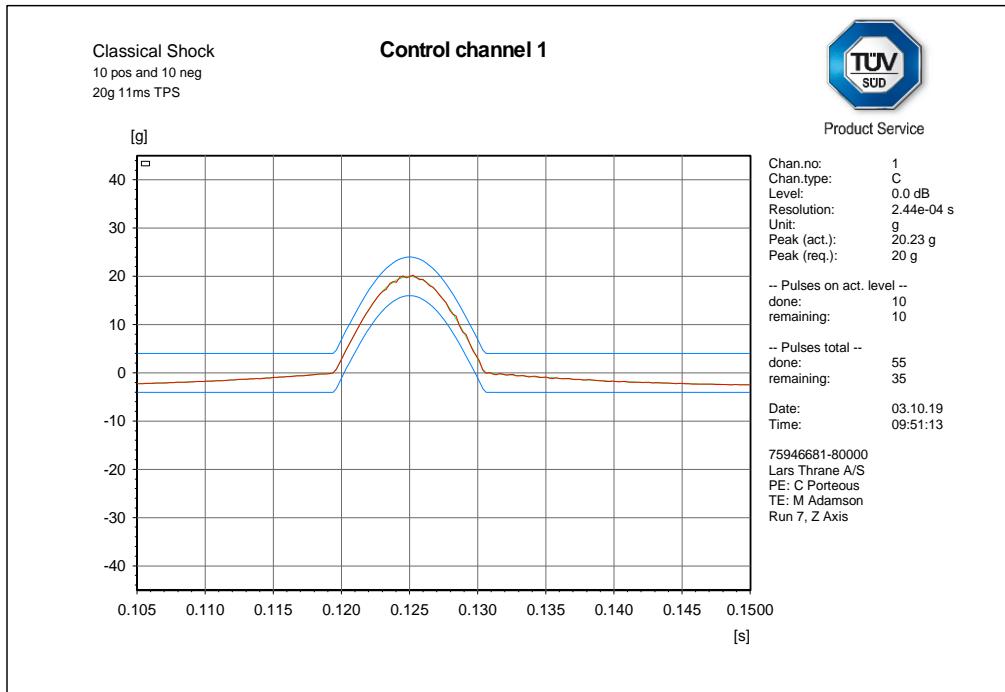
Figure 2.9.2 Run 07, Z Axis Shock +ve

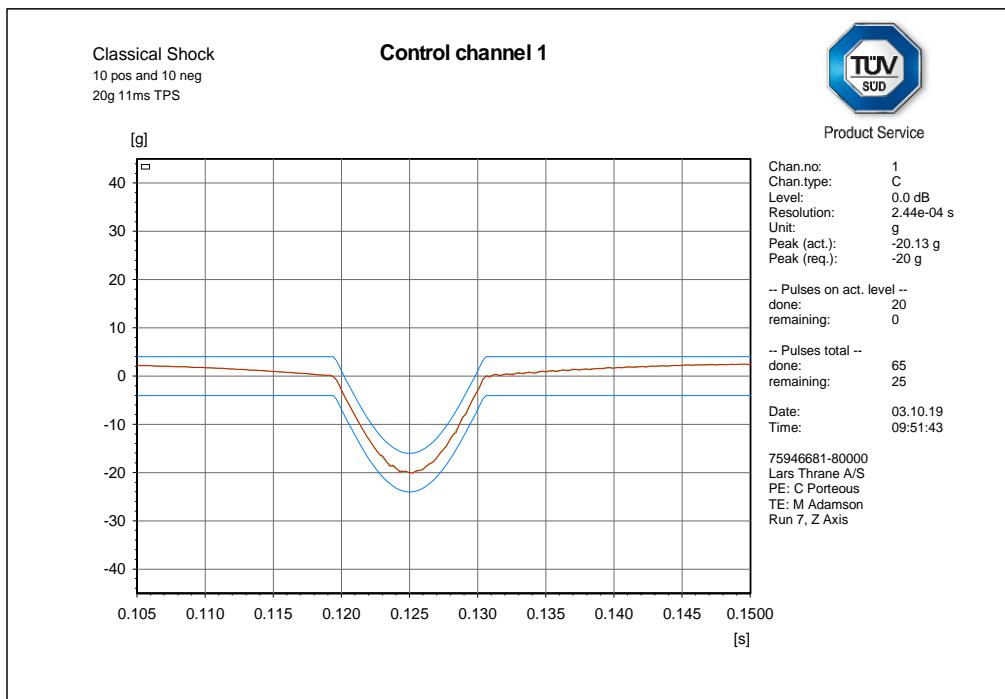
Figure 2.9.9 Run 07, Z axis, Shock -ve

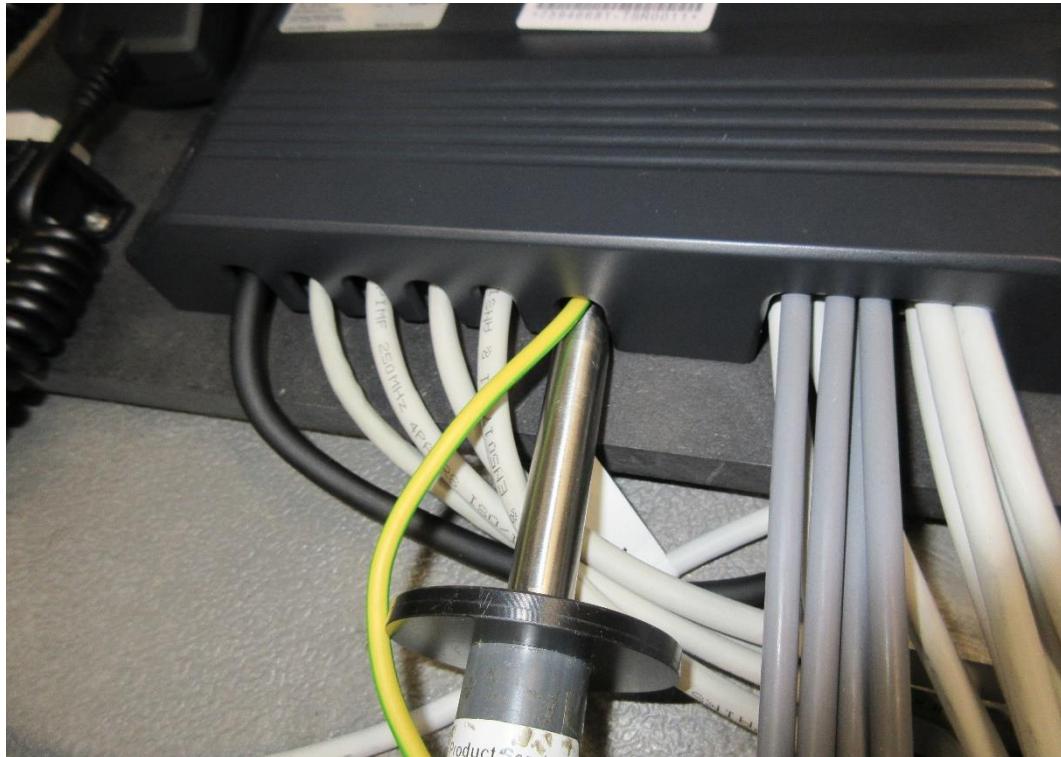
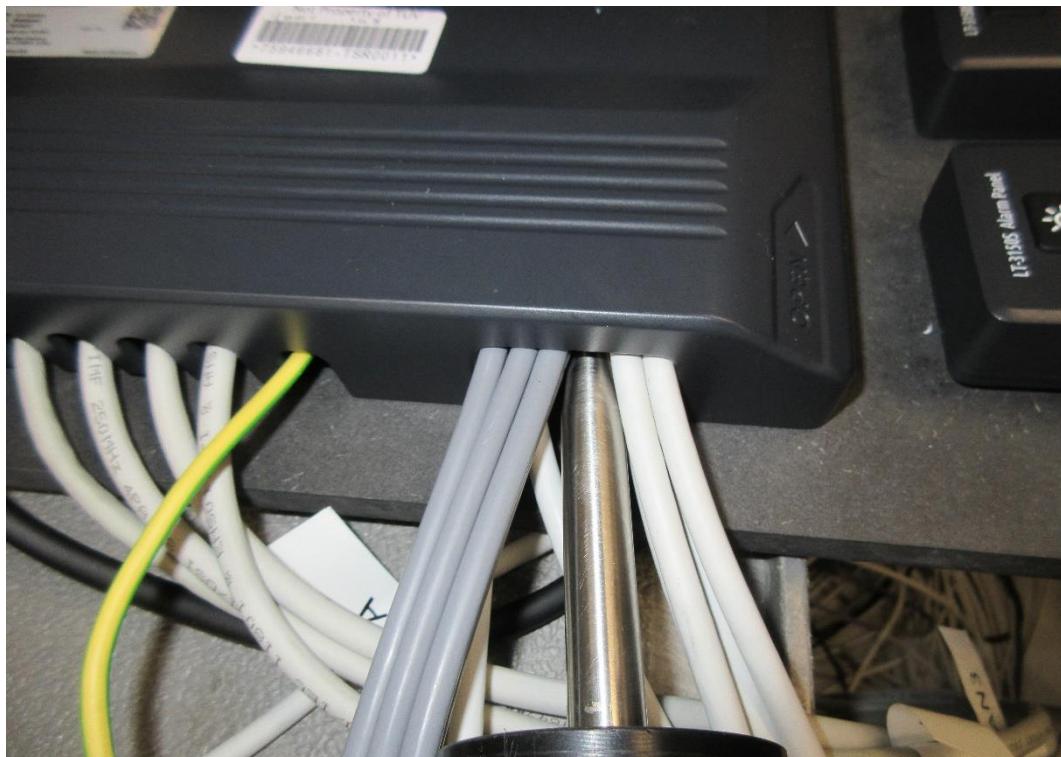
Figure 2.11.1 Test setup

Figure 2.11.2 Test setup

The un-jointed test finger was unable to touch any hazardous parts and the stop face of the test finger could not be inserted into any of the openings

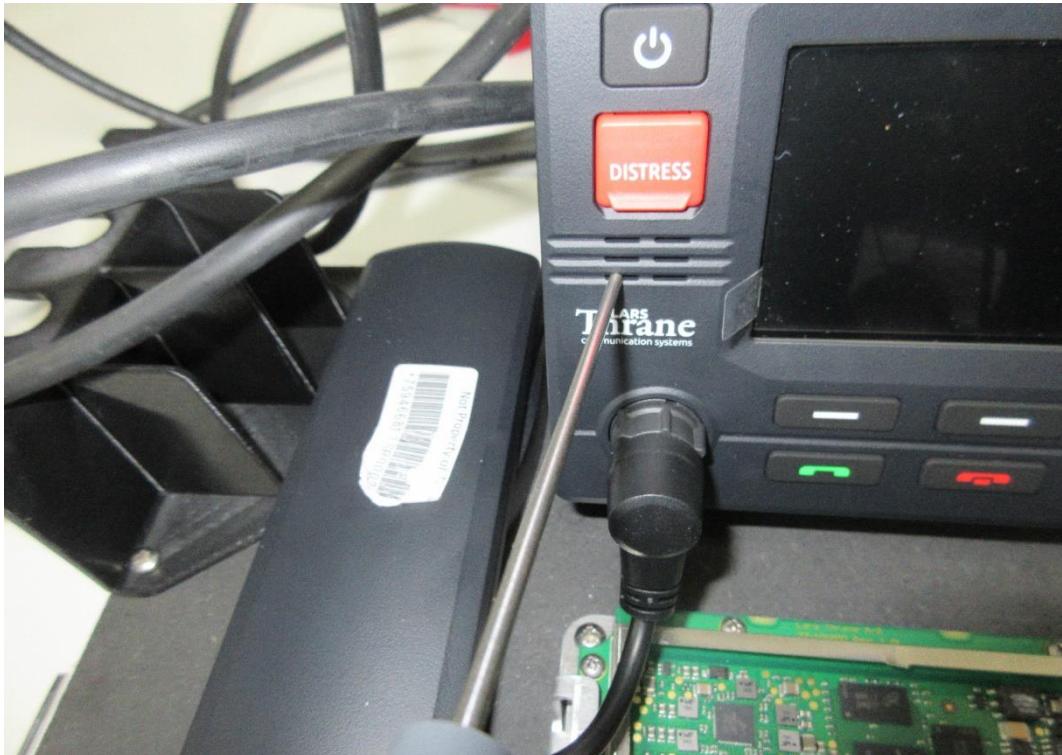
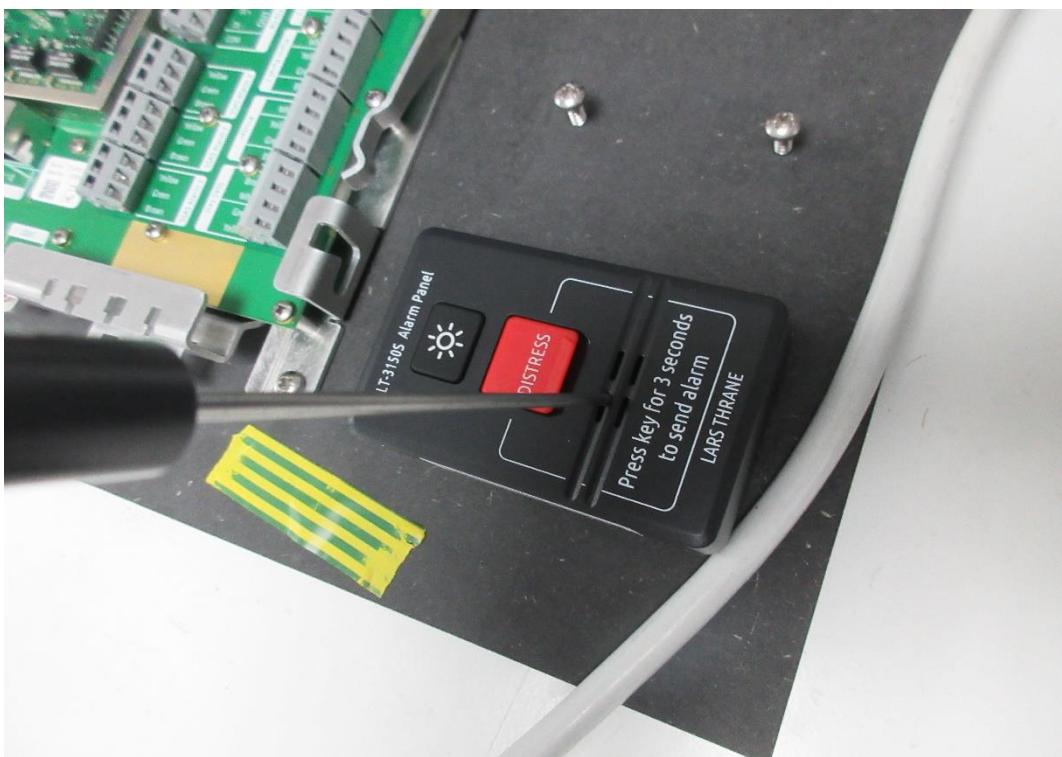
Figure 2.12.1 Test setup

Figure 2.12.2 Test setup

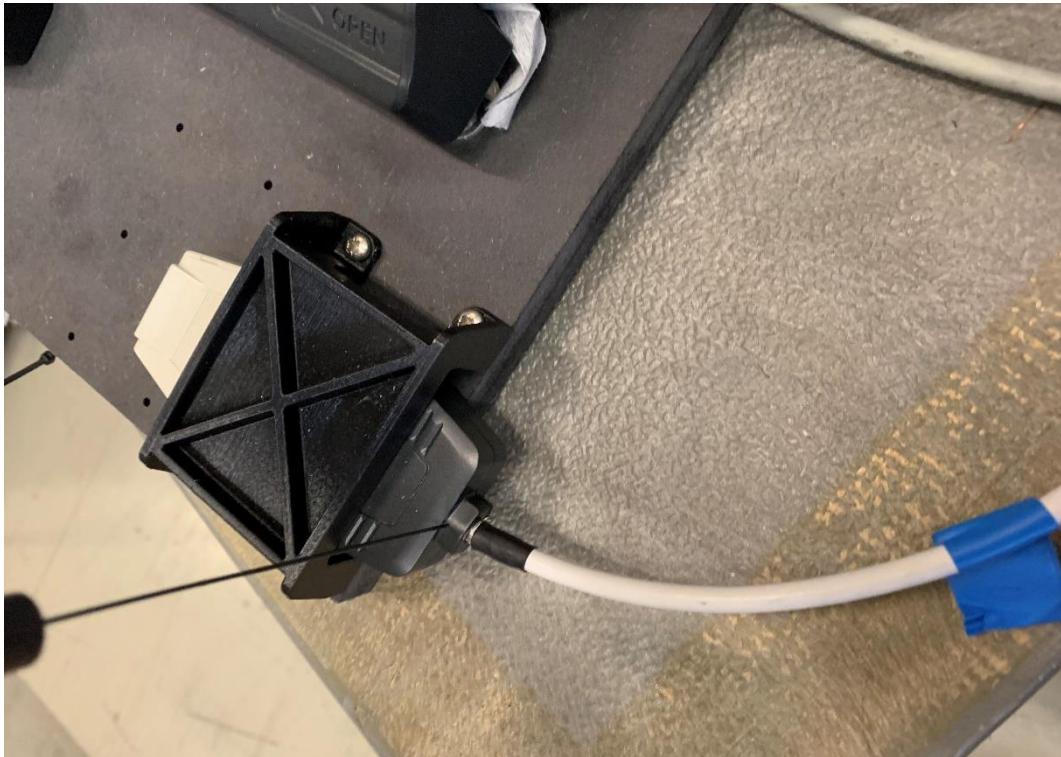
Figure 2.13.1 Printer Adaptor under test

No damage or deterioration was observed or reported. A visual examination and functional test carried out by the client's representative on completion of the test was reported as satisfactory.
