## Appendix B: photographs of test setup

## Appendix C: photographs of EUT

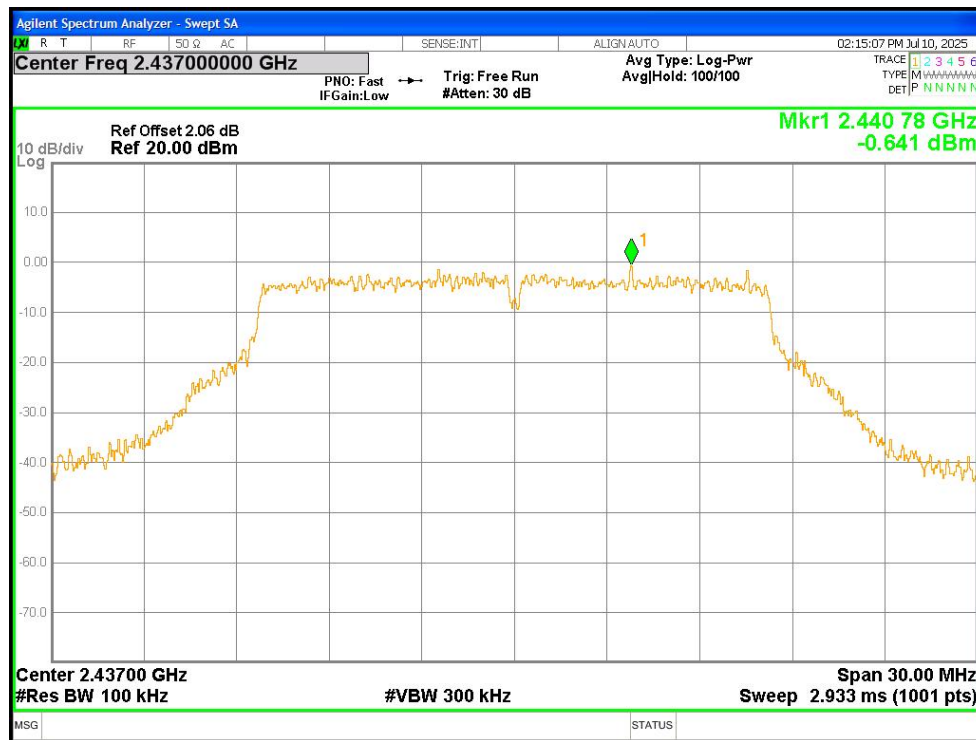
Tx. Spurious NVNT g 2437MHz Ant1 Emission

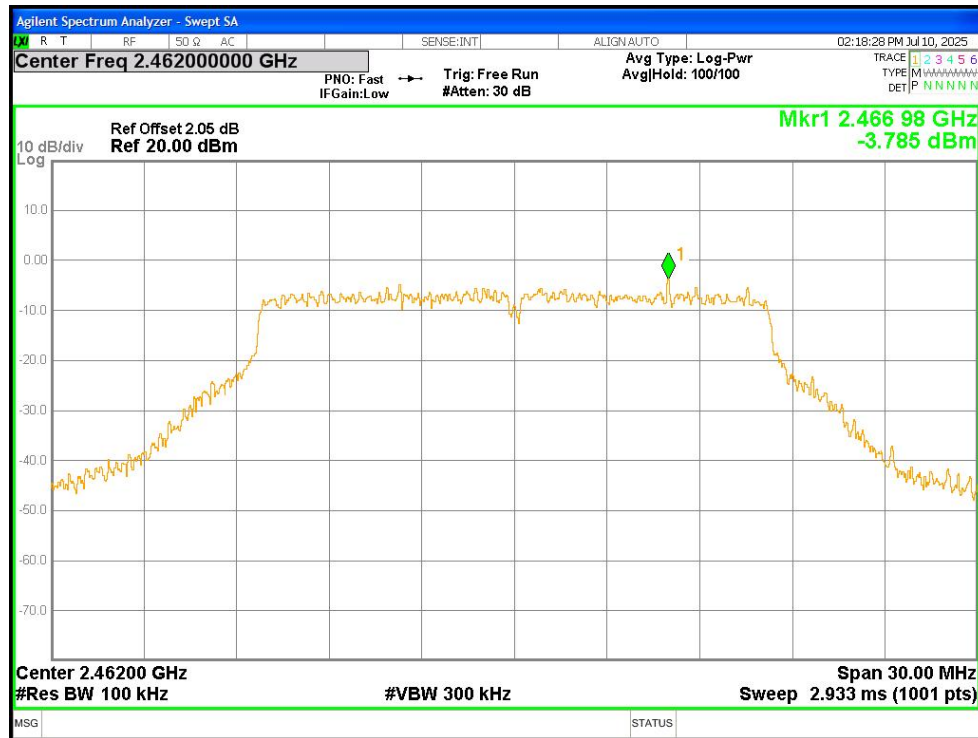
Tx. Spurious NVNT g 2462MHz Ant1 Emission

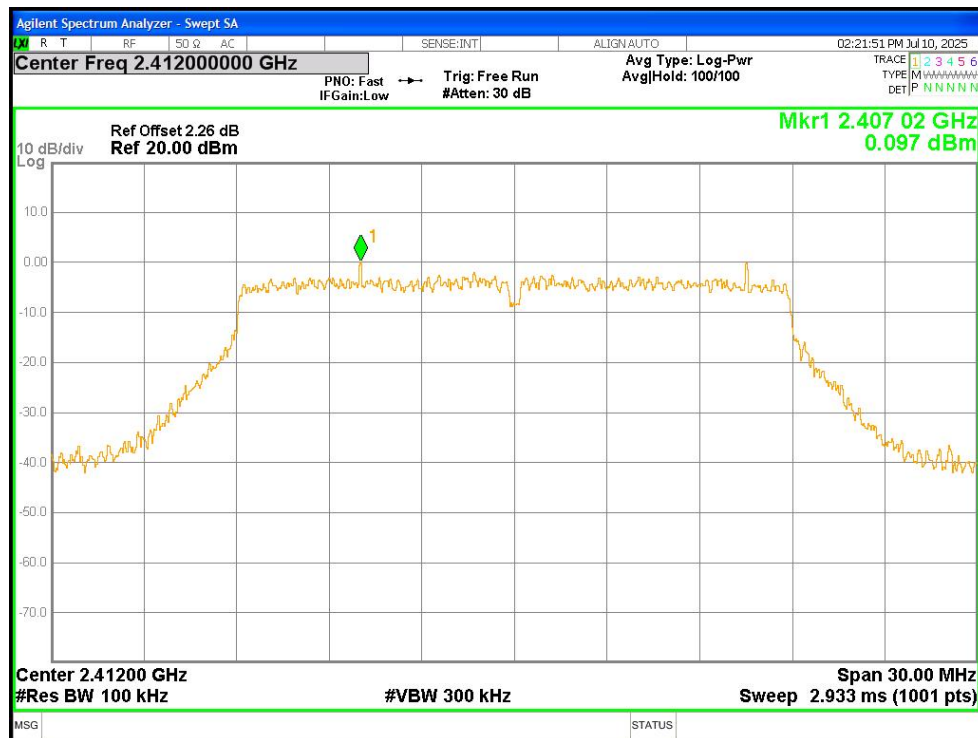
Tx. Spurious NVNT n20 2412MHz Ant1 Emission

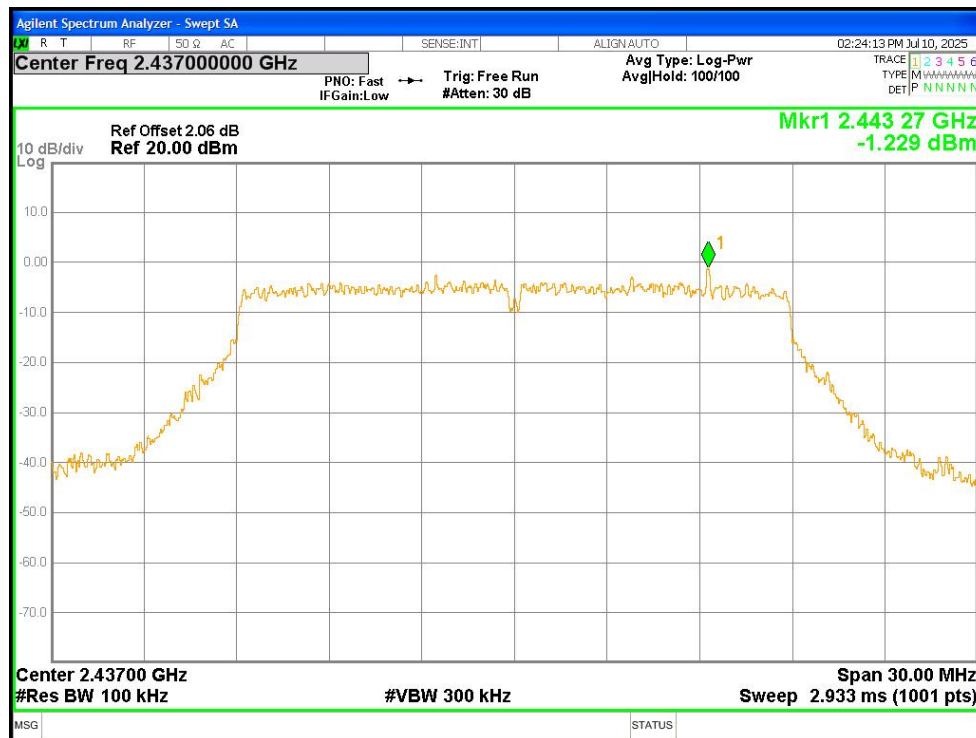
Tx. Spurious NVNT n20 2437MHz Ant1 Emission

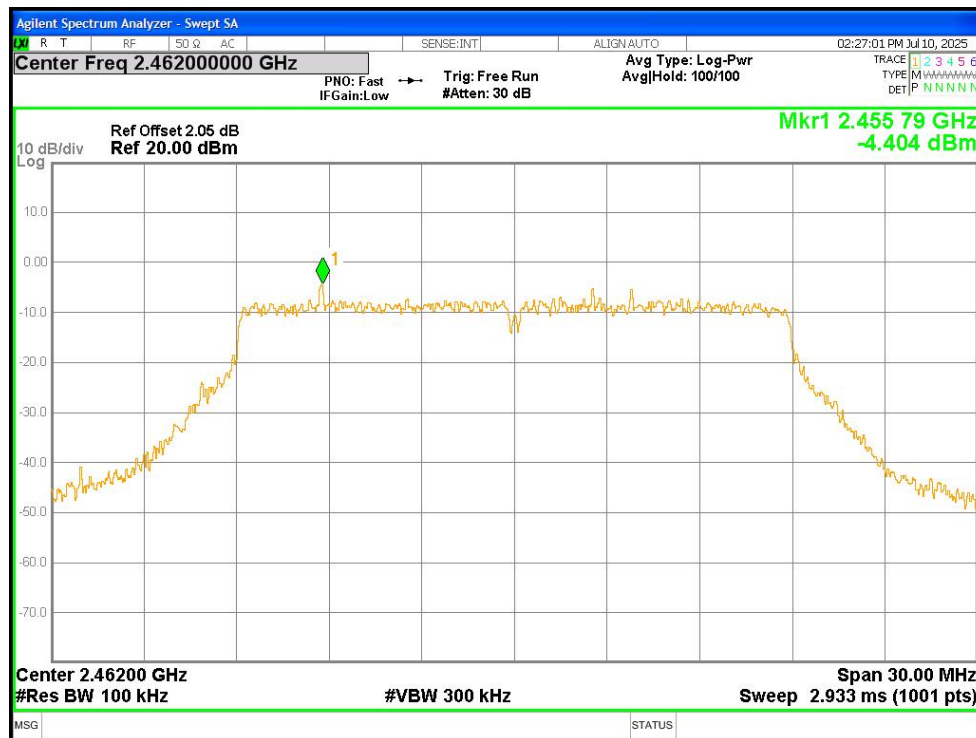
Tx. Spurious NVNT n20 2462MHz Ant1 Emission

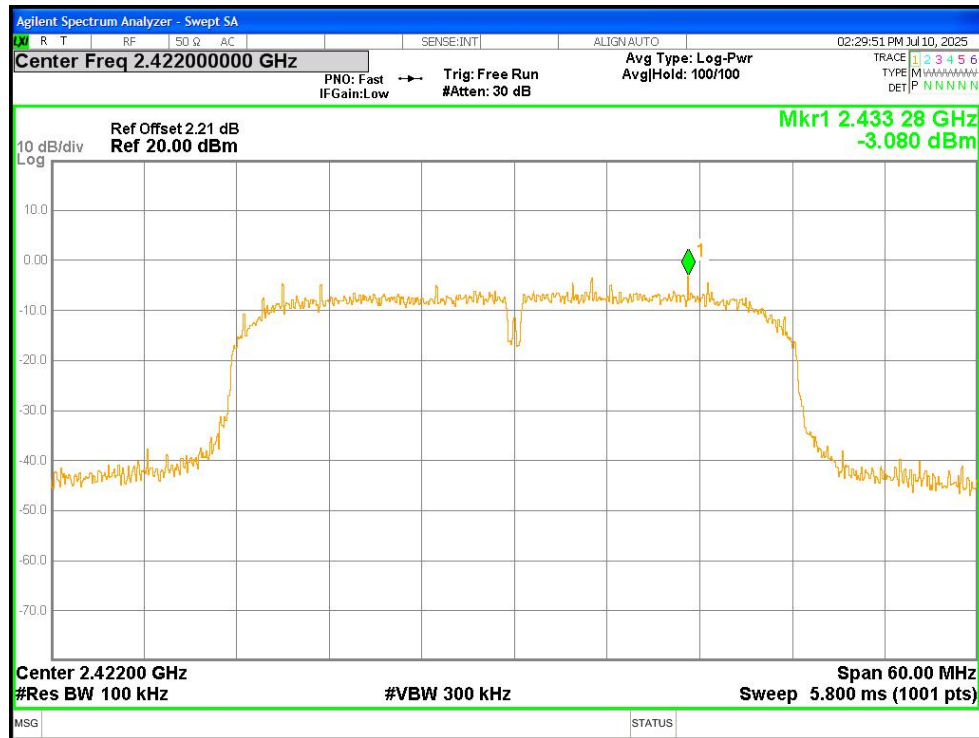
Tx. Spurious NVNT n40 2422MHz Ant1 Emission

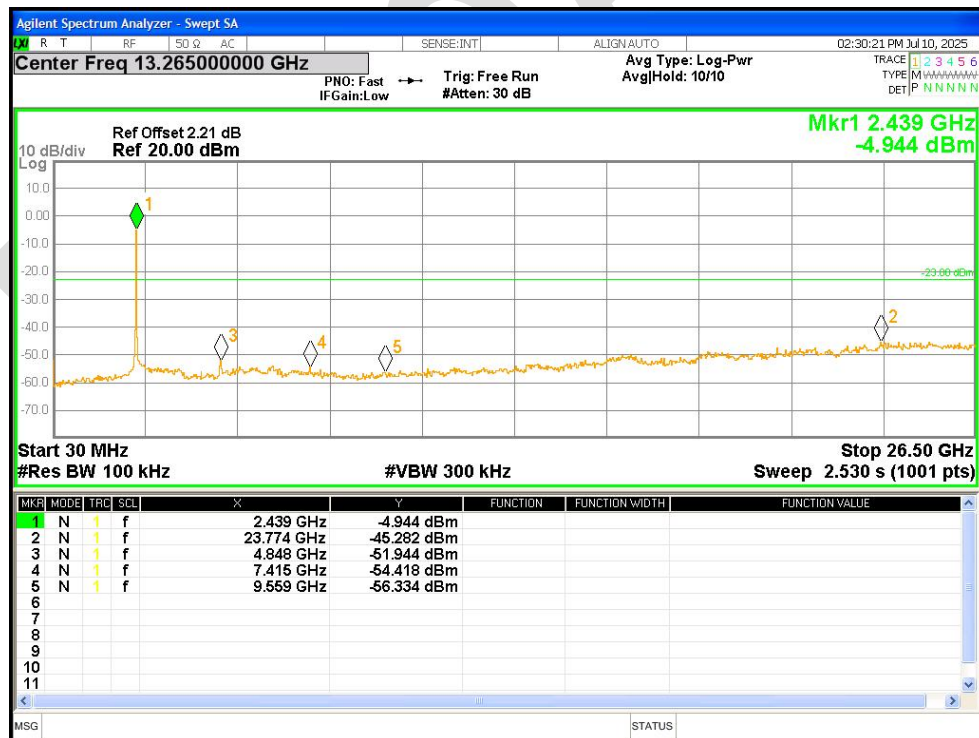
Tx. Spurious NVNT n40 2437MHz Ant1 Ref

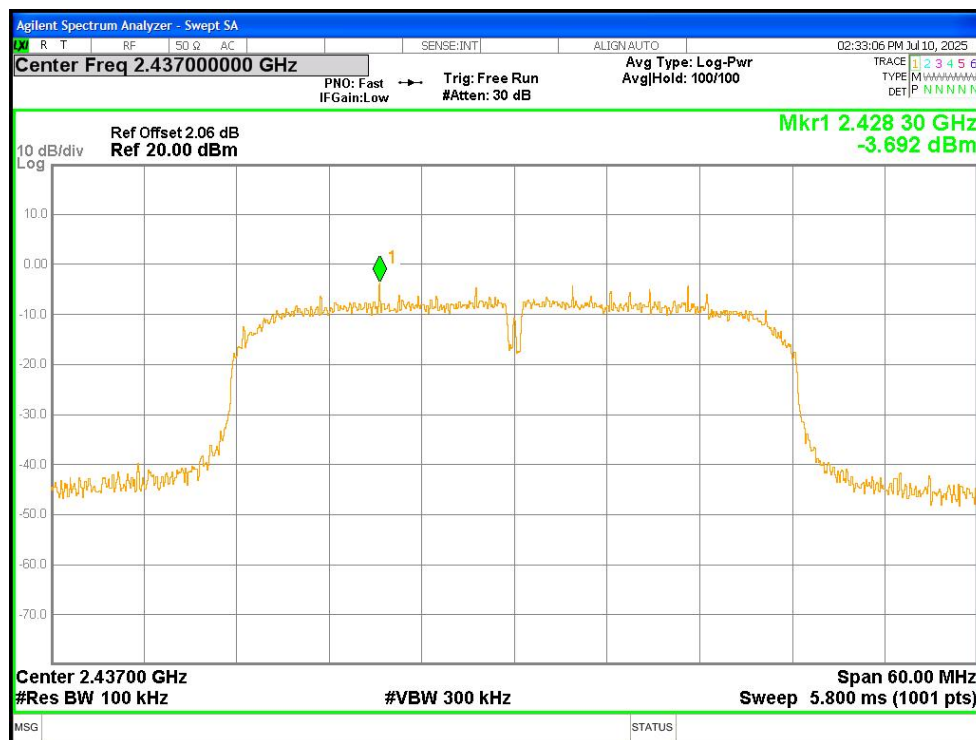
Tx. Spurious NVNT n40 2437MHz Ant1 Emission

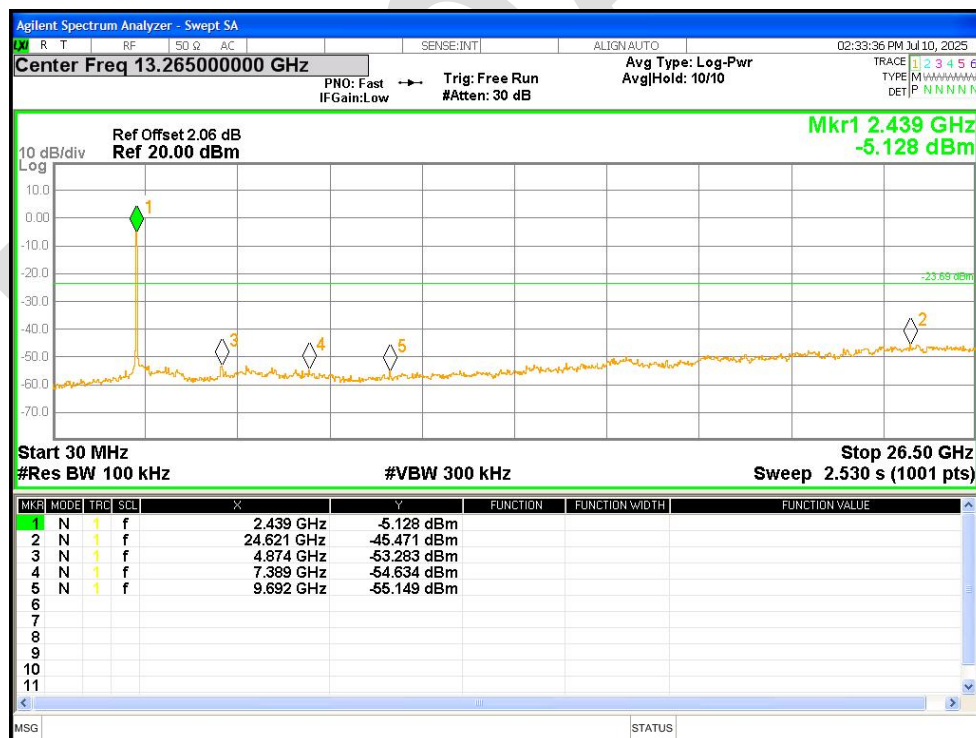
Tx. Spurious NVNT n40 2452MHz Ant1 Ref

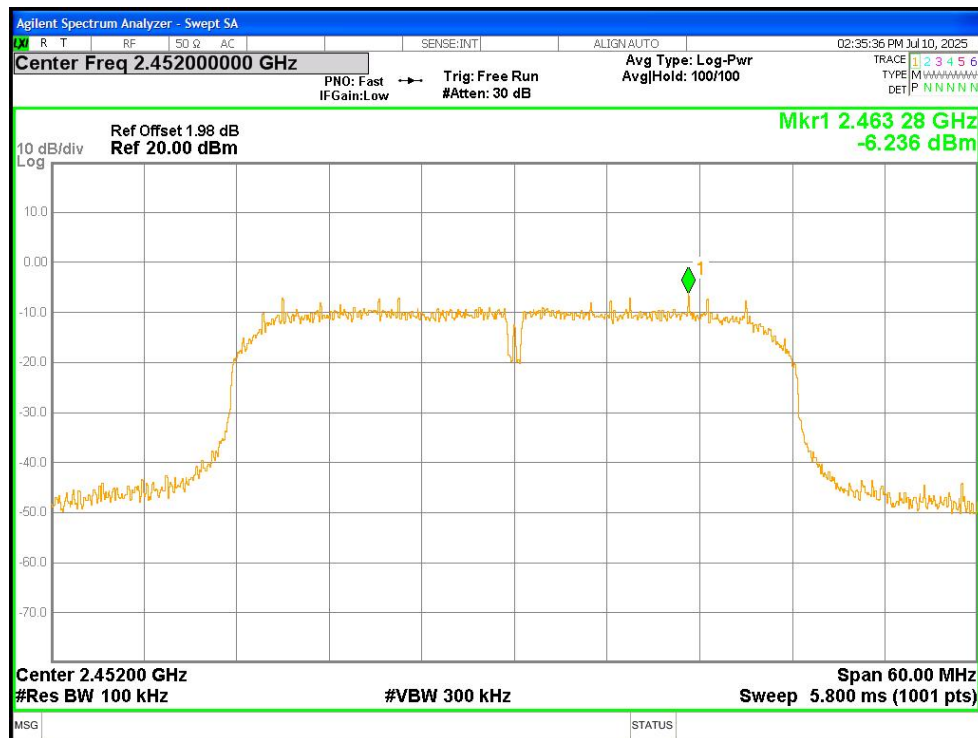
Tx. Spurious NVNT n40 2452MHz Ant1 Emission

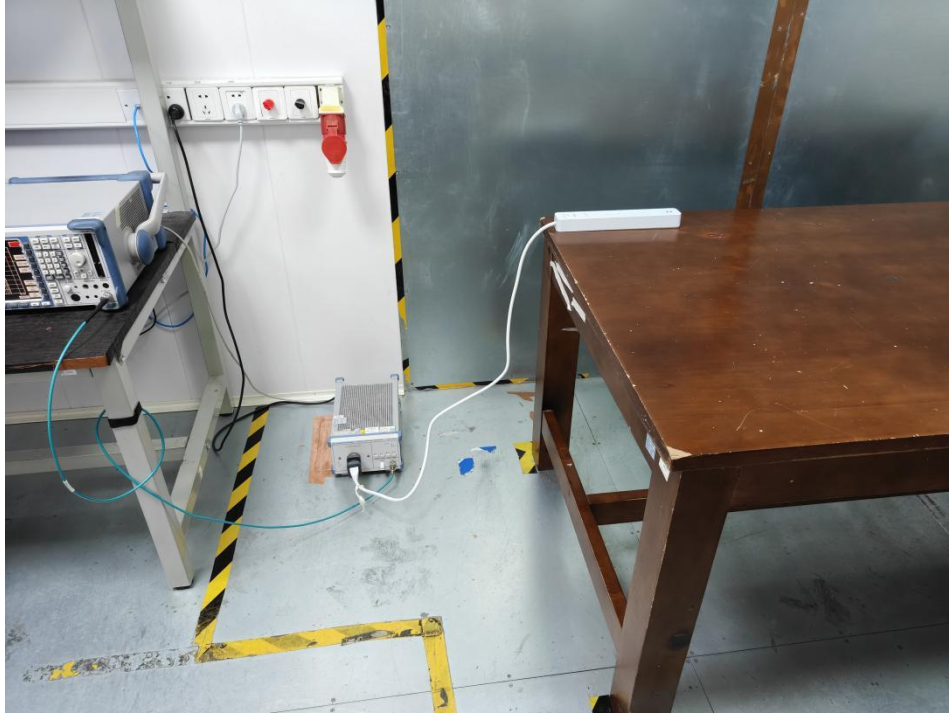
Conducted emissions at AC power line (150kHz-30MHz)

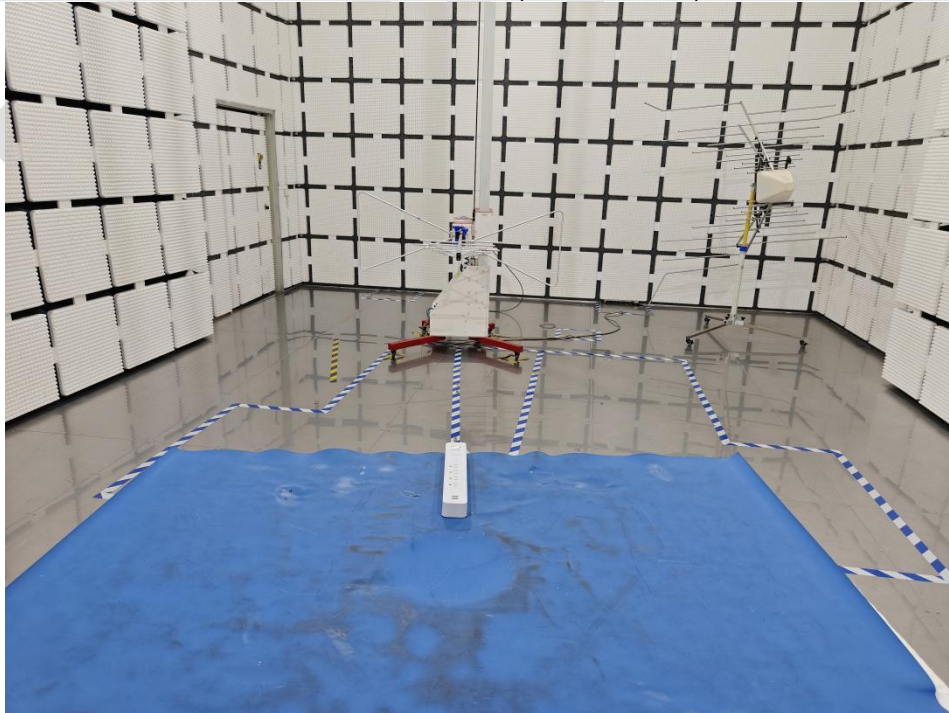
Radiated Emissions (30MHz-1GHz)

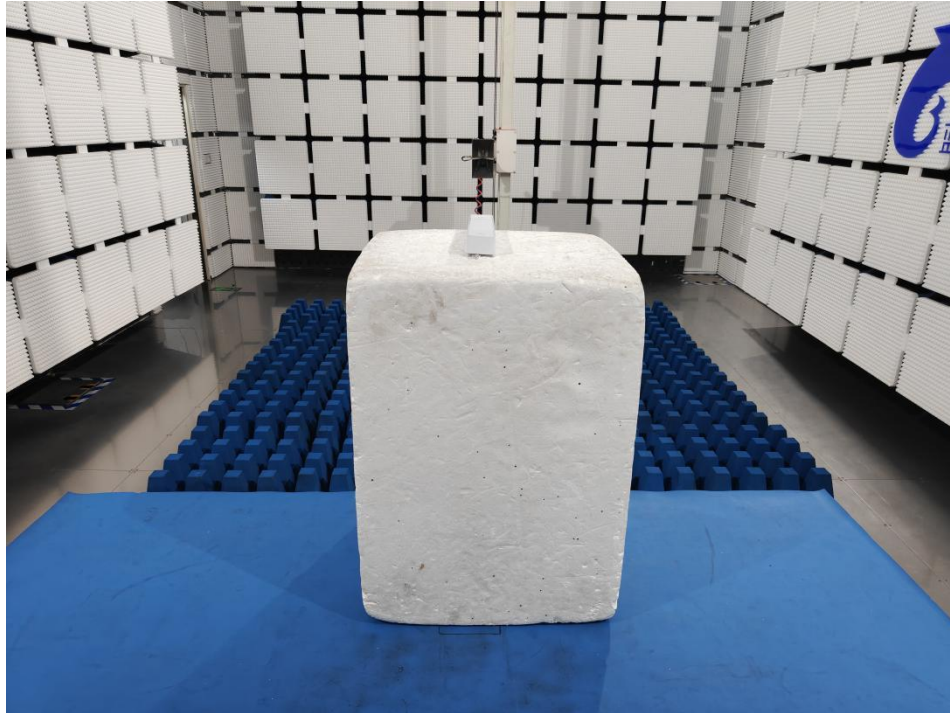
Radiated Emissions (above 1GHz)
