## APPENDIX A: PHOTOGRAPHS OF TEST SETUP

Reference to the test report No. BLA-EMC-202306-A5101

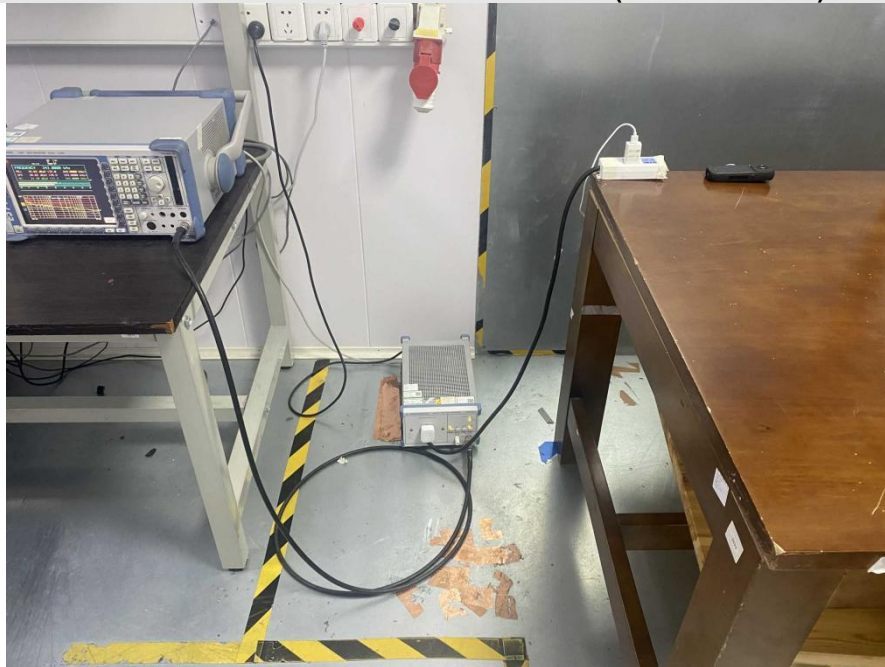
### Conducted Emissions at AC Power Line (150kHz-30MHz)

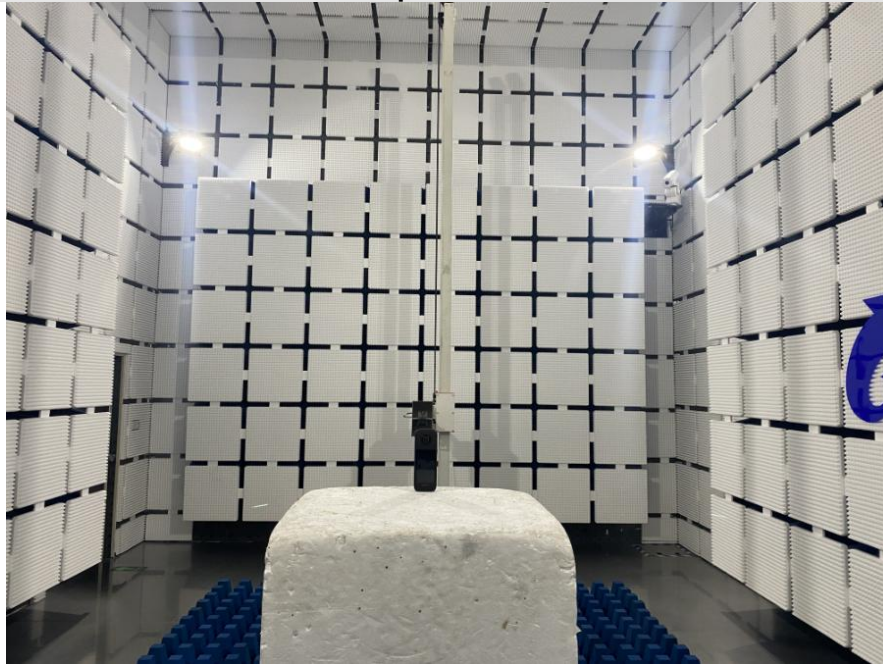
### Radiated Spurious Emissions
