## Appendix G: Band edge measurements

## Appendix H: Conducted Spurious Emission Test Result

13. TEST SETUP PHOTO

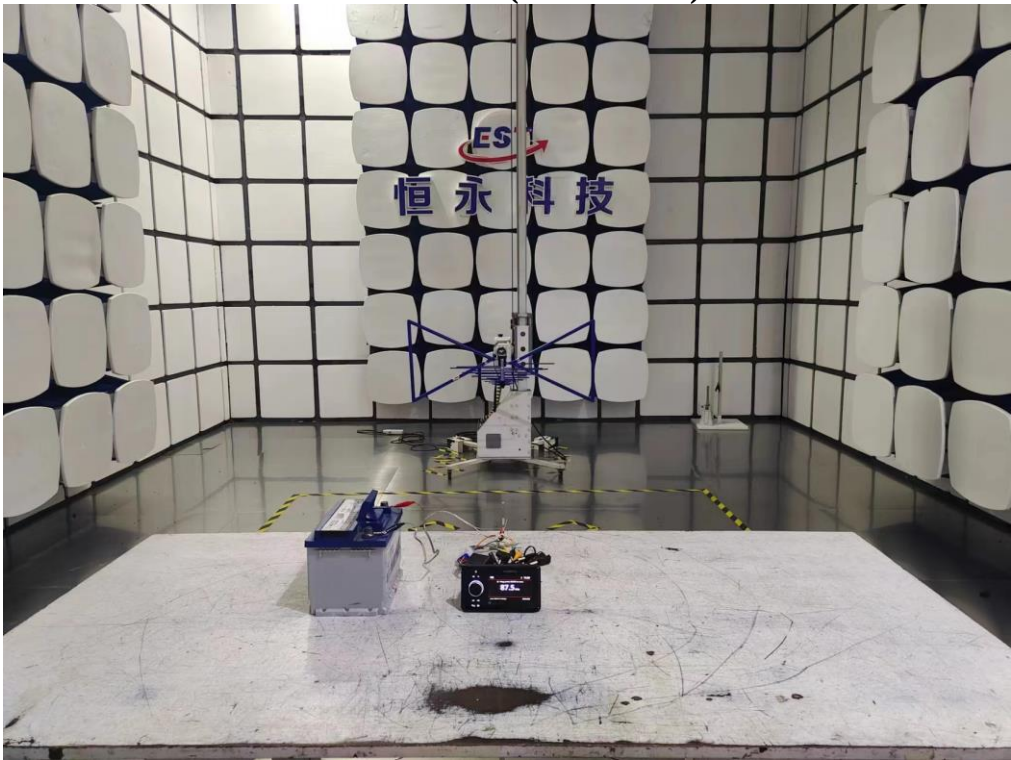
Radiated Test (Below 1GHz)

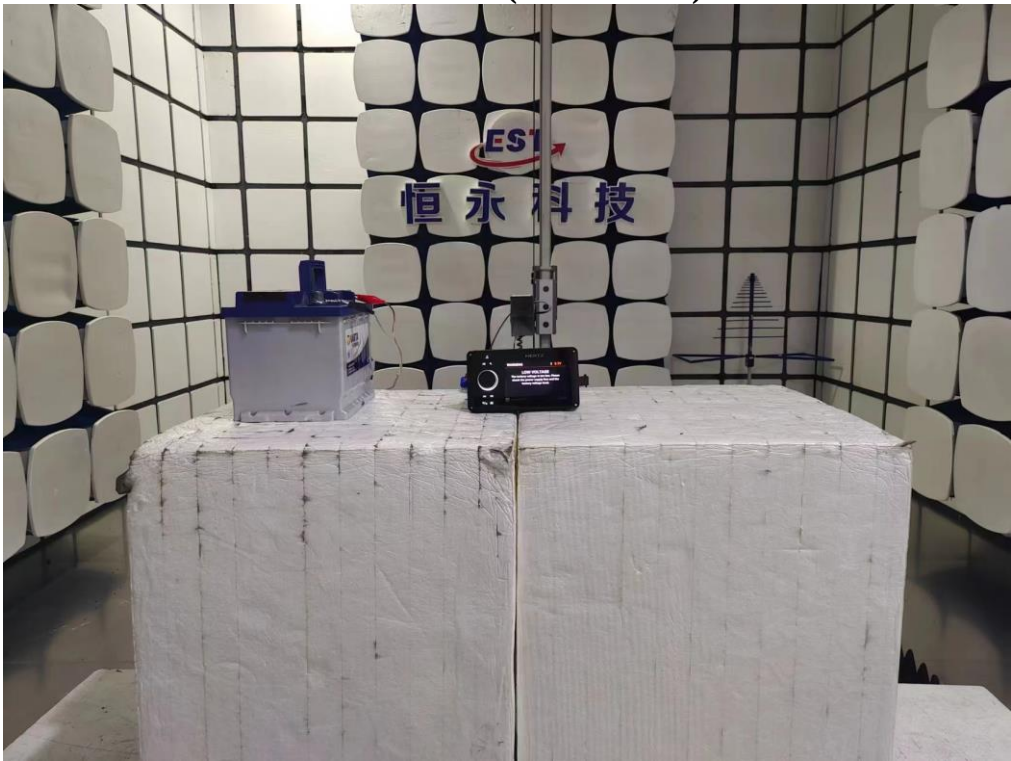
Radiated Test (Above 1GHz)

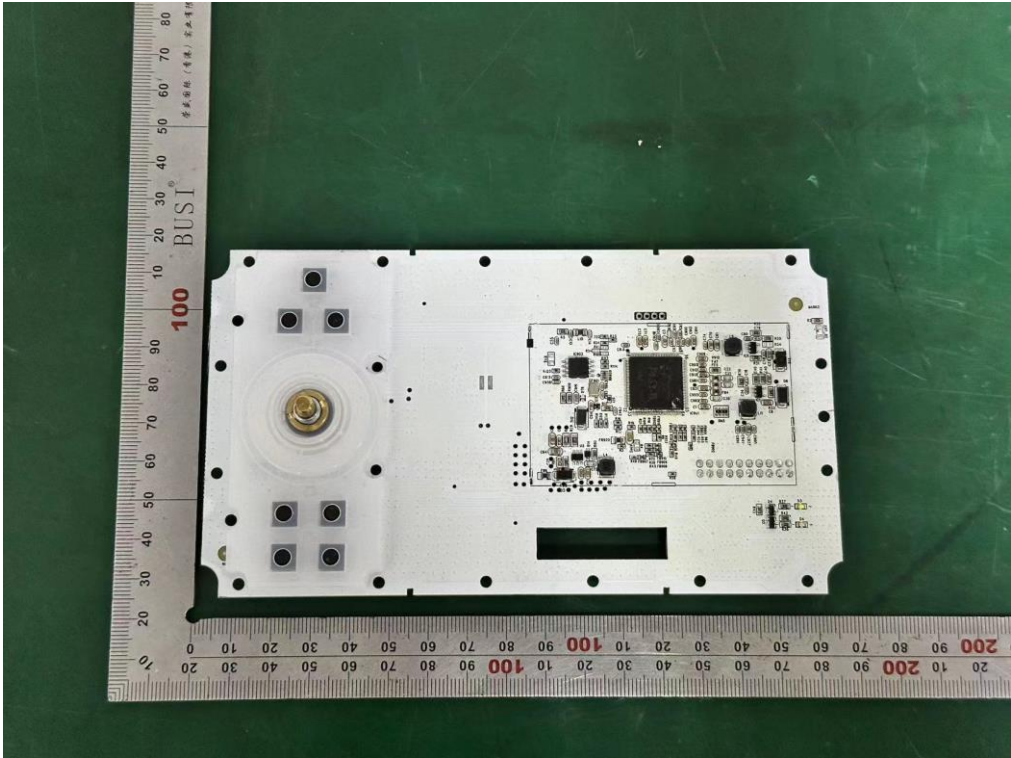
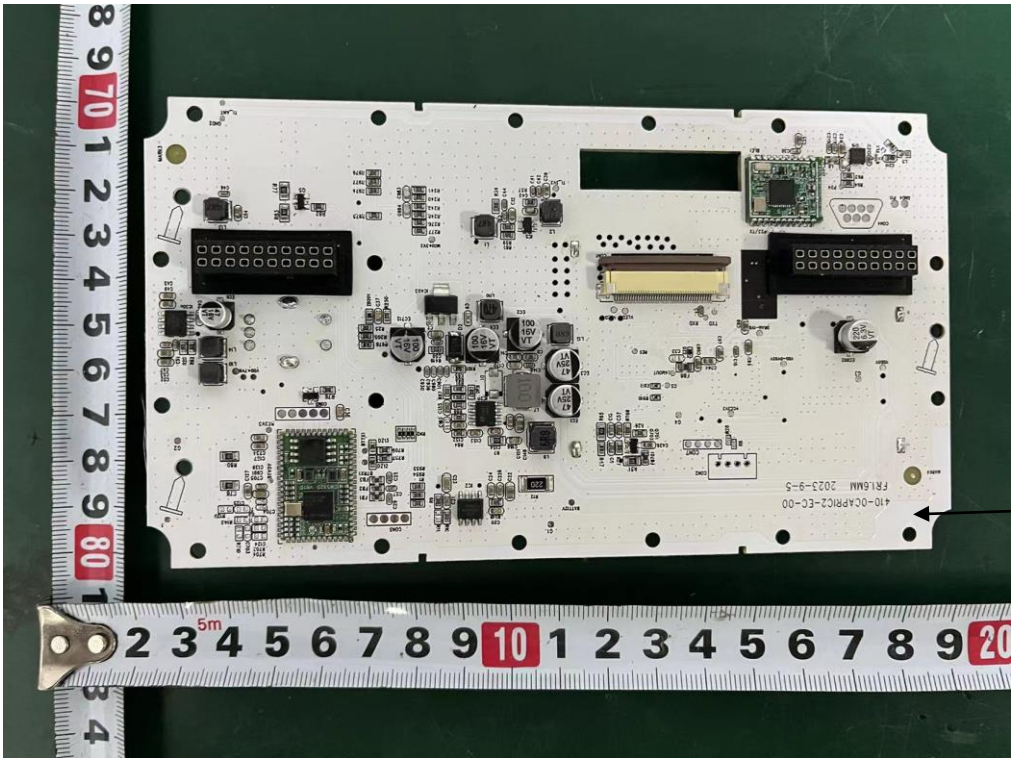
Bluetooth  
Antenna
