## Appendix B: photographs of test setup

Reference to the test report no. BLA-EMC-202502-A3801

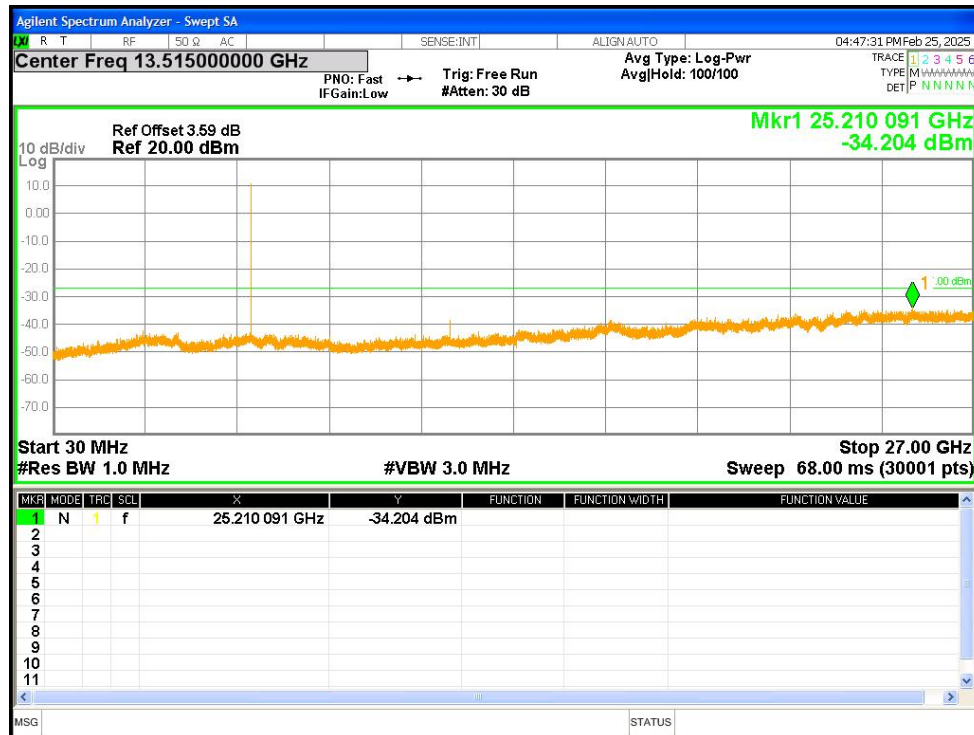
### Tx. Spurious NVNT GFSK 5825MHz Ant1 Emission

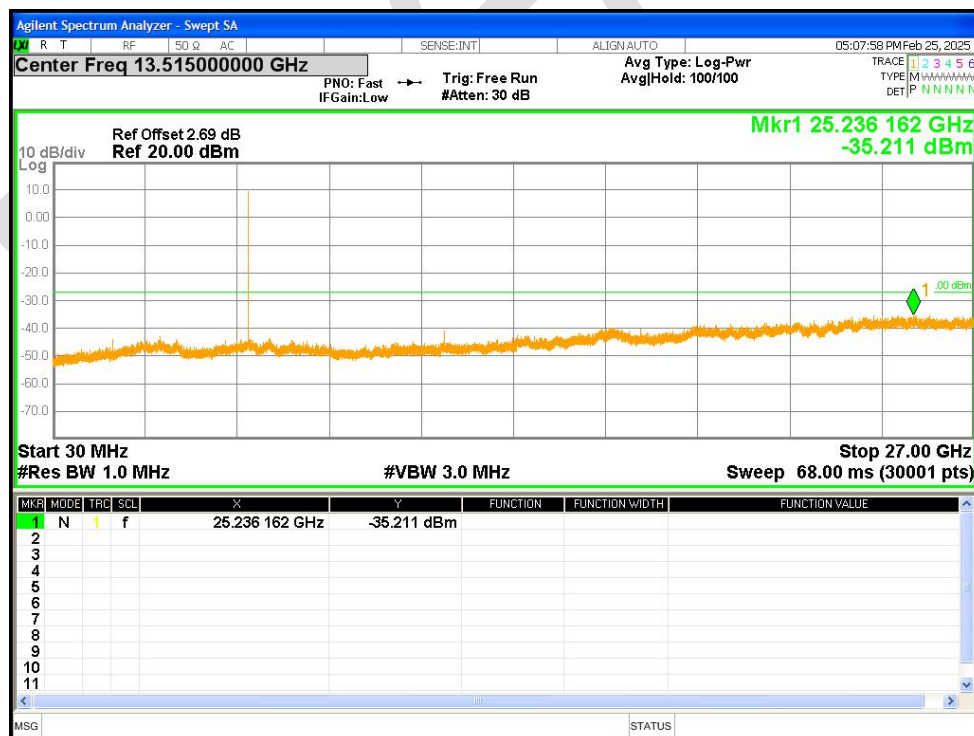
### Tx. Spurious NVNT GFSK 5745MHz Ant2 Emission

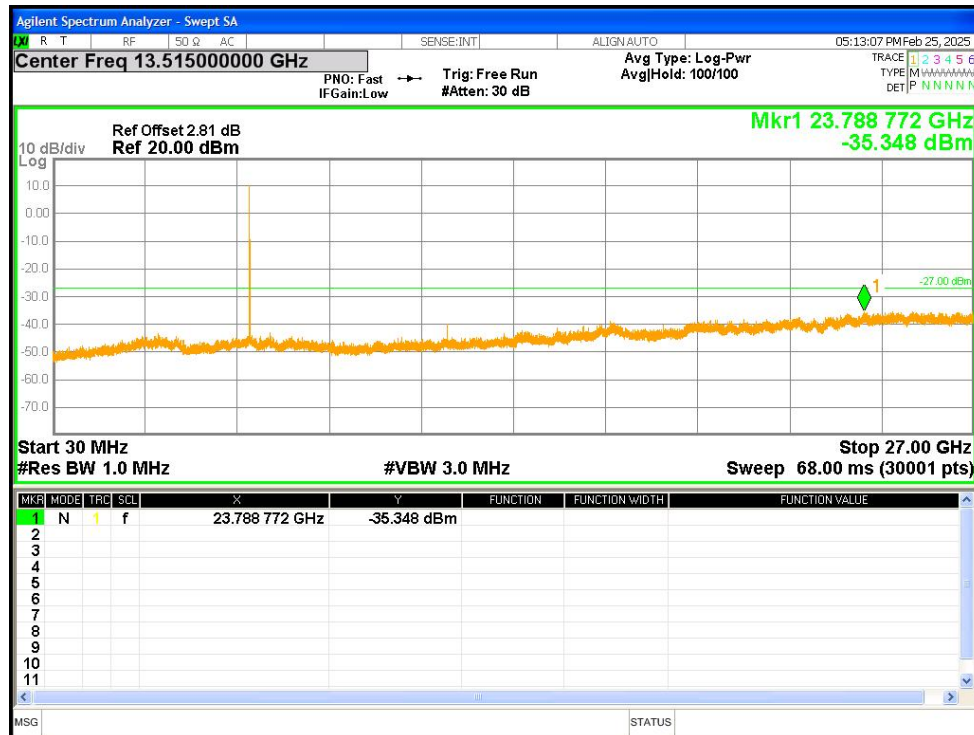
### Tx. Spurious NVNT GFSK 5785MHz Ant2 Emission

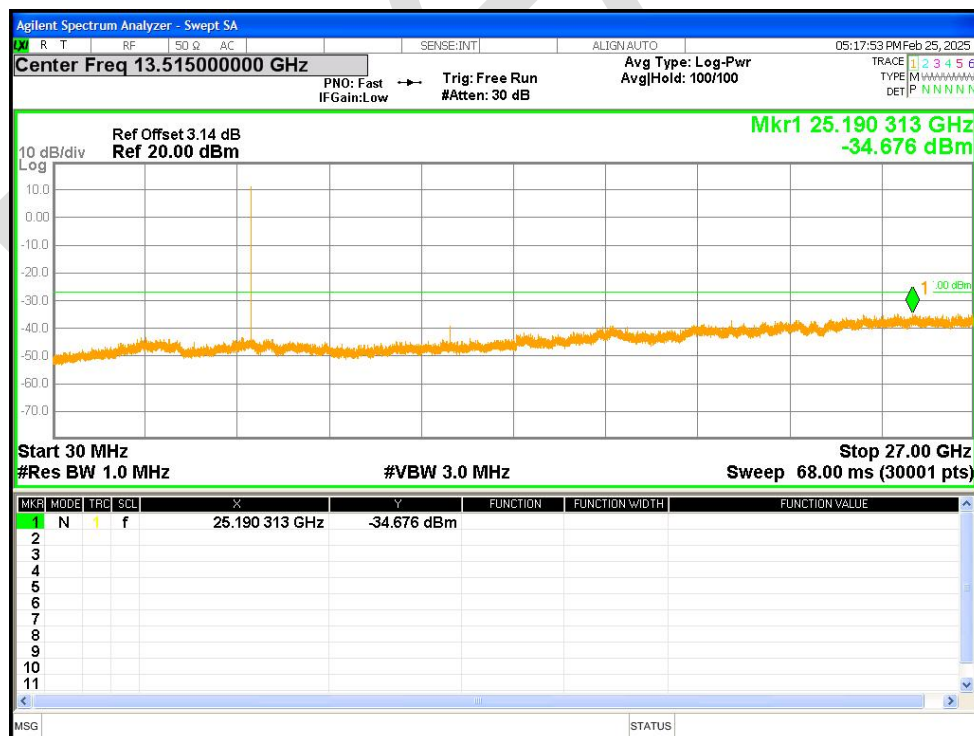
### Tx. Spurious NVNT GFSK 5825MHz Ant2 Emission

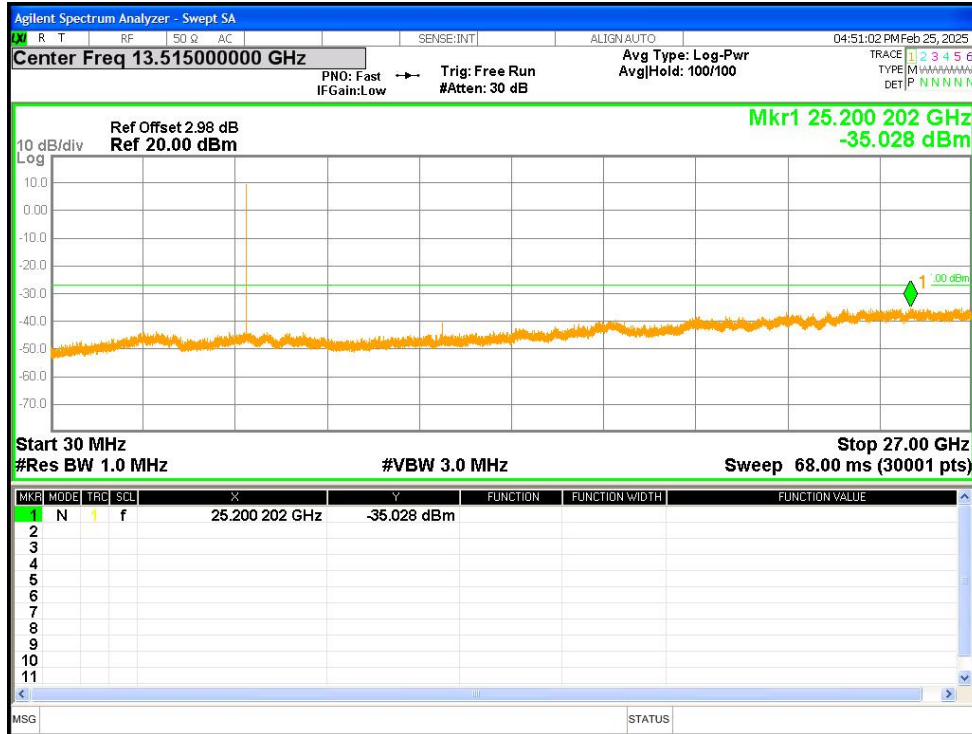
### Tx. Spurious NVNT GFSK 5745MHz Ant1 Emission

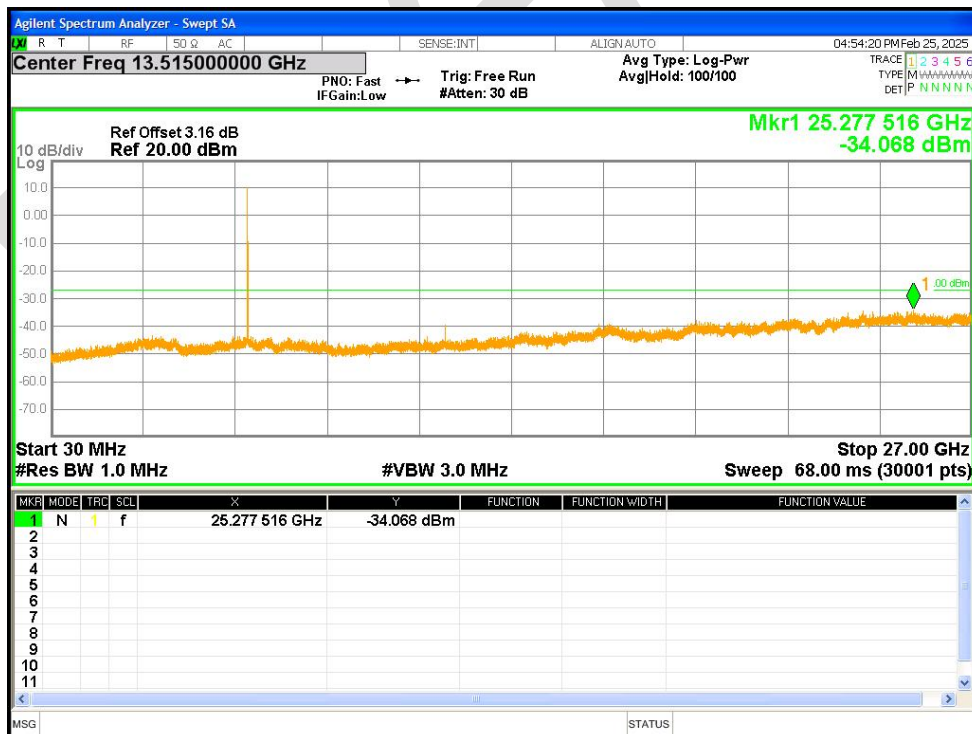
### Tx. Spurious NVNT GFSK 5785MHz Ant1 Emission

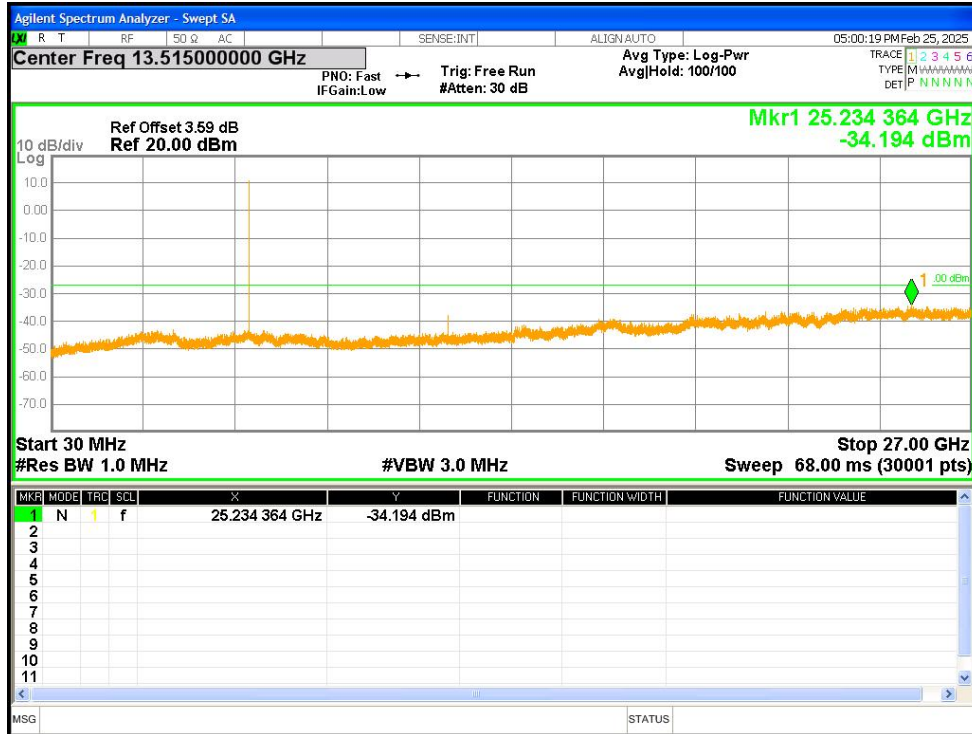
### Tx. Spurious NVNT GFSK 5825MHz Ant1 Emission

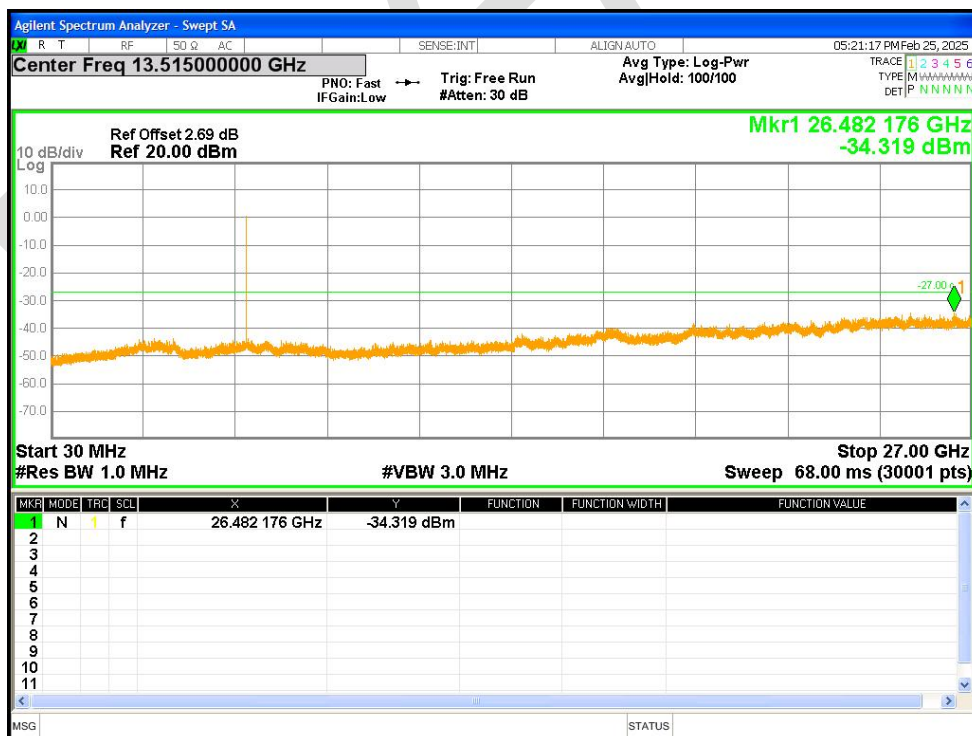
### Tx. Spurious NVNT GFSK 5745MHz Ant2 Emission

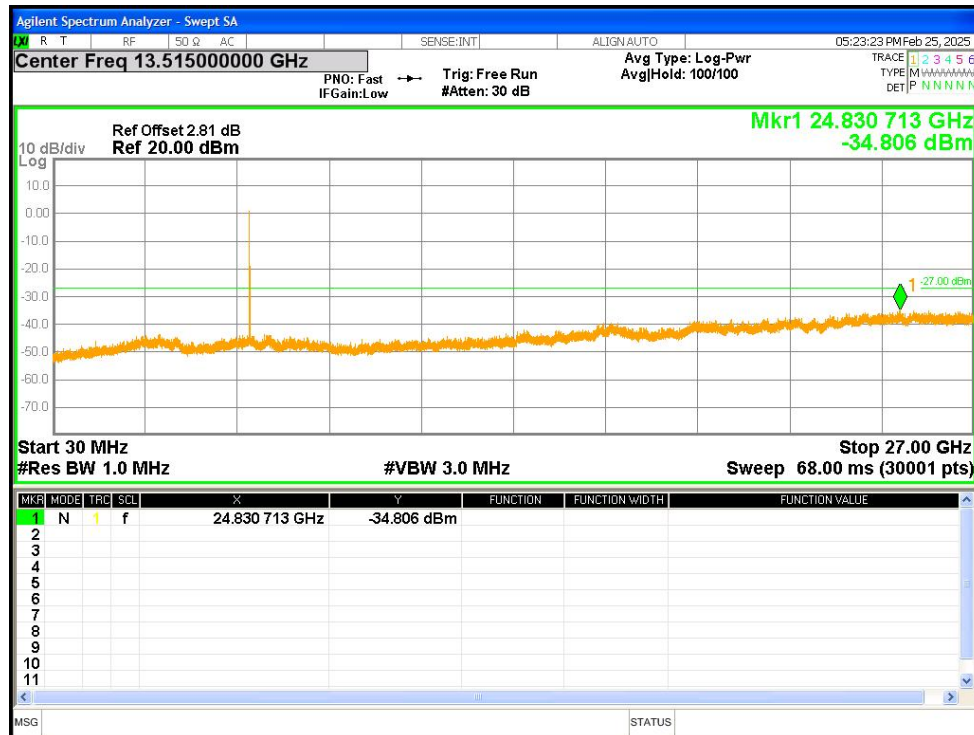
### Tx. Spurious NVNT GFSK 5785MHz Ant2 Emission

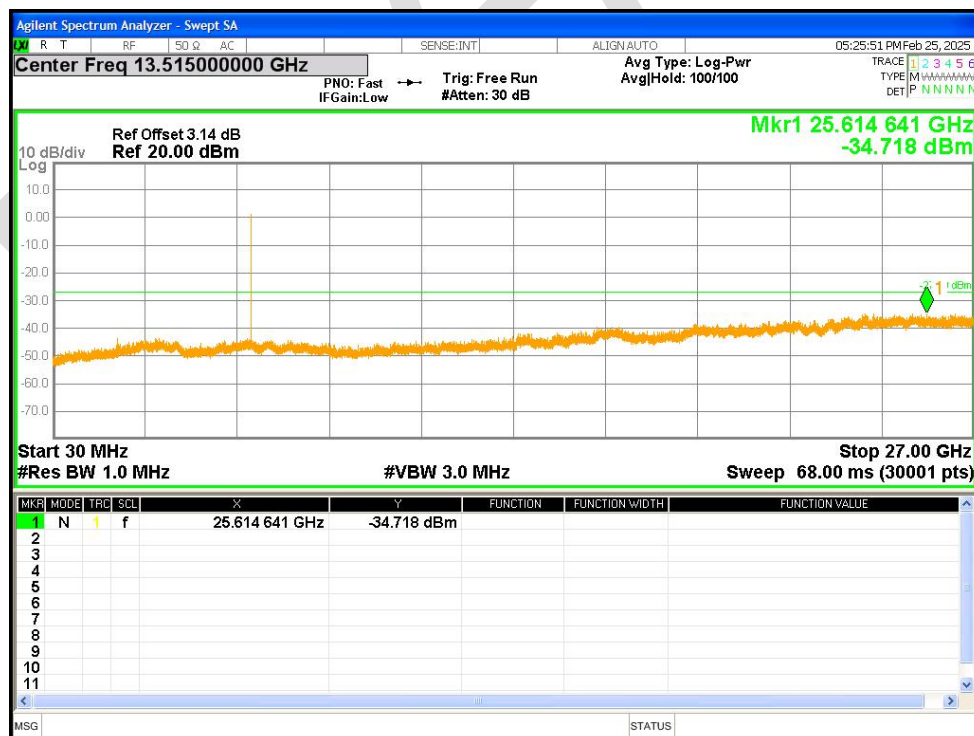
### Tx. Spurious NVNT GFSK 5825MHz Ant2 Emission

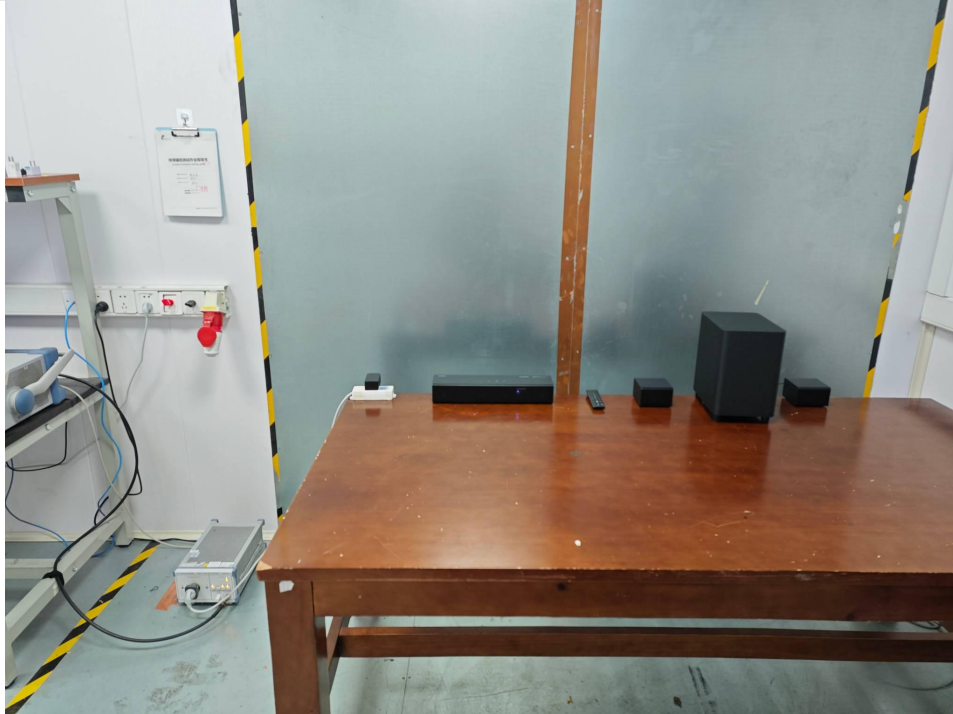
Conducted emissions at AC power line (150kHz-30MHz)

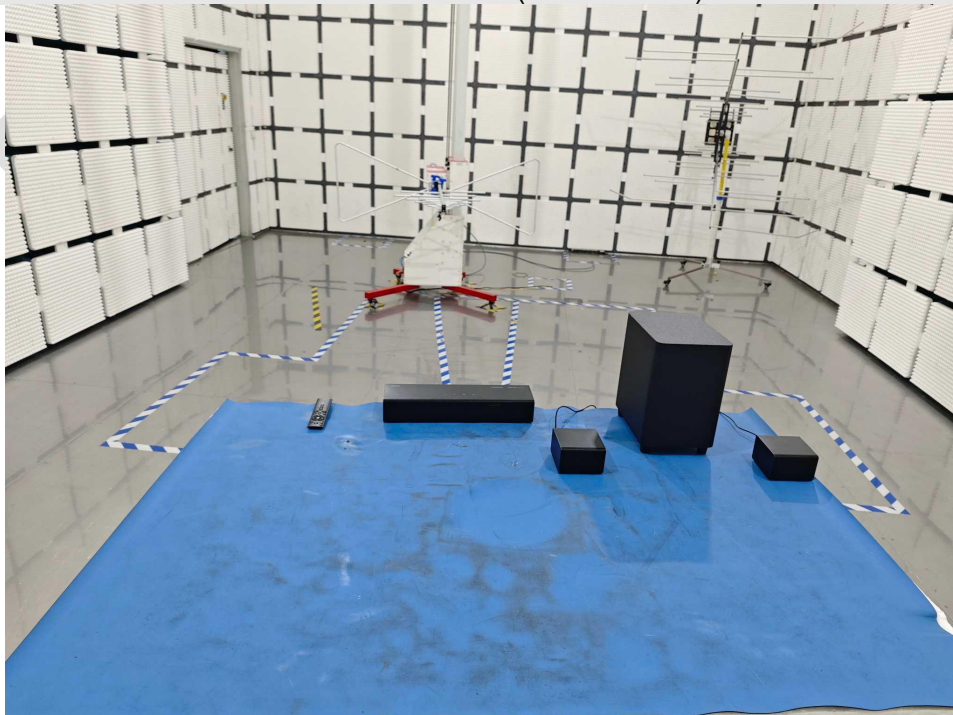
Radiated Emissions (30MHz-1GHz)

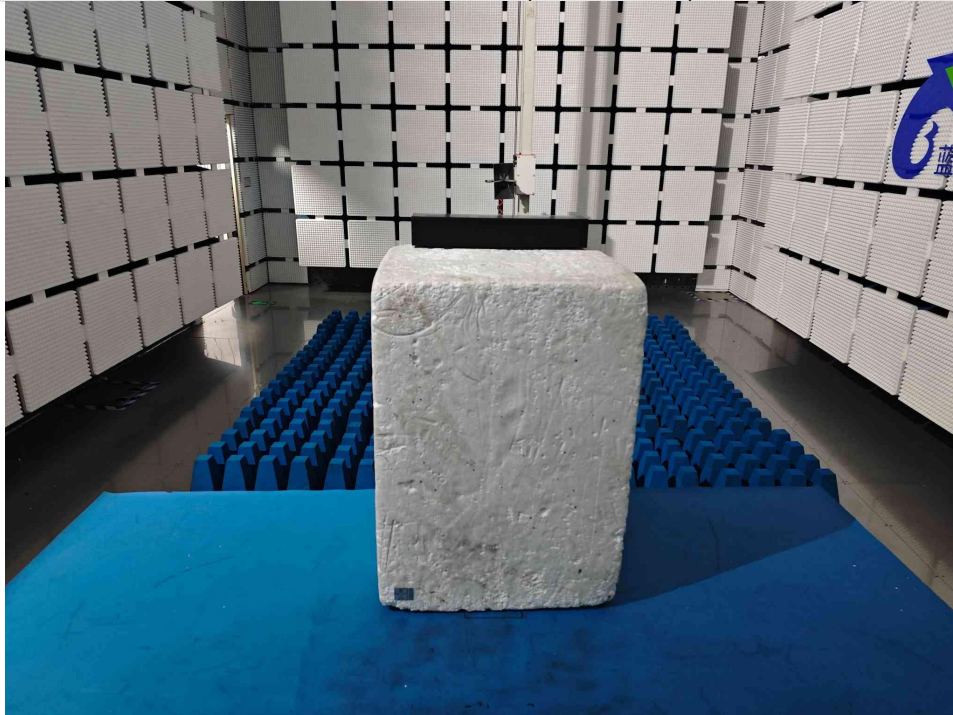
Radiated Emissions (above 1GHz)
