## 5.10 Spurious RF Conducted Emissions

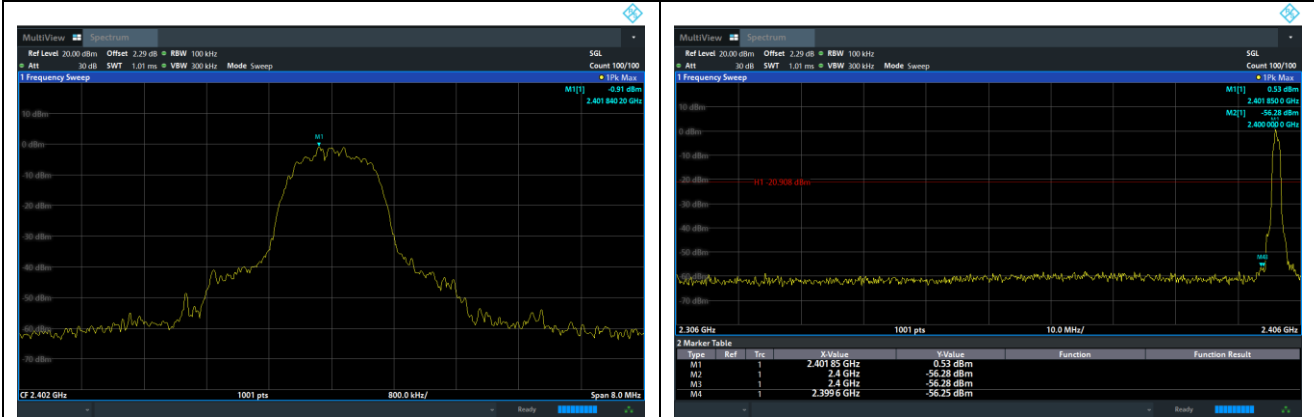
$\pi/4$ -DQPSK: Band Edge, Left Side

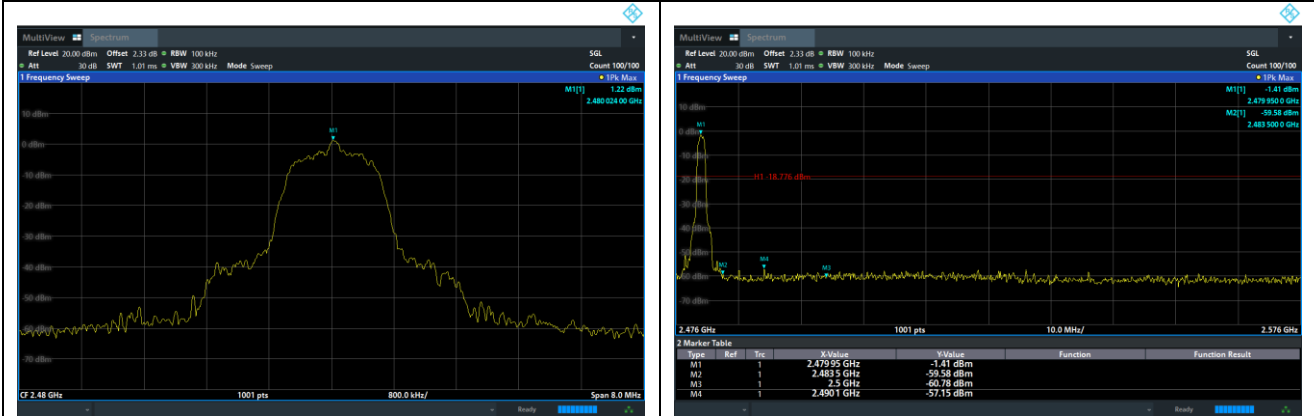
$\pi/4$ -DQPSK: Band Edge, Right Side

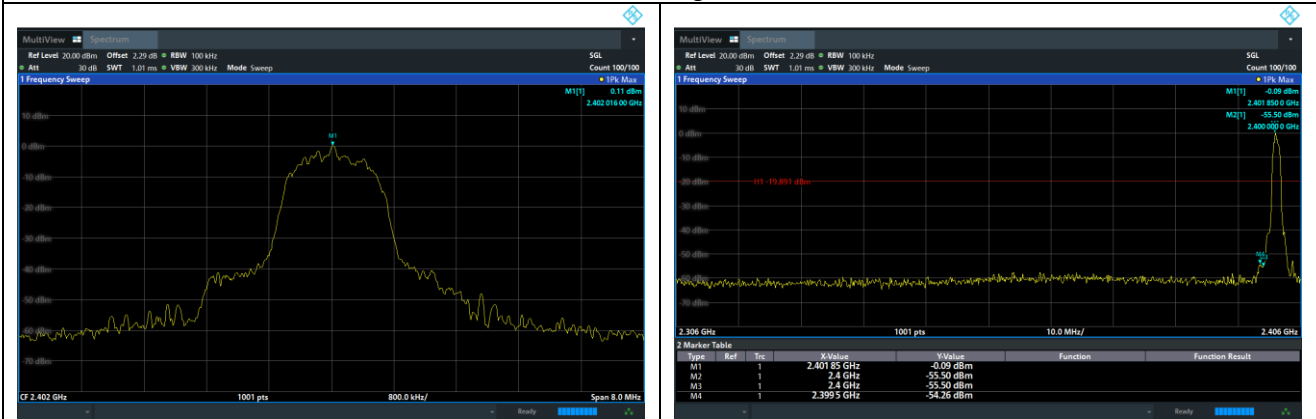
8DPSK: Band Edge, Left Side

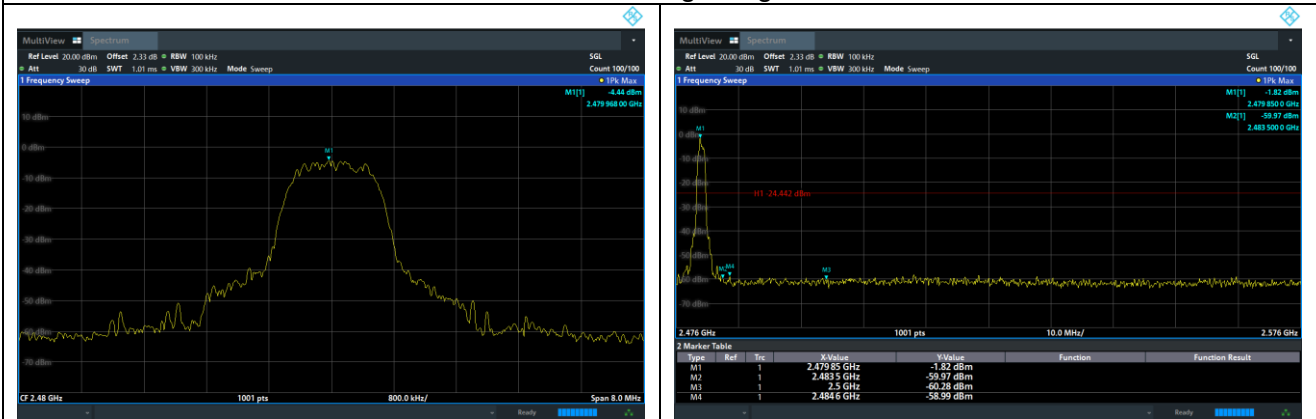
8DPSK: Band Edge, Right Side

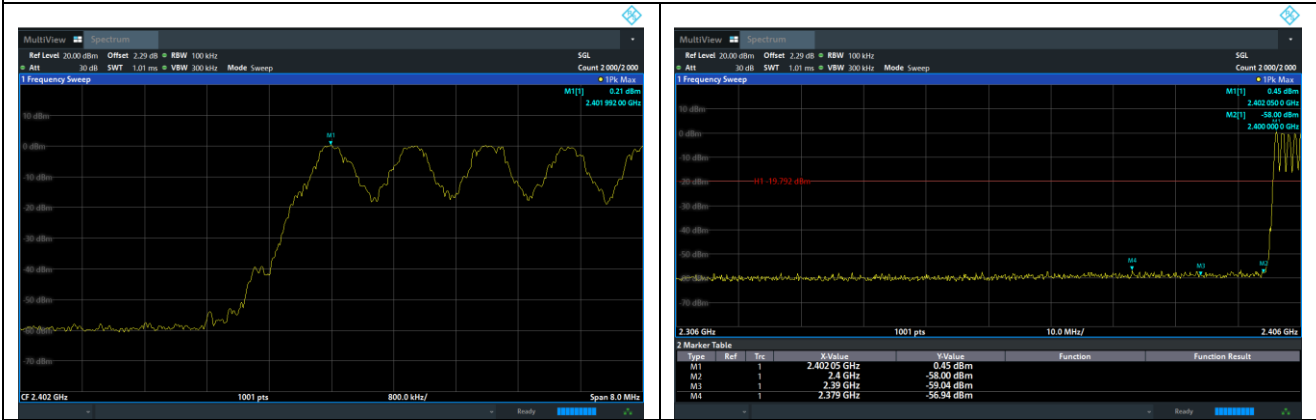
GFSK: Band Edge, Left Side

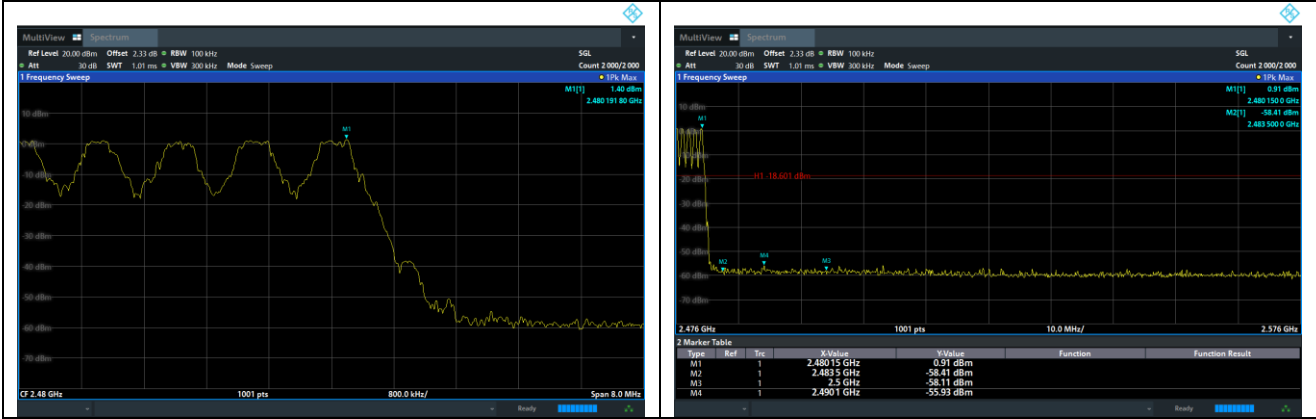
GFSK: Band Edge, Right Side

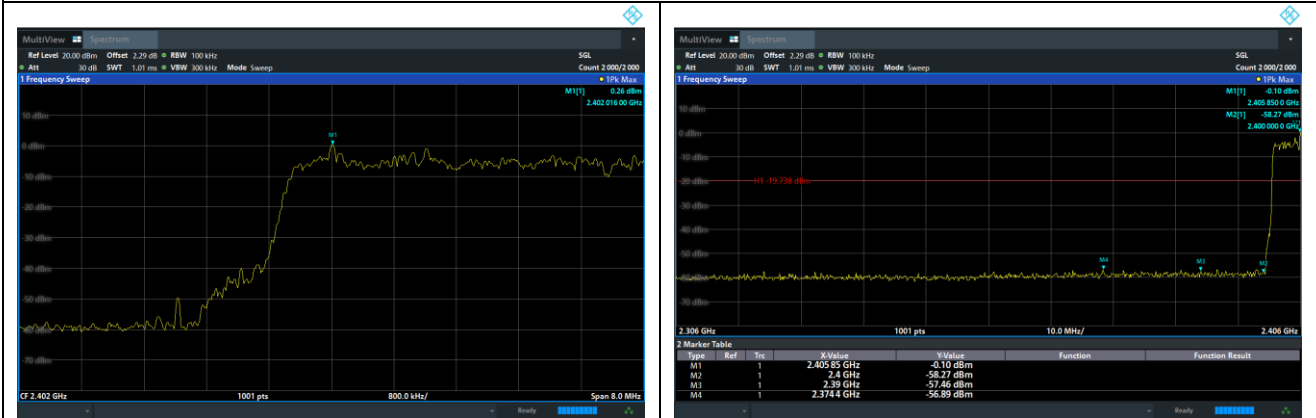
$\pi/4$ -DQPSK: Band Edge, Left Side

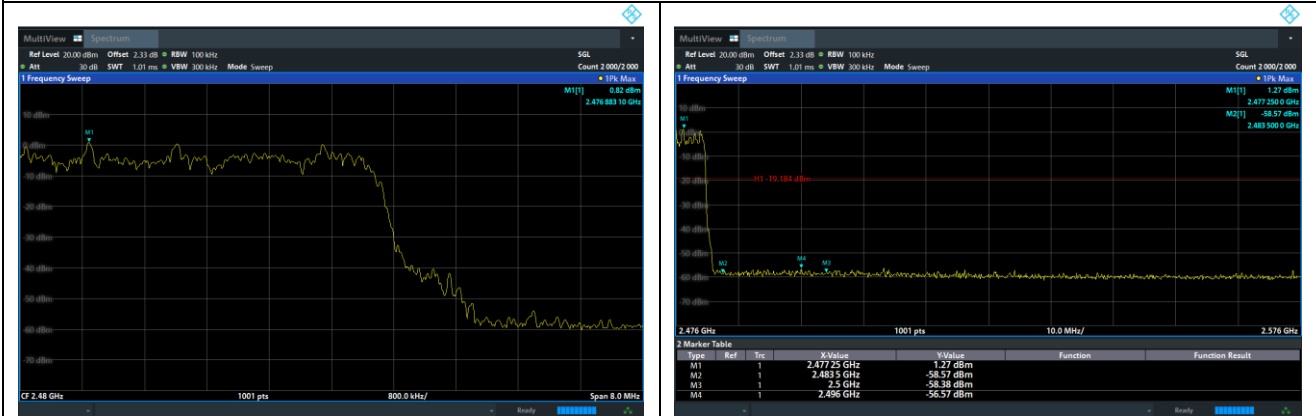
$\pi/4$ -DQPSK: Band Edge, Right Side

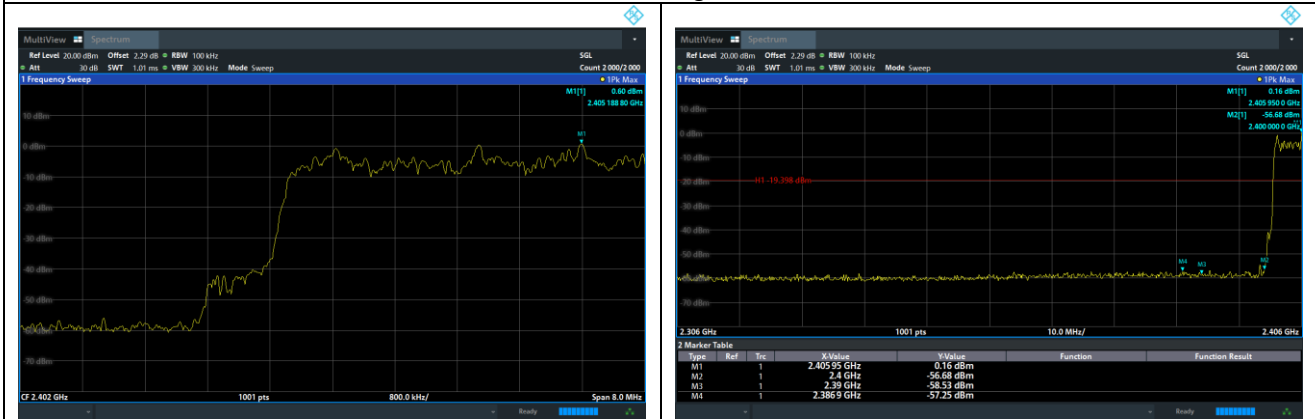
8DPSK: Band Edge, Left Side

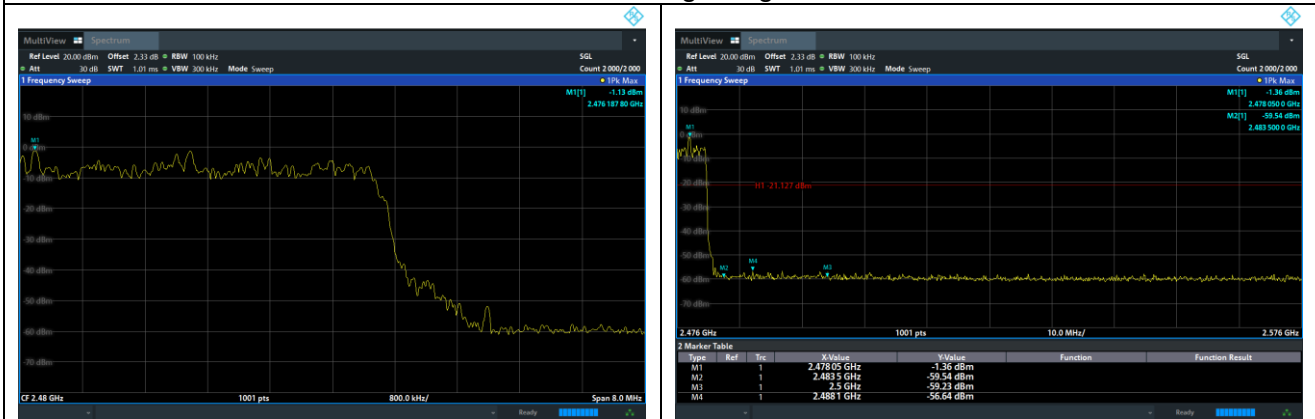
8DPSK: Band Edge, Right Side

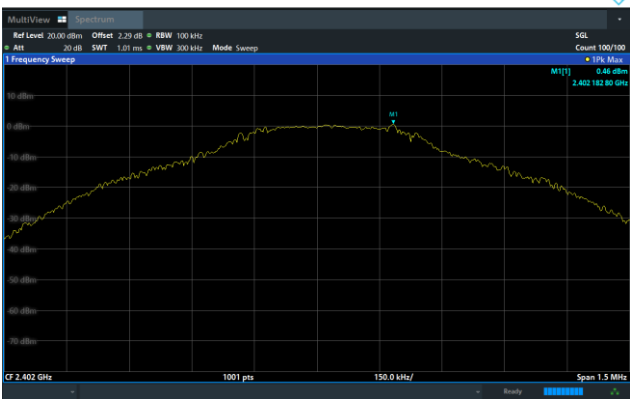
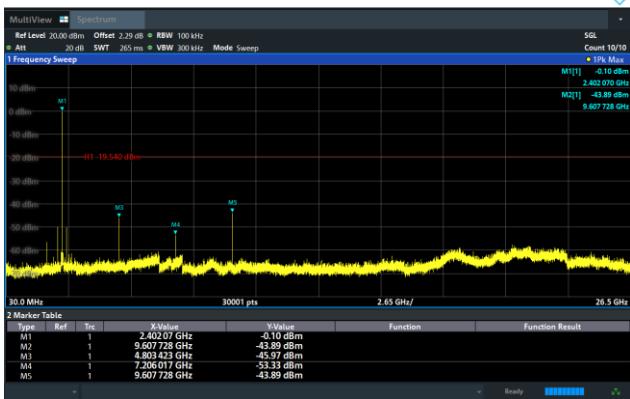
GFSK on Channel 00

1: The measurement frequency range is from 9kHz to the 10th harmonic of the fundamental frequency. The lowest, middle and highest channels are tested to verify the spurious emissions and band edge measurement data.

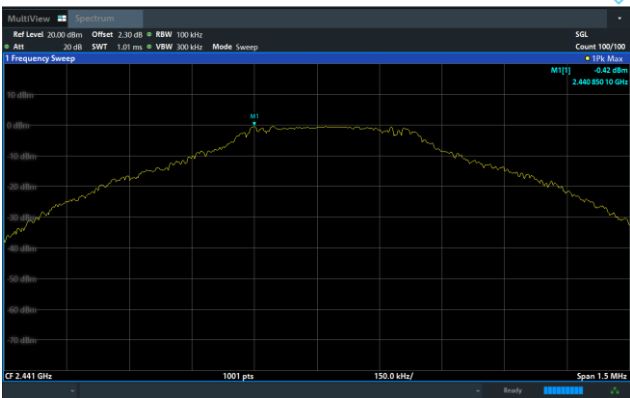
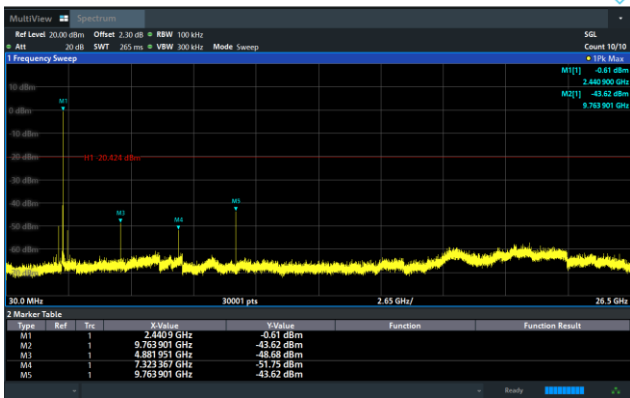
GFSK on Channel 39

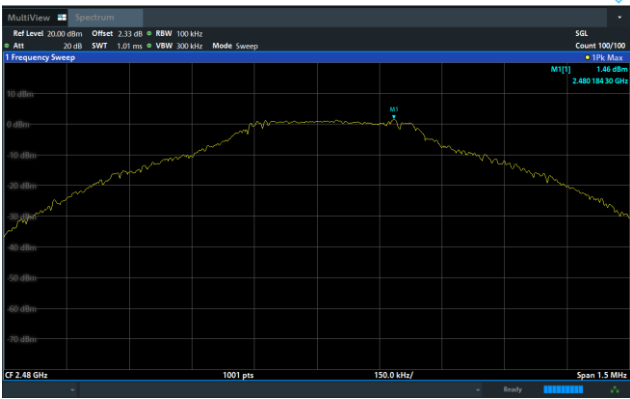
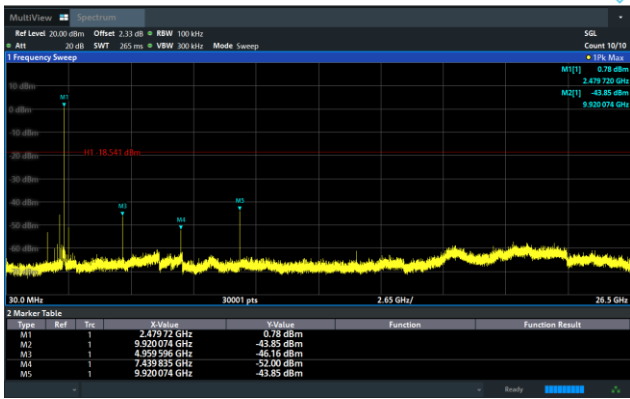
GFSK on Channel 78

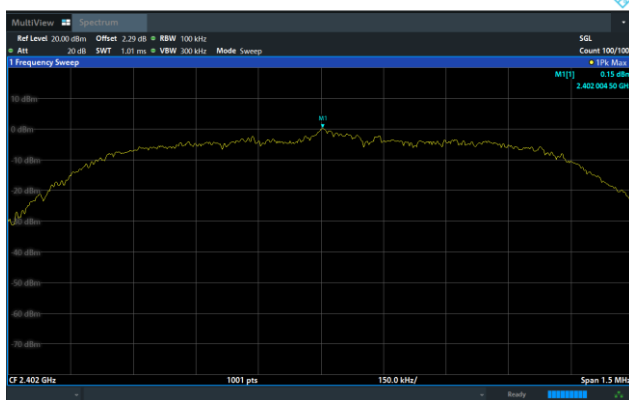
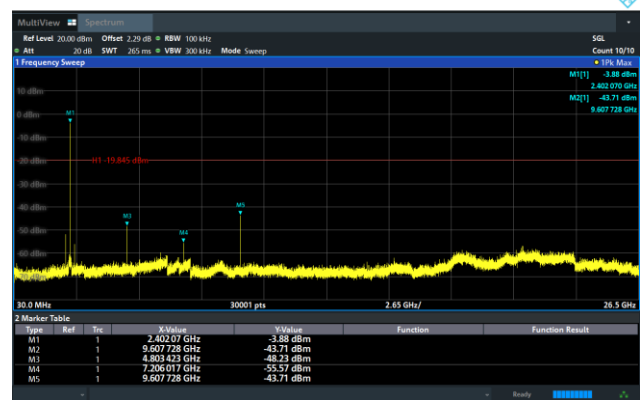
$\pi/4$ -DQPSK on Channel 00

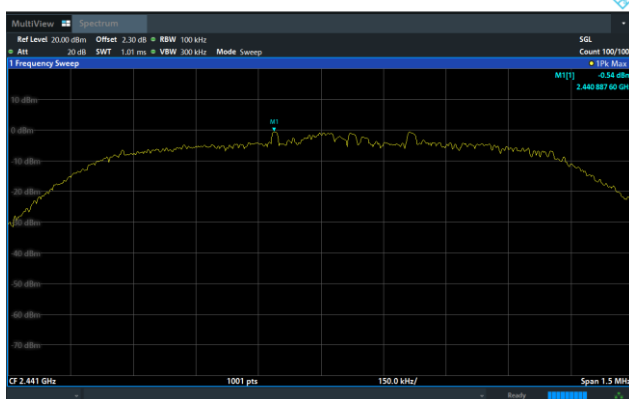
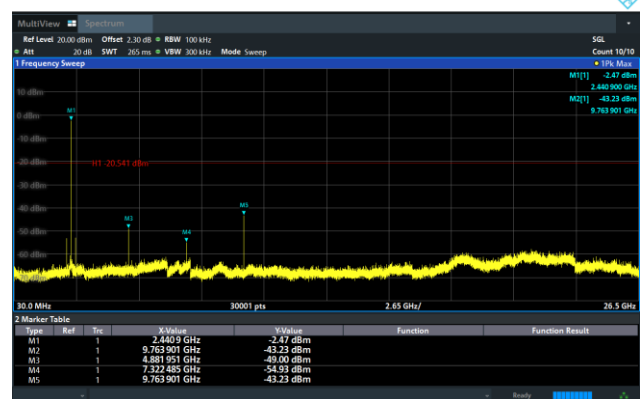
$\pi/4$ -DQPSK on Channel 39

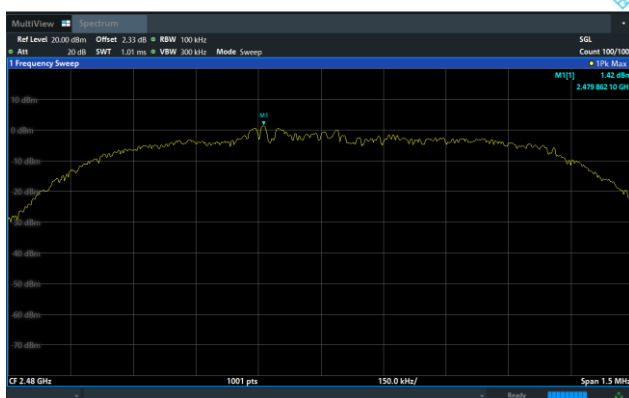
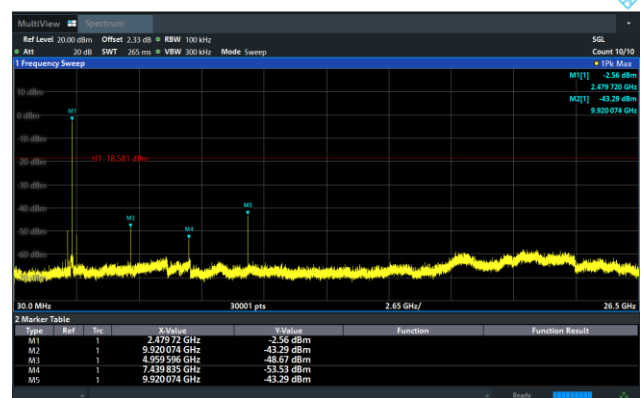
$\pi/4$ -DQPSK on Channel 78

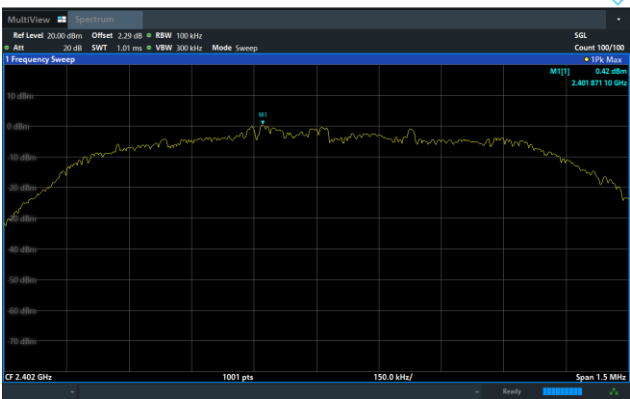
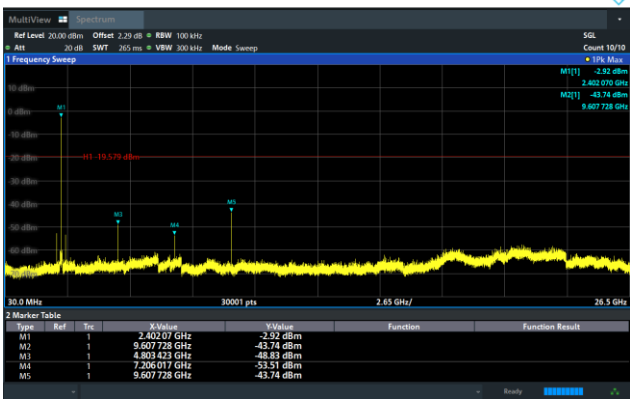
8DPSK on Channel 00

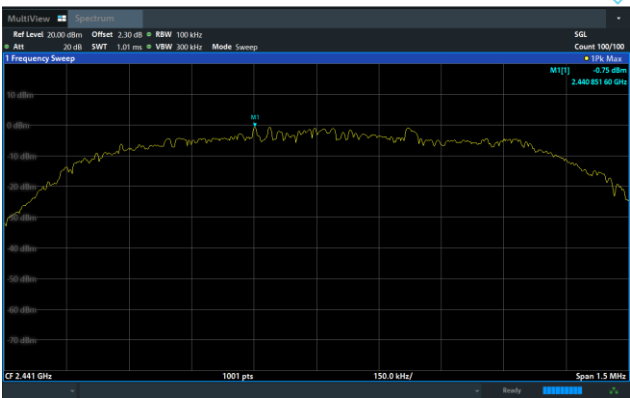
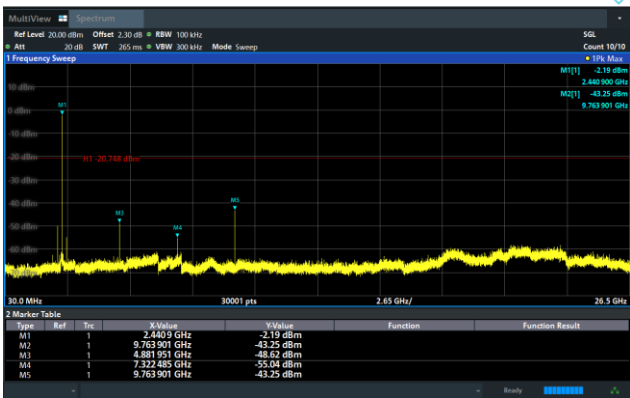
8DPSK on Channel 39

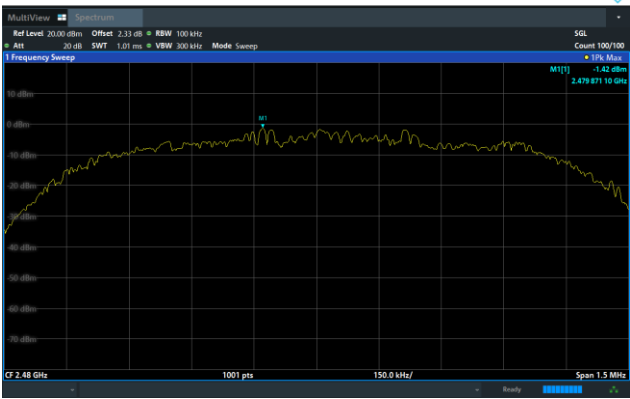
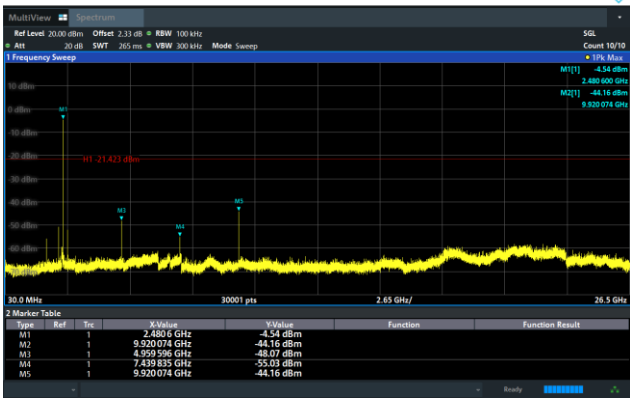
8DPSK on Channel 78

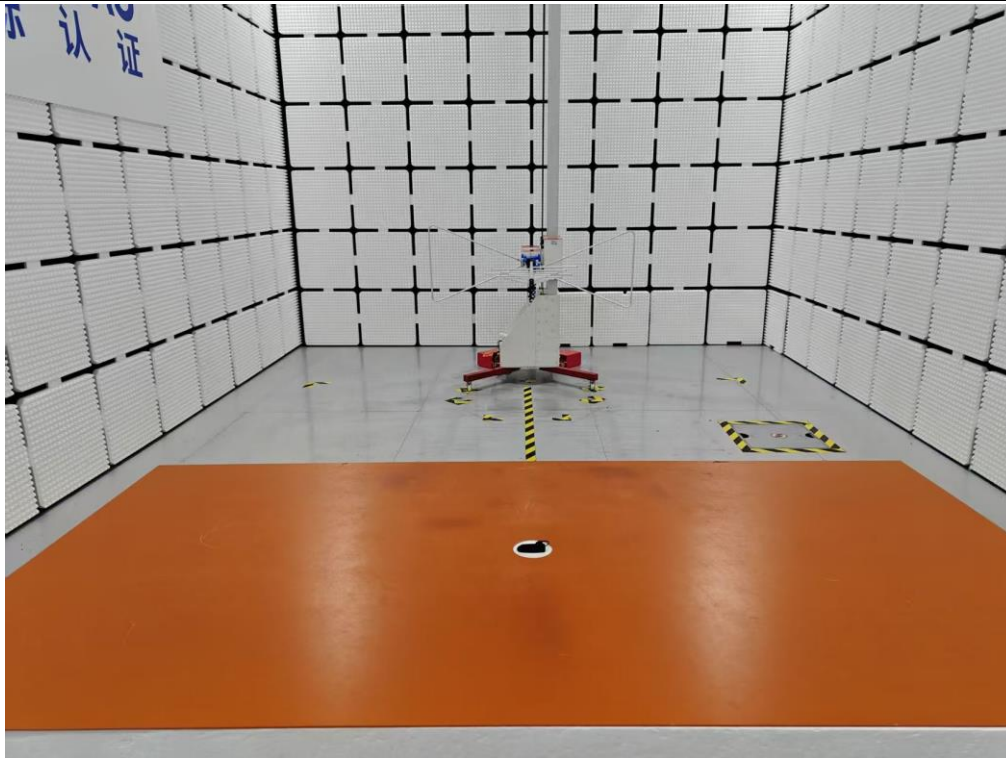
Radiated Emission Below 1GHz

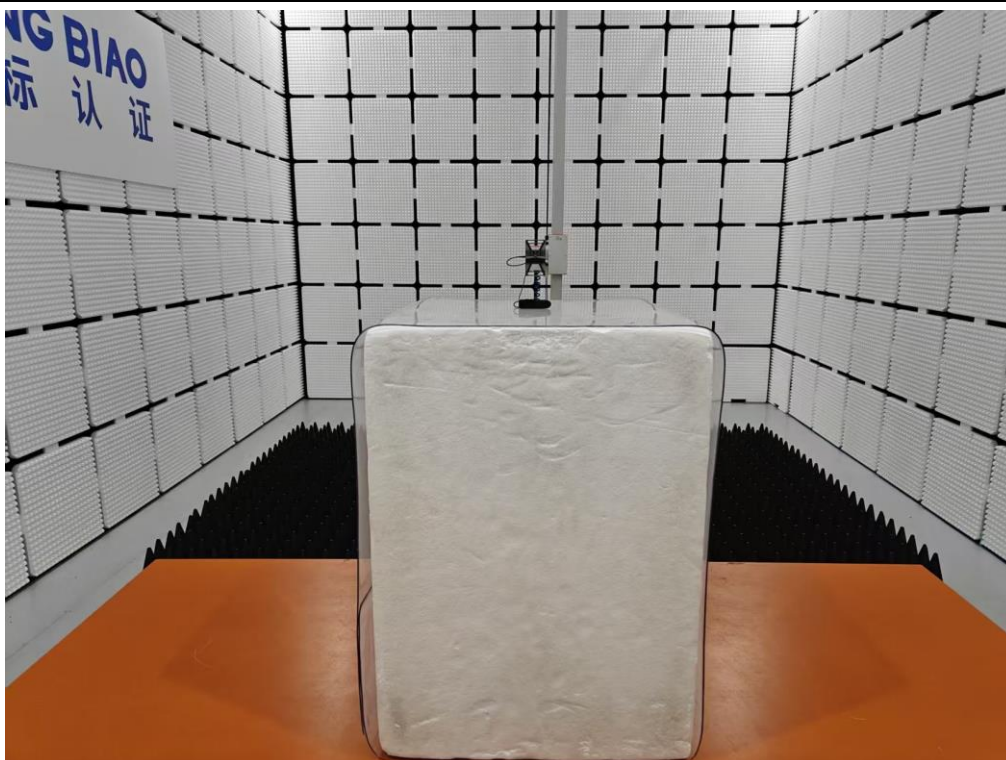
Radiated Emission Above 1GHz

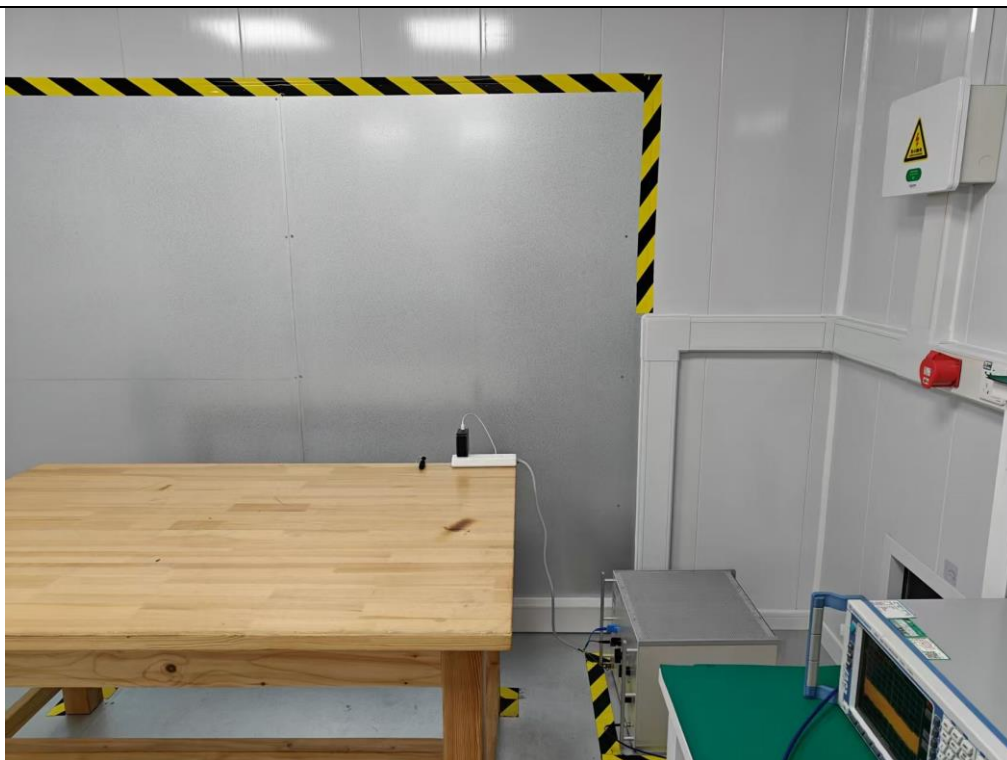
Conducted Emission
