## 5.10 Spurious RF Conducted Emissions

### 5.10.4 Test Results

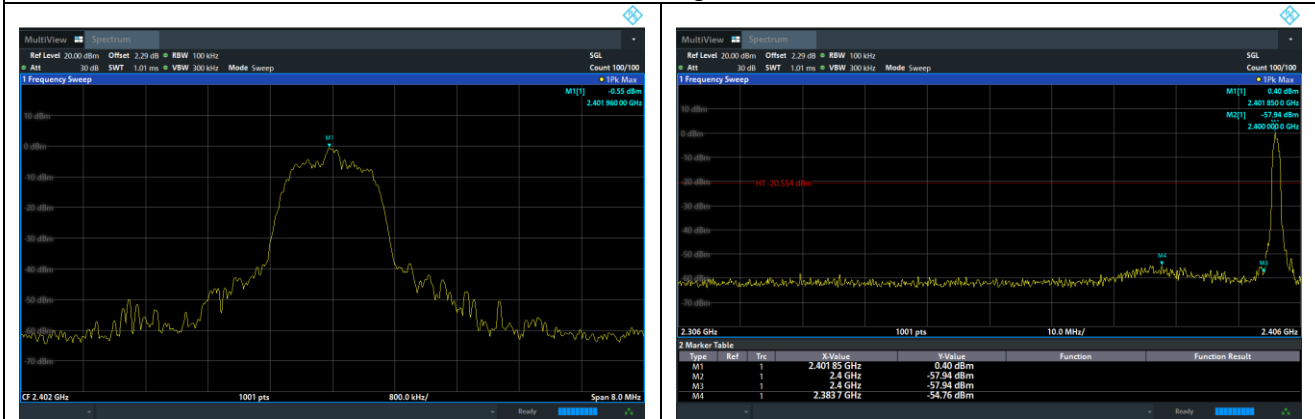
8DPSK: Band Edge, Left Side

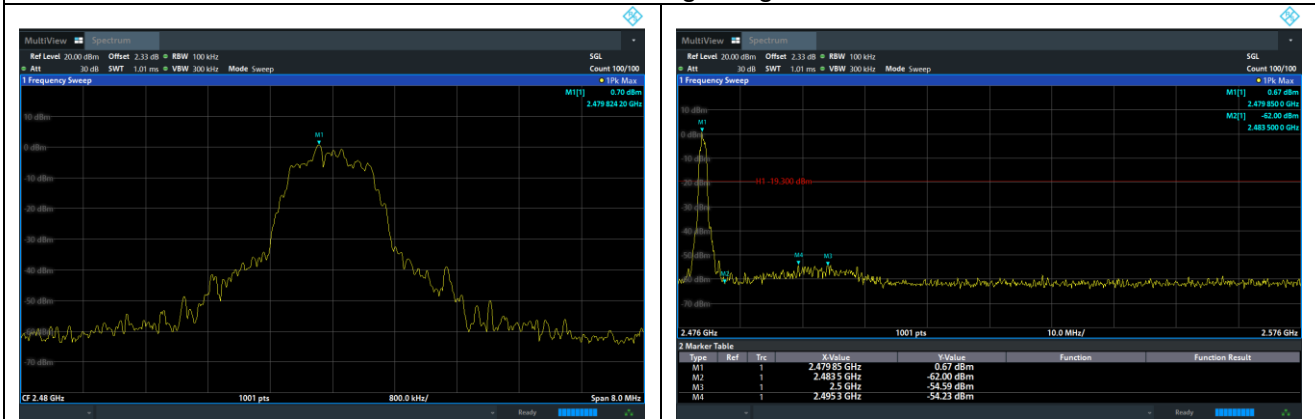
8DPSK: Band Edge, Right Side

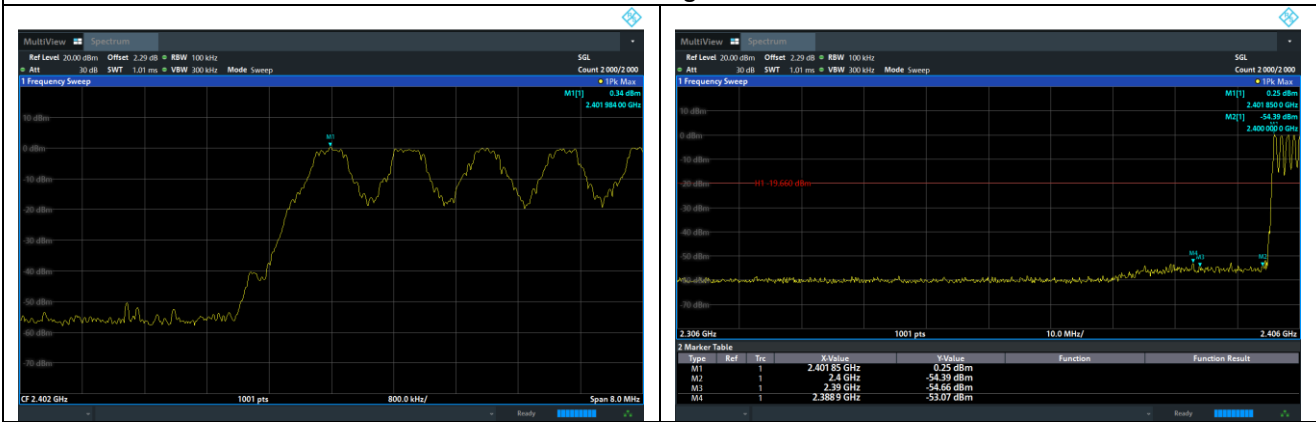
GFSK: Band Edge, Left Side

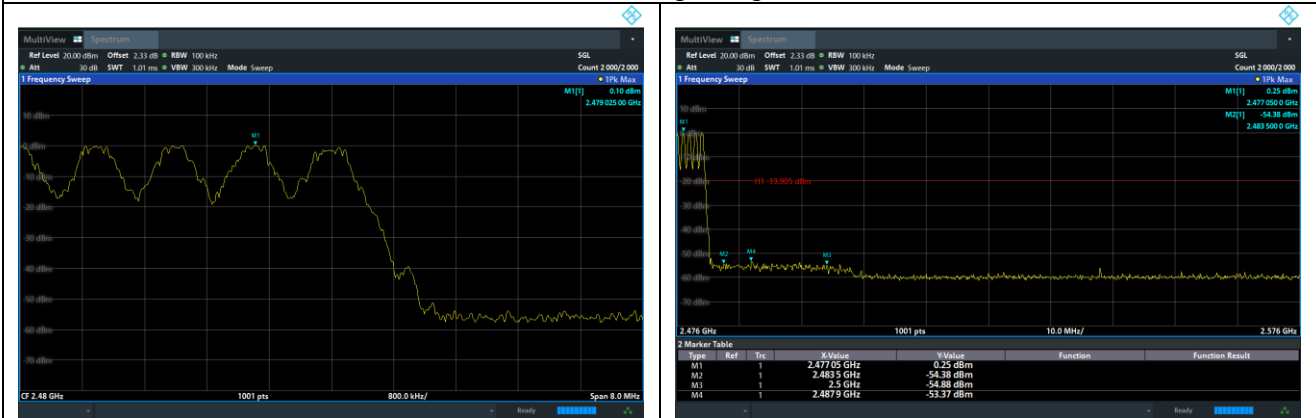
GFSK: Band Edge, Right Side

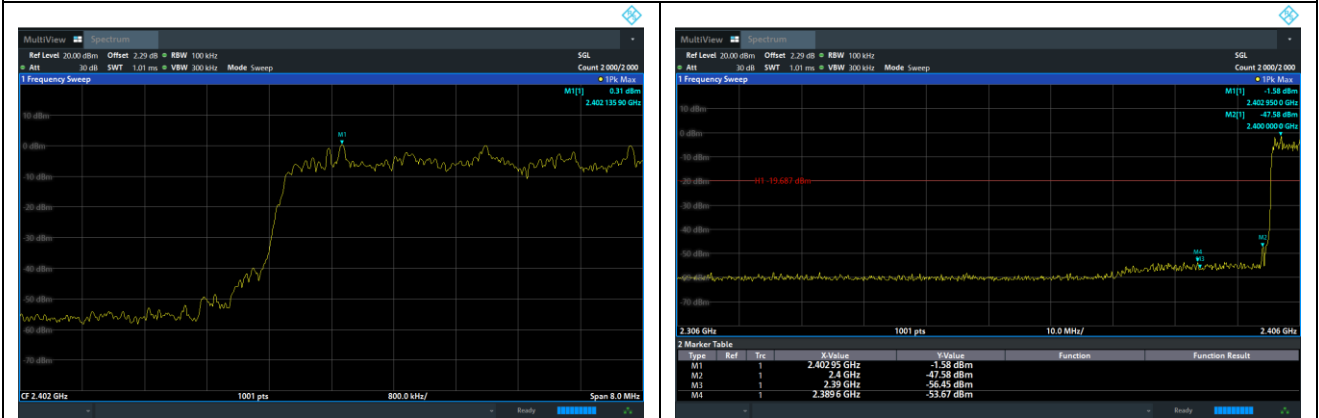
$\pi/4$ -DQPSK: Band Edge, Left Side

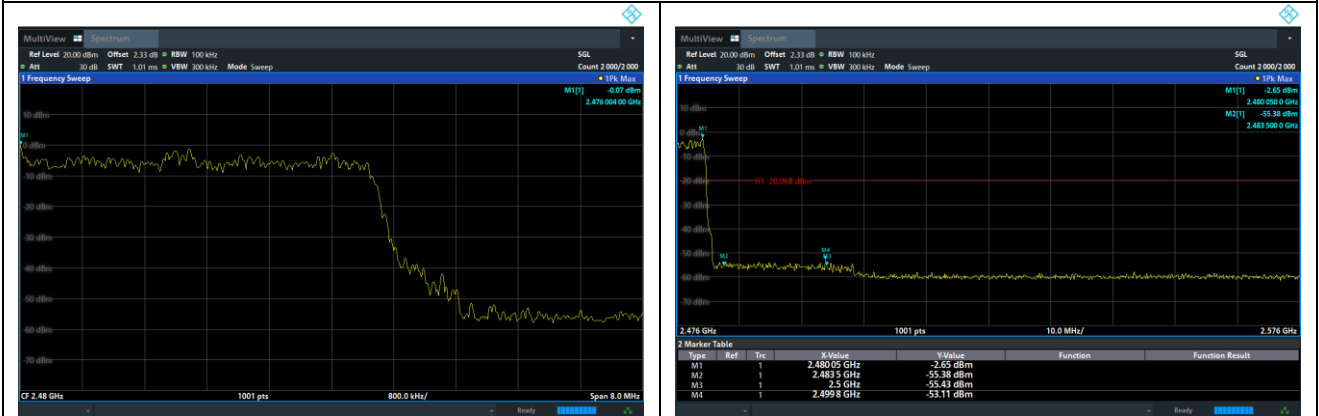
$\pi/4$ -DQPSK: Band Edge, Right Side

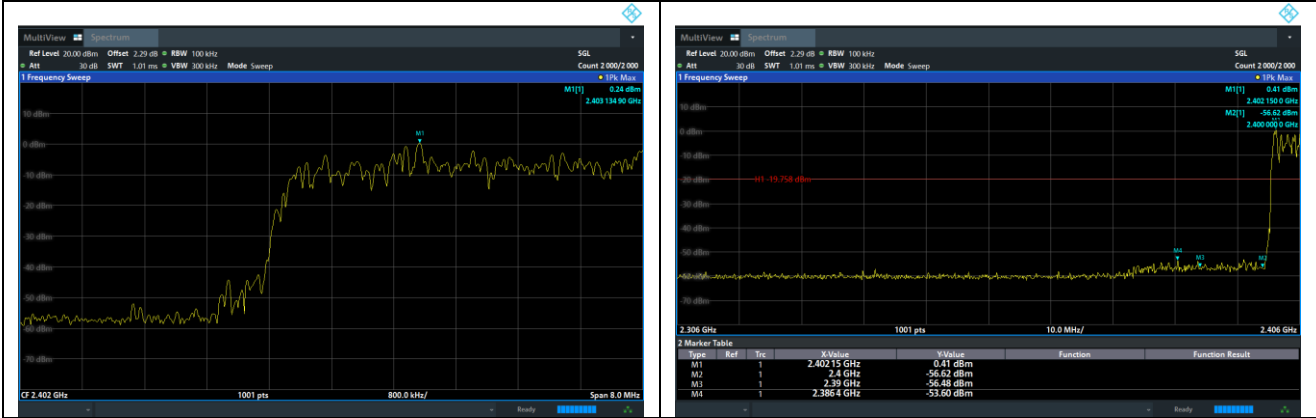
8DPSK: Band Edge, Left Side

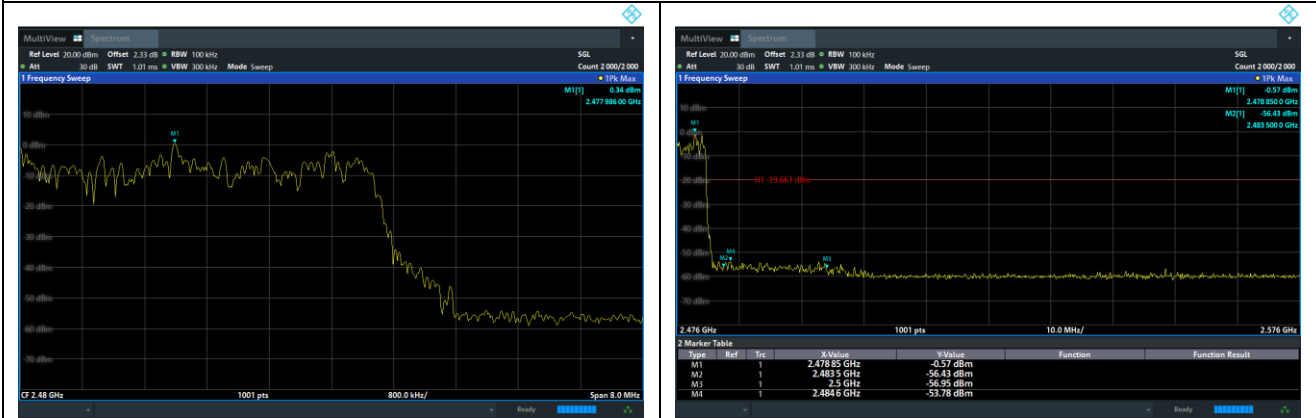
8DPSK: Band Edge, Right Side

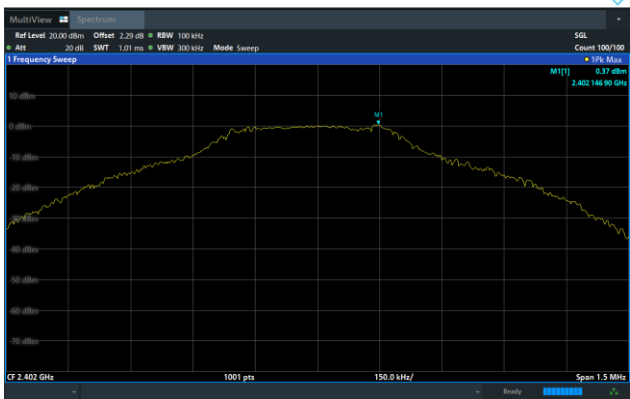
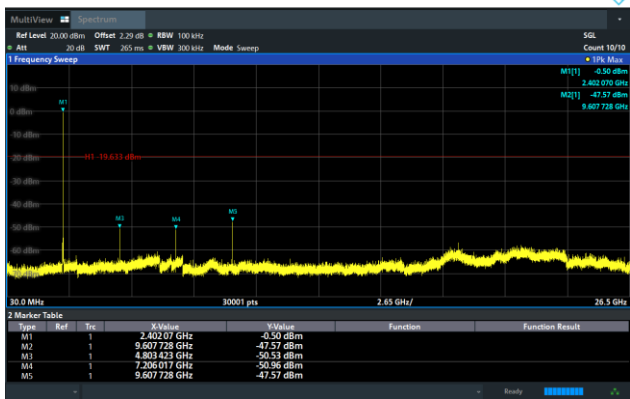
GFSK on Channel 00

1: The measurement frequency range is from 9kHz to the 10th harmonic of the fundamental frequency. The lowest, middle and highest channels are tested to verify the spurious emissions and band edge measurement data.

2: The worst mode is GFSK mode, and the report only show the worst mode data.

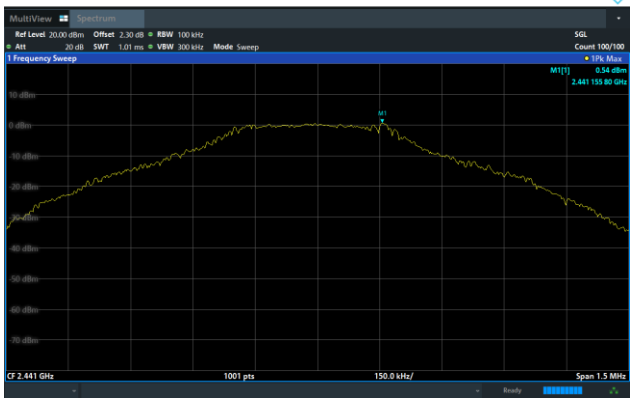
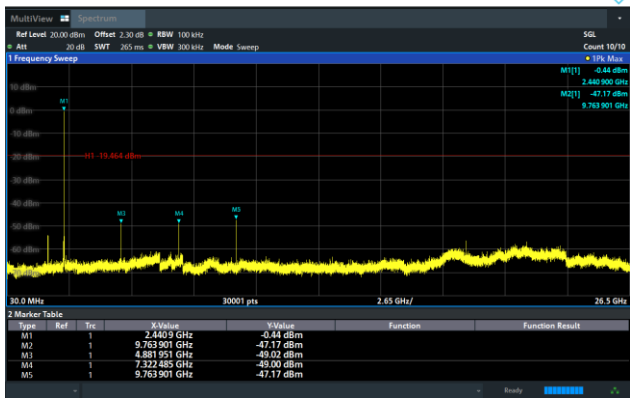
GFSK on Channel 39

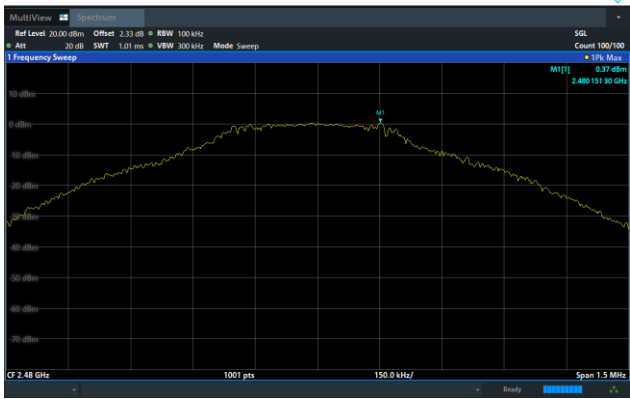
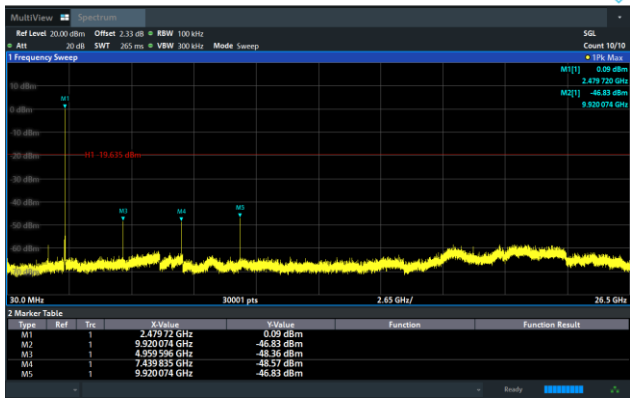
GFSK on Channel 78

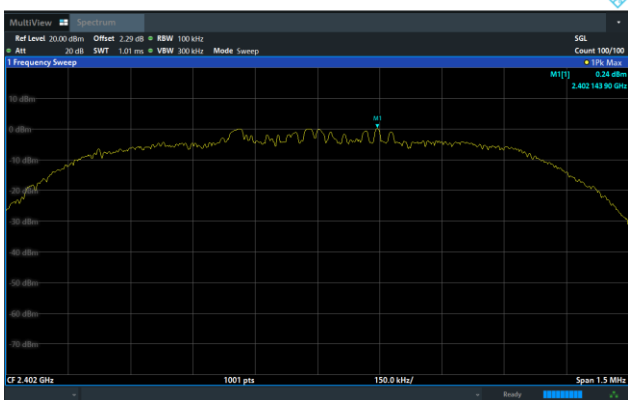
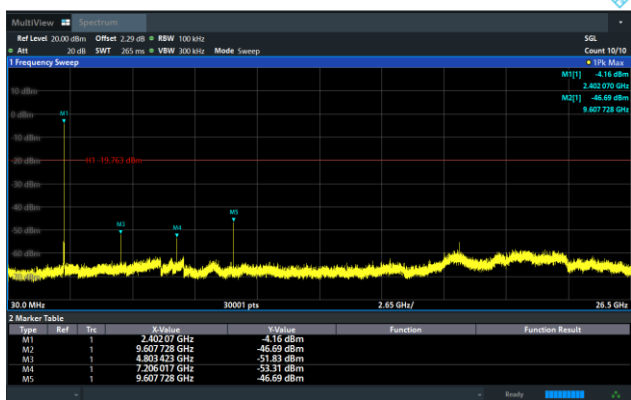
$\pi/4$ -DQPSK on Channel 00

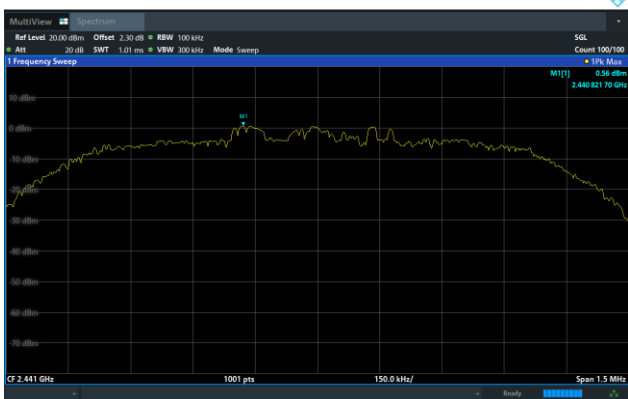
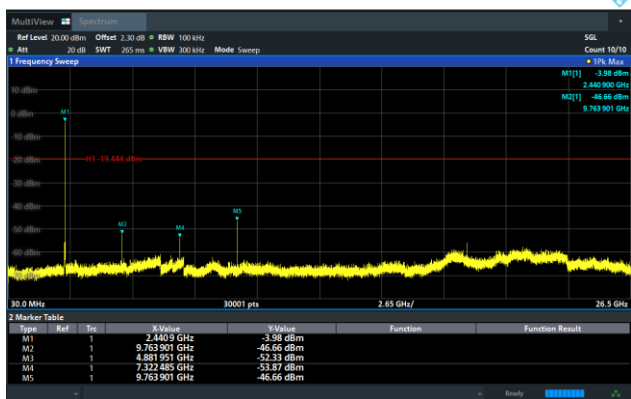
$\pi/4$ -DQPSK on Channel 39

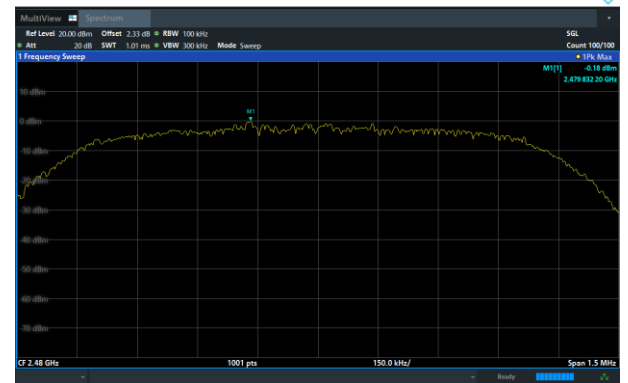
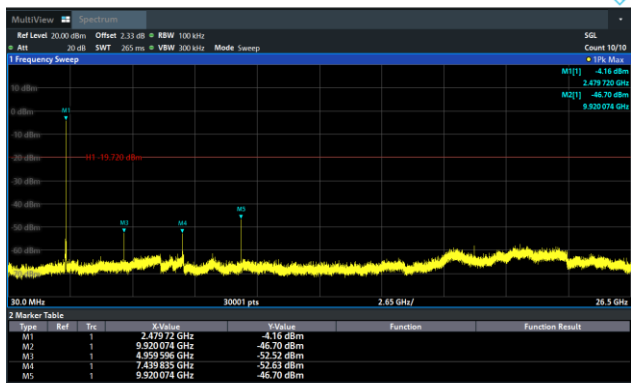
$\pi/4$ -DQPSK on Channel 78

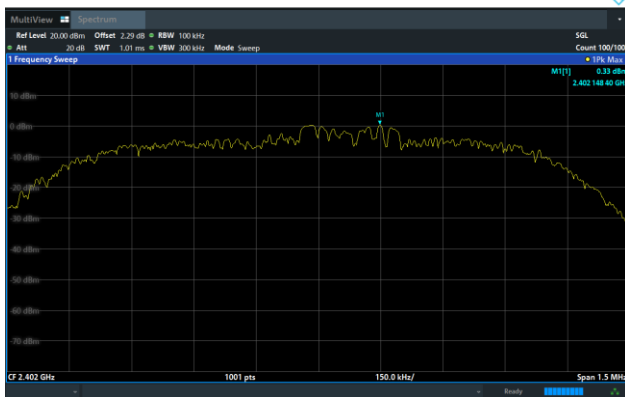
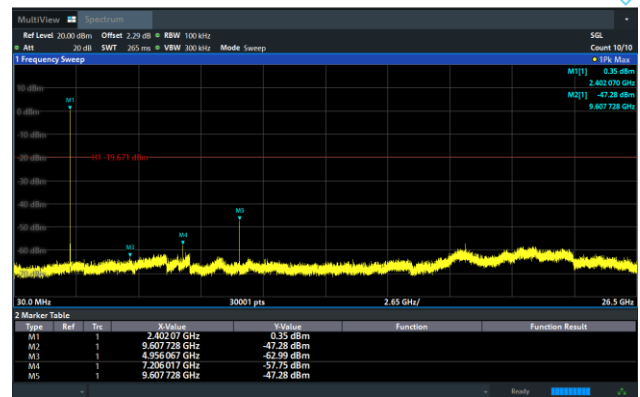
8DPSK on Channel 00

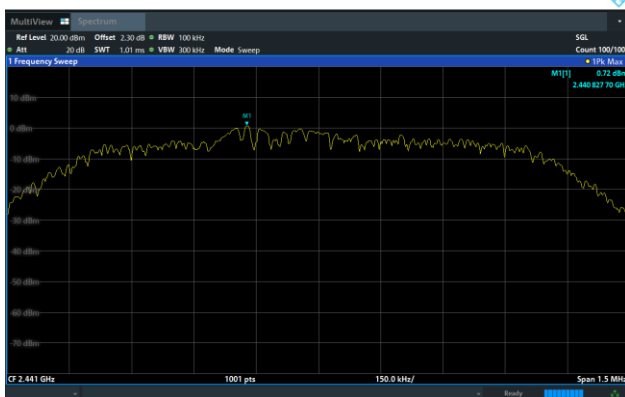
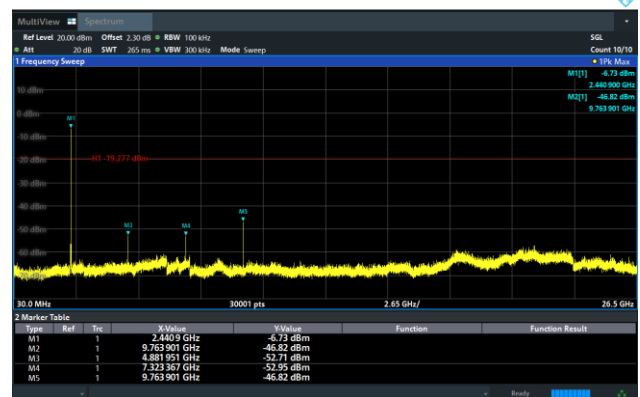
8DPSK on Channel 39

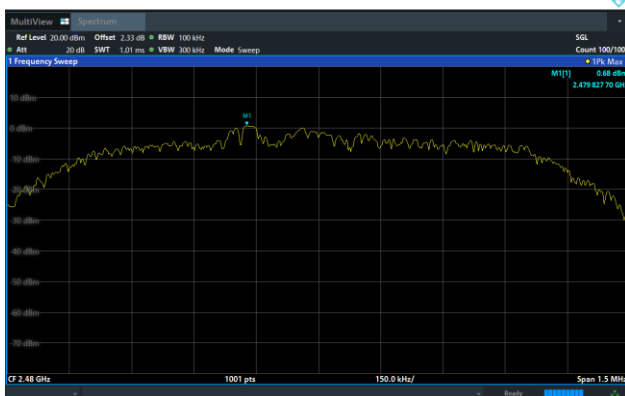
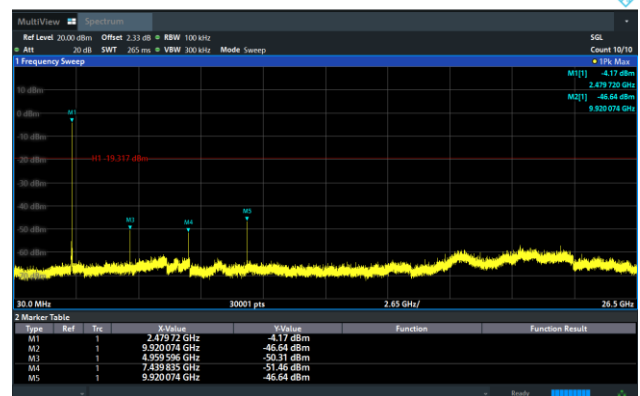
8DPSK on Channel 78

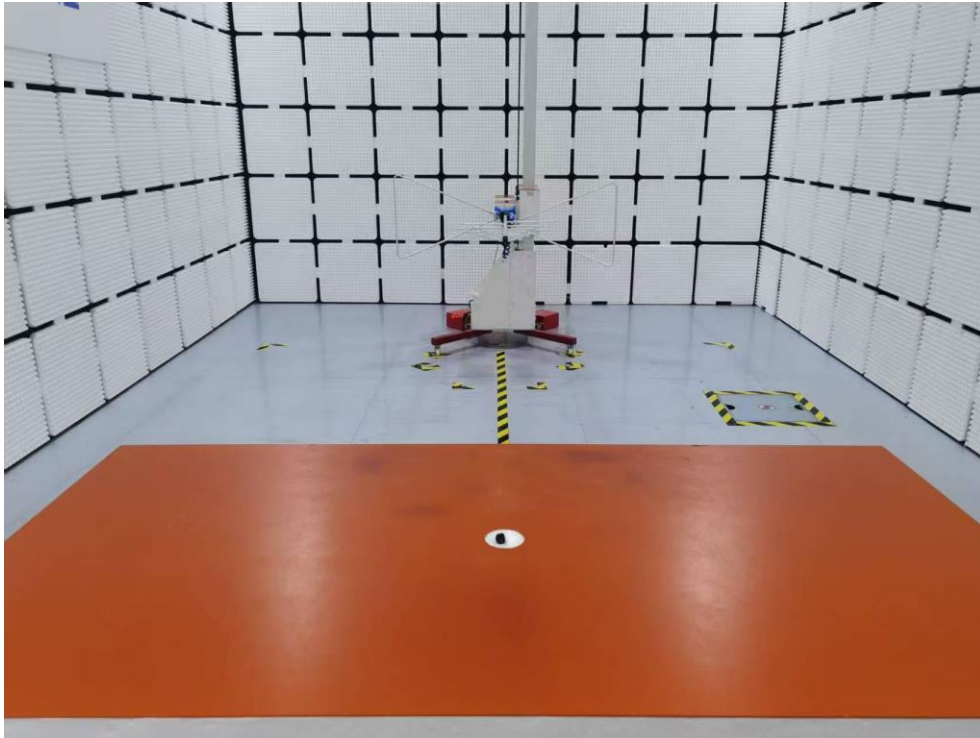
Radiated Emission Below 1GHz

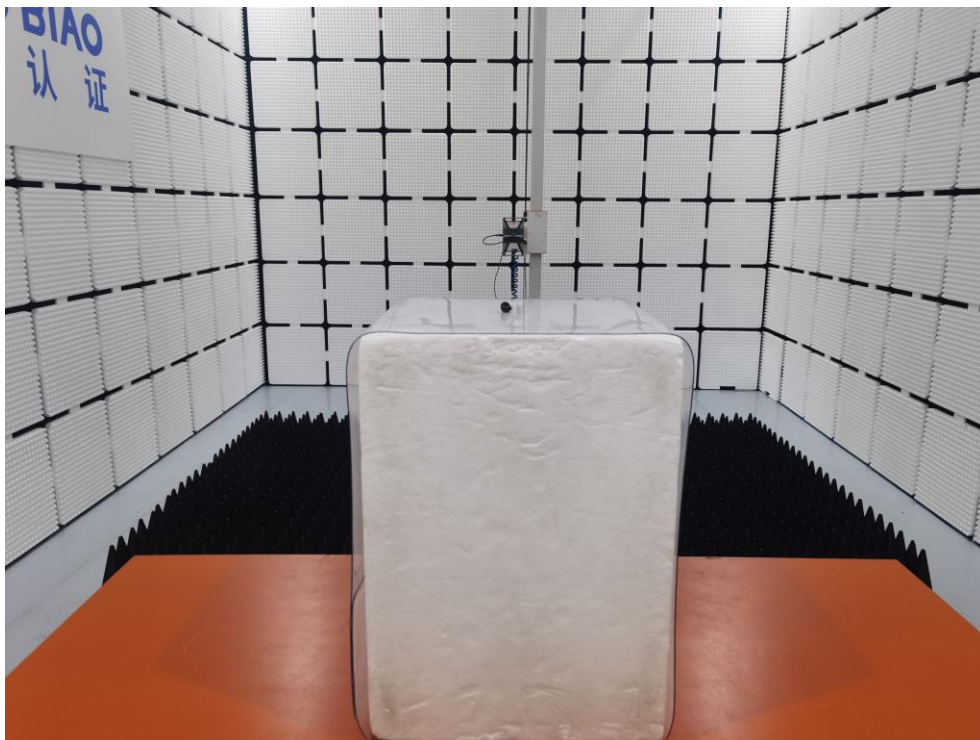
Radiated Emission Above 1GHz

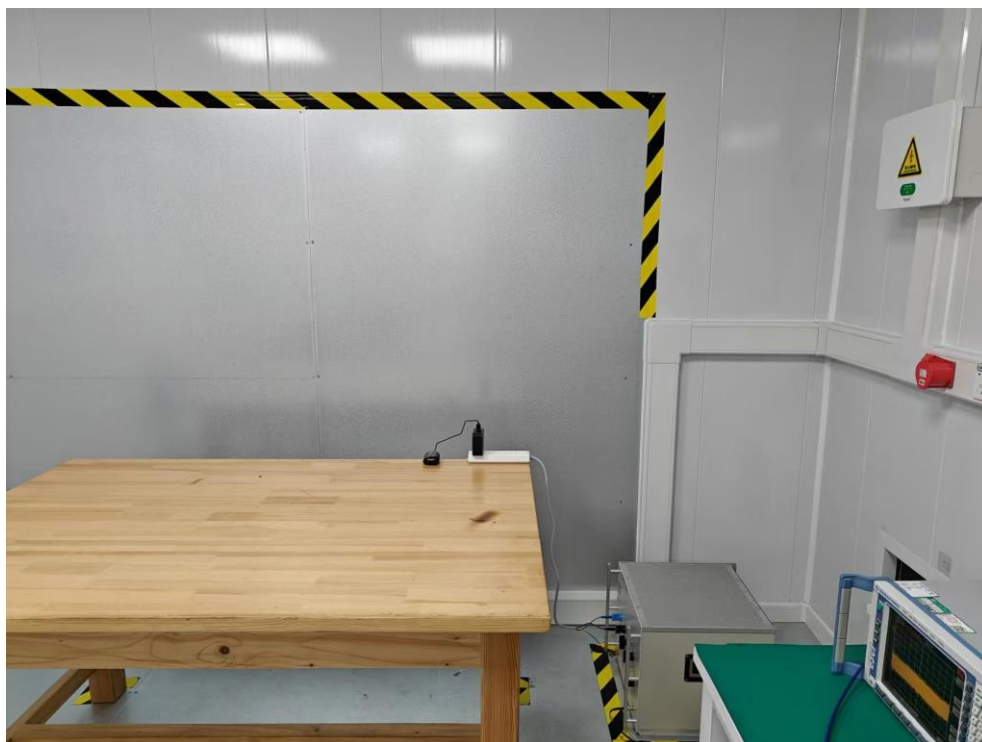
Conducted Emission
