| EUT | Pestoptix camera | Model Name | EPM001 |

13. FCC LINE CONDUCTED EMISSION TEST

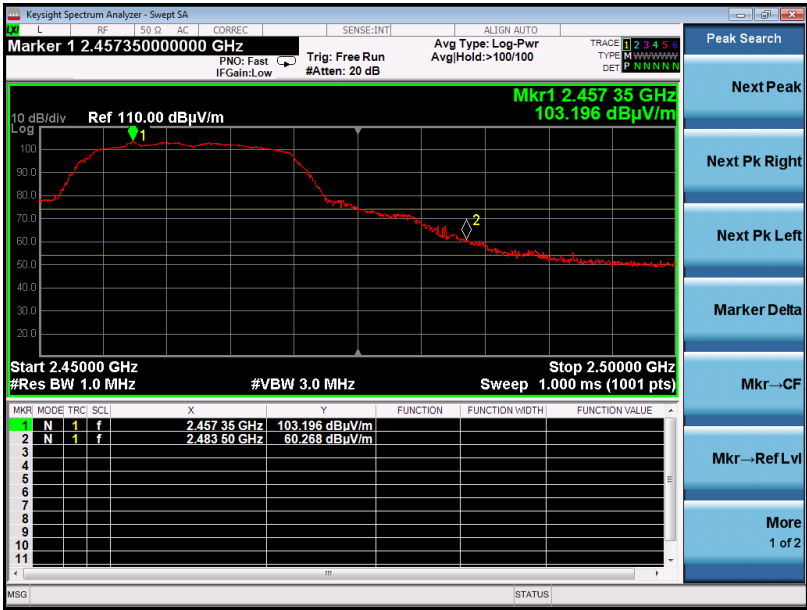
PK

| Test Mode | 802.11g with data rate 6 2462MHZ | Antenna | Vertical |

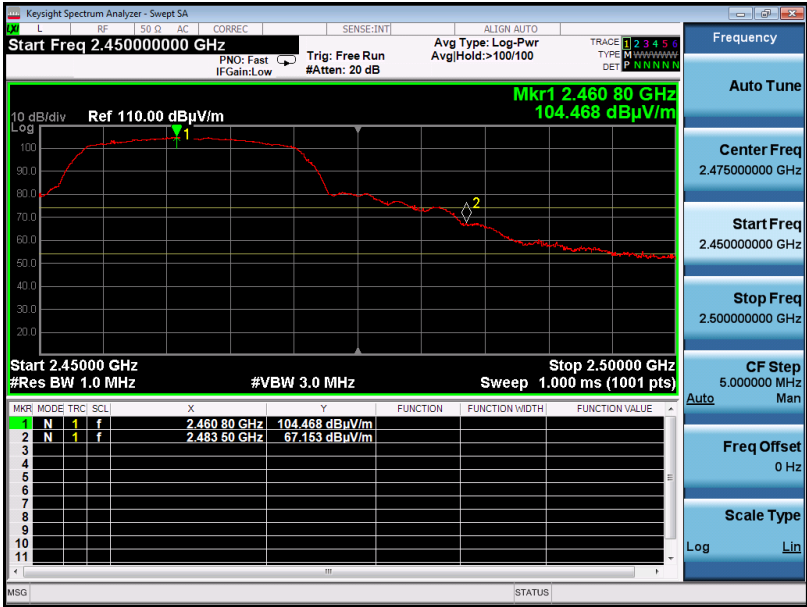
PK

| Test Mode | 802.11n 20 with data rate 6.5 2462MHZ | Antenna | Horizontal |

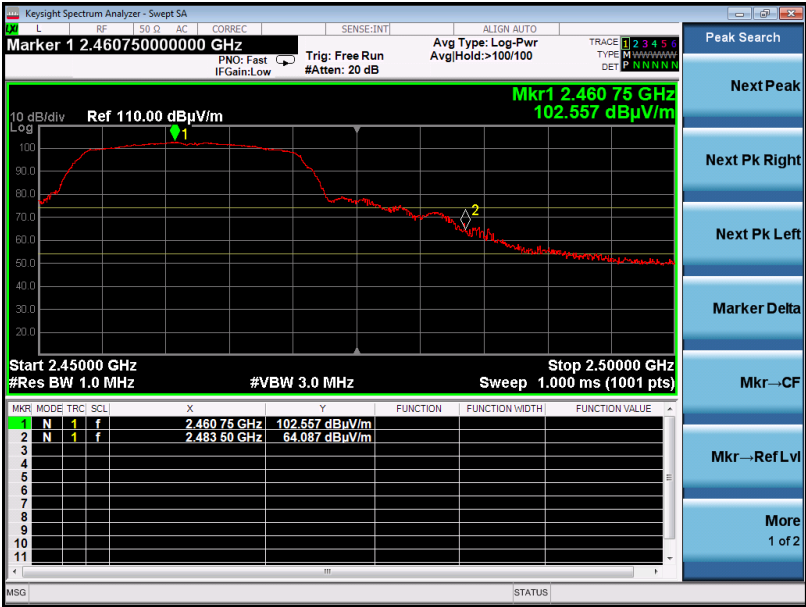
PK

| Test Mode | 802.11n 20 with data rate 6.5 2462MHZ | Antenna | Vertical |

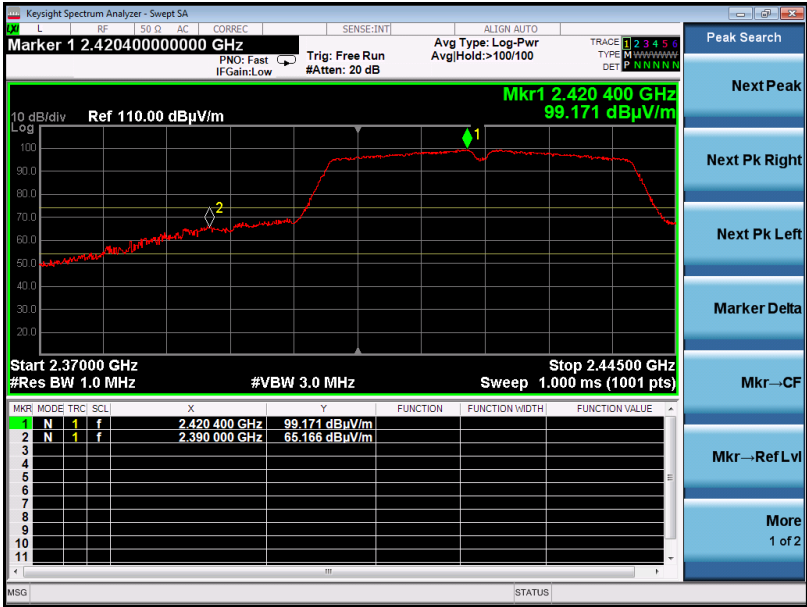
PK

| Test Mode | 802.11n 40 with data rate 13.5 2422MHZ | Antenna | Horizontal |

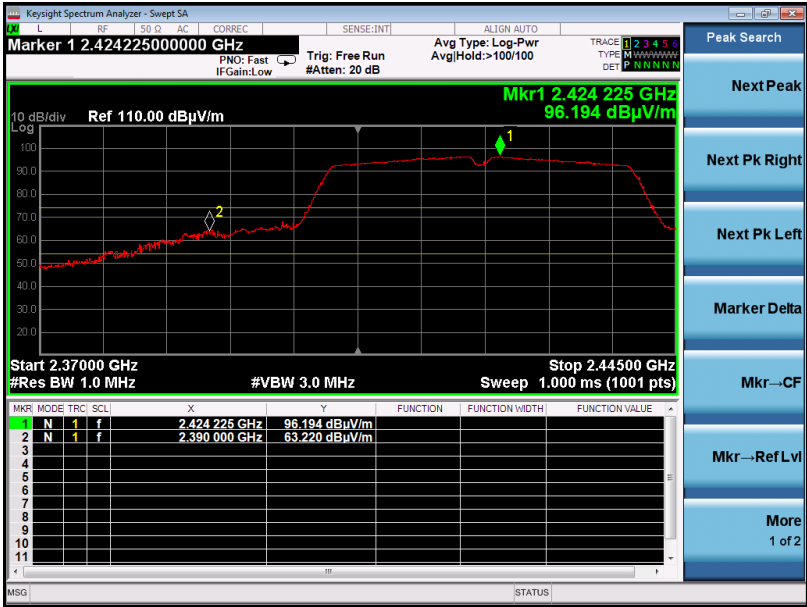
PK

| Test Mode | 802.11n 40 with data rate 13.5 2422MHZ | Antenna | Vertical |

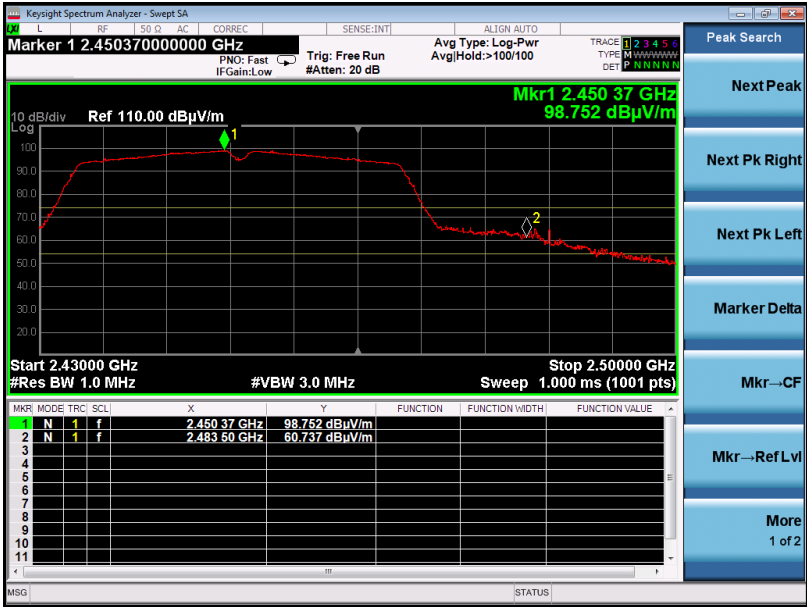
PK

| Test Mode | 802.11n 40with data rate 13.5 2452MHZ | Antenna | Horizontal |

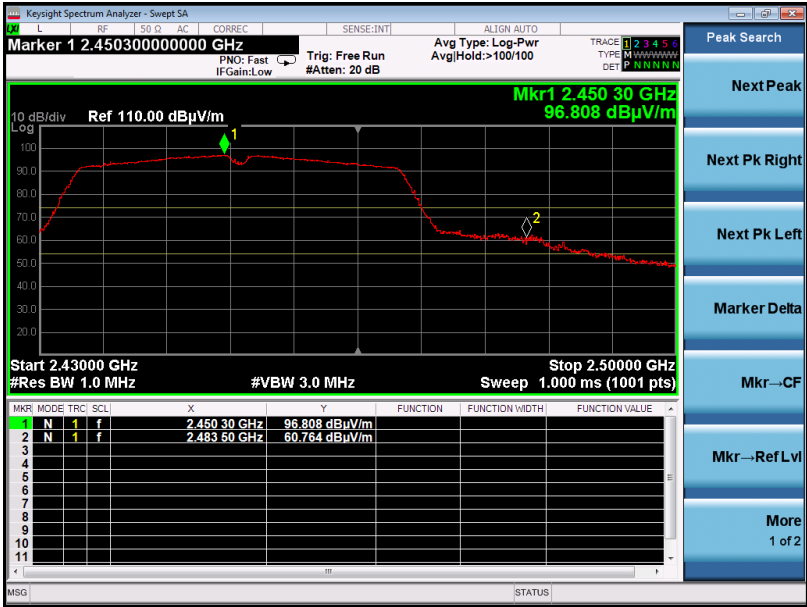
PK

| Test Mode | 802.11n 40 with data rate 13.5 2452MHZ | Antenna | Vertical |

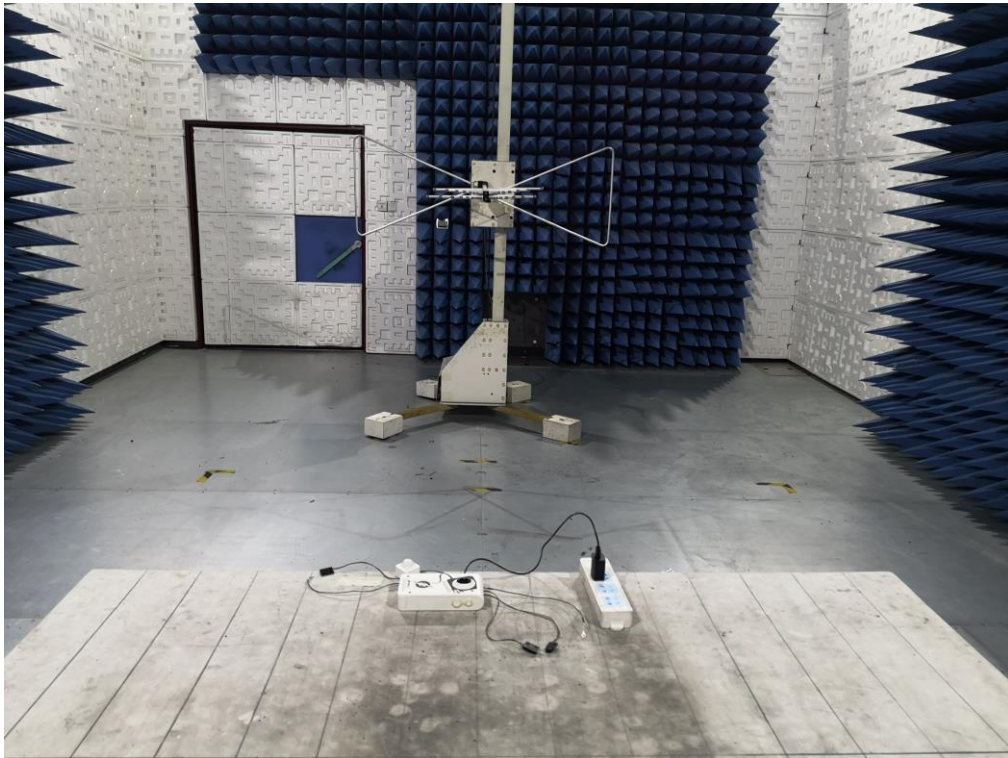
FCC RADIATED EMISSION TEST SETUP BELOW 1GHZ

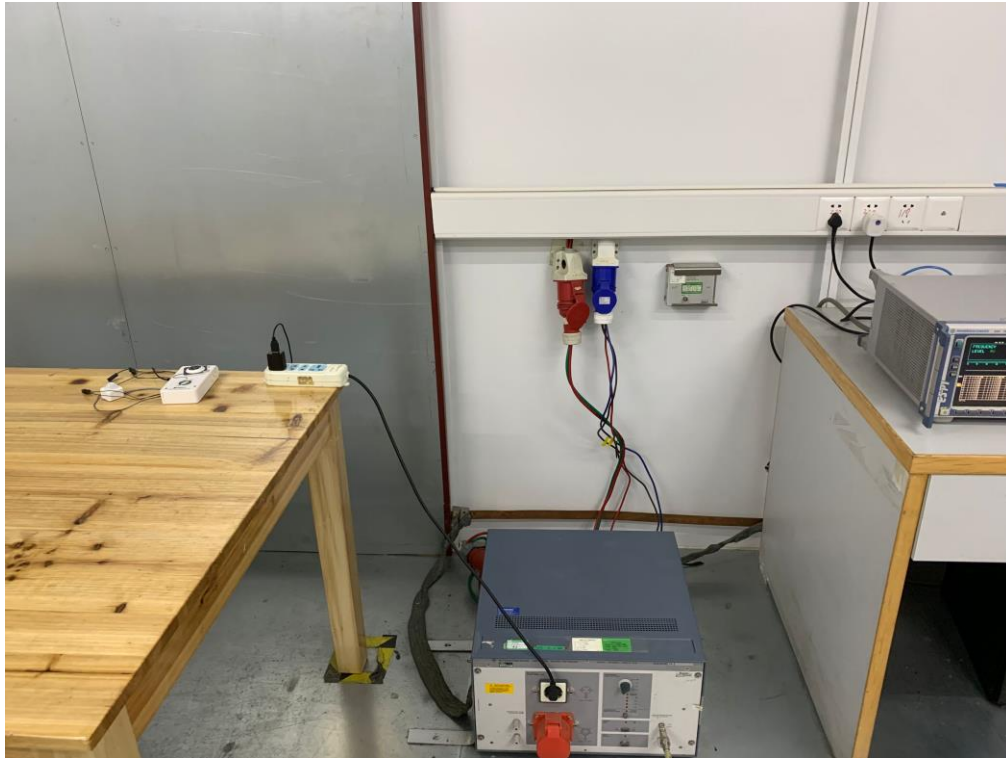
FCC CONDUCTED EMISSION TEST SETUP
