# Photo Report on Healy

**Report Reference:** MDE\_WQS\_1901\_FCC\_Photo\_Setups

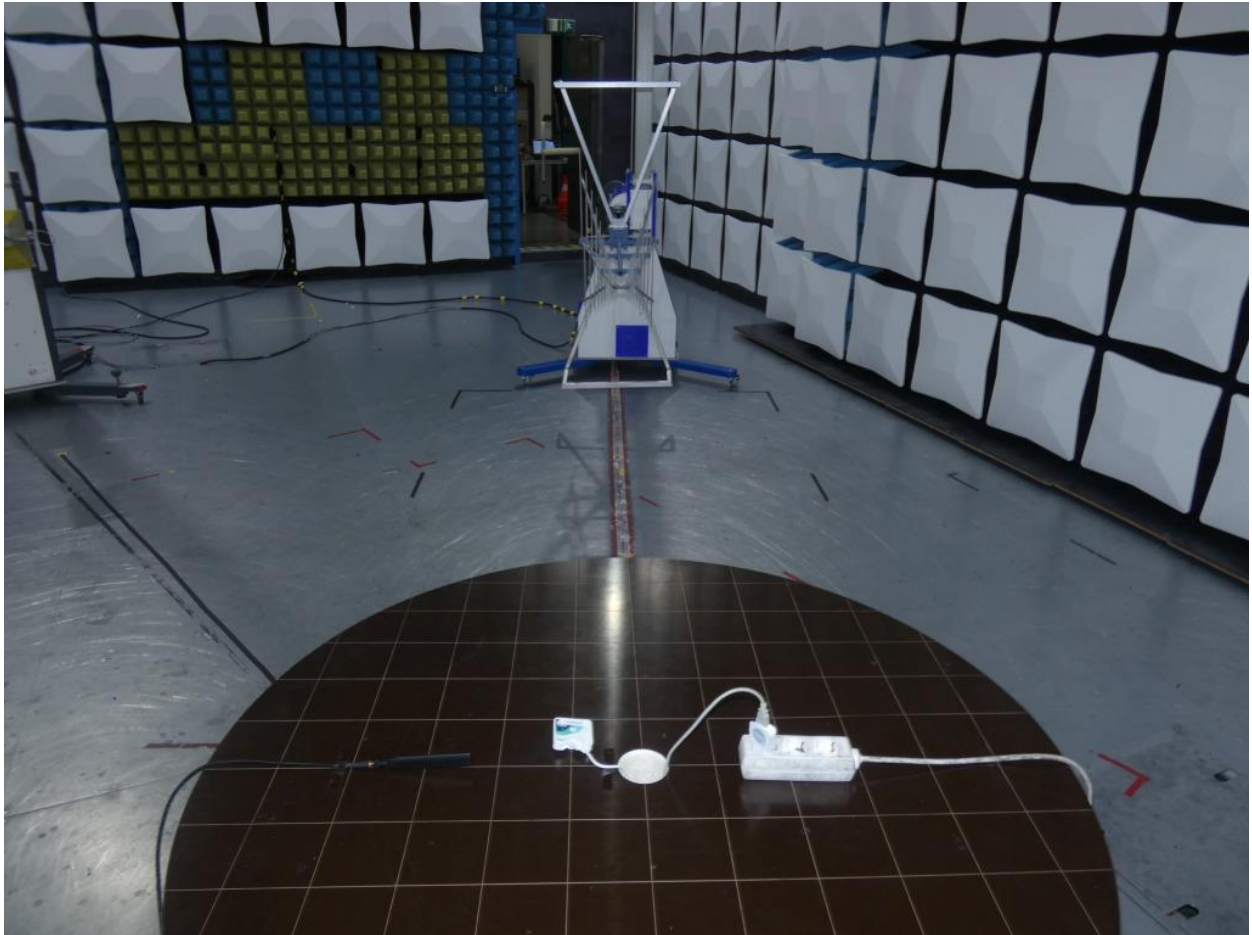
**Photo 1:** Test setup for radiated measurements (stand alone , semi-anechoic chamber 30 MHz – 1 GHz; unintentional radiator §15.109, ANSI C63.4)

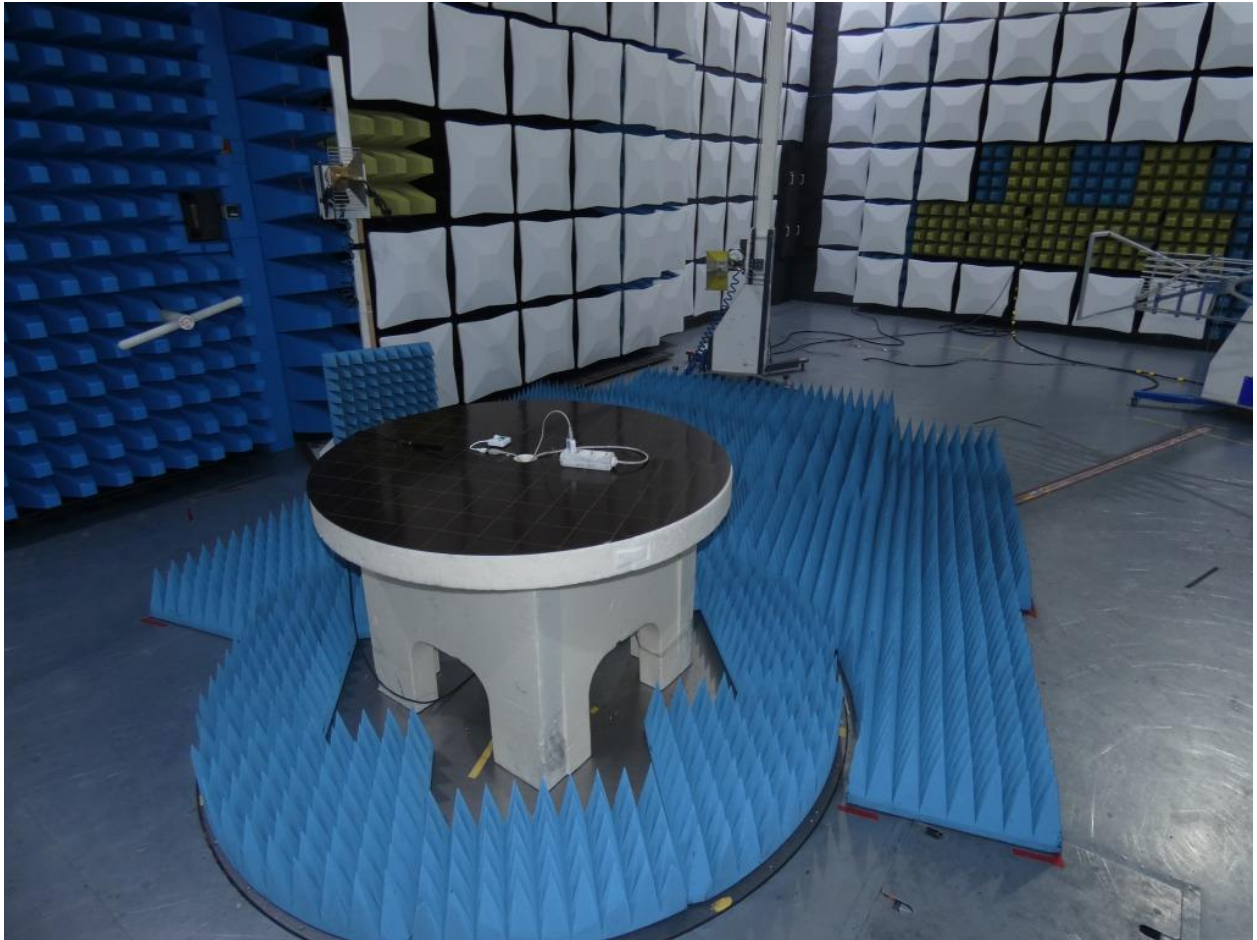
**Photo 2:** Test setup for radiated measurements (stand alone setup, semi-anechoic chamber above 1 GHz ; unintentional radiator §15.109, ANSI C63.4)

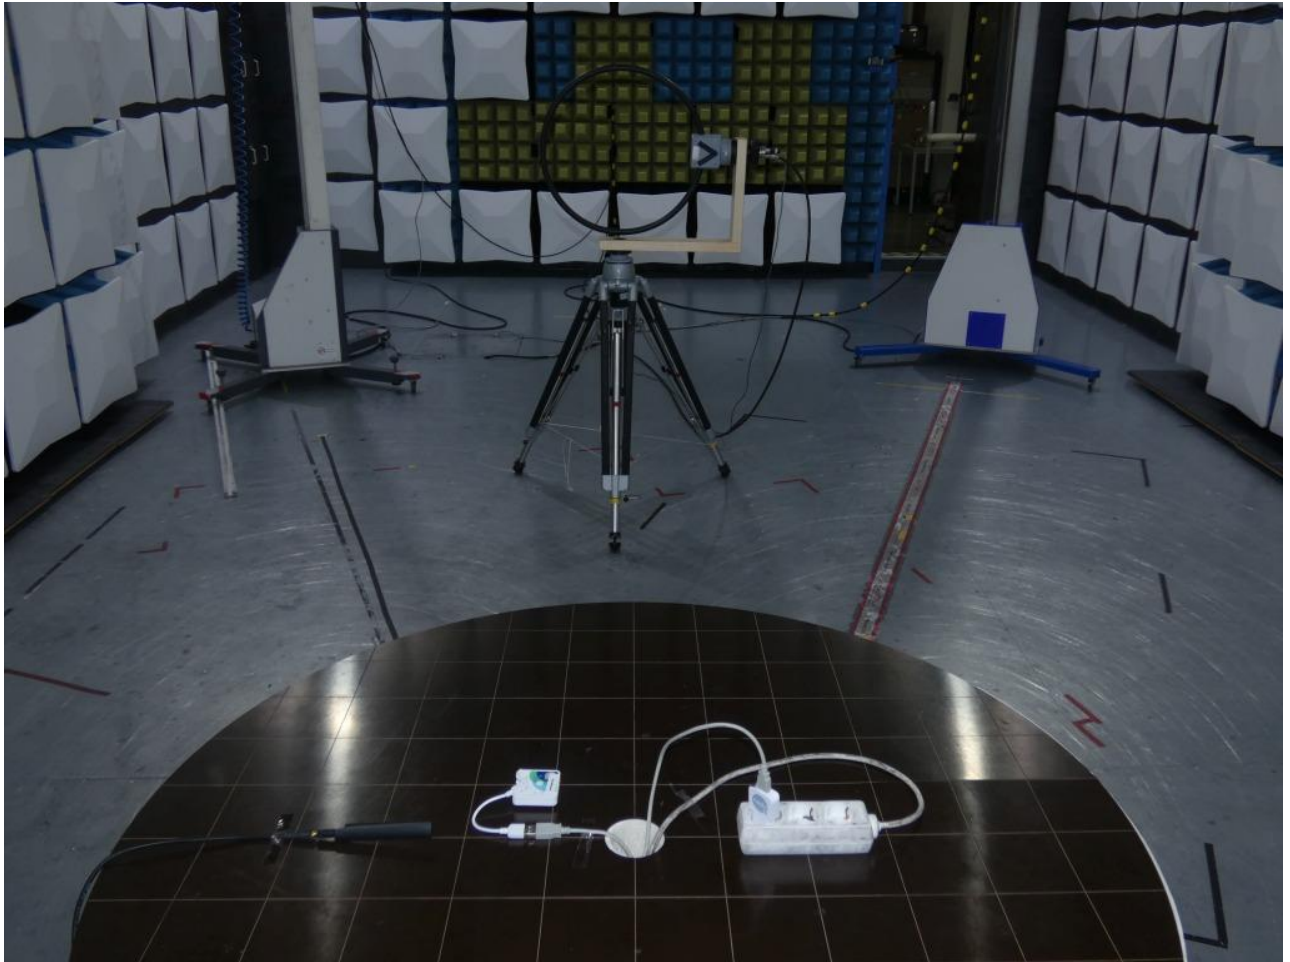
**Photo 3:** Test setup for radiated measurements (stand alone setup, 9 kHz - 30 MHz; FCC 15c247)

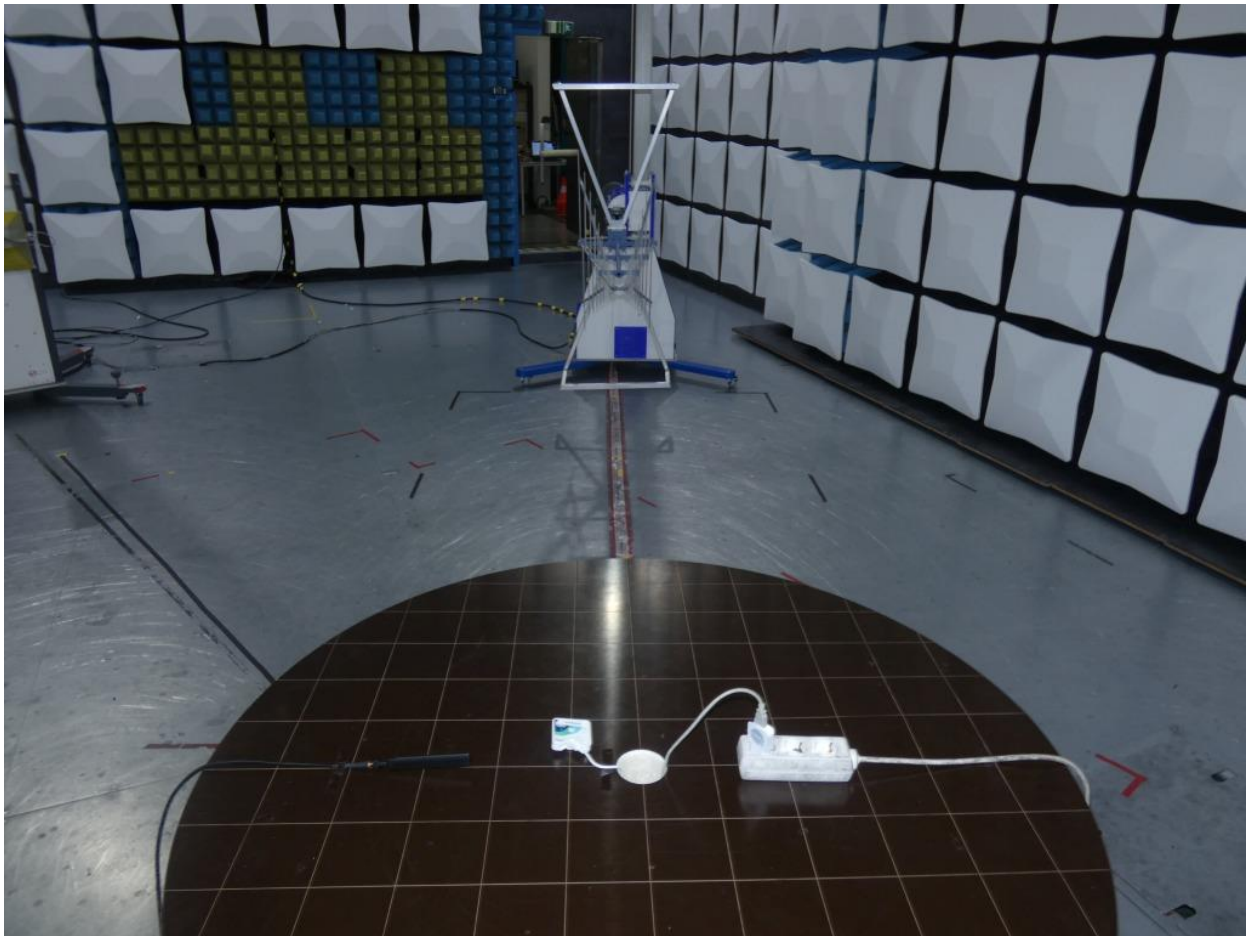
**Photo 4:** Test setup for radiated measurements (stand alone setup, 30 MHz - 1 GHz; FCC 15c247)

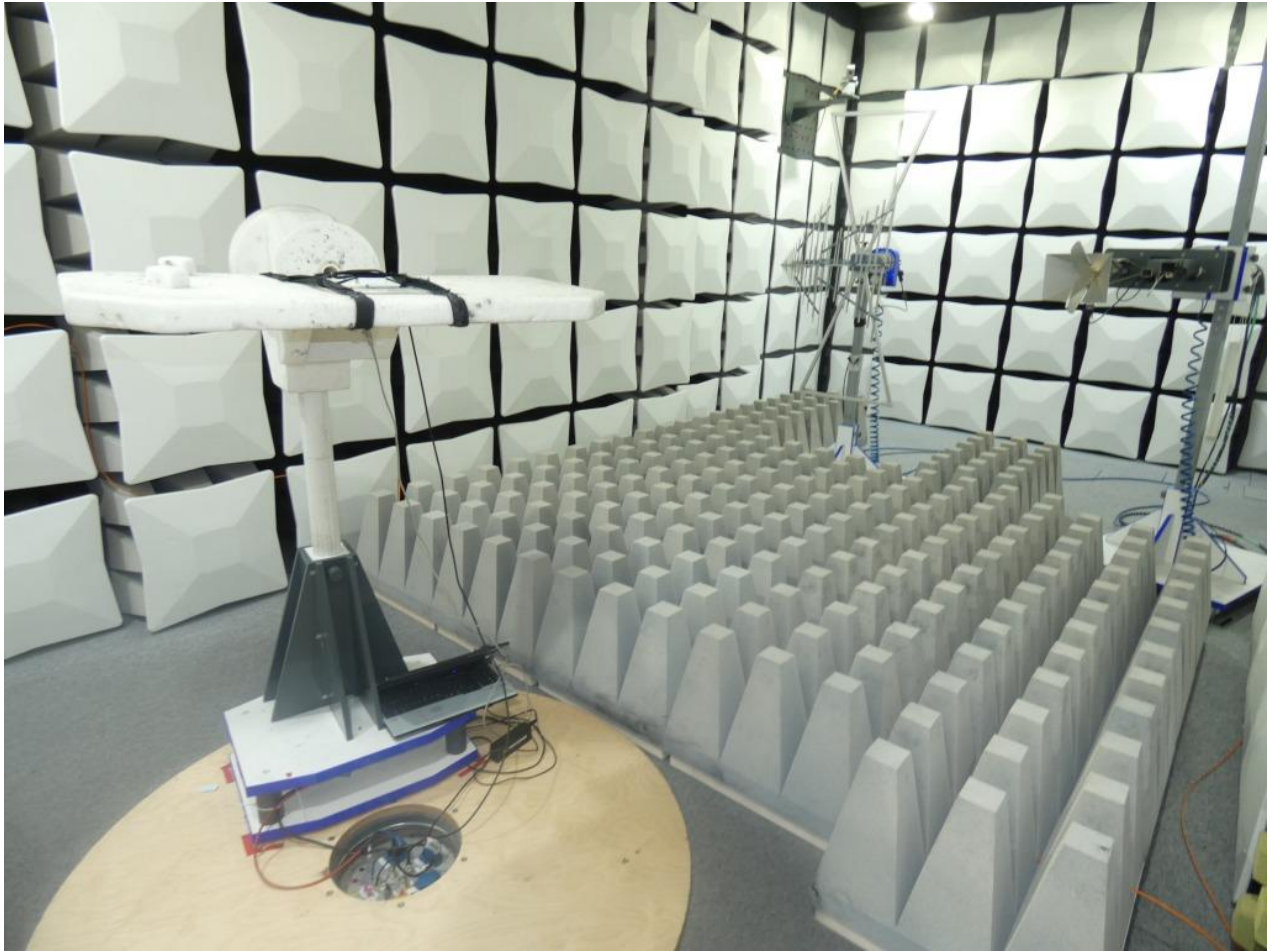
**Photo 5:** Test setup for radiated measurements (stand alone setup, 1 GHz – 24 GHz; FCC 15c247)

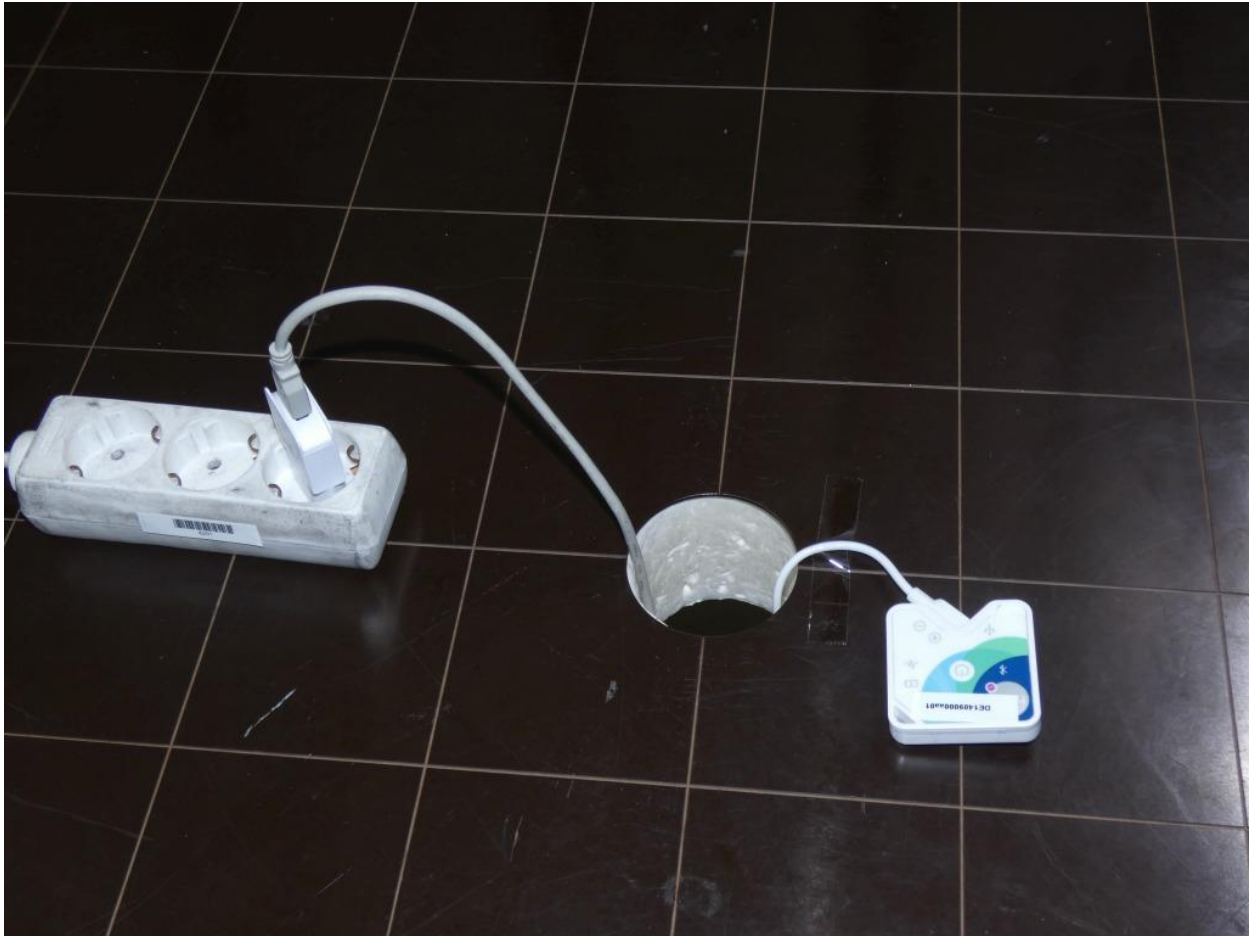
**Photo 6:** detailed view of EUT
