### **APPENDIX 3: Photographs of test setup**

#### **Radiated Emission**

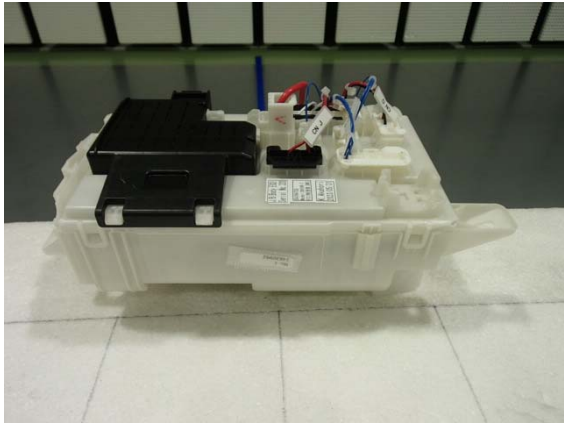
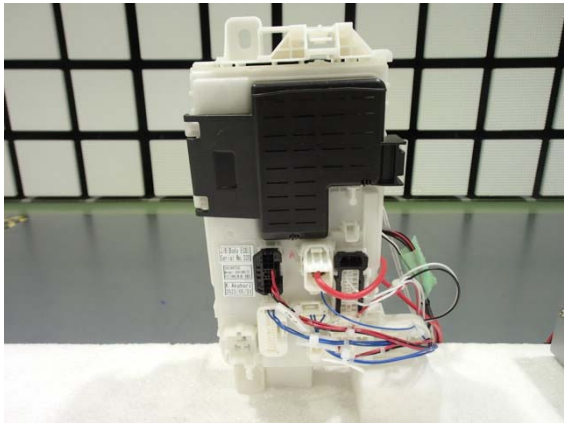
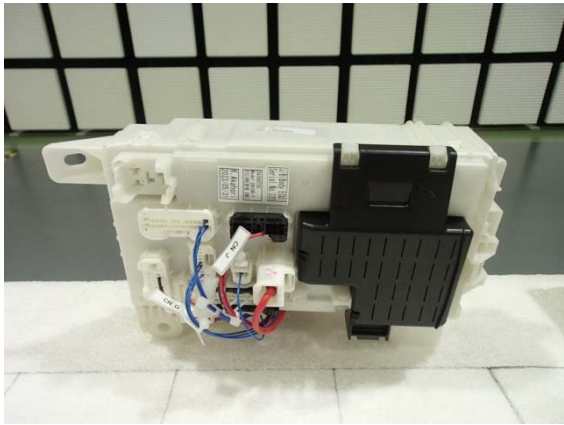
**ECU**  
Below 30 MHz  
X-axis  
Above 30 MHz  
Horizontal: X-axis / Vertical: X-axis

**X-axis**

**Y-axis**

**Z-axis**

**Worst Case Position**

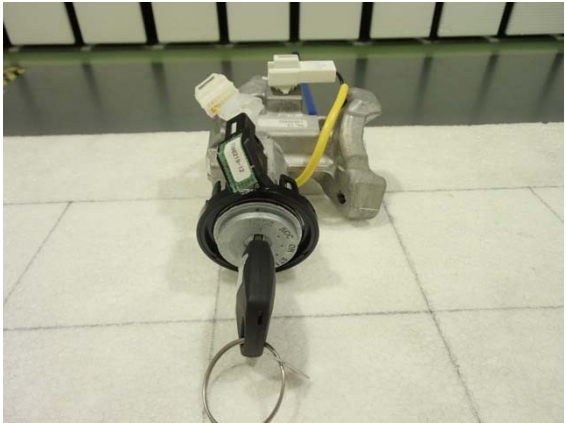
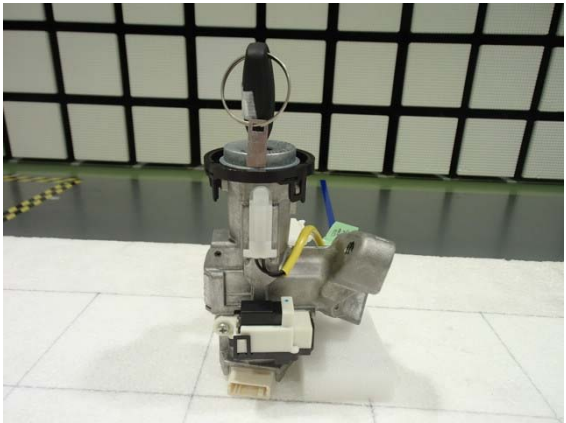
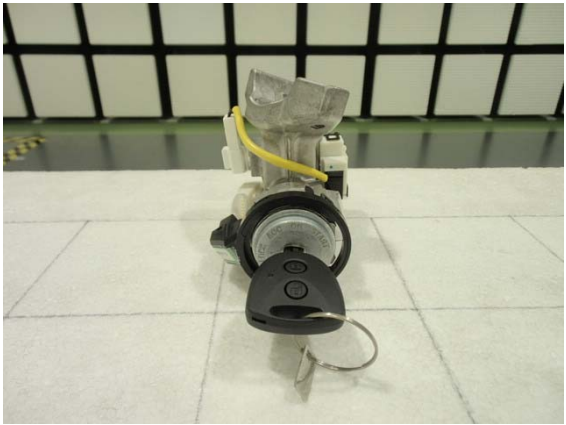
**ANT**  
Below 30 MHz  
X-axis  
Above 30 MHz  
Horizontal: X-axis / Vertical: X-axis

**X-axis**

**Y-axis**

**Z-axis**

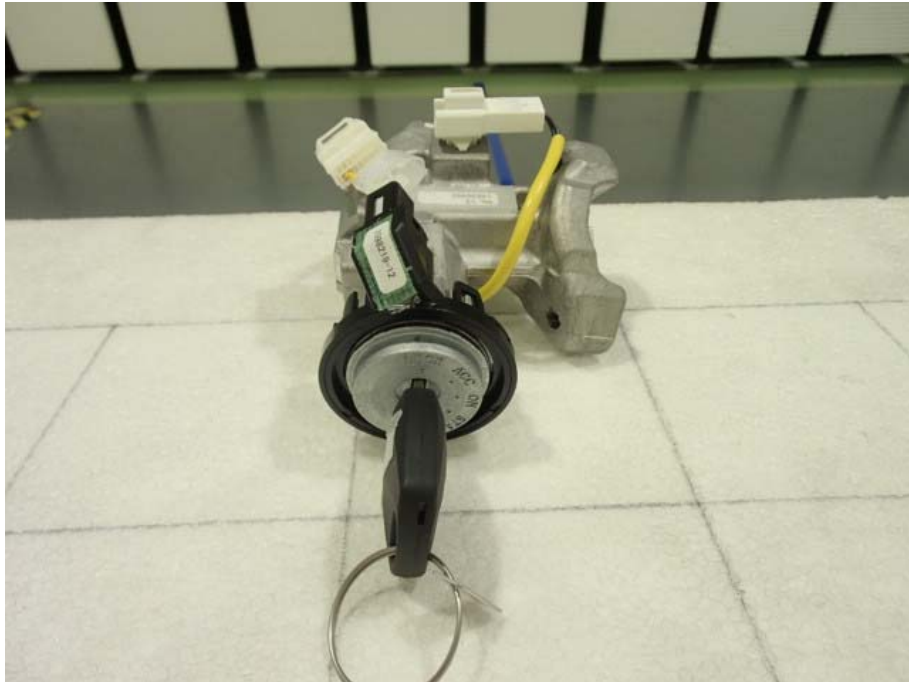
**Worst case position**

With transponder key inserted (Worst)

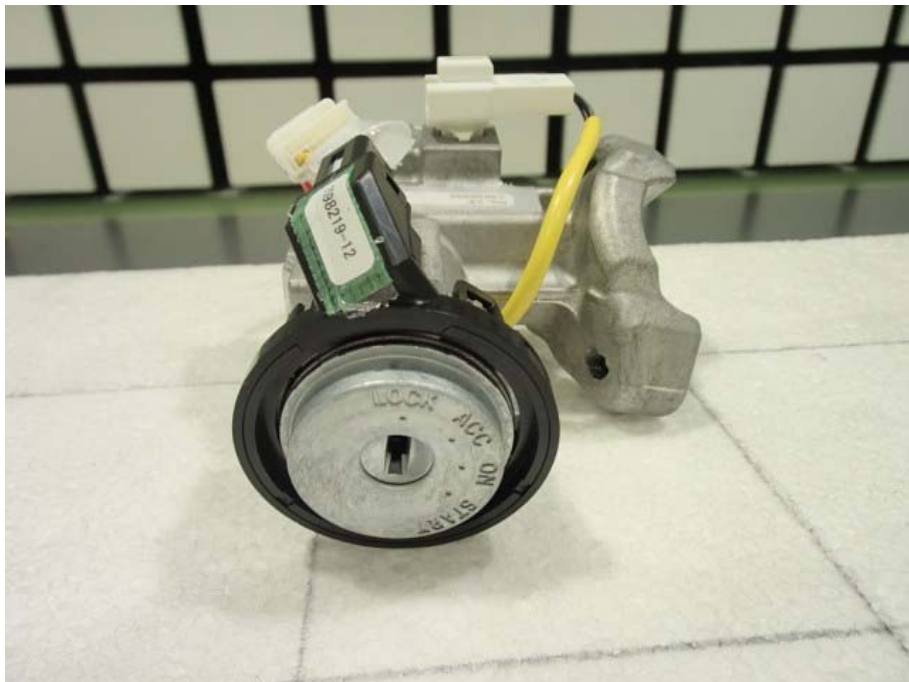
Without transponder key inserted
