## Appendix B: photographs of test setup

Reference to the test report no. BLA-EMC-202508-A2601

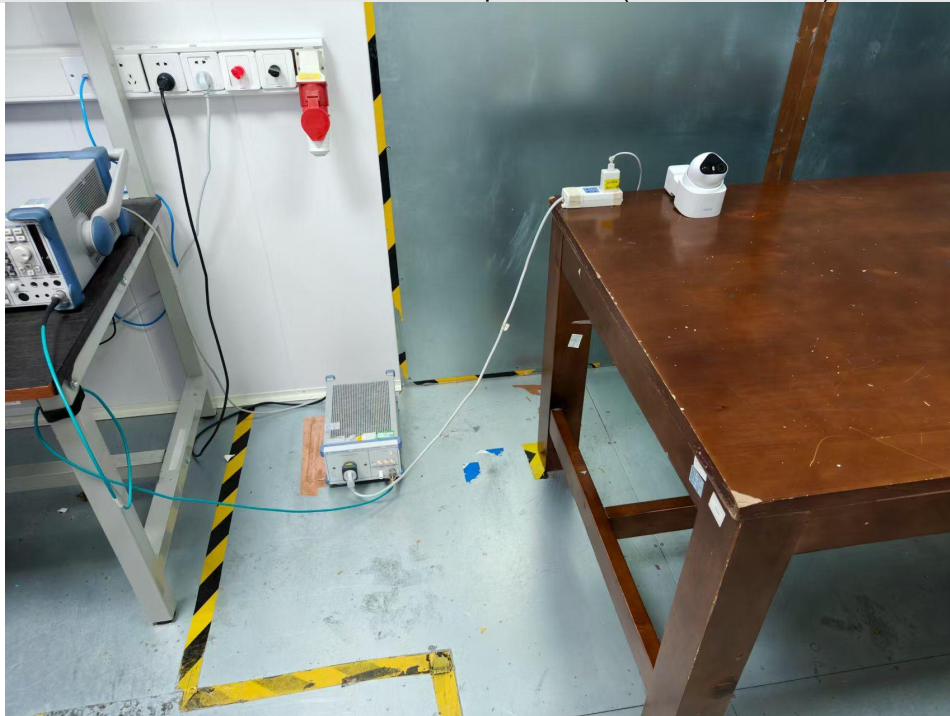
### Conducted emissions at AC power line (150kHz-30MHz)

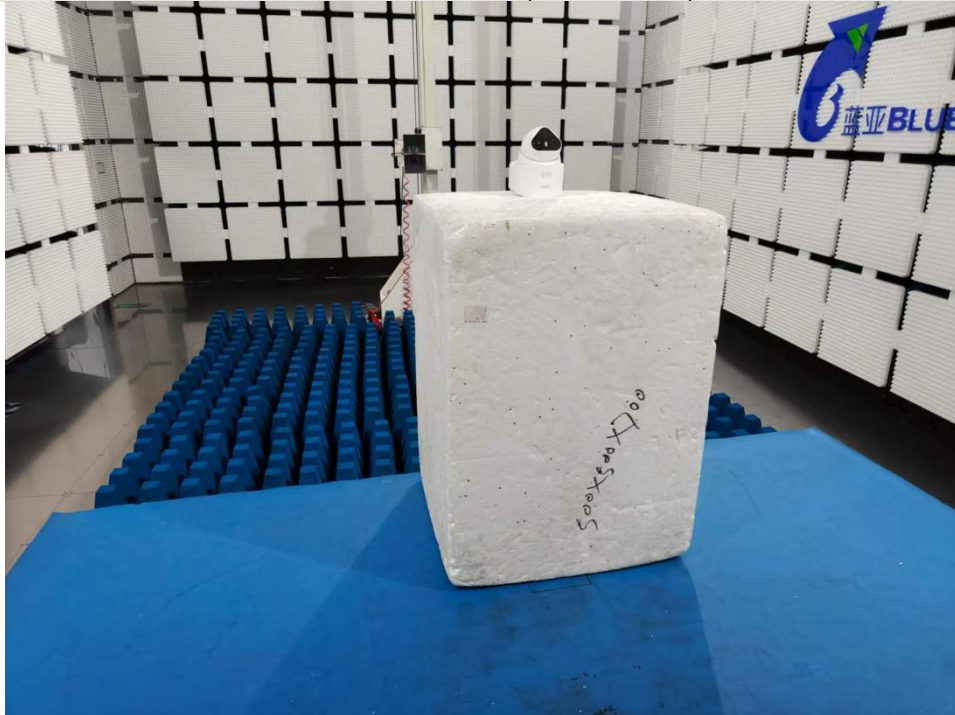
Radiated Emissions (above 1GHz)
