# Appendix F: Reference level measurement Test Result

## Appendix G: Band edge measurements

## Appendix H: Conducted Spurious Emission Test Result

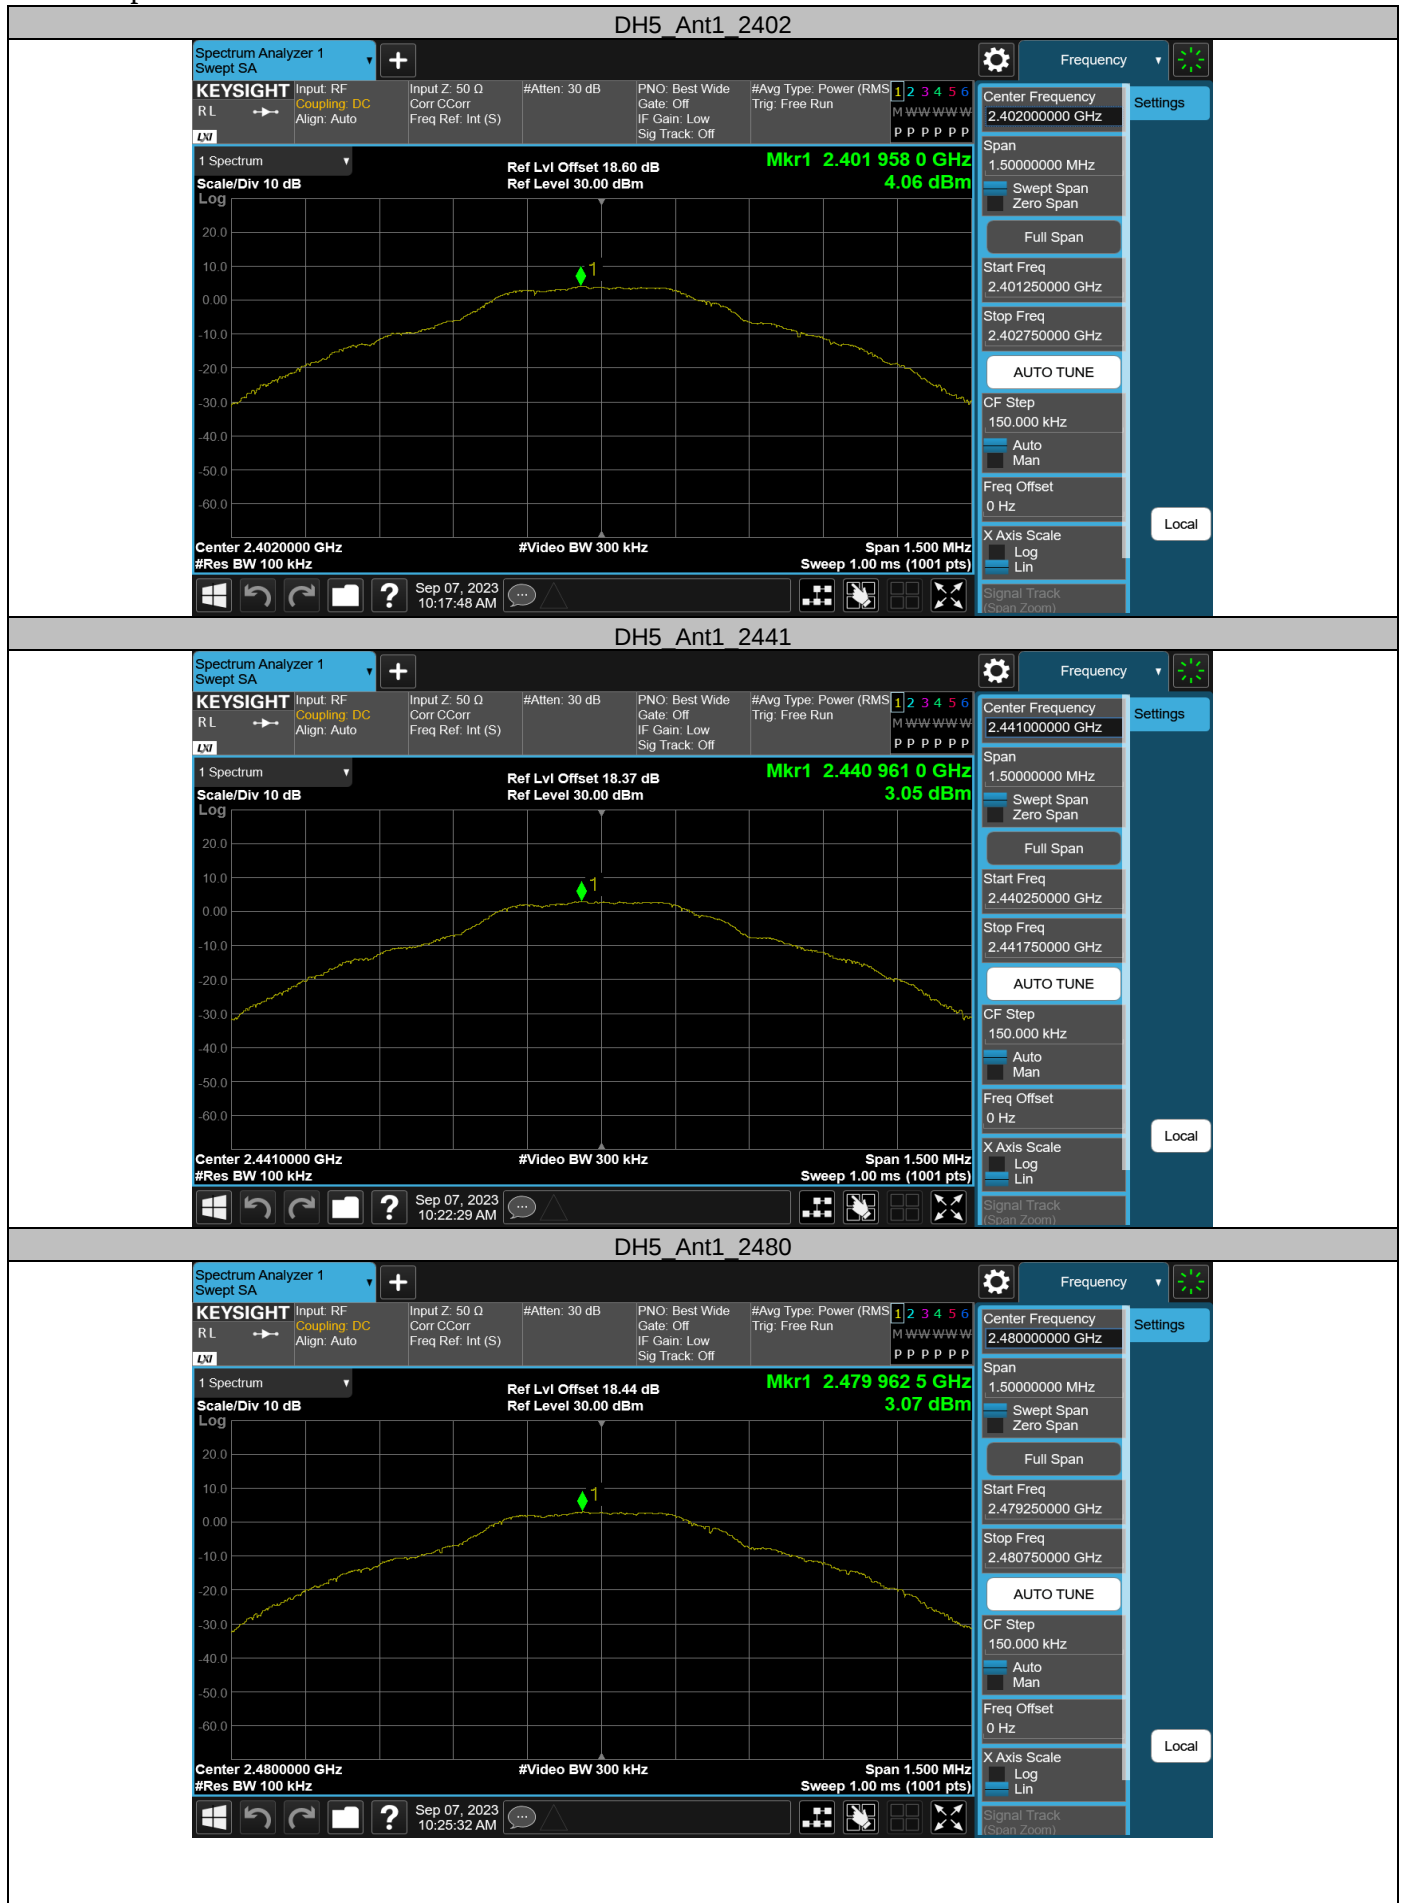
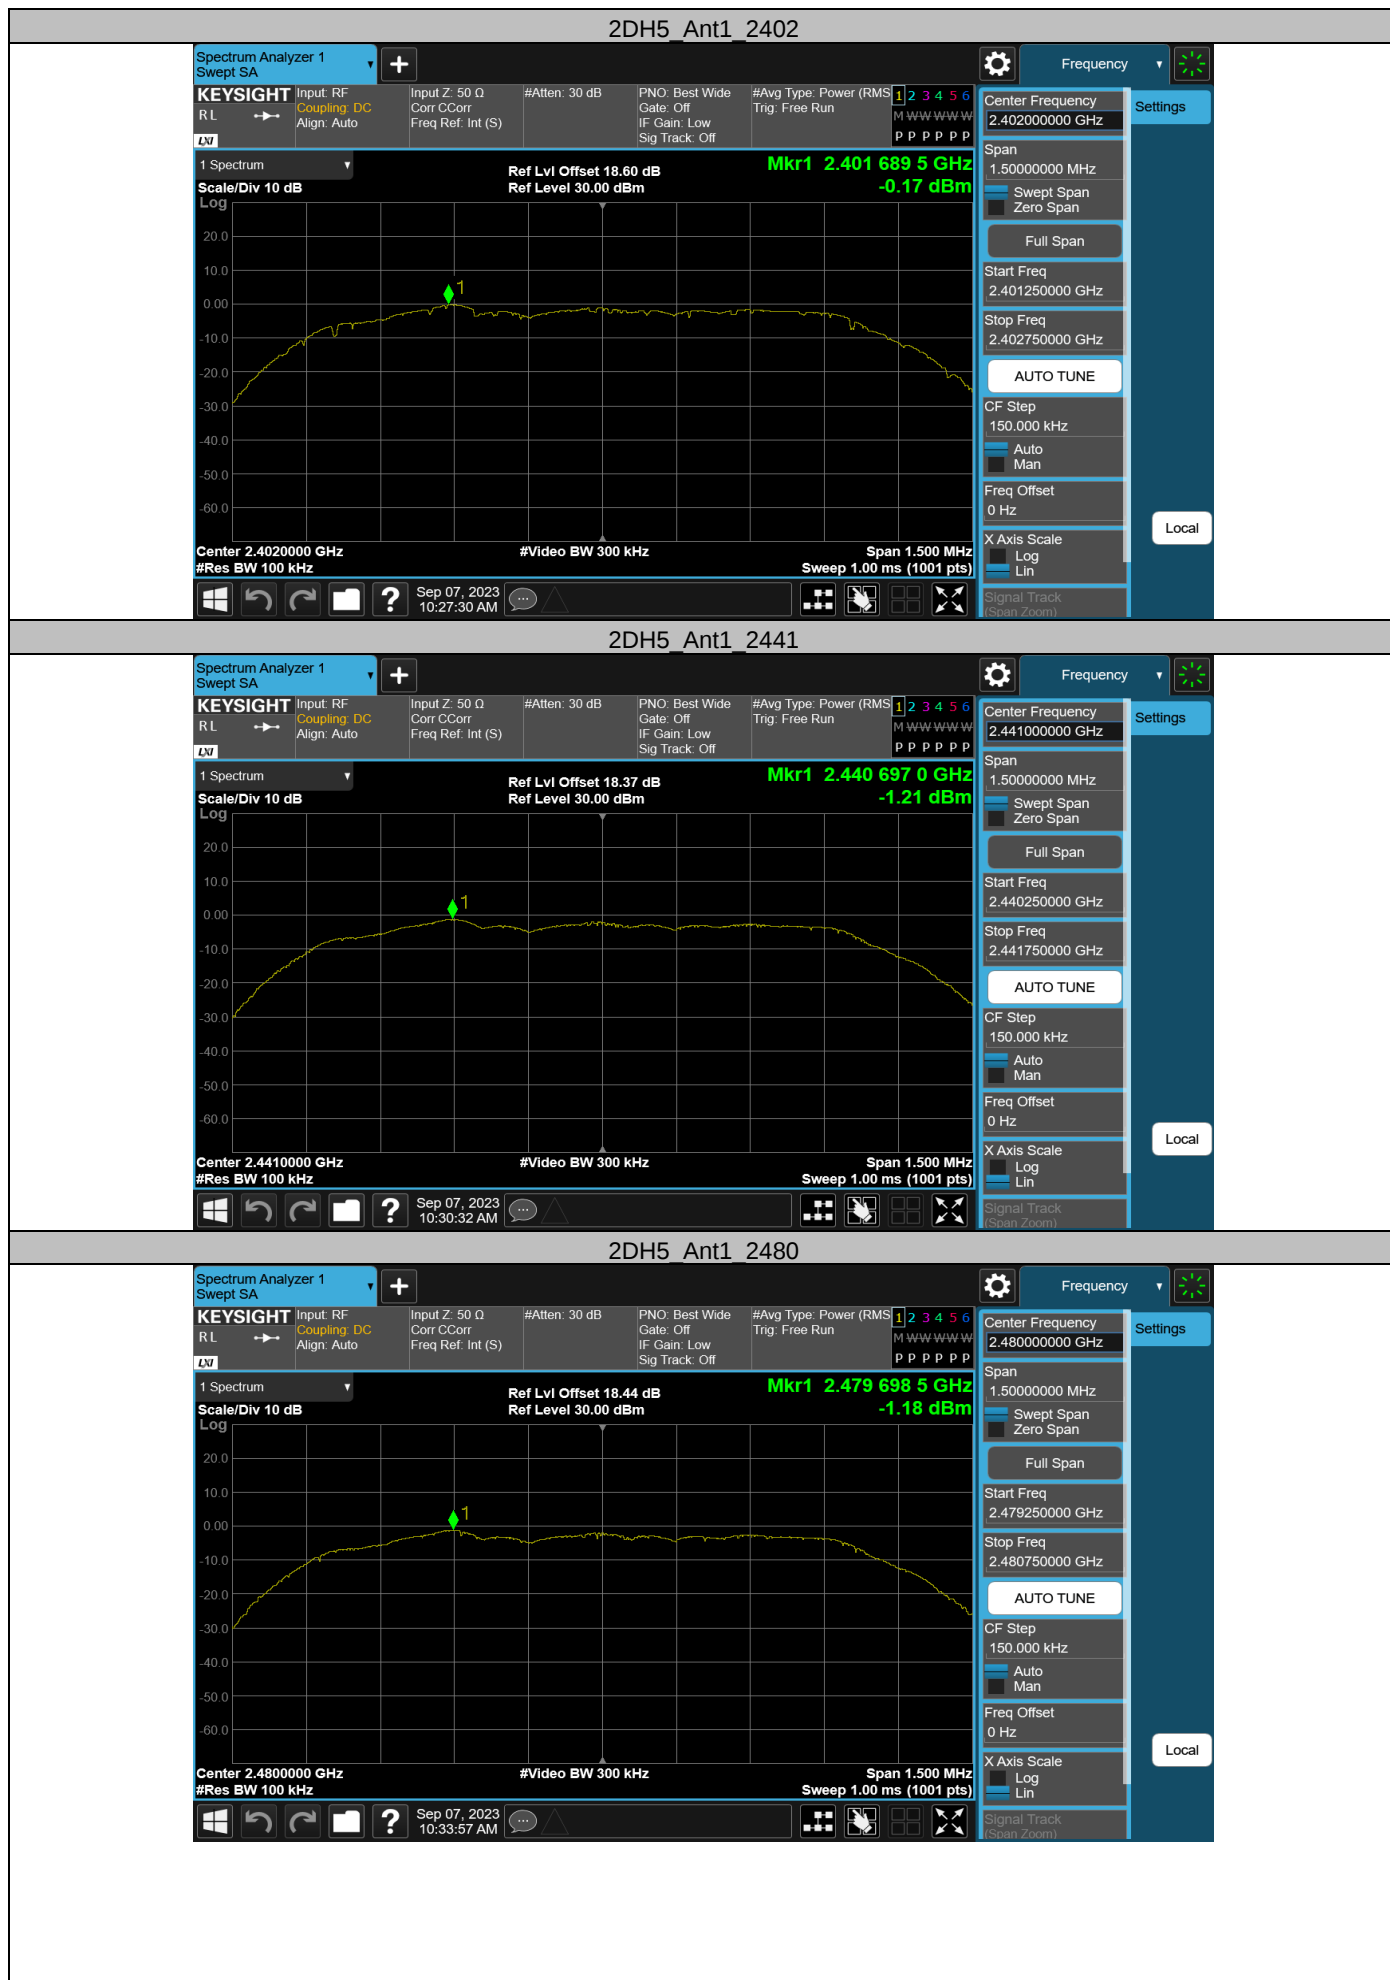
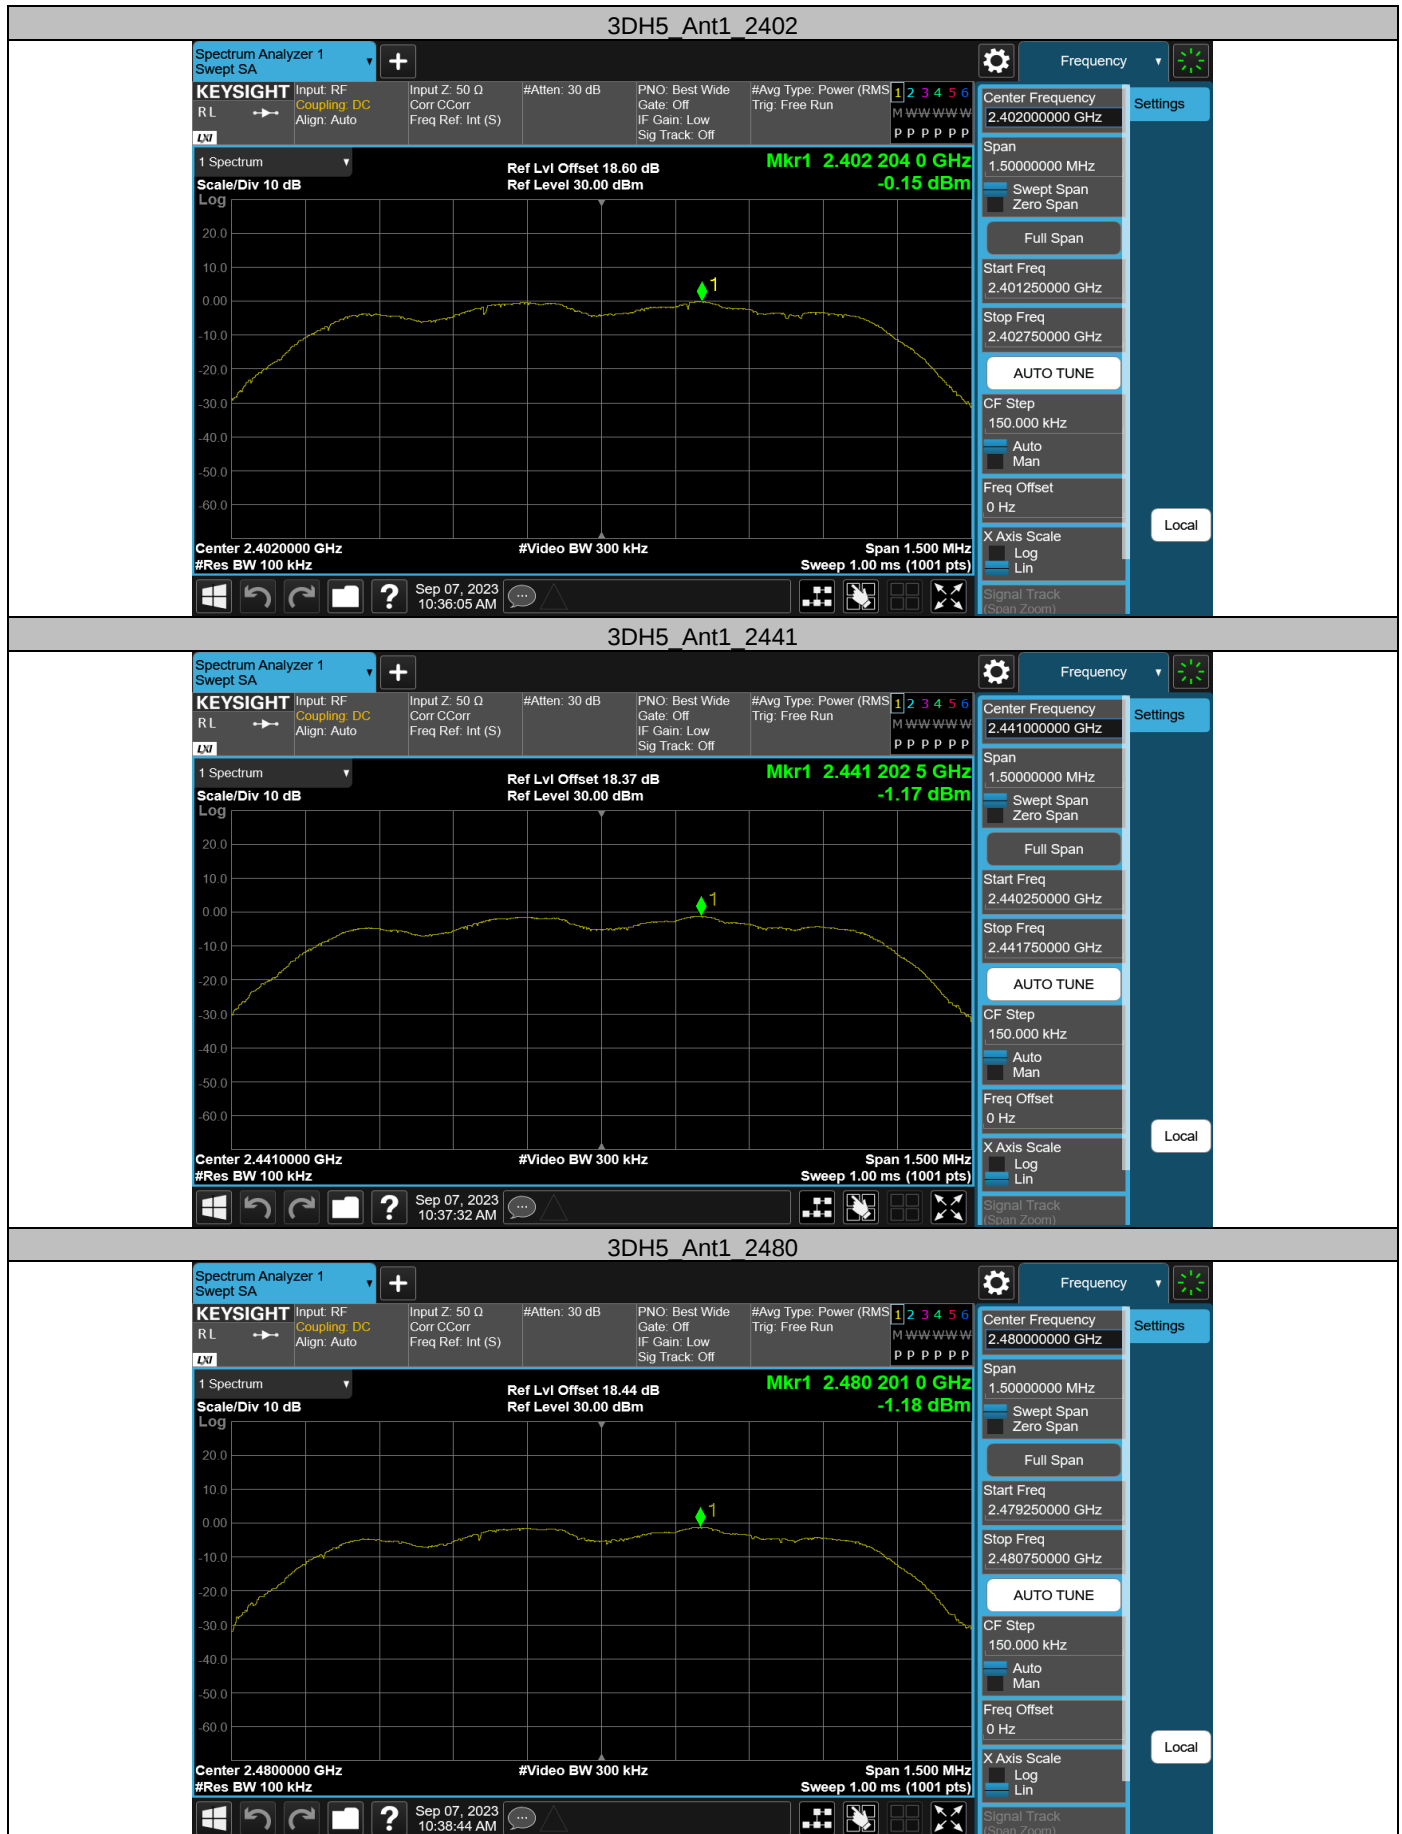
## Test Graphs

| Test Mode | Antenna | Freq(MHz) | Max.Point[MHz] | Result[dBm] |

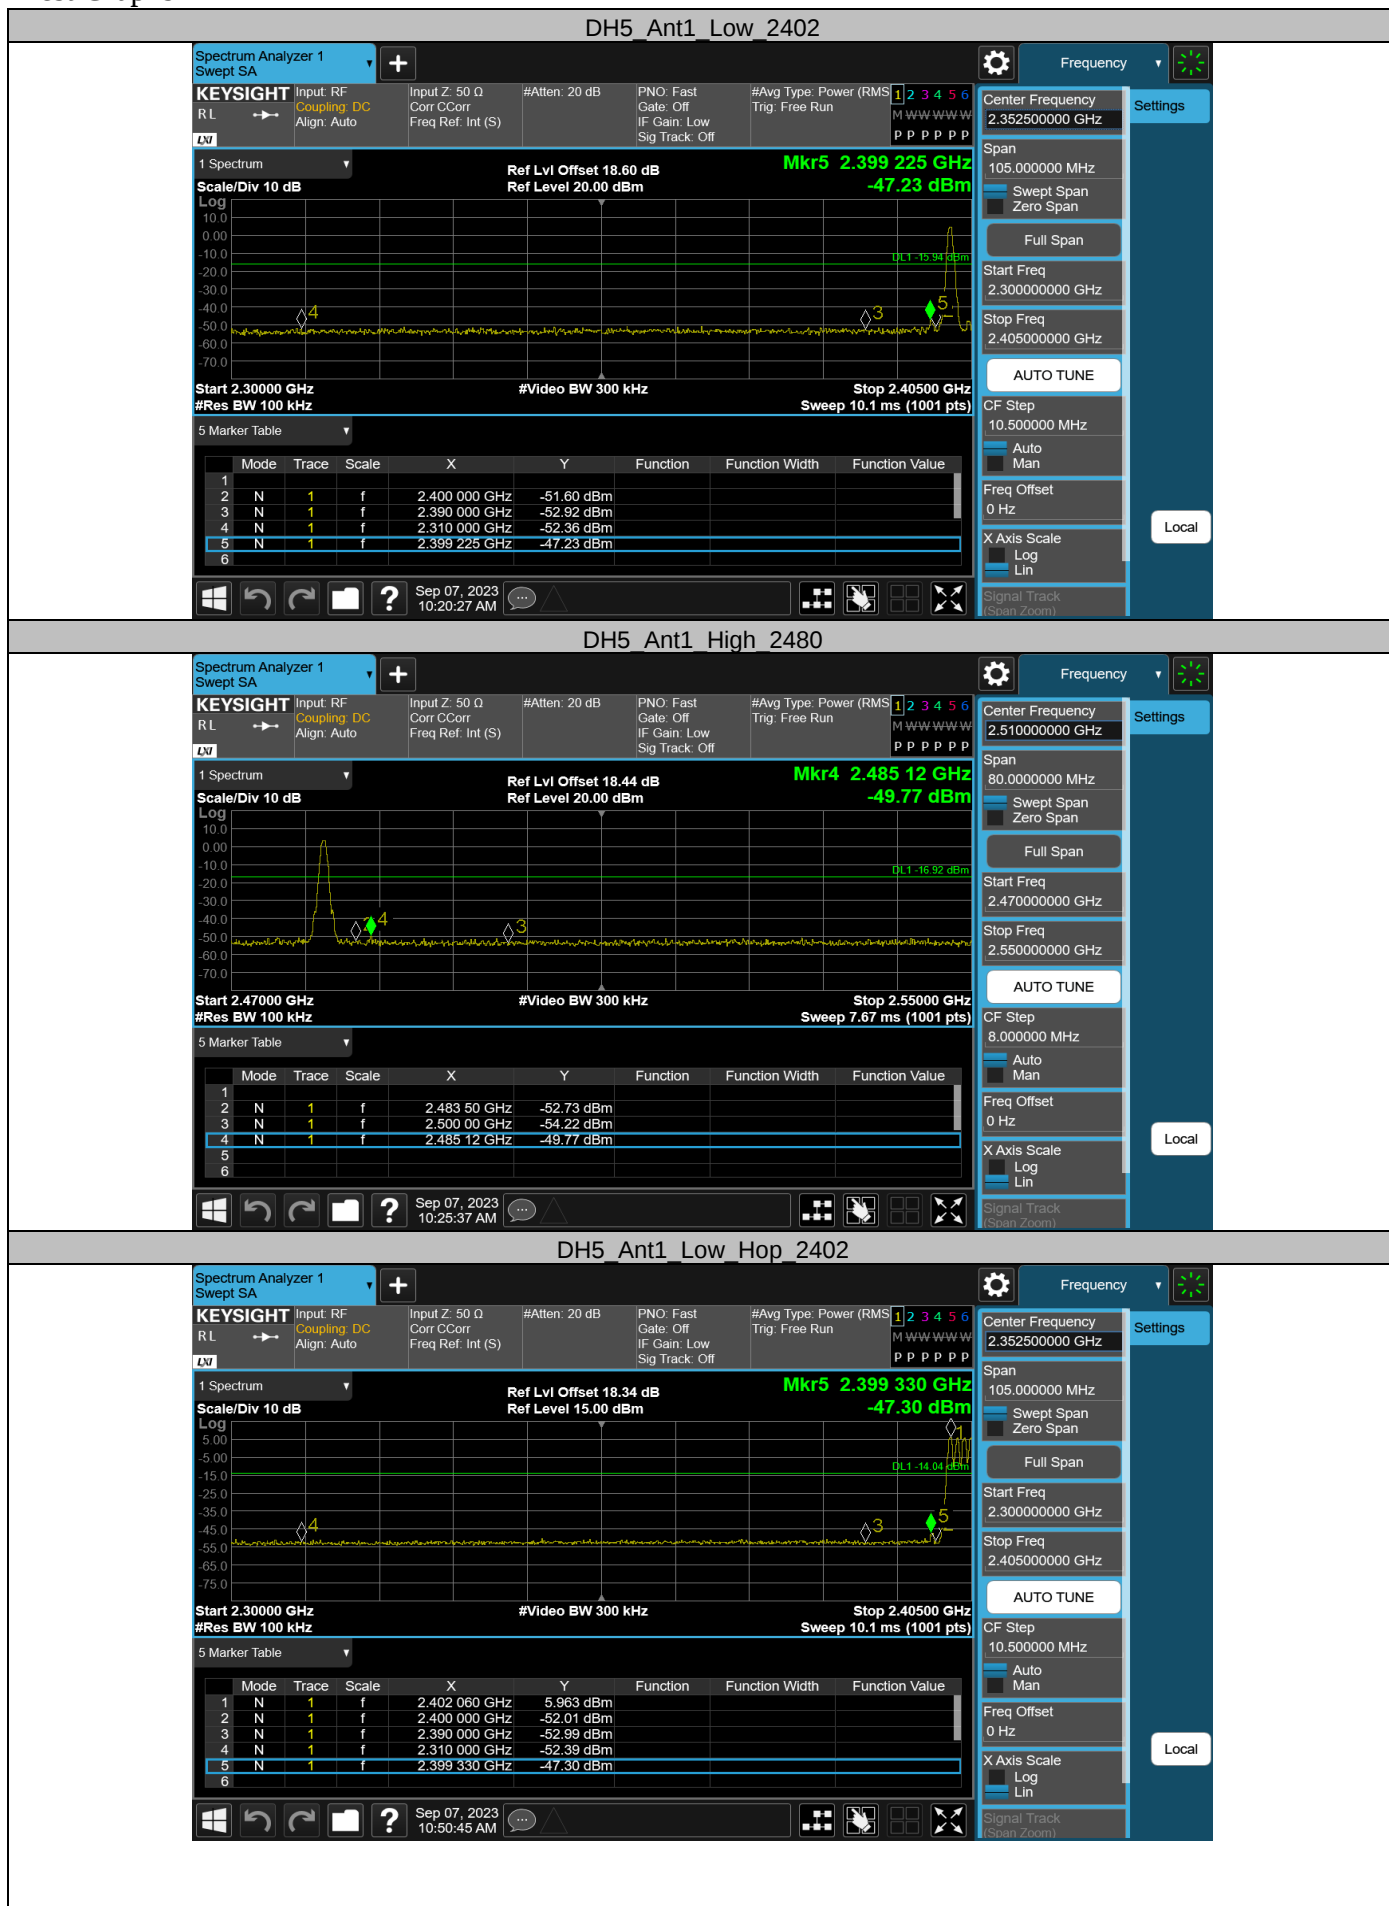
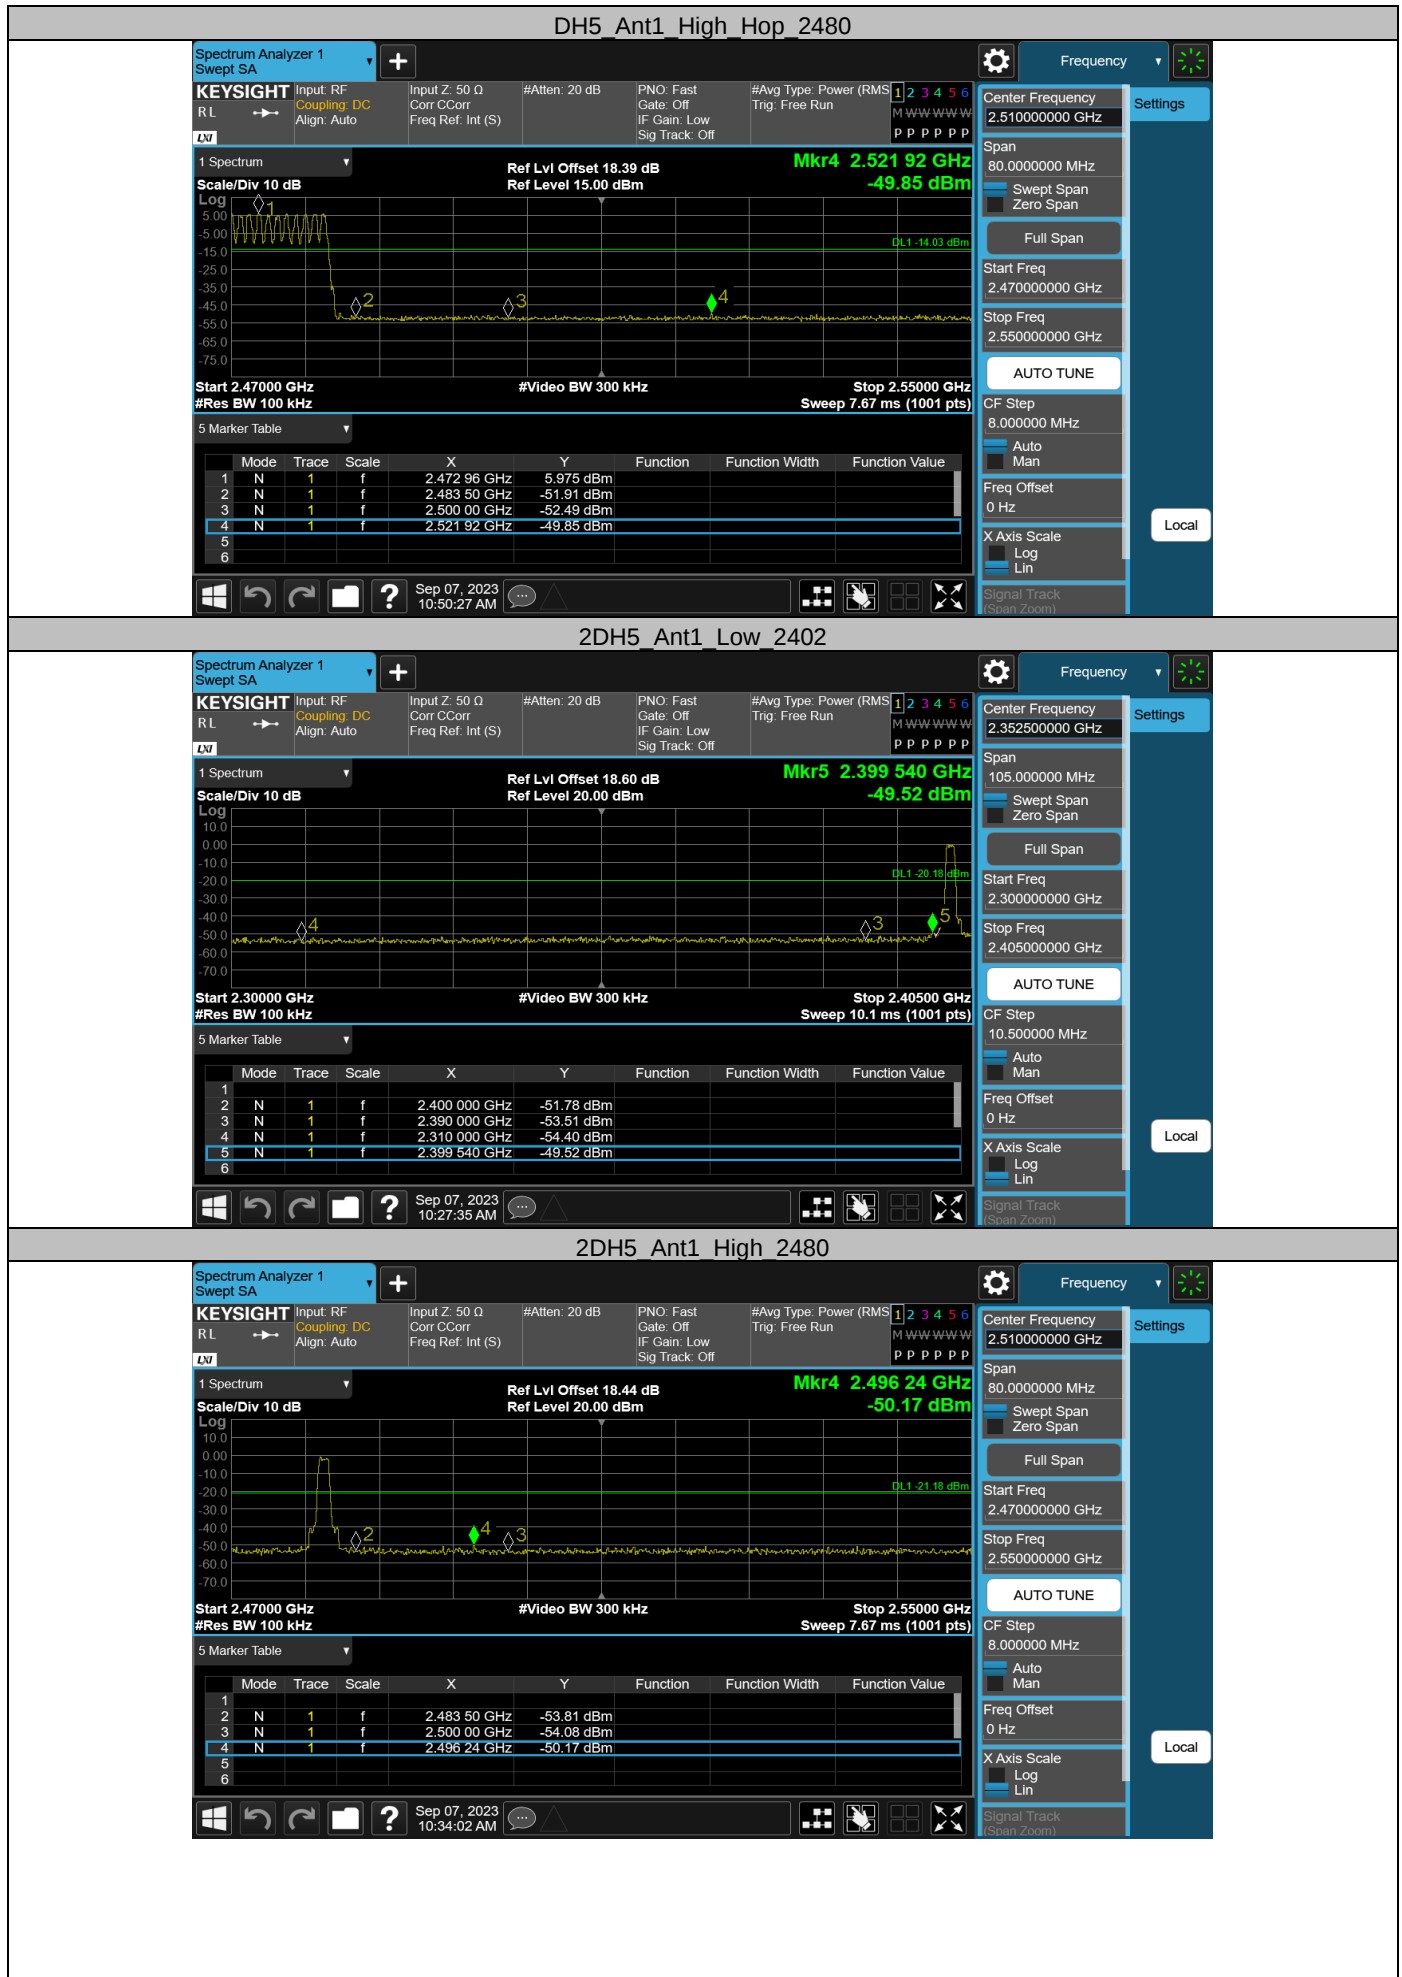
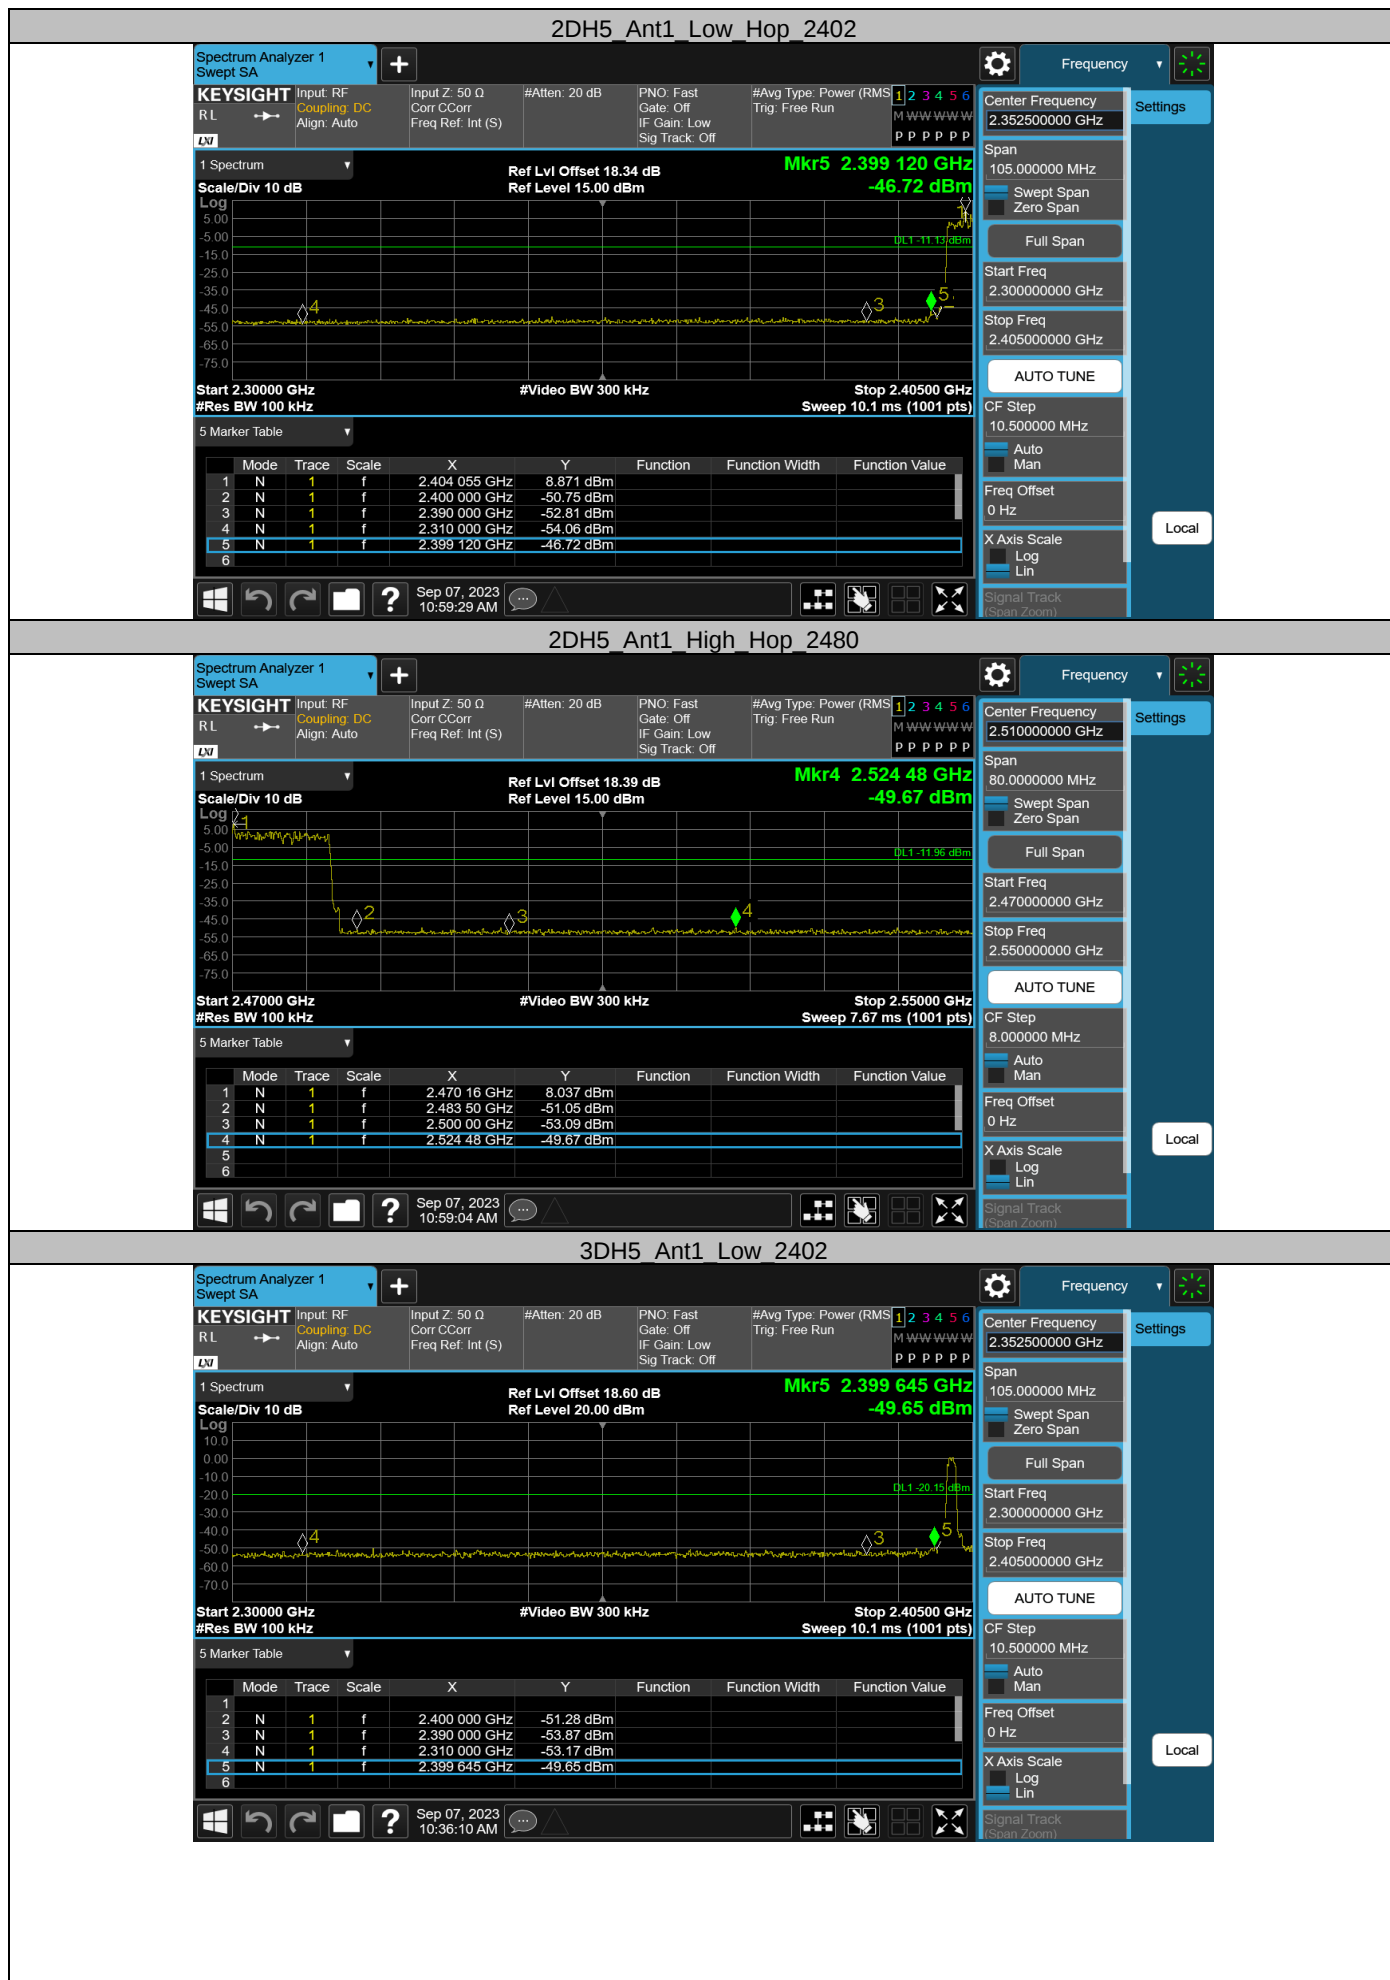
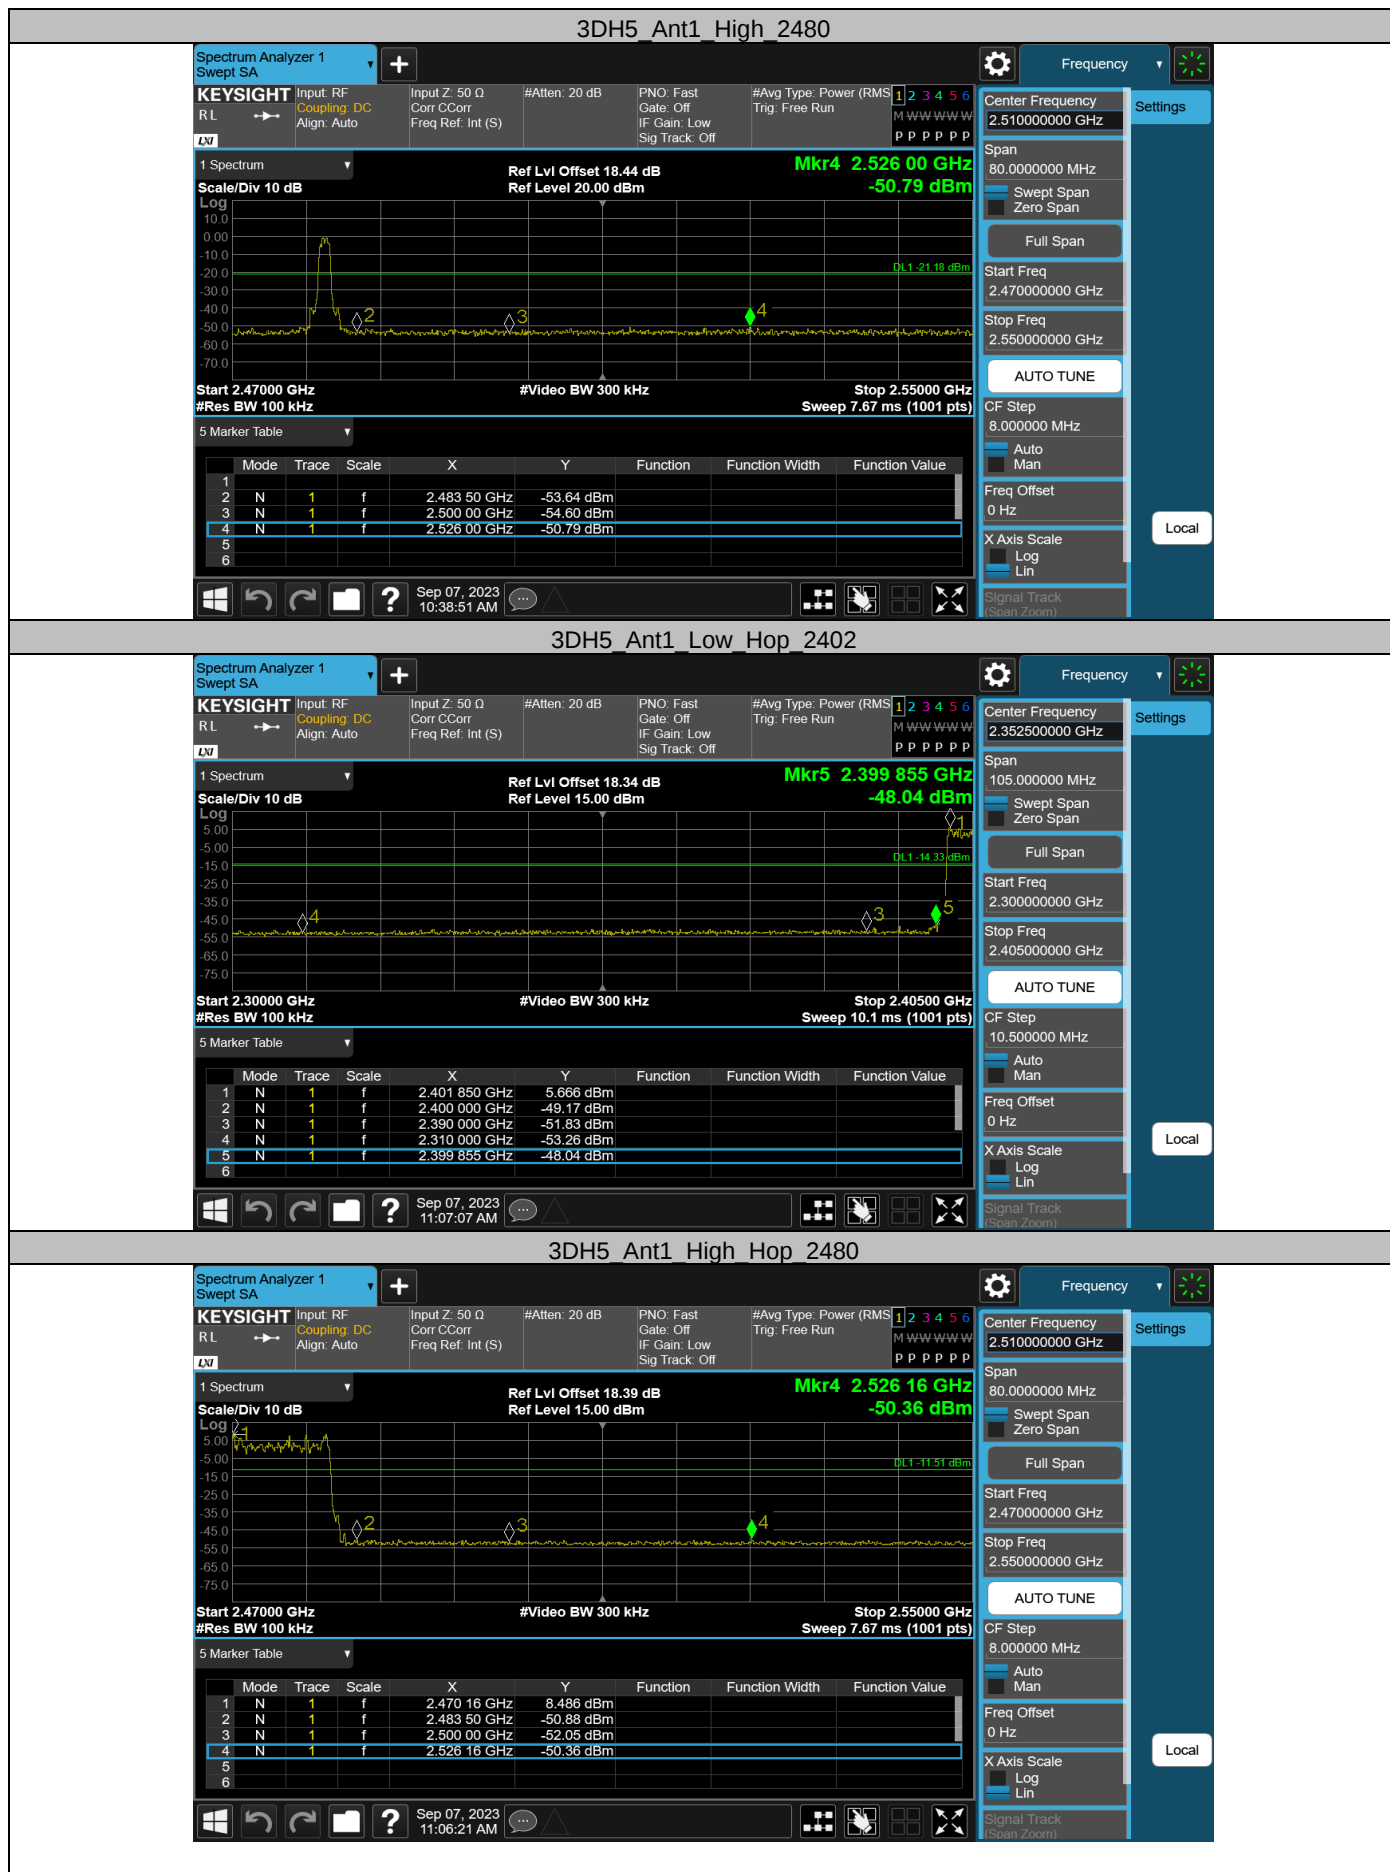
## Test Graphs

| Test Mode | Antenna | Ch Name | Freq(MHz) | Ref Level [dBm] | Result [dBm] | Limit [dBm] | Verdict |
