# Appendix F: Reference level measurement Test Result

## Appendix G: Band edge measurements

## Appendix H: Conducted Spurious Emission Test Result

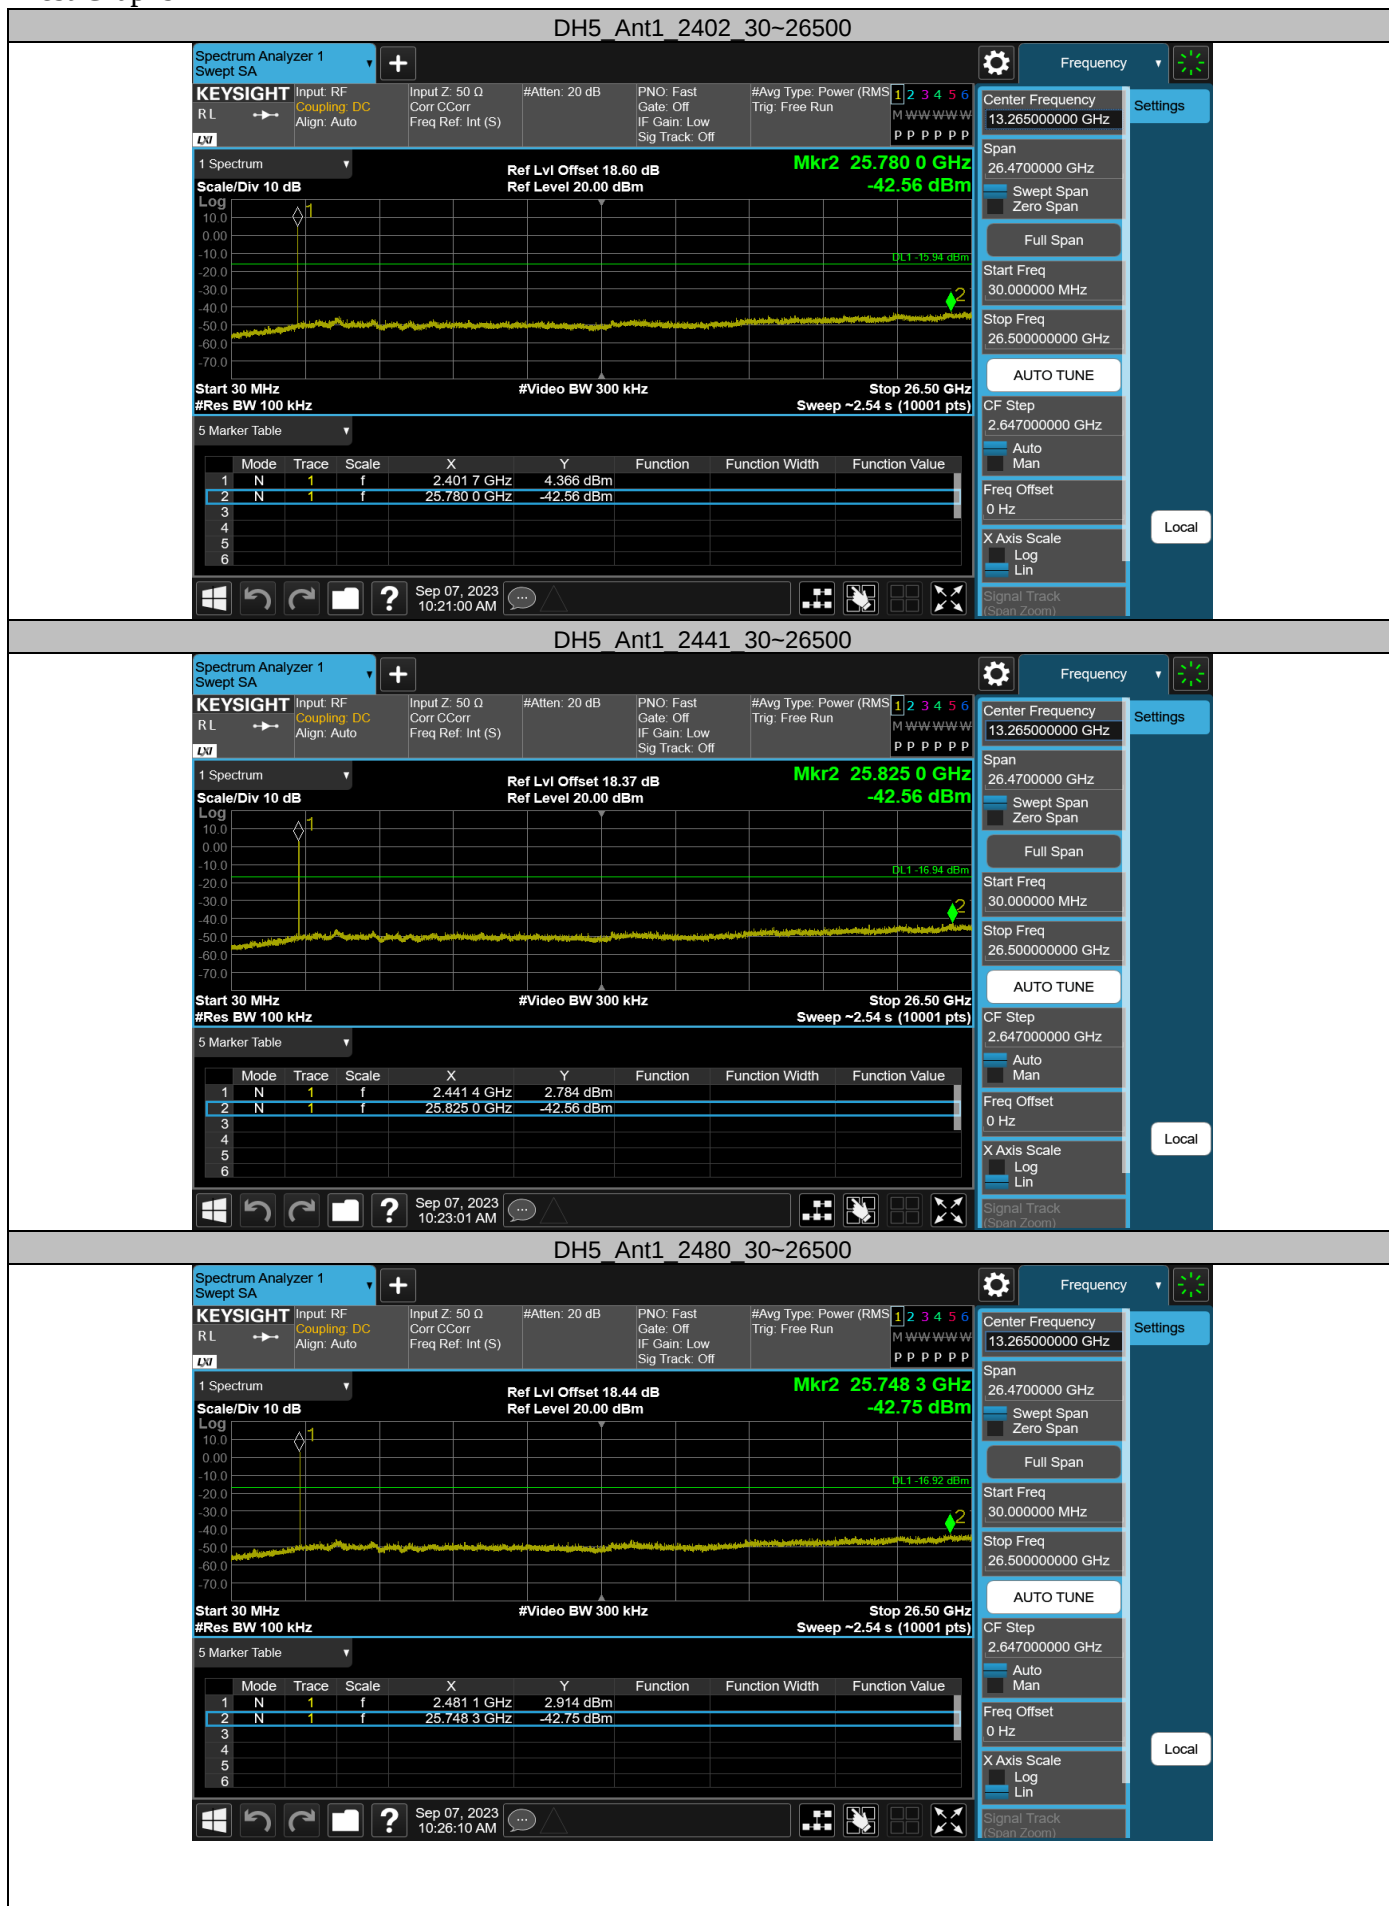
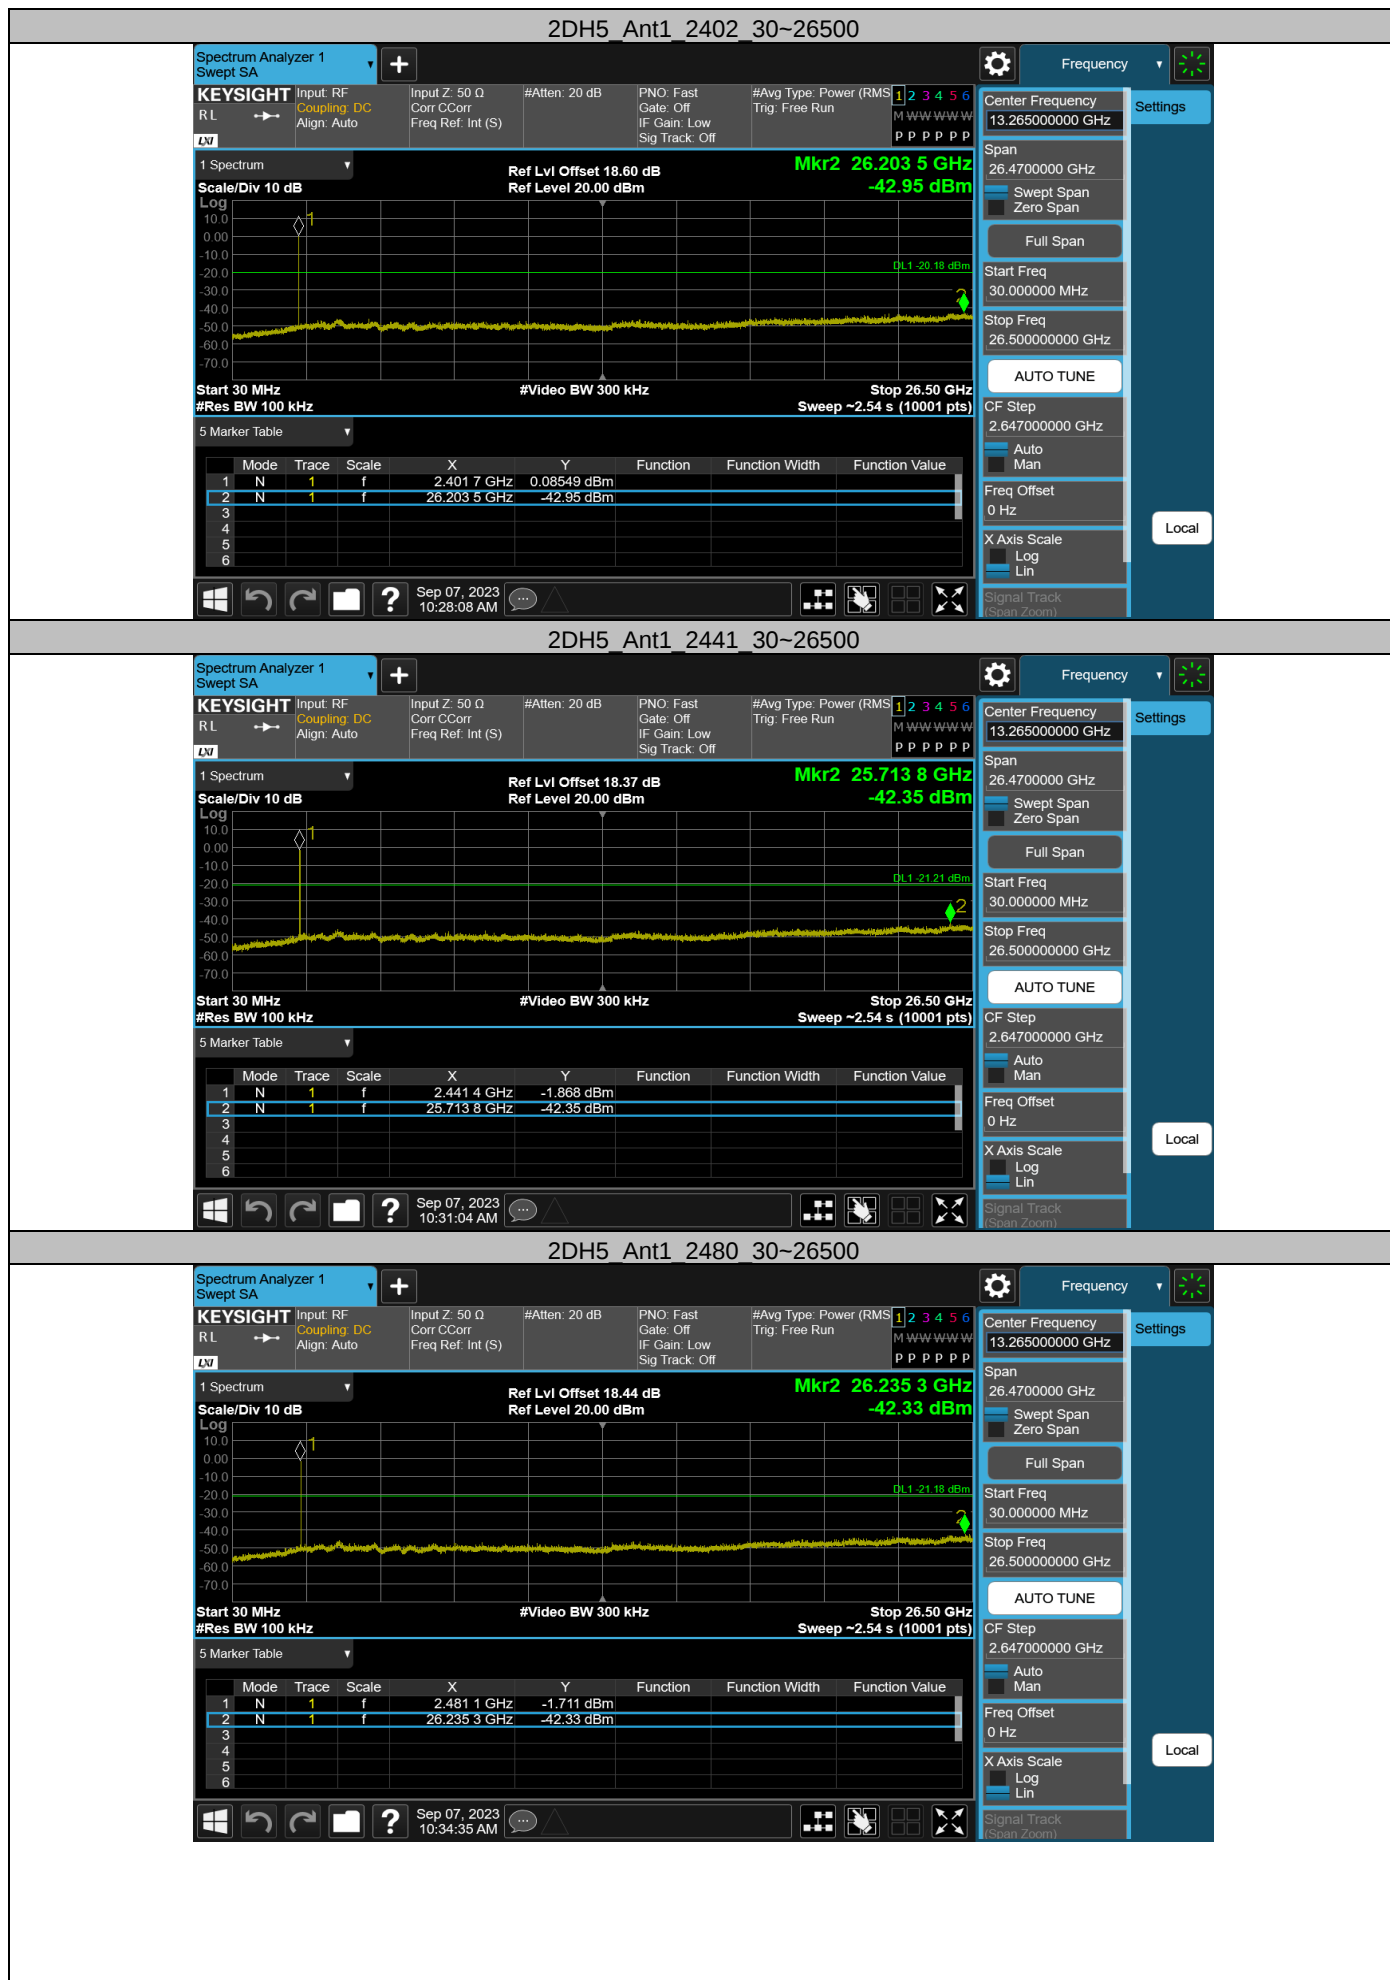
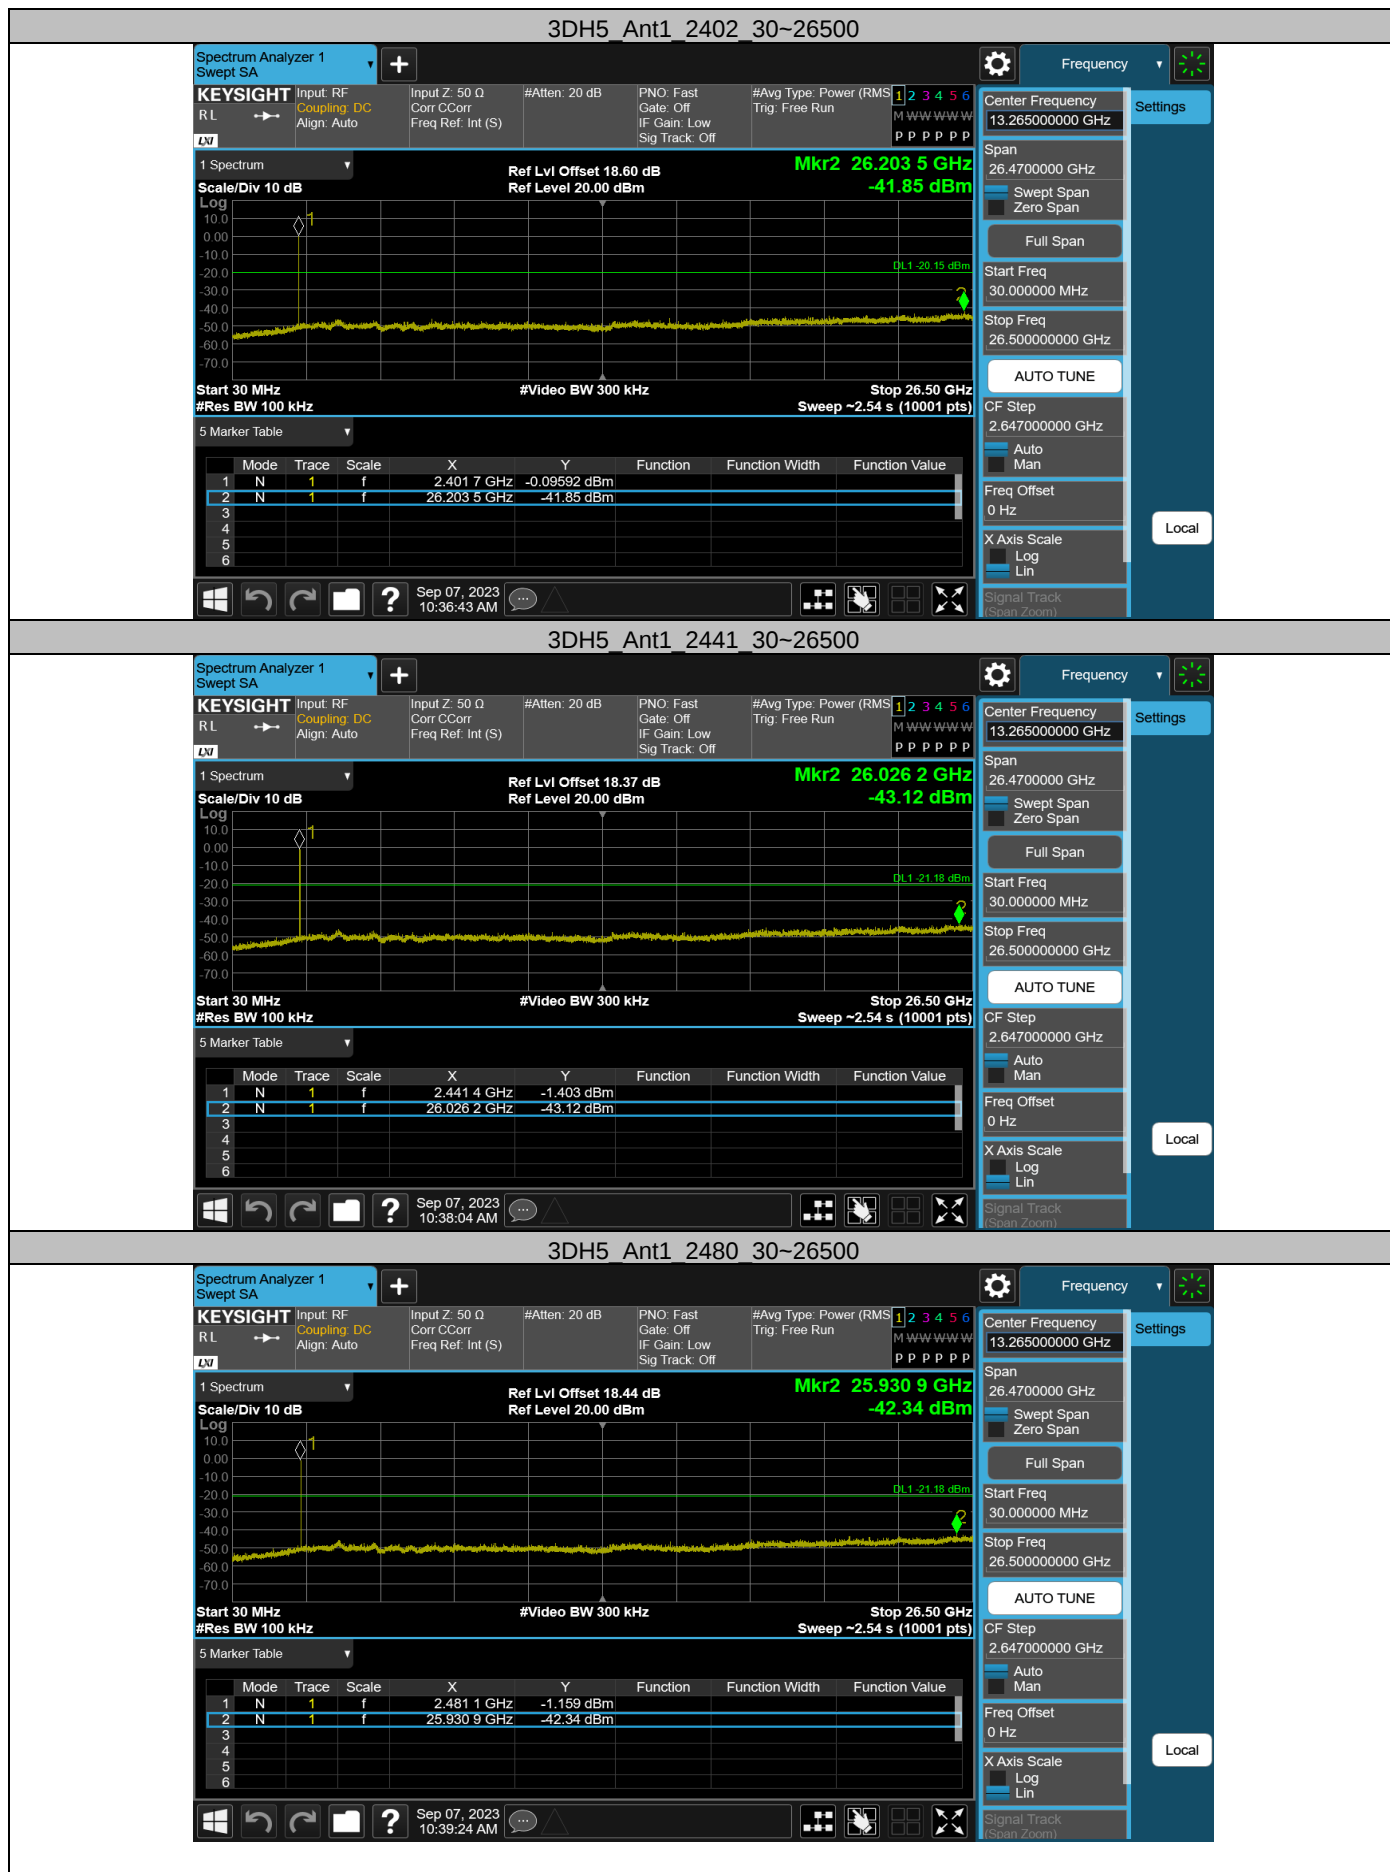
## Test Graphs

| Test Mode | Antenna | Freq(MHz) | Freq Range [MHz] | Ref Level [dBm] | Result [dBm] | Limit [dBm] | Verdict |

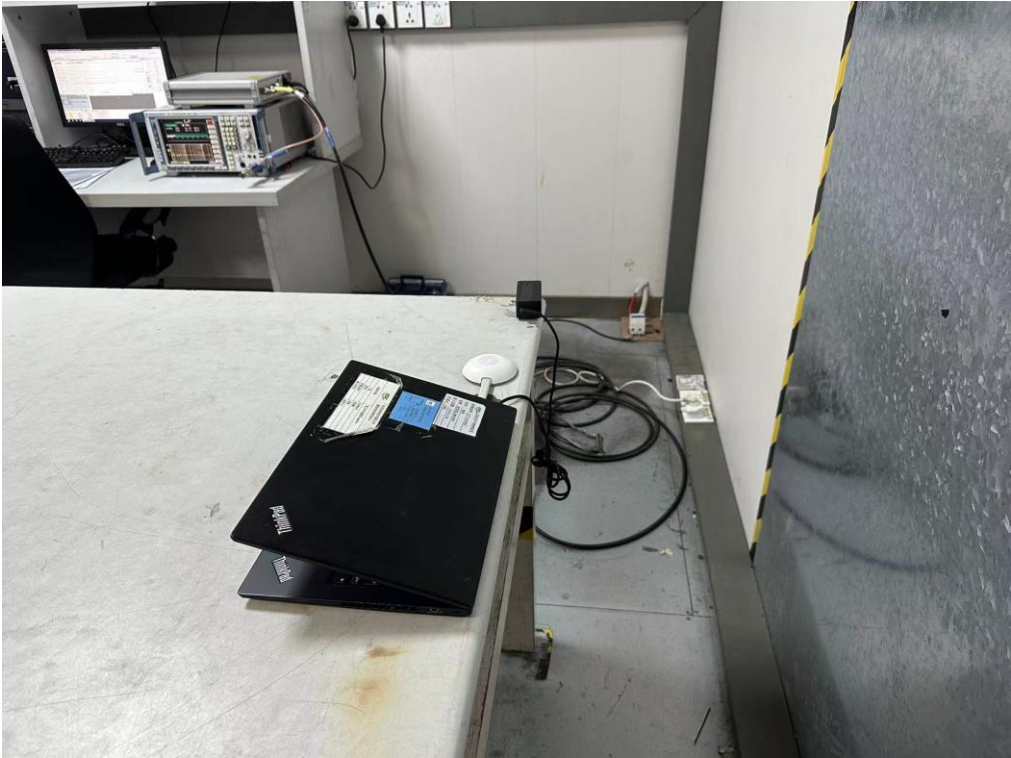
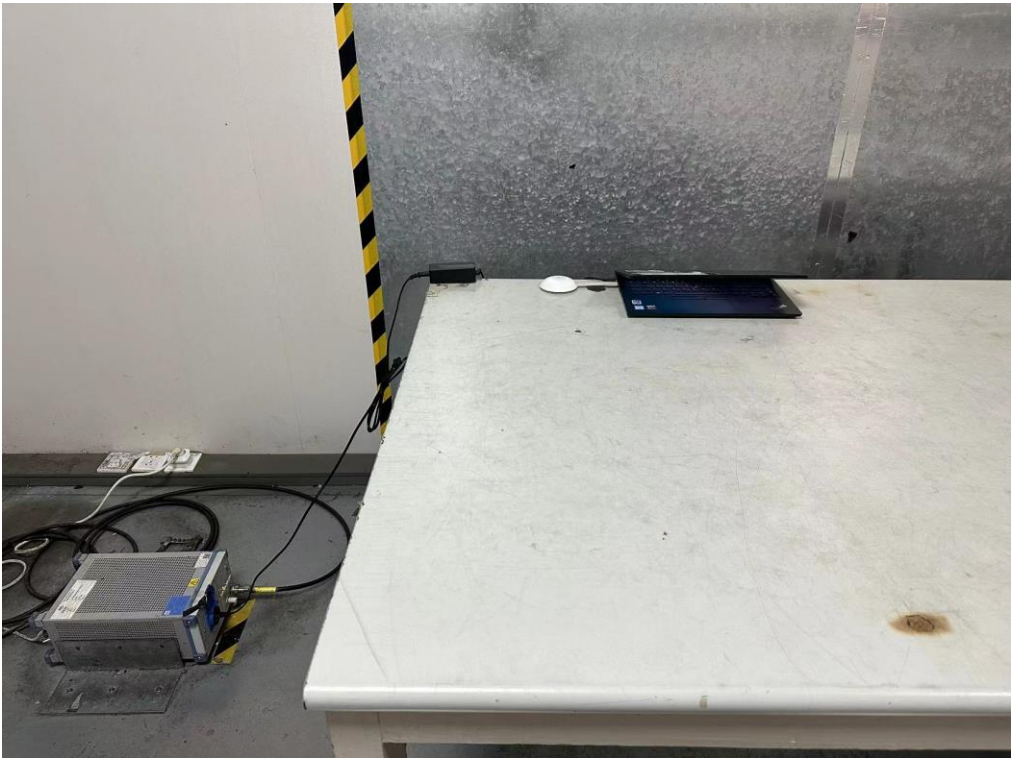
Conducted Test

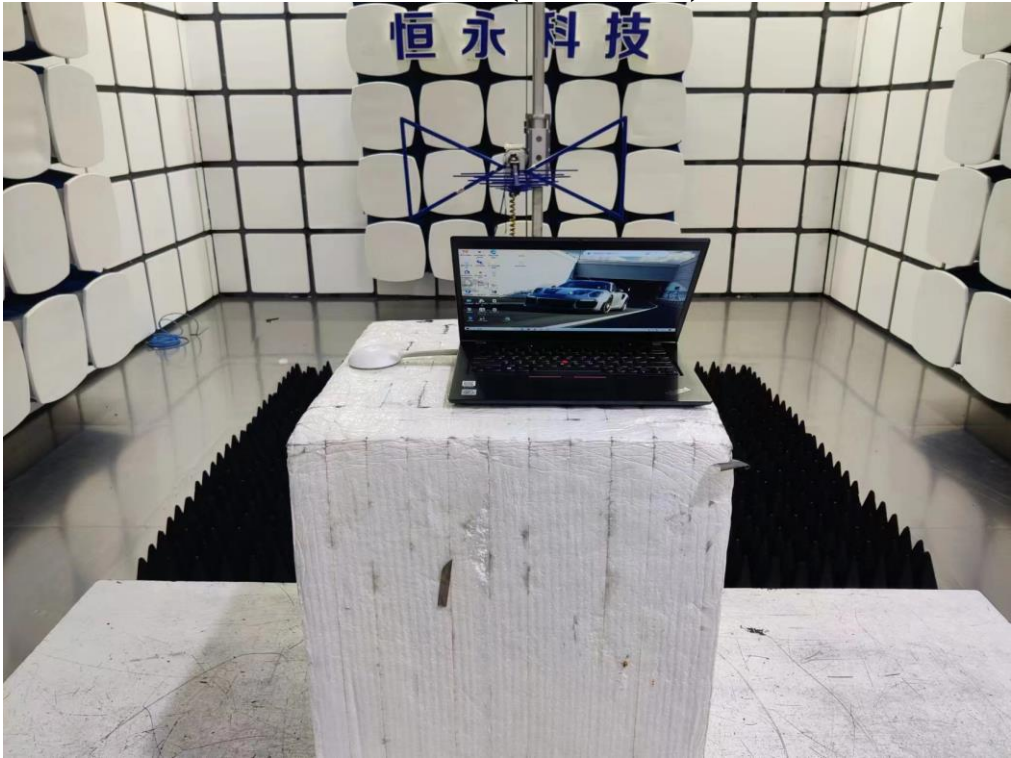
Radiated Test (Below 1GHz)

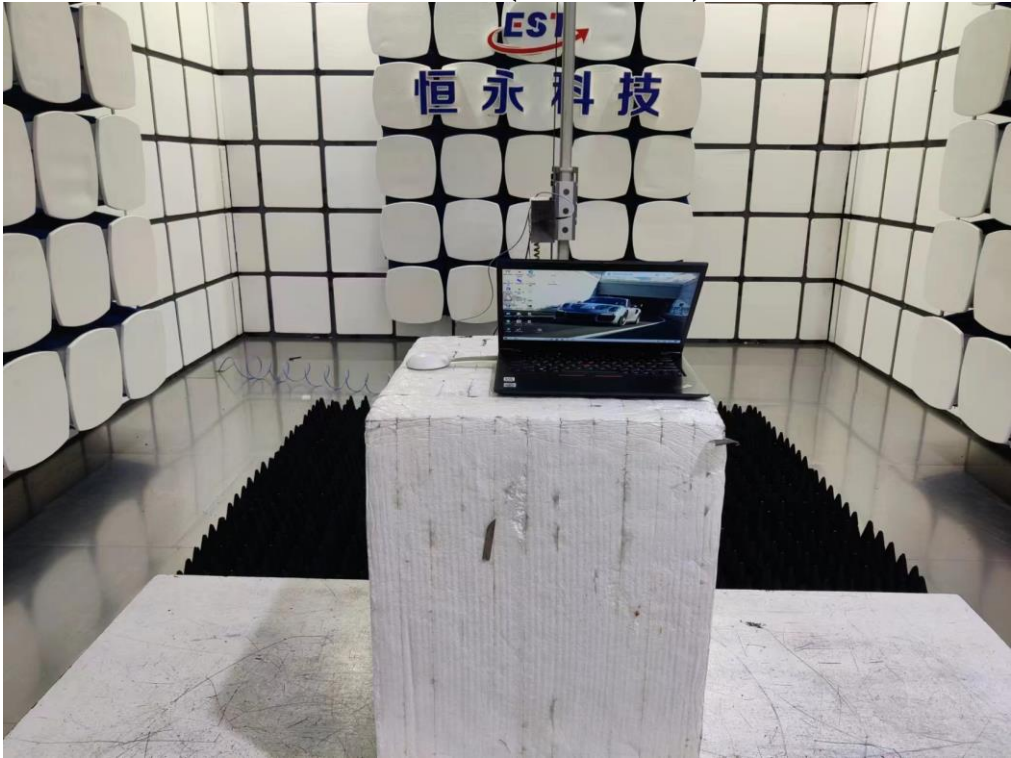
Radiated Test (Above 1GHz)

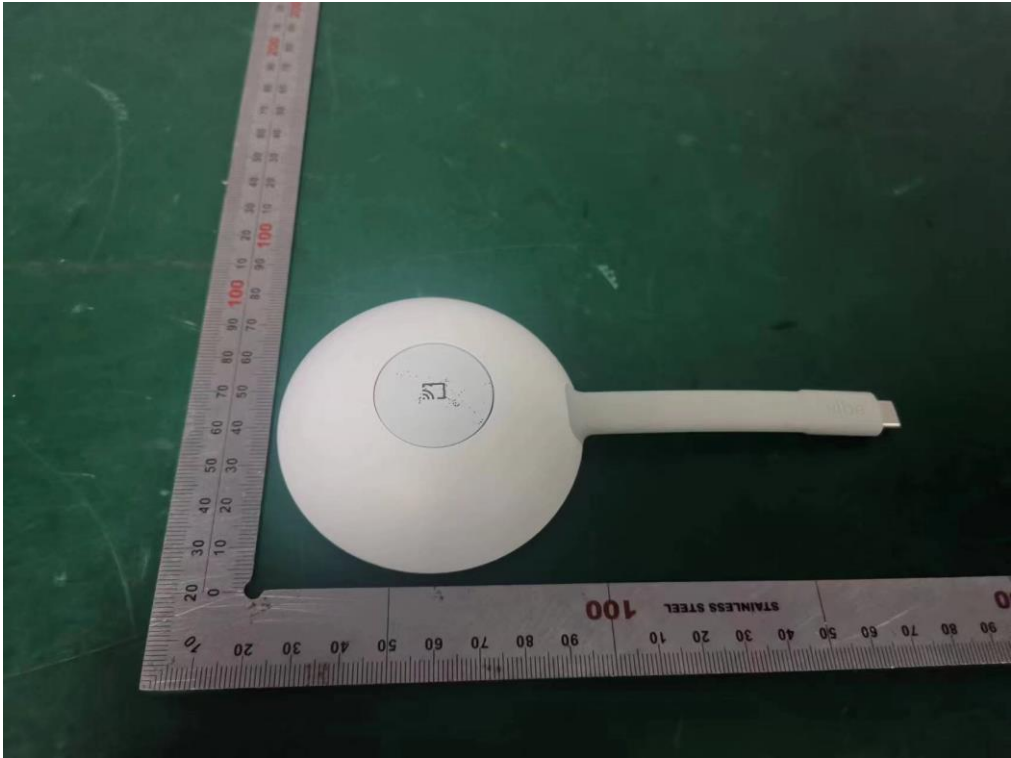
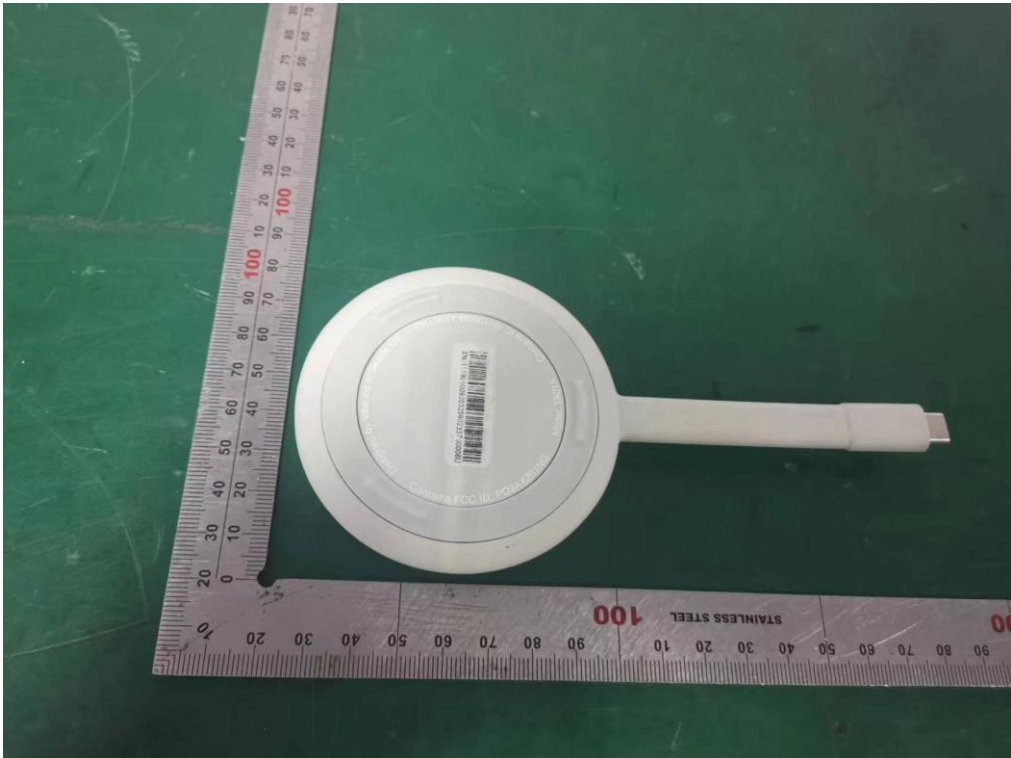
External Photos  
M/N: TA01A

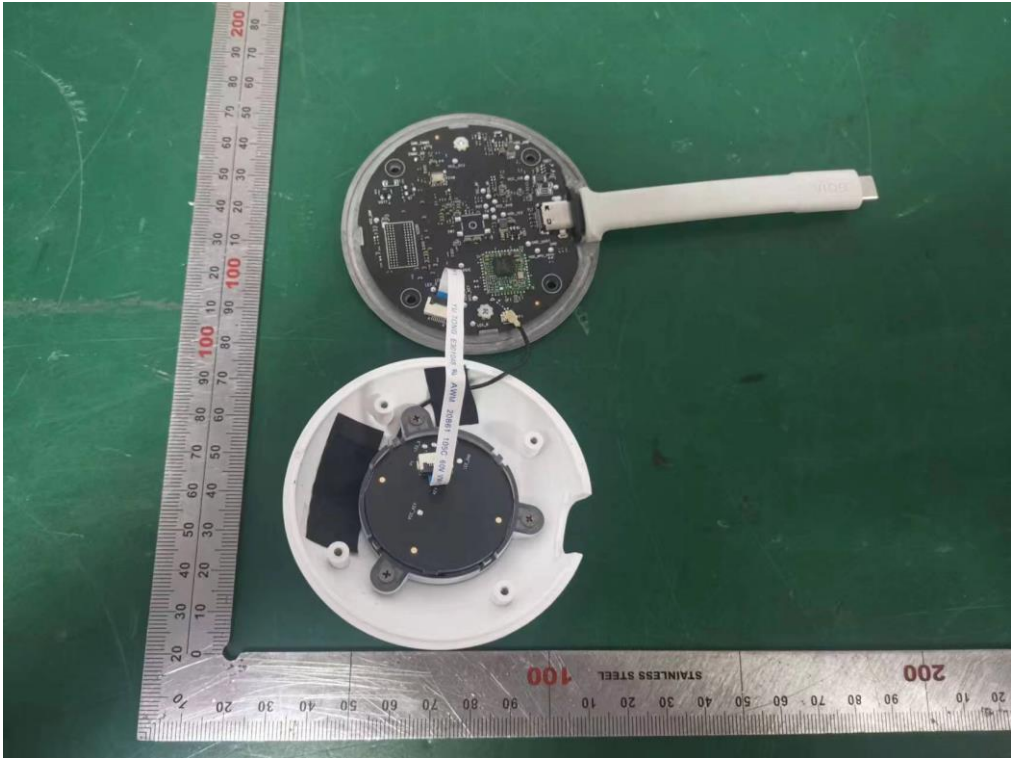
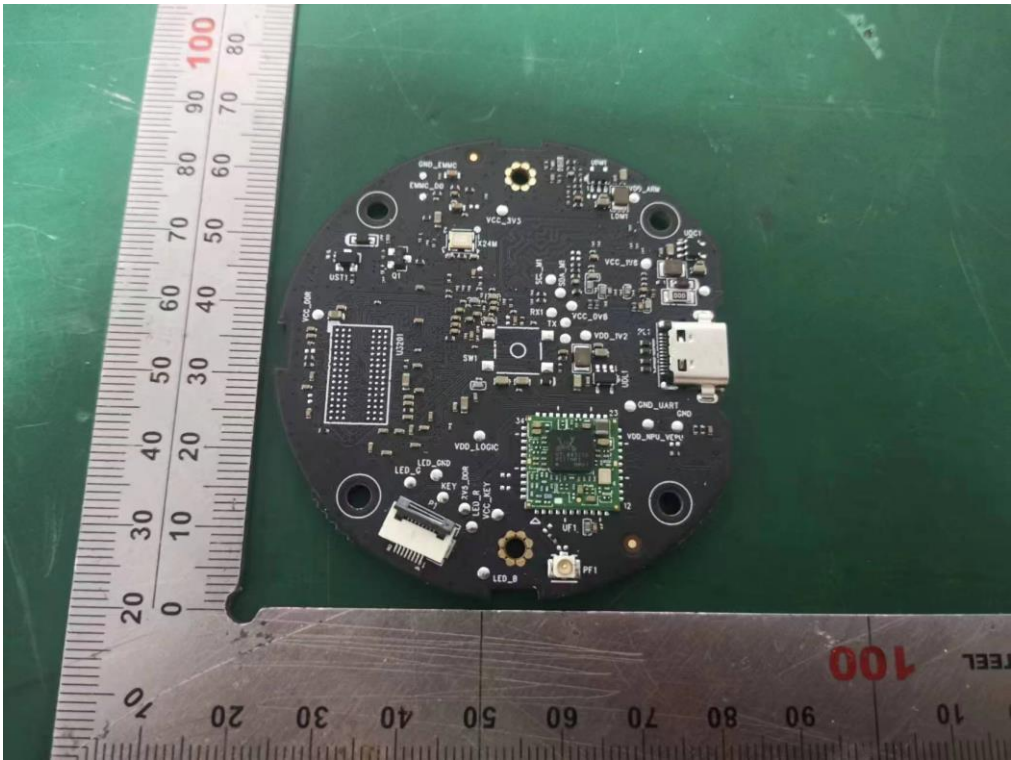
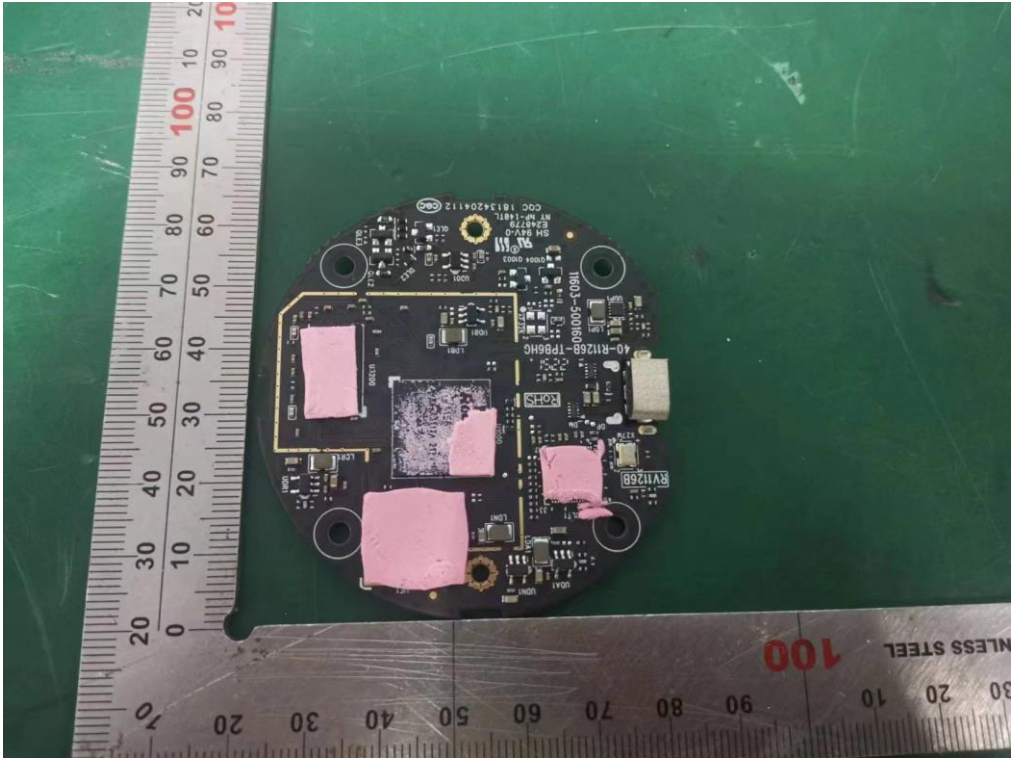
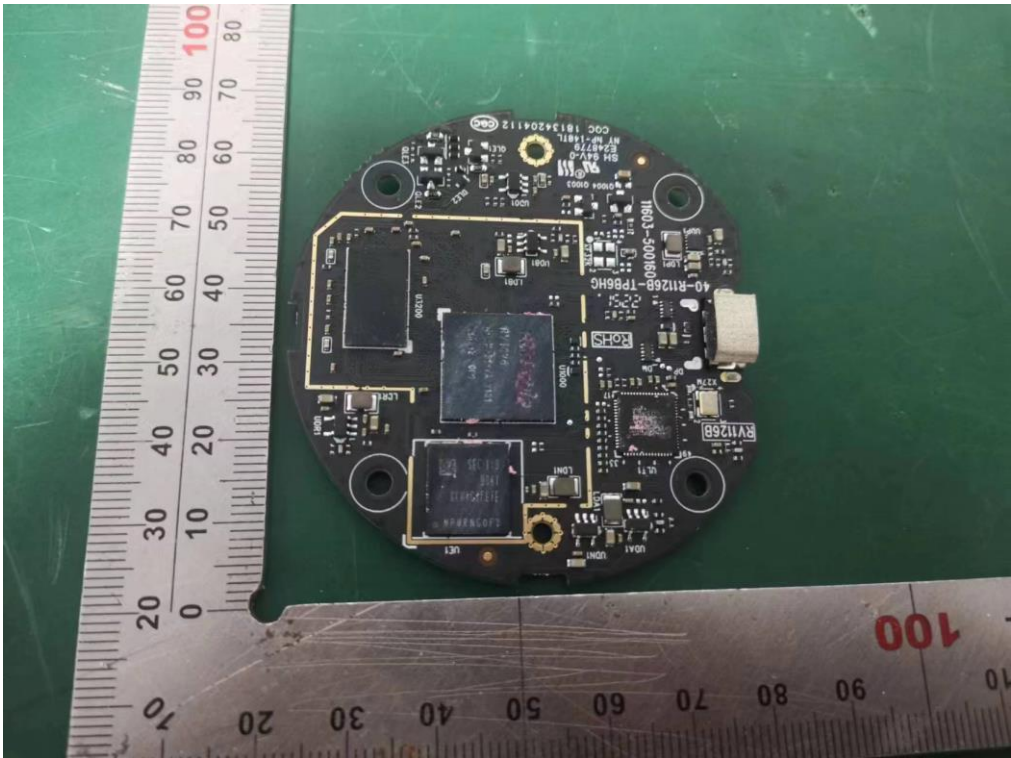
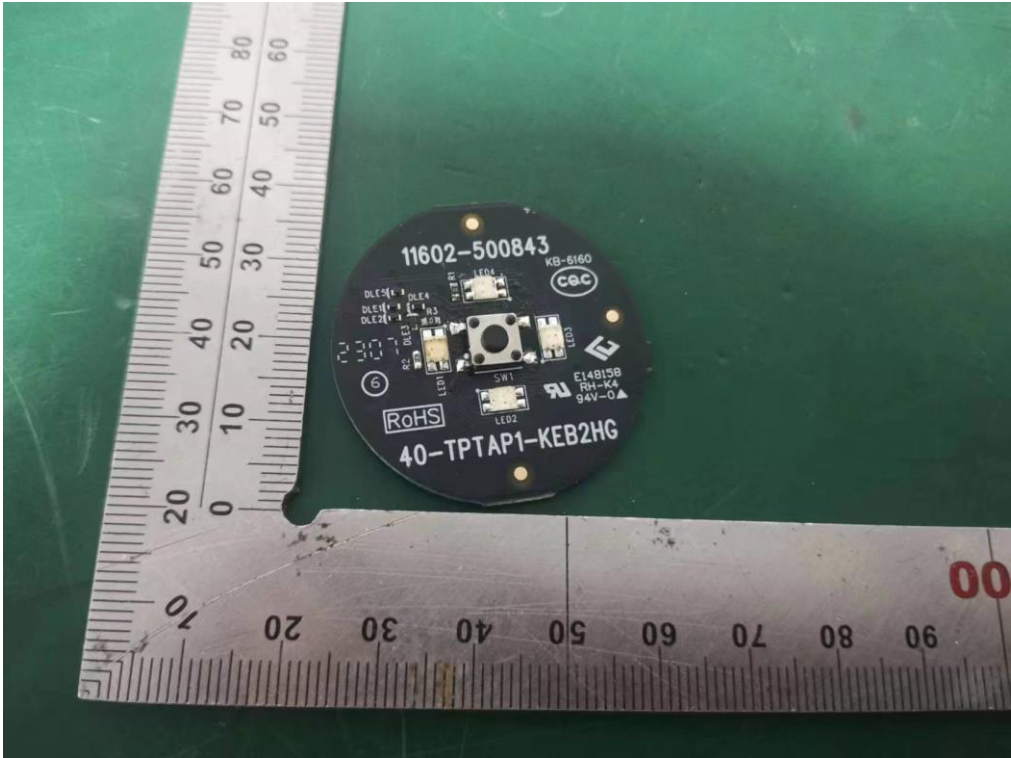
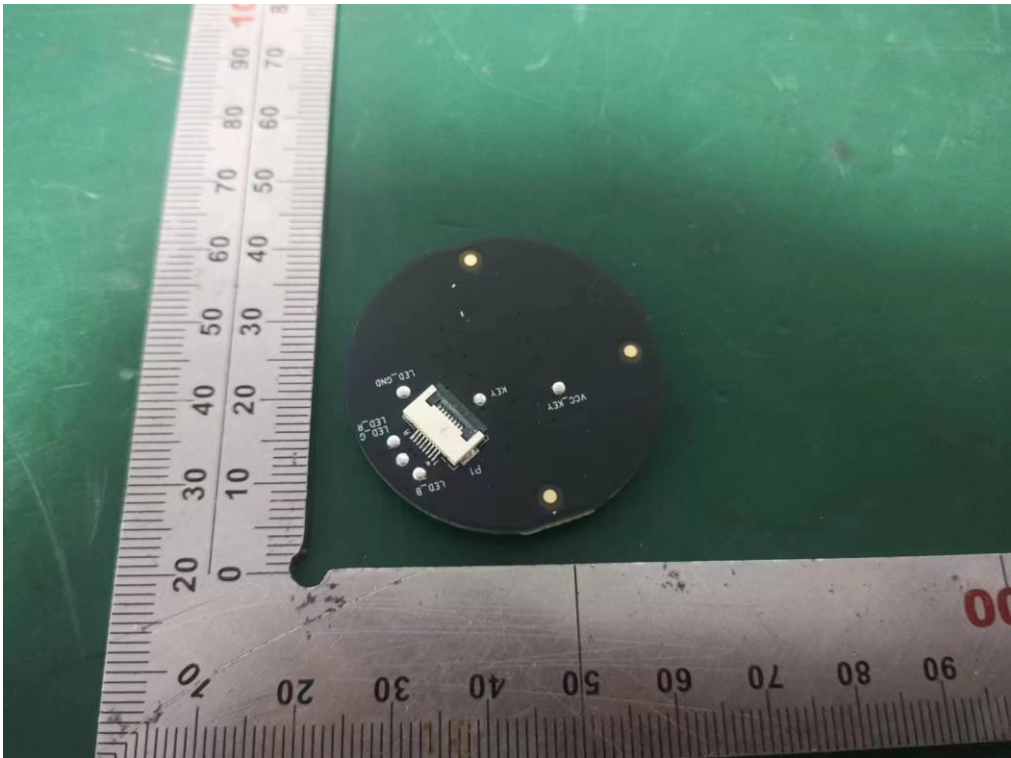
Internal Photos  
M/N: TA01A
