Report No.: EED32Q81046101 Page 36 of 45

## **8 PHOTOGRAPHS OF TEST SETUP**

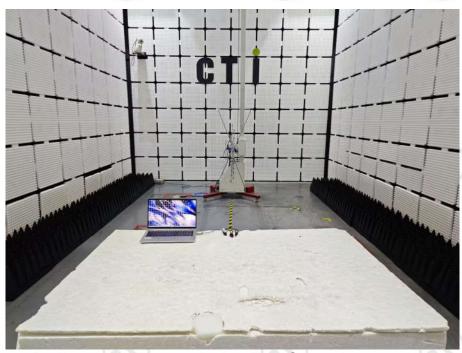
Radiated spurious emission Test Setup-1(Below 1GHz)

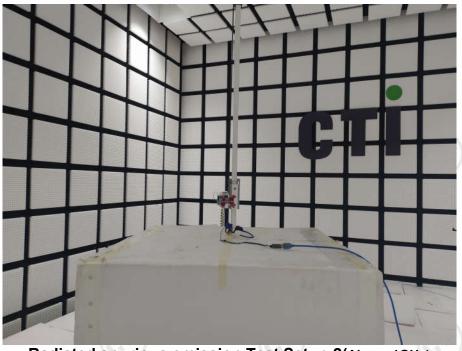
Radiated spurious emission Test Setup-2(Above 1GHz)

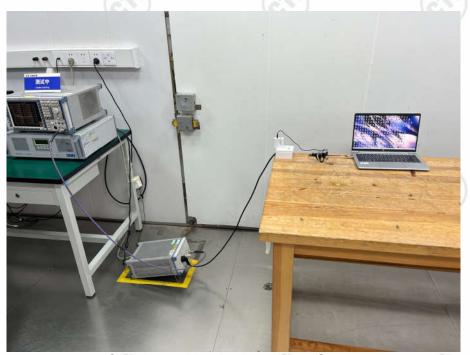
**Conducted Emissions Test Setup**
