APPENDIX A: PHOTOGRAPHS OF TEST SETUP

Reference to the test report No. BLA-EMC-202306-A2401

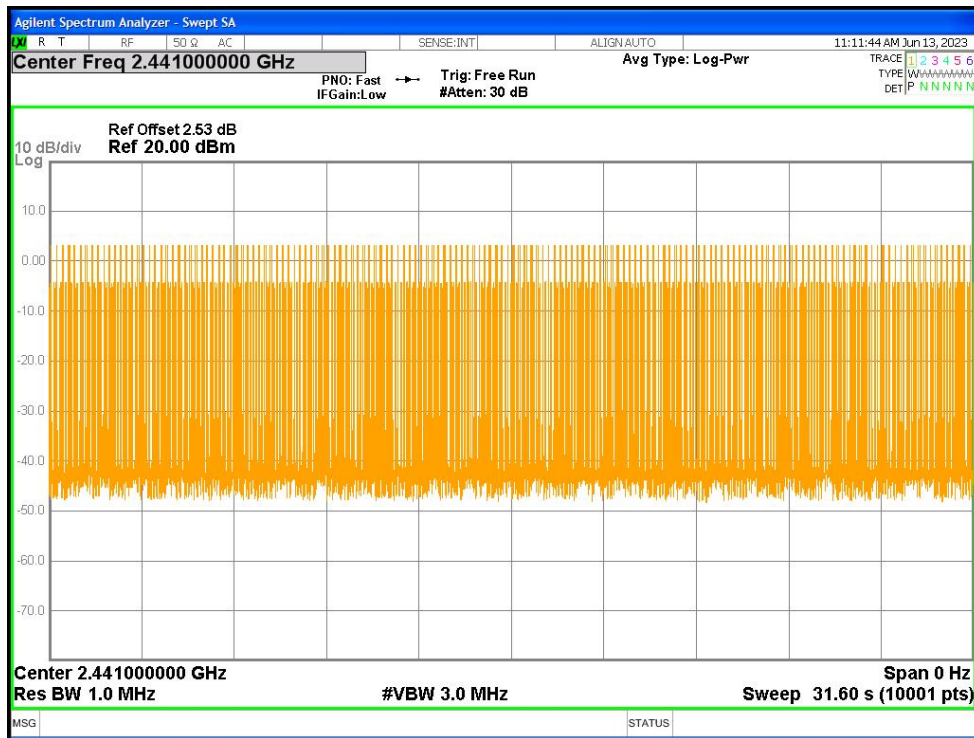
Dwell NVNT 1-DH3 2441MHz Ant1 One Burst

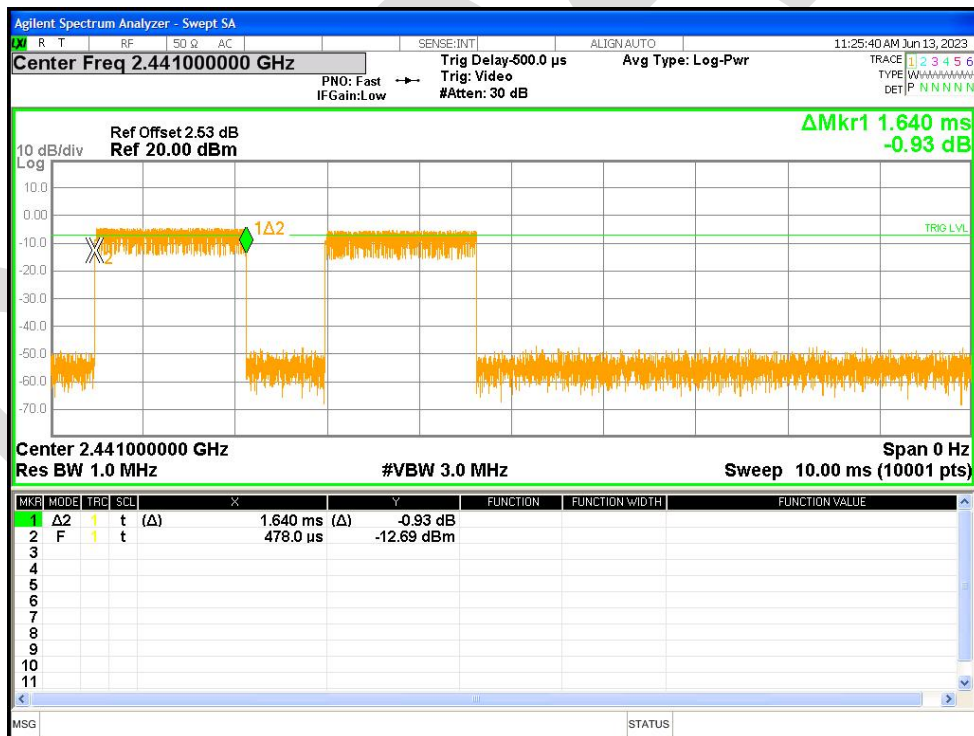
Dwell NVNT 1-DH3 2441MHz Ant1 Accumulated

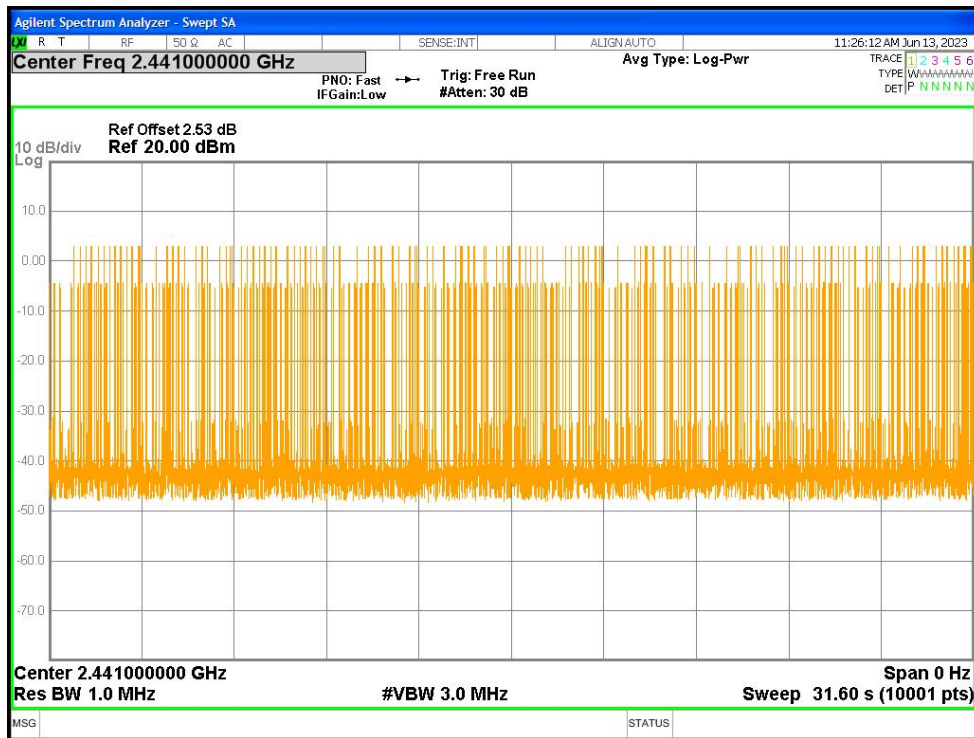
Dwell NVNT 1-DH5 2441MHz Ant1 One Burst

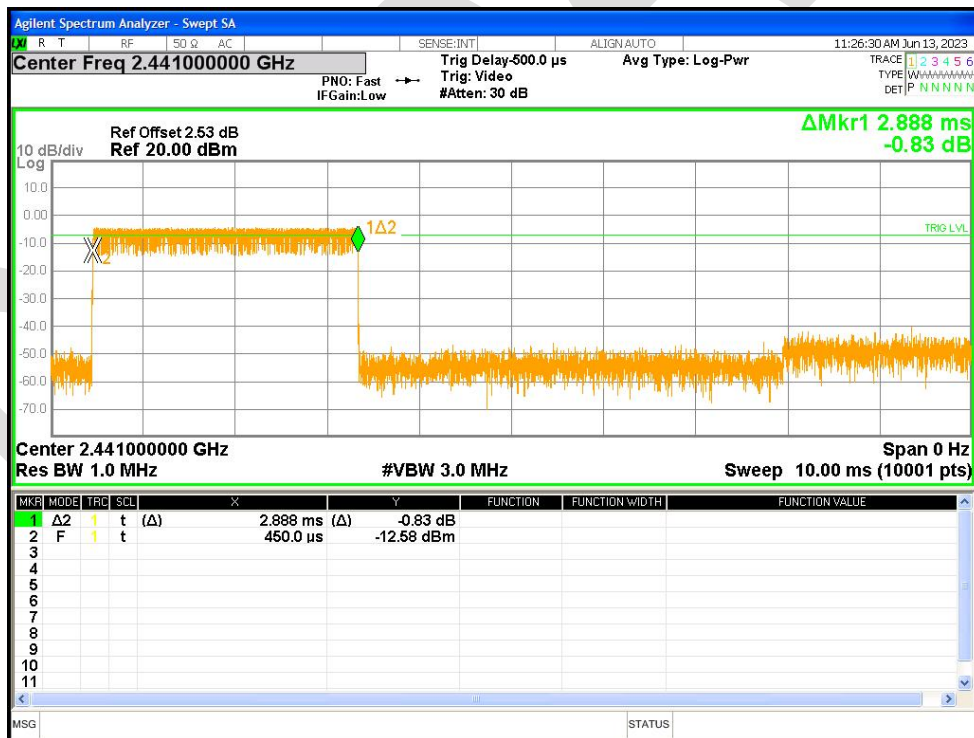
Dwell NVNT 1-DH5 2441MHz Ant1 Accumulated

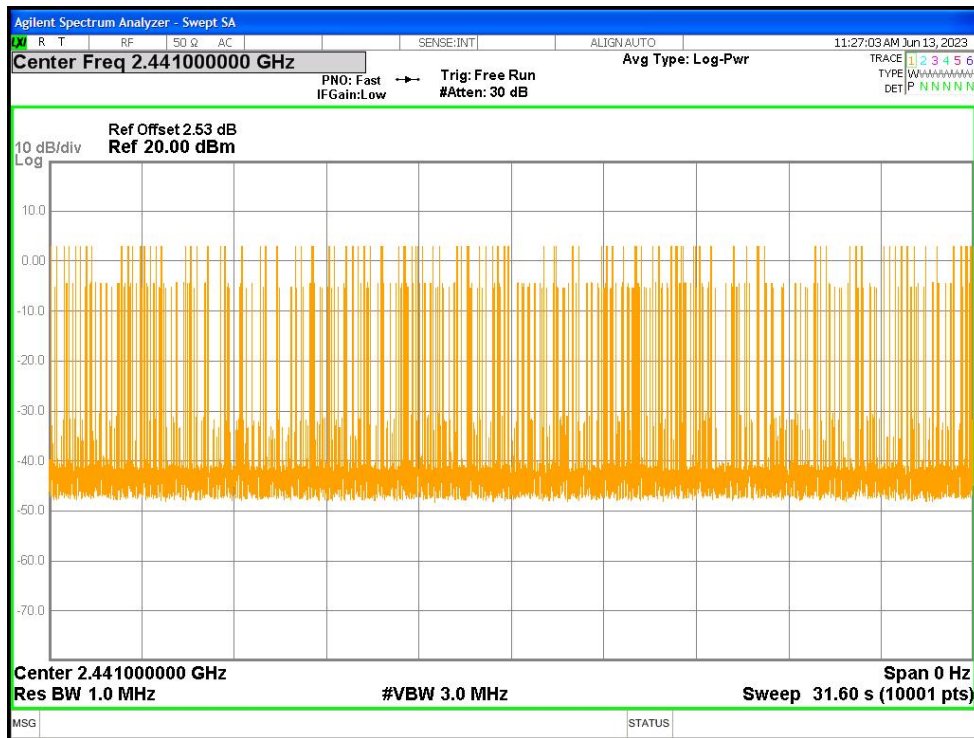
Dwell NVNT 2-DH1 2441MHz Ant1 One Burst

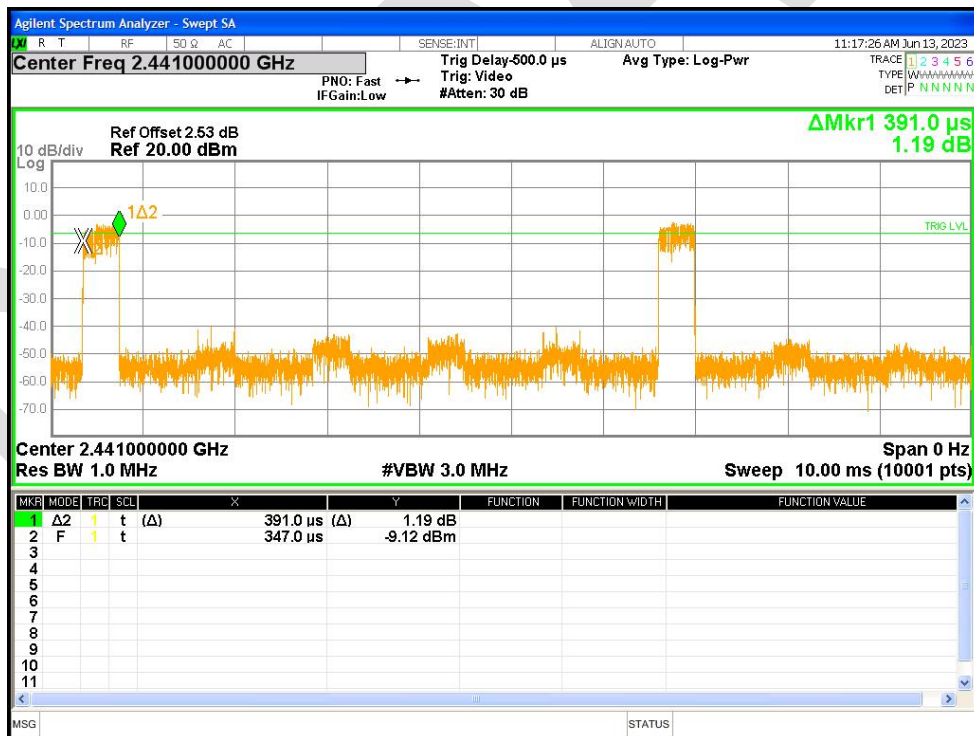
Dwell NVNT 2-DH1 2441MHz Ant1 Accumulated

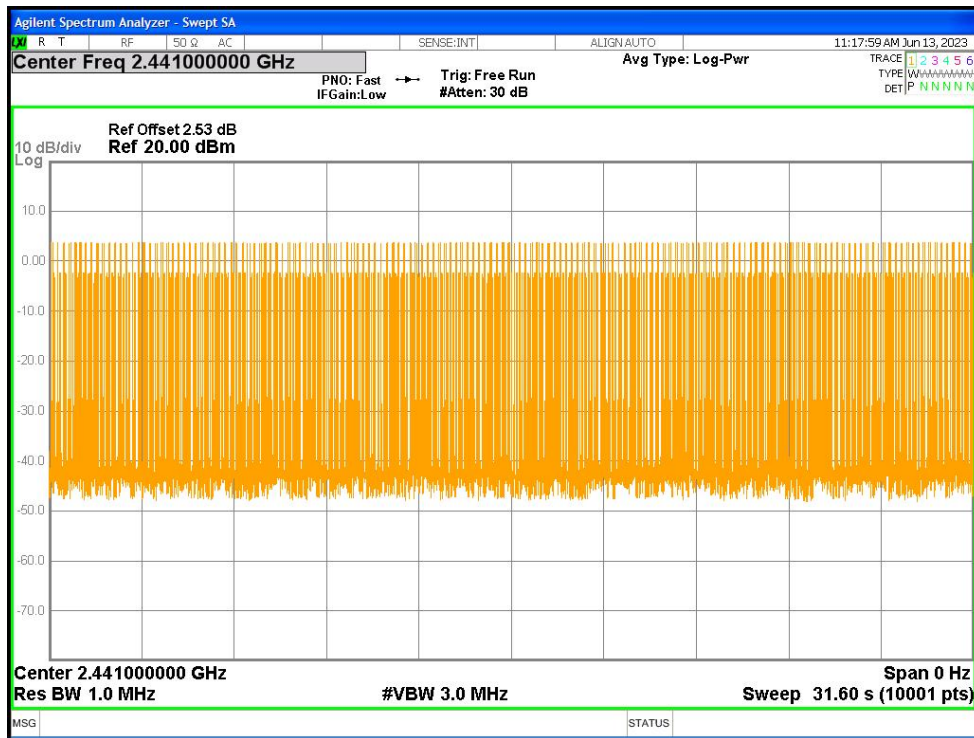
Dwell NVNT 2-DH5 2441MHz Ant1 One Burst

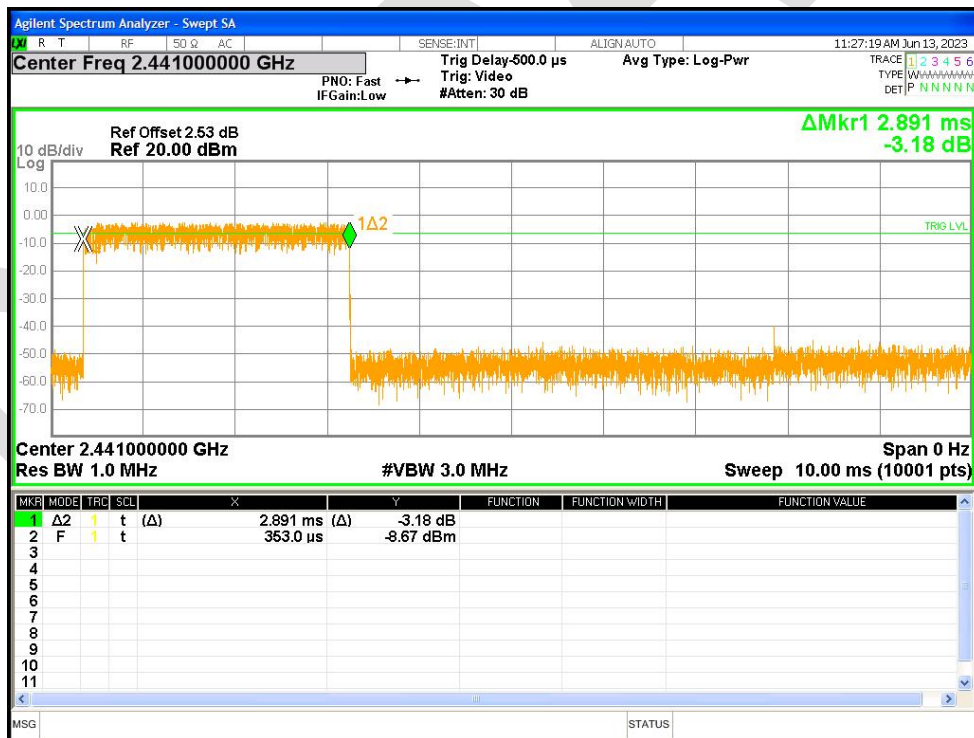
Dwell NVNT 2-DH5 2441MHz Ant1 Accumulated

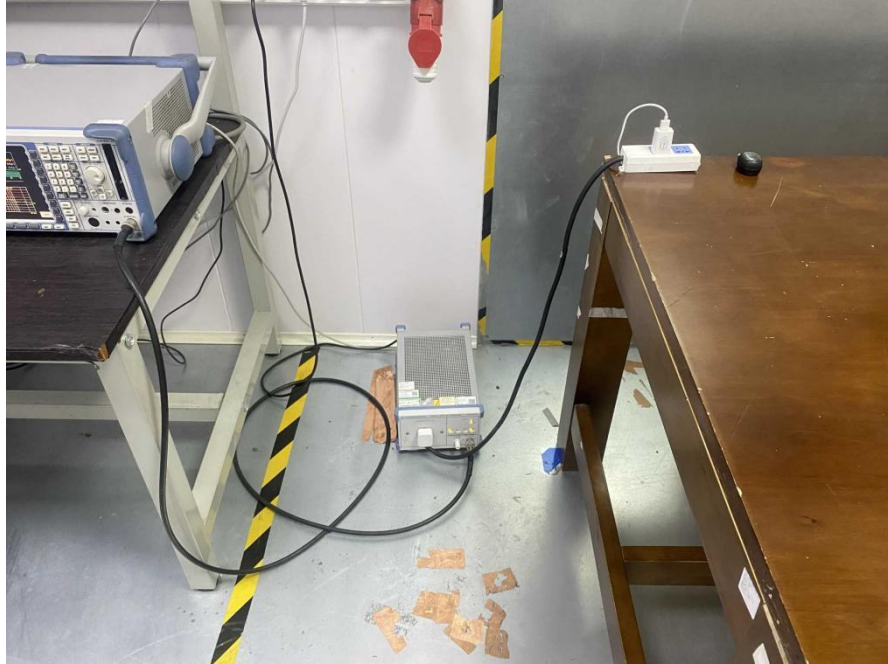
Conducted Emissions at AC Power Line (150kHz-30MHz)

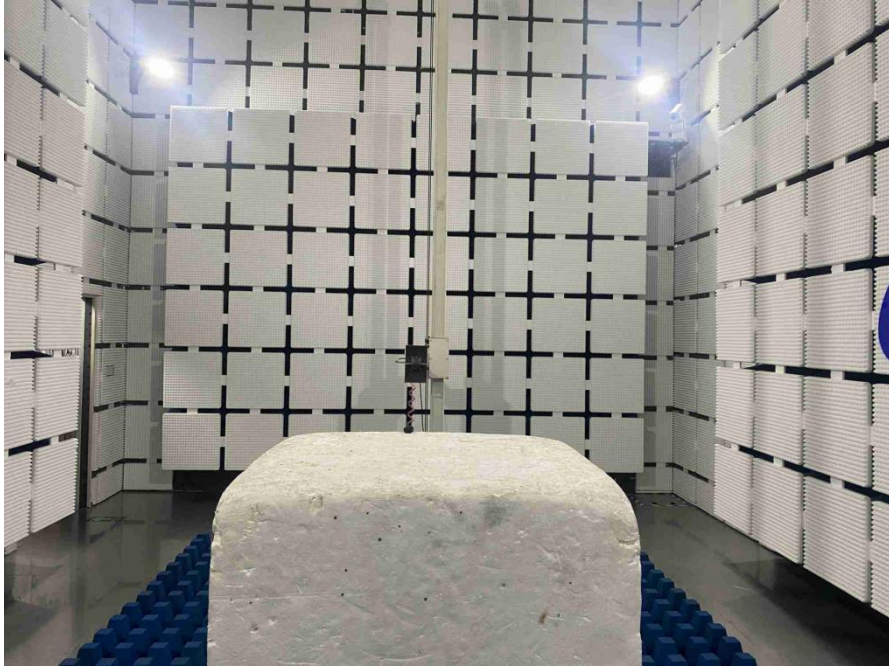
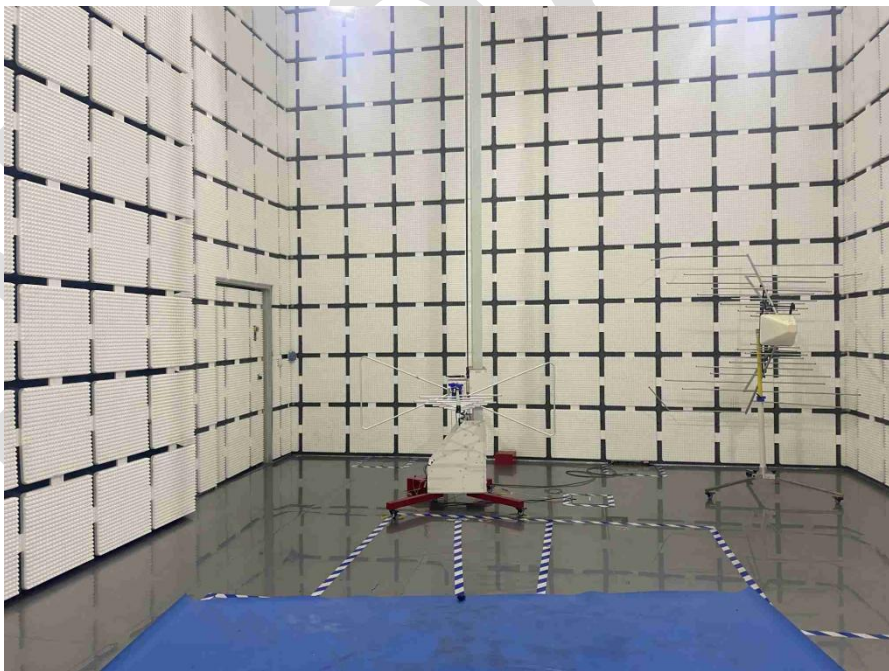
Radiated Spurious Emissions
