Dwell NVNT 1-DH3 2441MHz Ant1 One Burst

APPENDIX A: PHOTOGRAPHS OF TEST SETUP

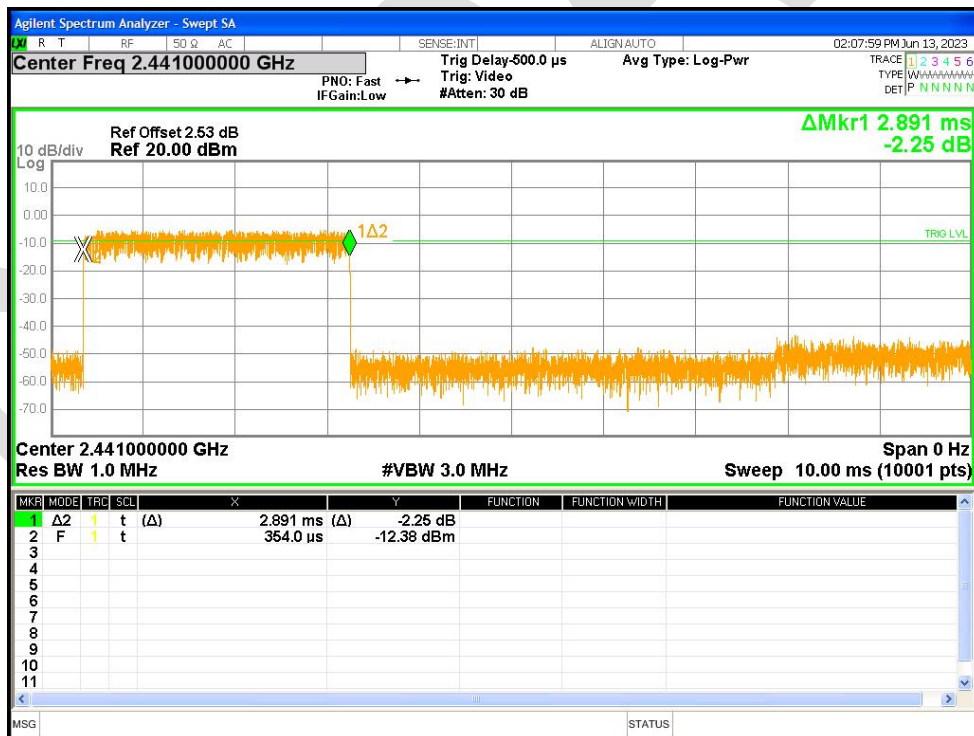
Dwell NVNT 2-DH5 2441MHz Ant1 Accumulated

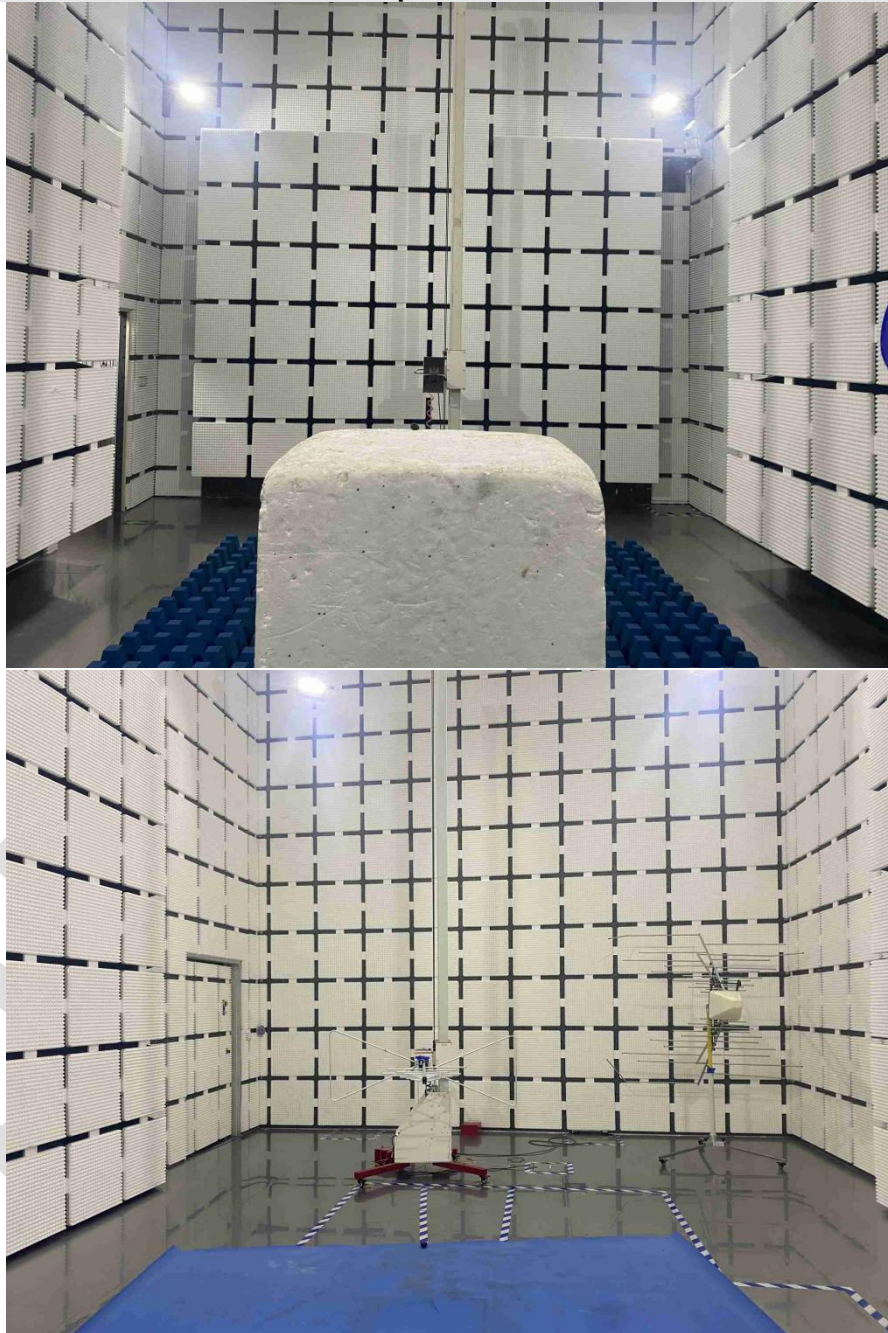
Radiated Spurious Emissions
