# Xin Qi electronic -EM8E project commissioning report -A

2023年07月06日

上海赫达电子有限公司  
Shanghai HEDA Electronics. Co., Ltd

Project name: EM8E

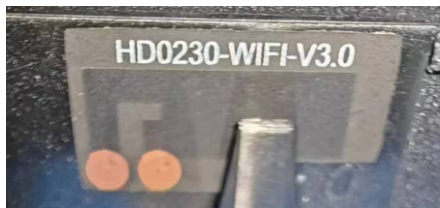
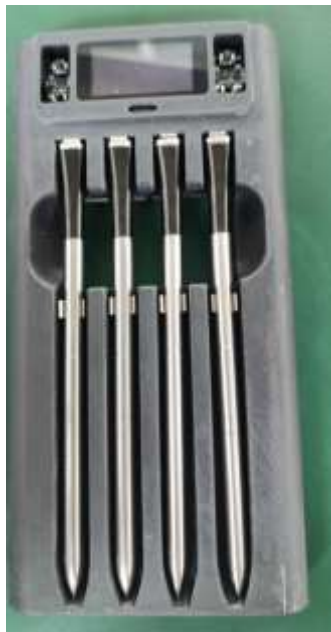
Antenna position

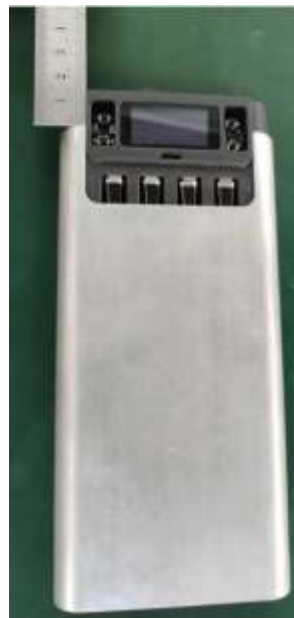
No shell test status

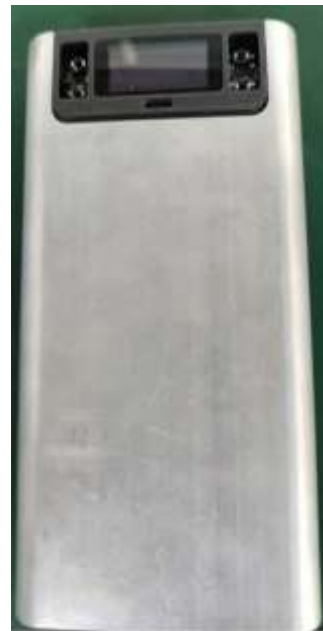
housing is 15mm  
from the top

Full shell test status

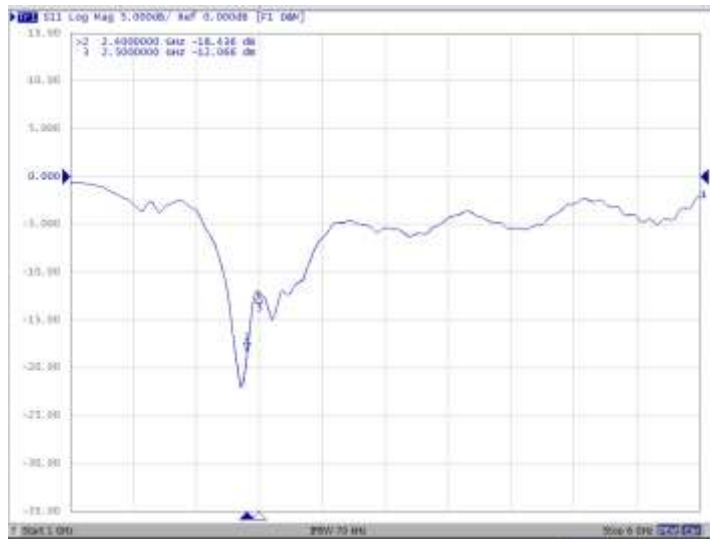
# 天线测试数据-（外壳距离顶部15MM状态）

| Fre (MHz) | Gain(dBi) | Eff(%) |
| 2400 | -3.4 | 45.4 |
| 2450 | -3.4 | 45.7 |

| OTA | | |
| 1 | 17.22 | -82.35 |

1. Because of interference, the antenna waveform is adjusted correctly, but the efficiency is low. Current antenna waveform, deflection status
2. Test several groups of comparative data. The top of the metal shell is cut 15mm short, which is basically similar to without the shell
3. Test TIS reported an error, the test can not run

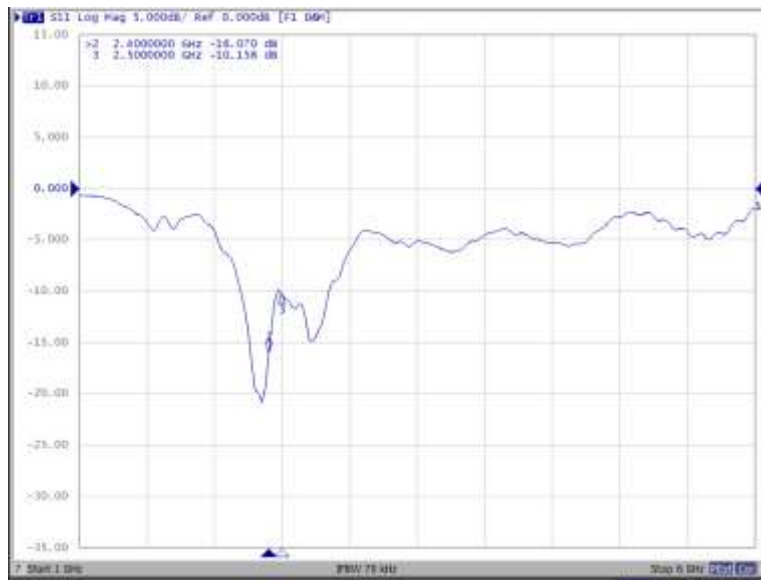
# 天线测试数据-（外壳距离顶部10MM状态）

| Fre (MHz) | Gain(dBi) | Eff(%) |
| 2400 | -4.2 | 37.7 |
| 2450 | -3.8 | 41.9 |

| OTA | | |
| 1 | 16.88 | -81.25 |

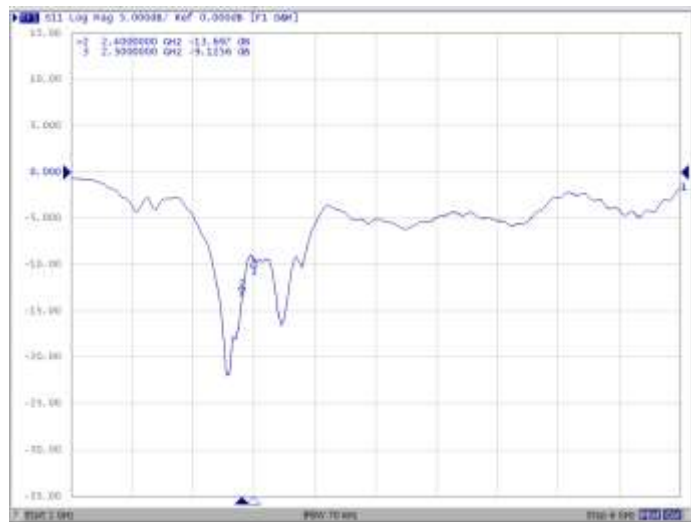
# 天线测试数据-（外壳距离顶部7MM状态）

| Fre (MHz) | Gain(dBi) | Eff(%) |
| 2400 | -4.1 | 38.8 |
| 2450 | -4.8 | 33.0 |

| OTA | | |
| 1 | 16.62 | -80.53 |

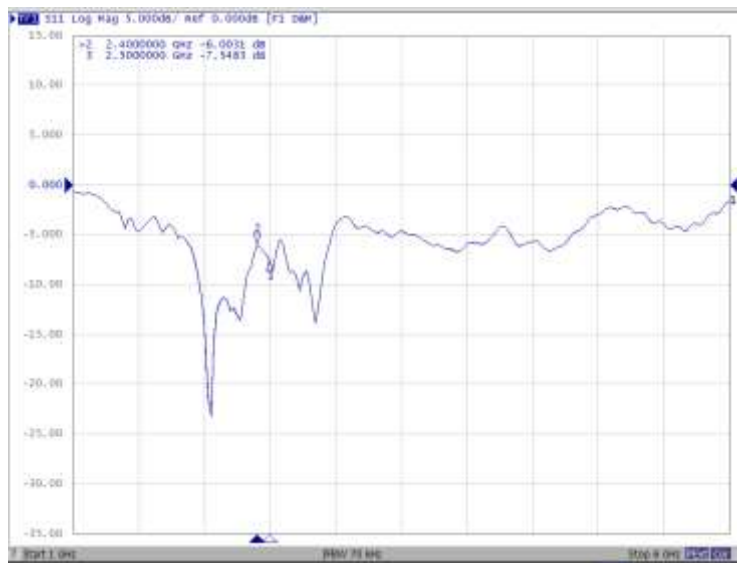
# 天线测试数据-（全部外壳状态）

| Fre (MHz) | Gain(dBi) | Eff(%) |
| 2410 | -7.4 | 18.2 |
| 2450 | -7.0 | 19.9 |

| OTA | | |
| 1 | 8.6 | -77.6 |
