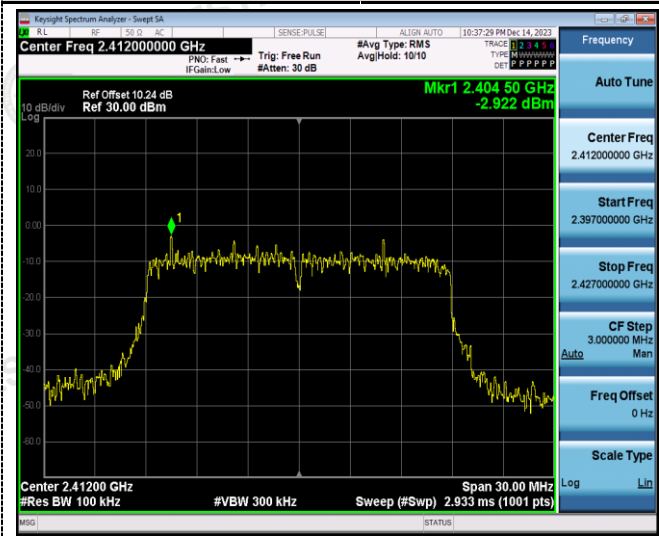
802.11n20
