## Appendix B: Photographs of Test Setup

Product: US Standard Dimmer Switch  
Model: USD-3WI  
Radiated Emission

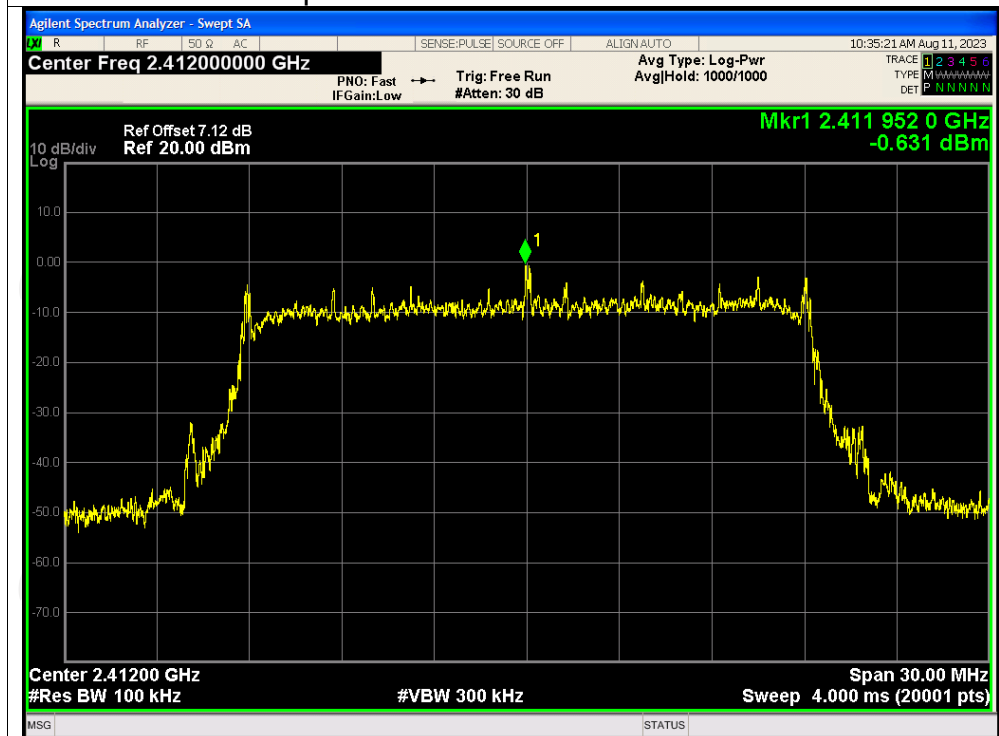
## Tx. Spurious NVNT n20 2412MHz Ref

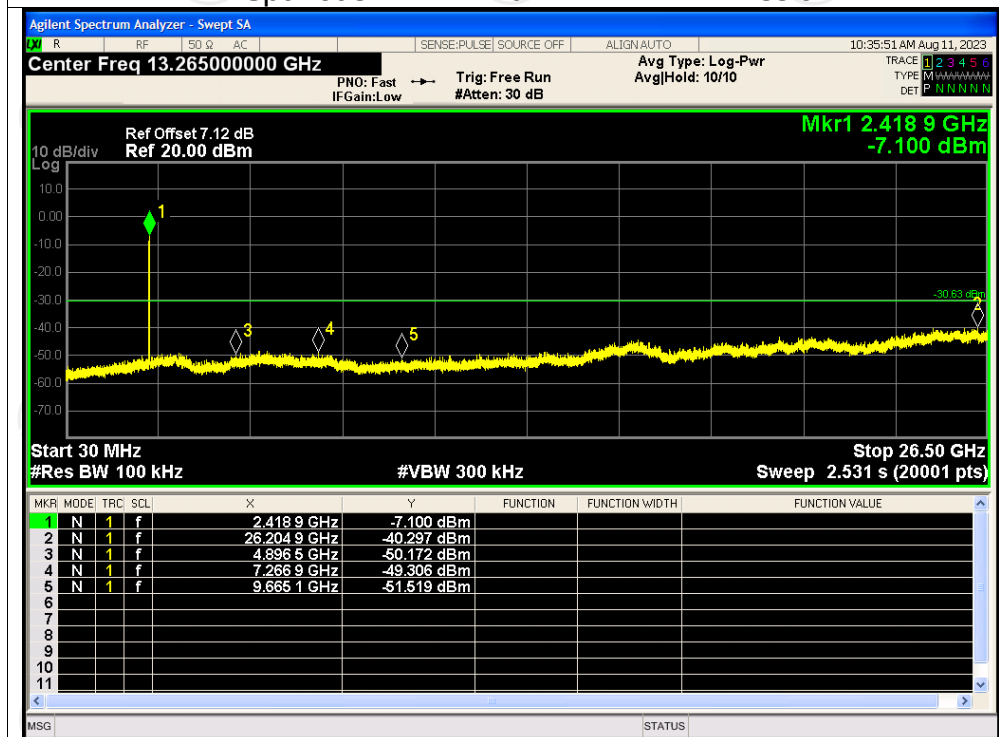
## Tx. Spurious NVNT n20 2412MHz Emission

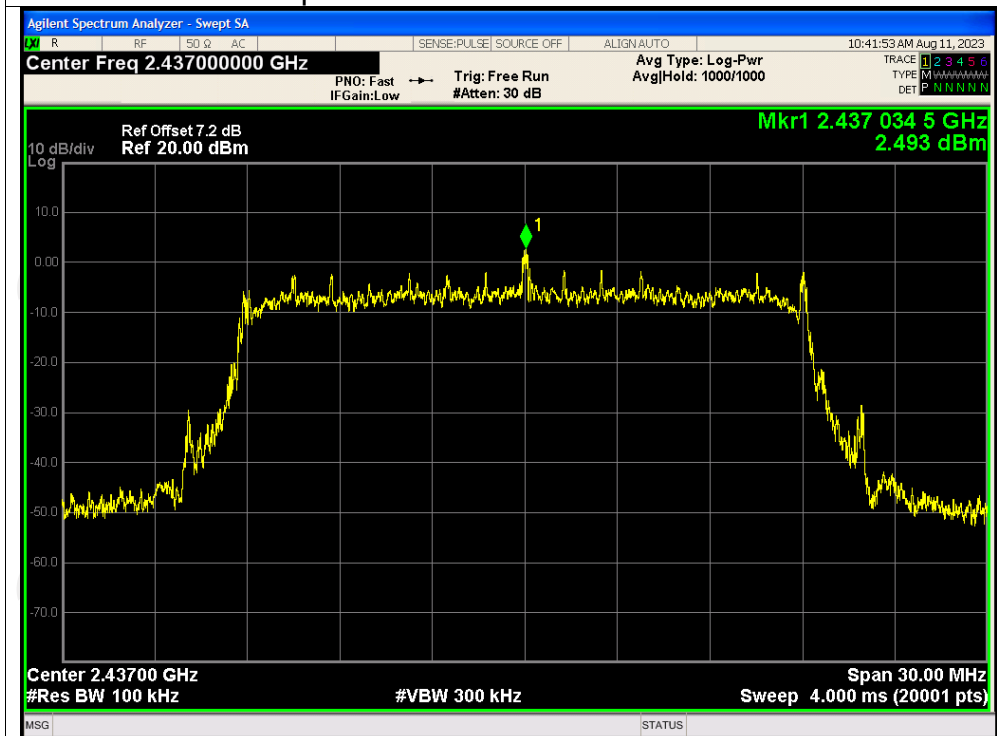
## Tx. Spurious NVNT n20 2437MHz Ref

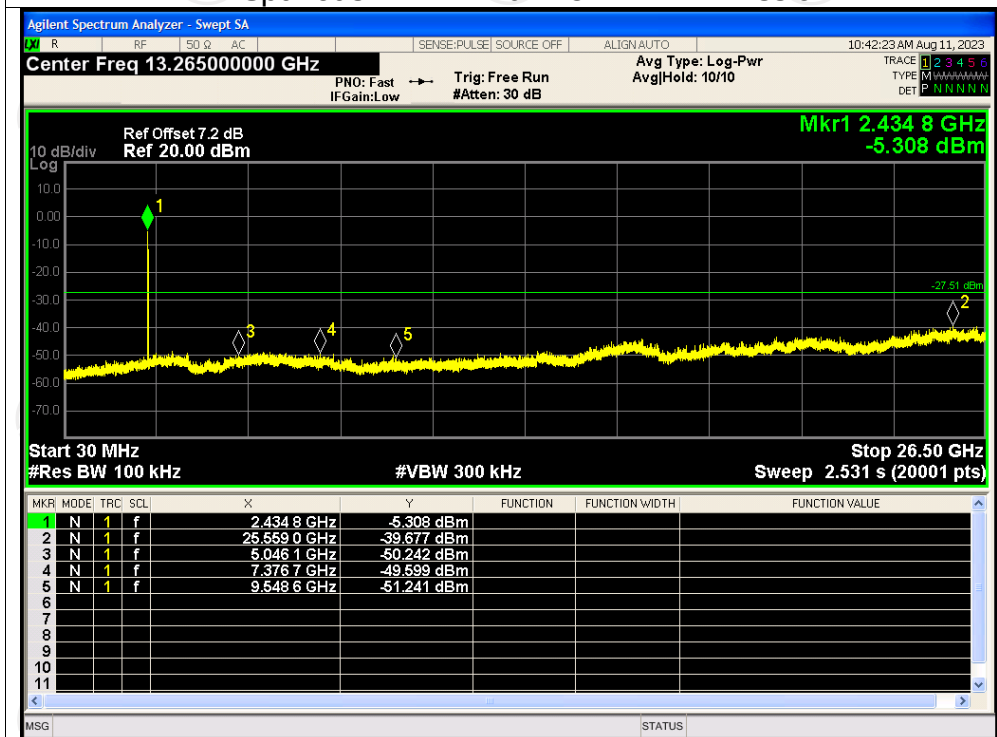
## Tx. Spurious NVNT n20 2437MHz Emission

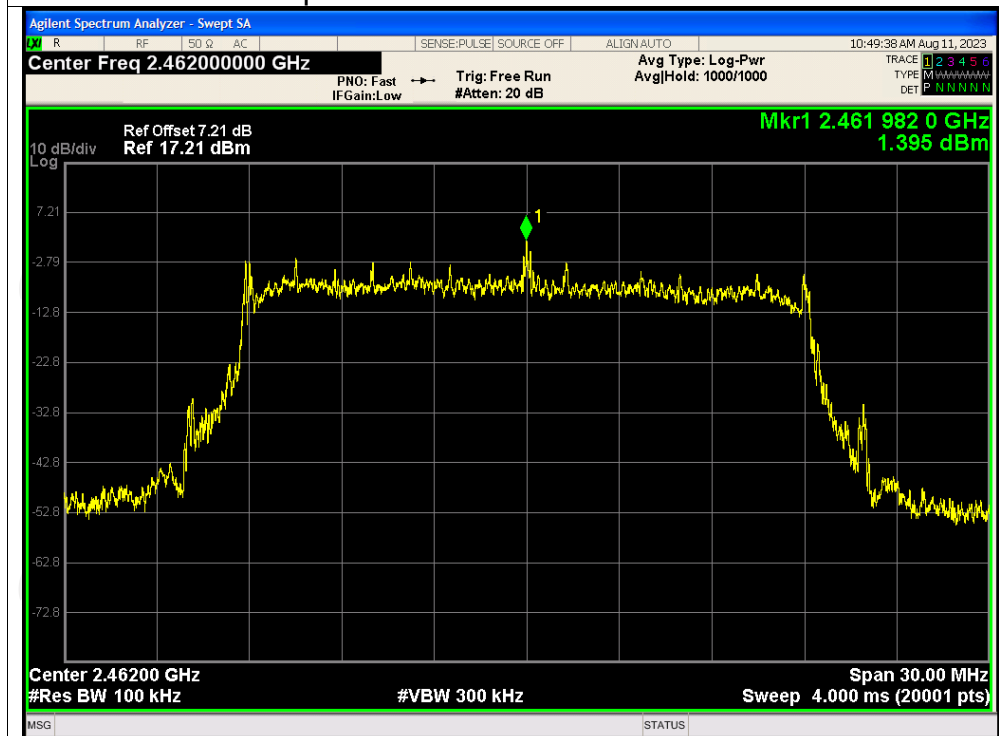
## Tx. Spurious NVNT n20 2462MHz Ref

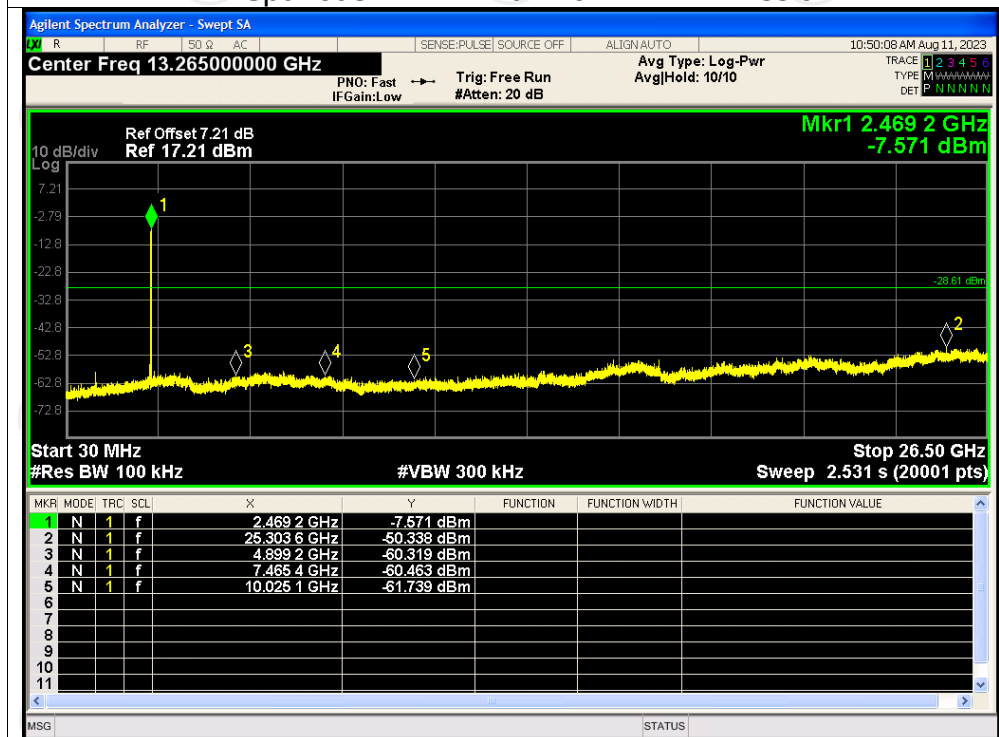
## Tx. Spurious NVNT n20 2462MHz Emission

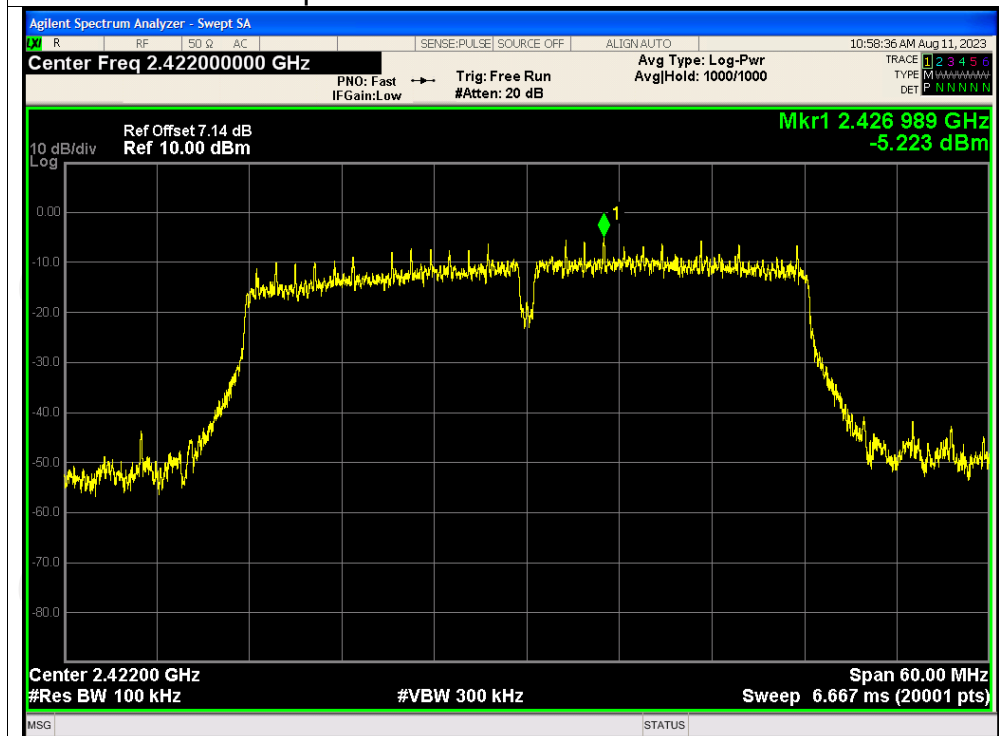
## Tx. Spurious NVNT n40 2422MHz Ref

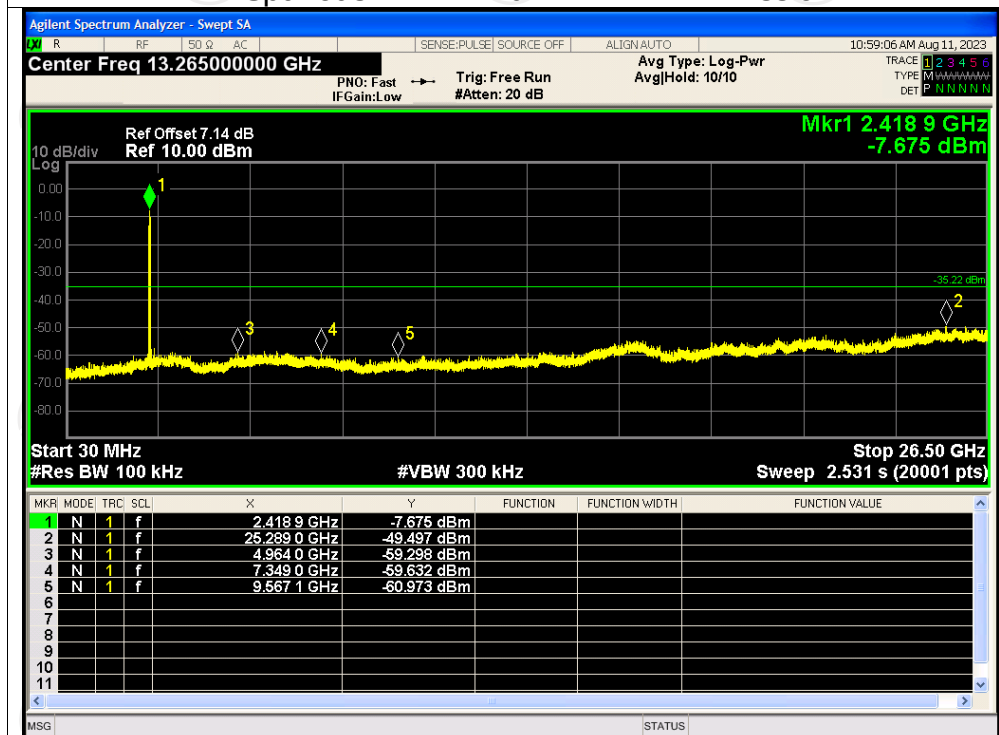
## Tx. Spurious NVNT n40 2422MHz Emission

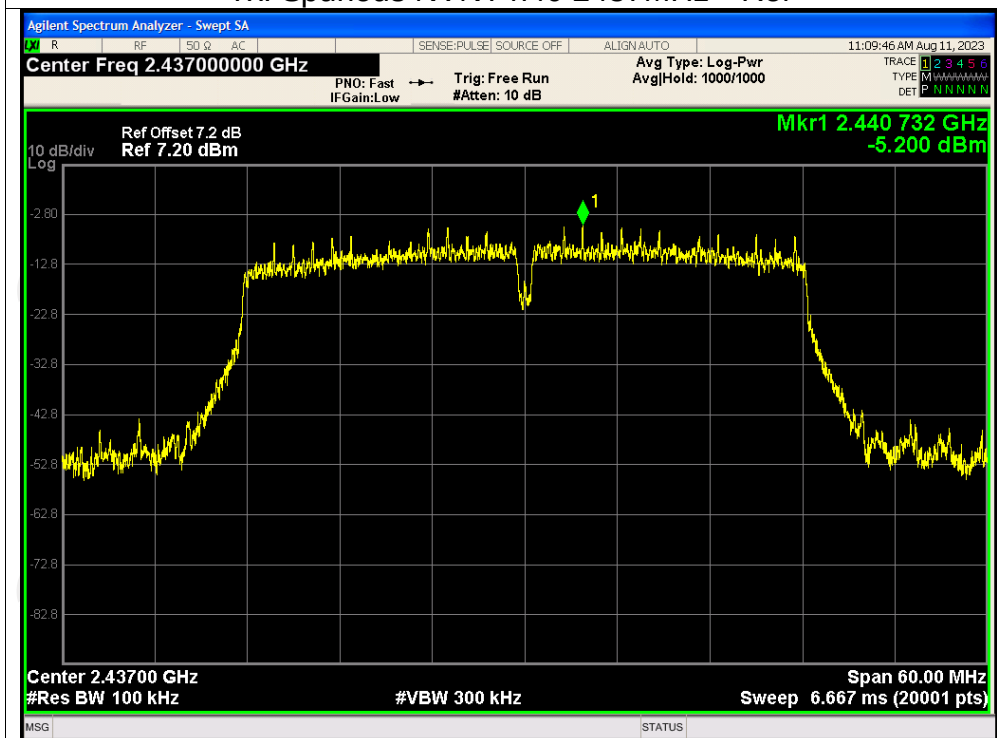
## Tx. Spurious NVNT n40 2437MHz Ref

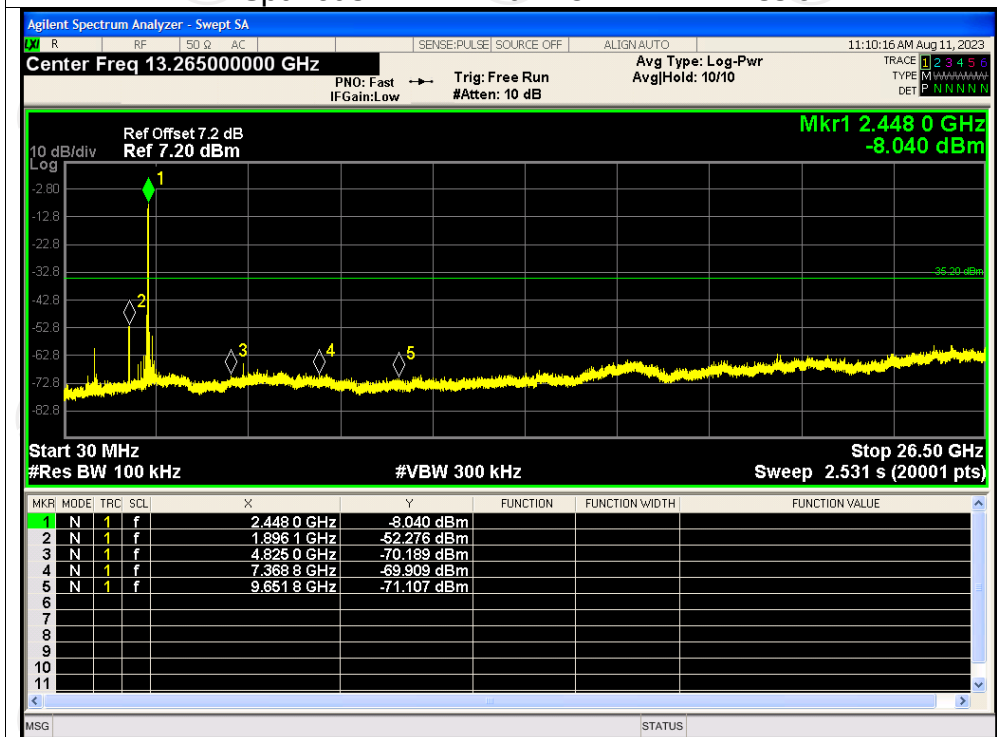
## Tx. Spurious NVNT n40 2437MHz Emission

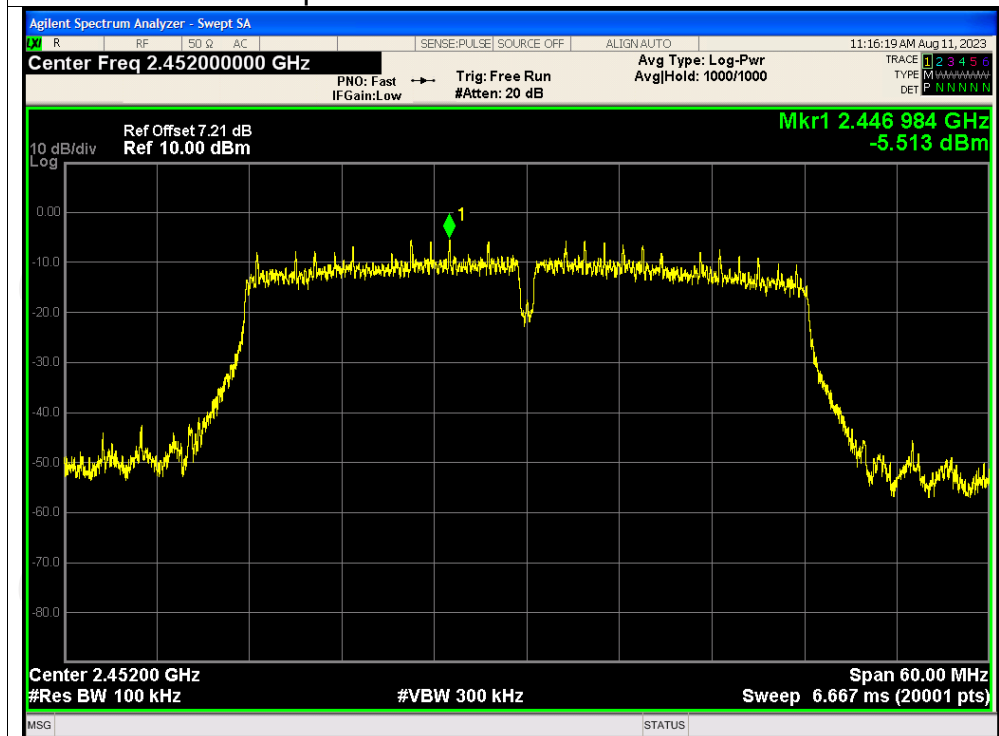
## Tx. Spurious NVNT n40 2452MHz Ref

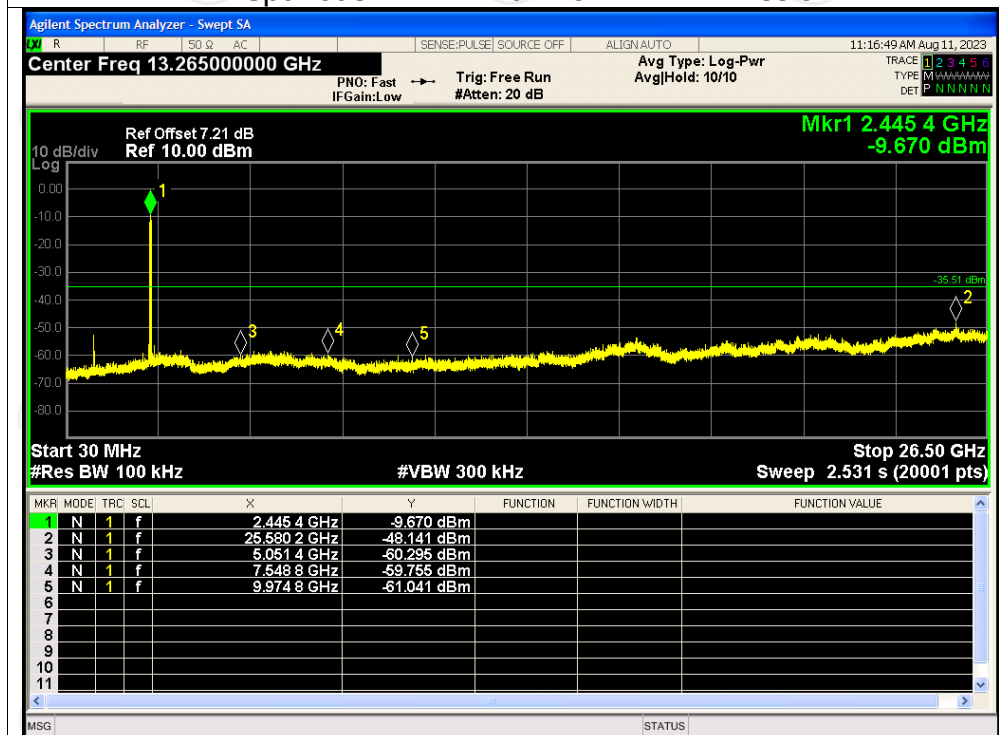
## Tx. Spurious NVNT n40 2452MHz Emission

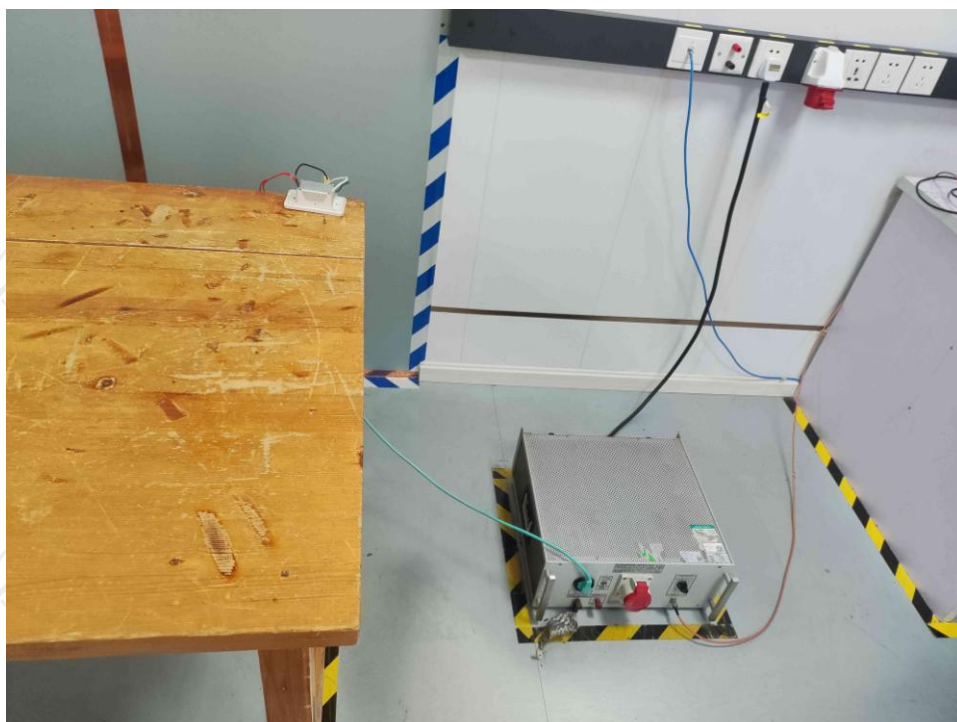
### Conducted Emission
