# TEST REPORT

Report No.: SHE23100070-02DE

Date: 2023-12-05

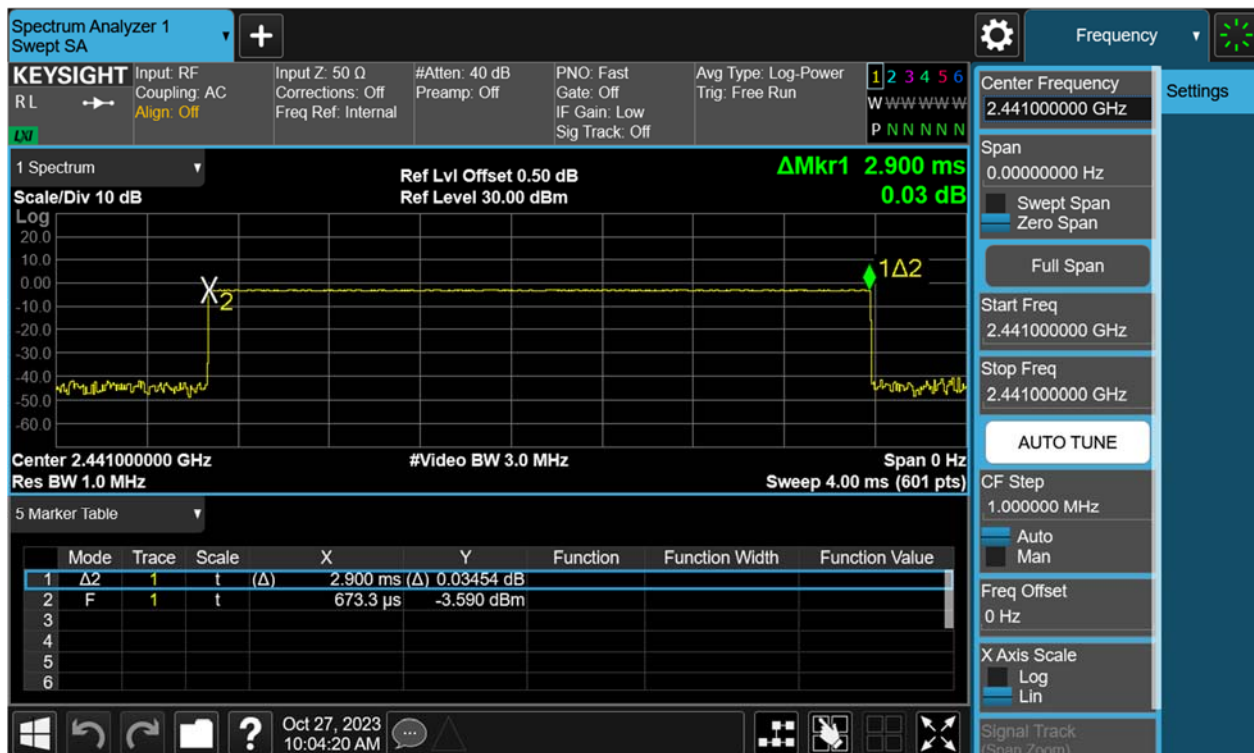
Figure 39: Time of Occupancy, 2441MHz, GFSK DH5

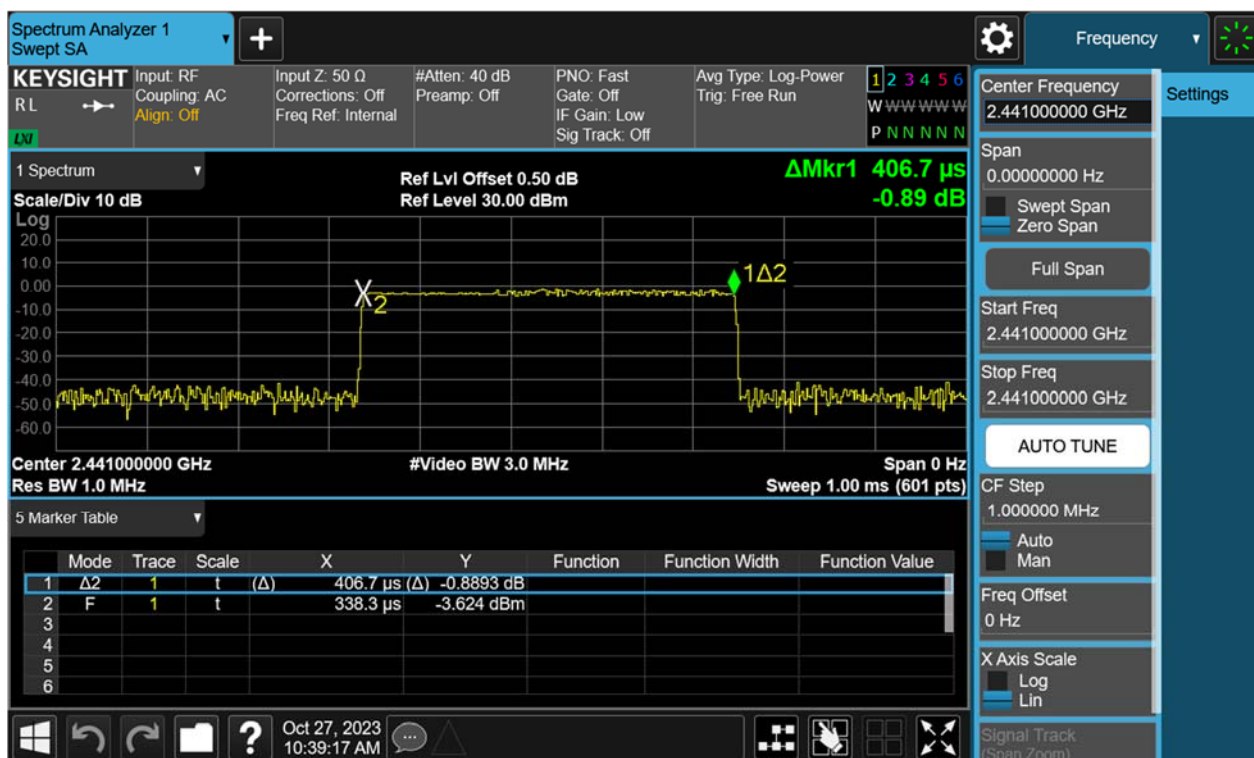
Figure 40: Time of Occupancy, 2441MHz,  $\pi/4$ -DQPSK DH1

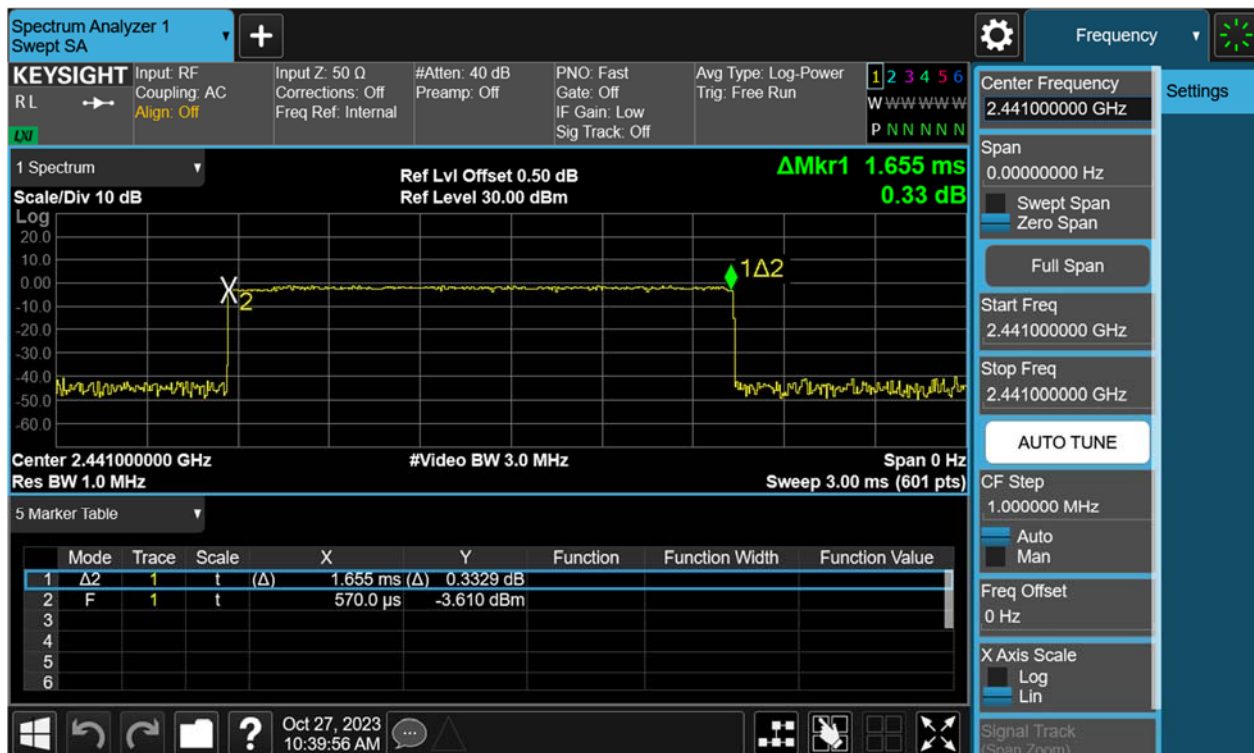
Figure 41: Time of Occupancy, 2441MHz,  $\pi/4$ -DQPSK DH3

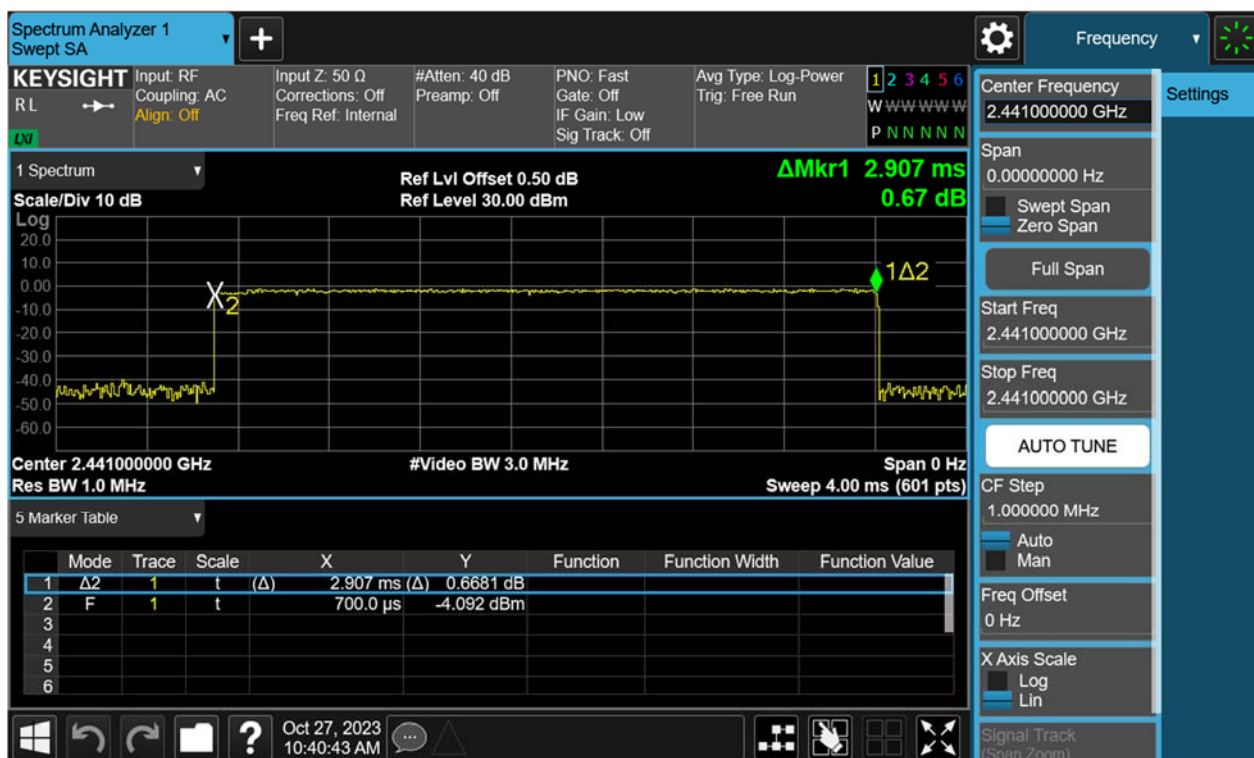
Figure 42: Time of Occupancy, 2441MHz,  $\pi/4$ -DQPSK DH5

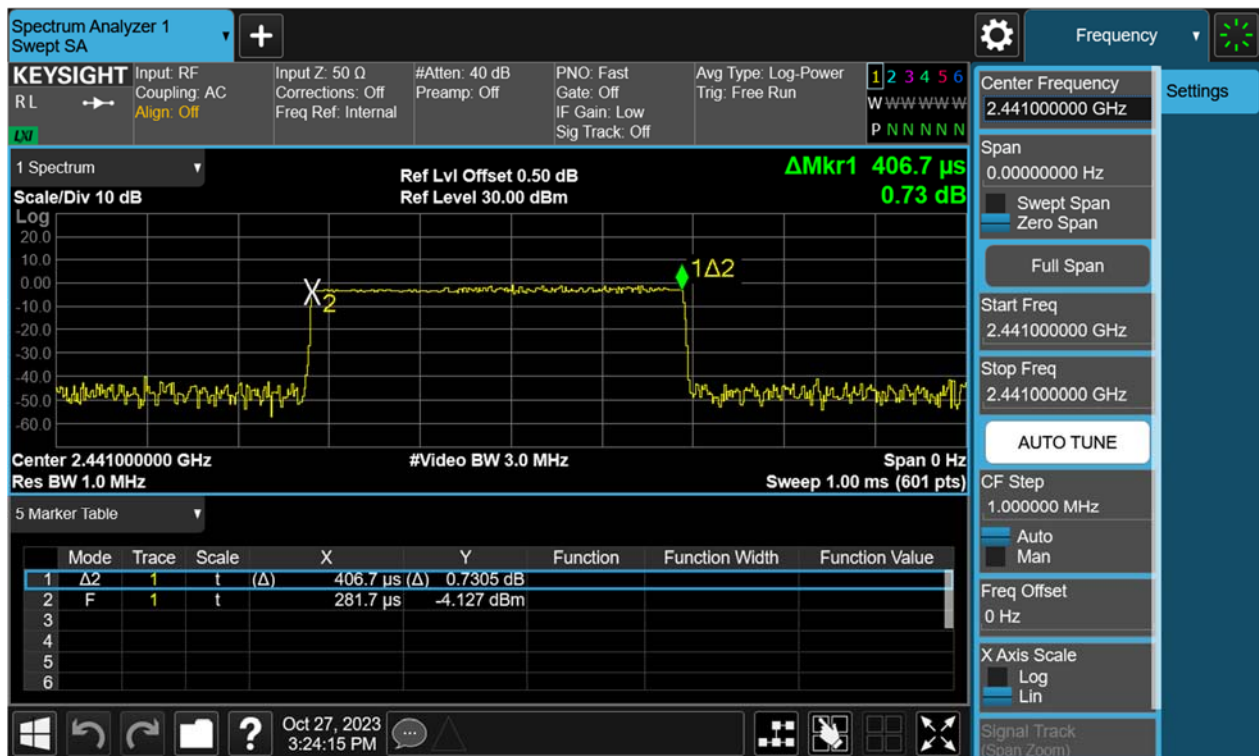
Figure 43: Time of Occupancy, 2441MHz, 8-DPSK DH1

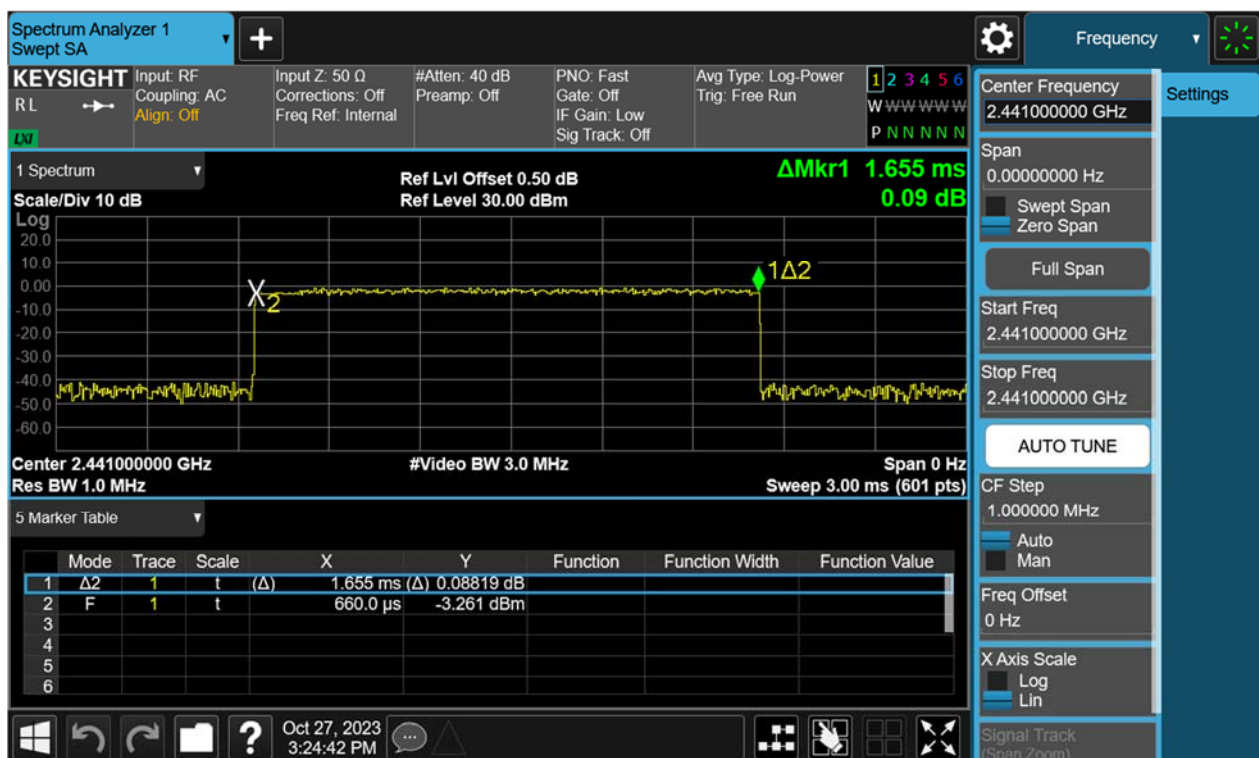
Figure 44: Time of Occupancy, 2441MHz, 8-DPSK DH3

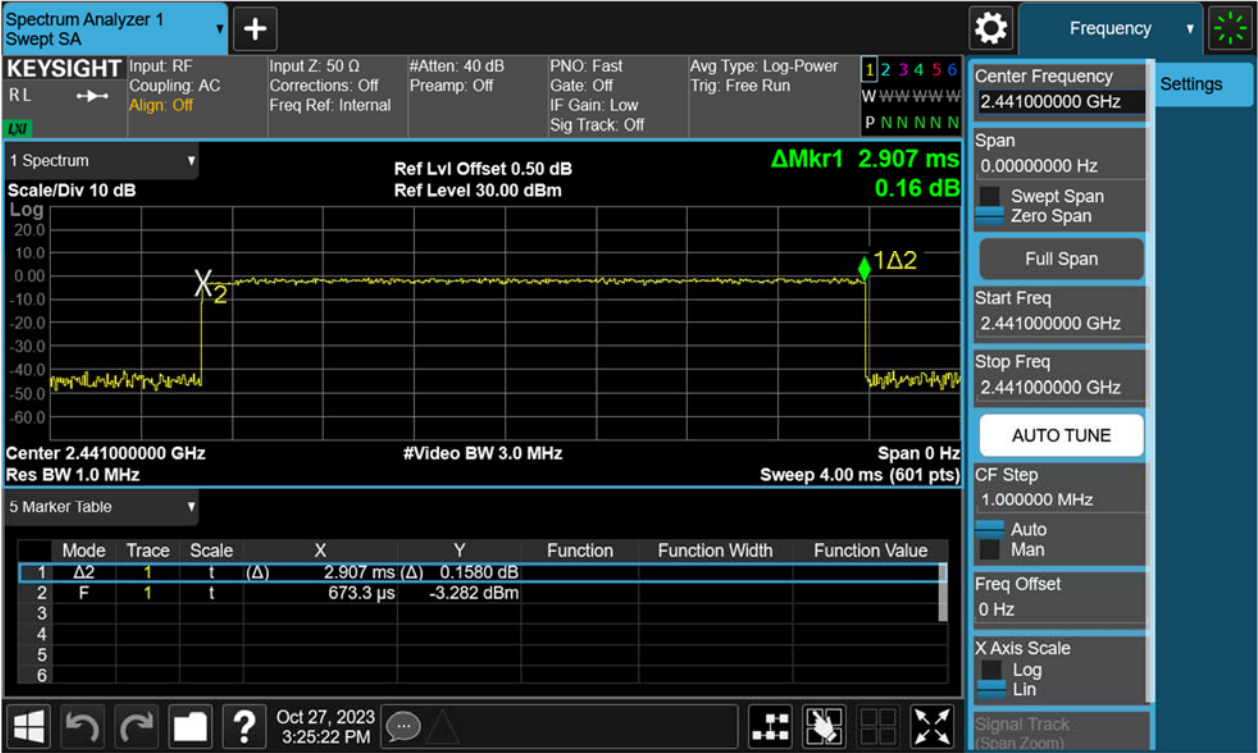
Figure 45: Time of Occupancy, 2441MHz, 8-DPSK DH5

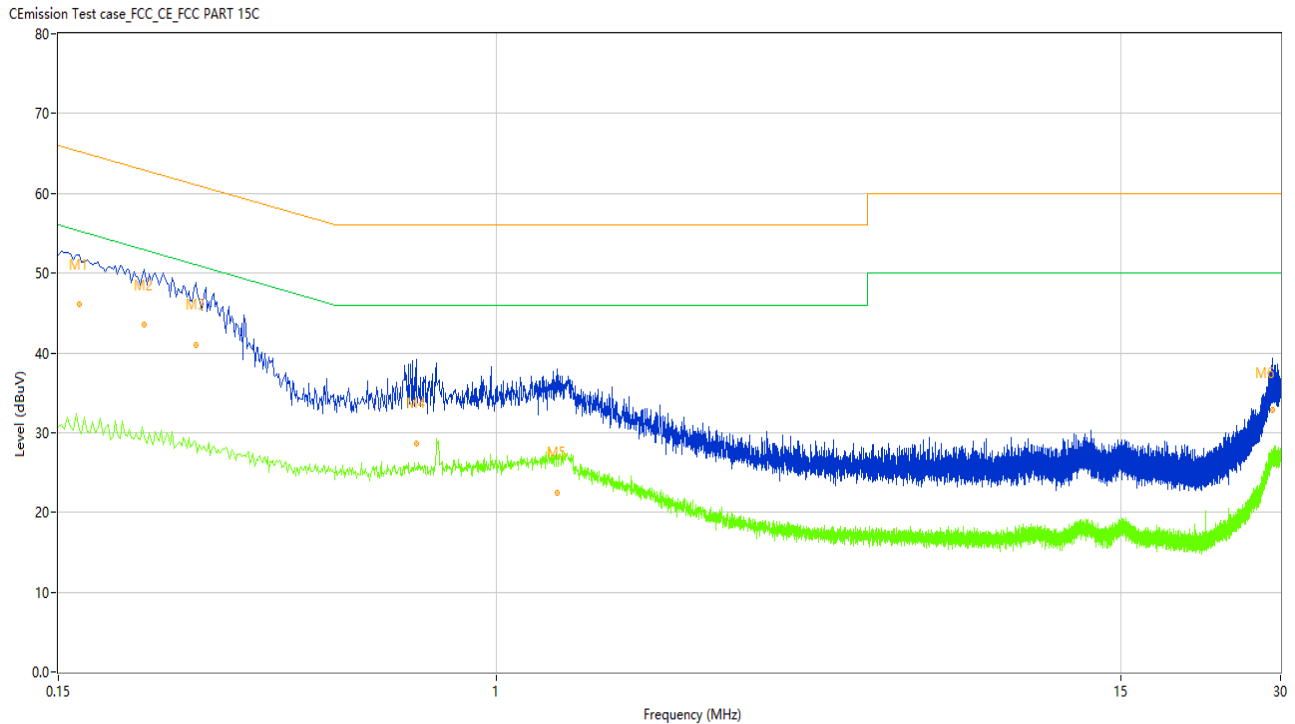
*Note: The all configurations were tested respectively, Only the worst mode data of 8DPSK-hopping-DH5 was recorded in the test report.*

**Figure 46: Conducted Emission on AC Mains, L Phase**

No.	Frequency (MHz)	Results (dBuV)	Factor (dB)	Limit (dBuV)	Margin (dB)	Detector	Line	Verdict
1	0.164	52.45	9.94	65.26	12.81	Peak	L	Pass
1*	0.164	46.18	9.94	65.26	19.08	QP	L	Pass
1**	0.164	30.34	9.94	55.26	24.92	AV	L	Pass
2	0.218	50.26	9.96	62.89	12.63	Peak	L	Pass
2*	0.218	43.49	9.96	62.89	19.40	QP	L	Pass
2**	0.218	29.34	9.96	52.89	23.55	AV	L	Pass
3	0.272	48.46	9.97	61.06	12.60	Peak	L	Pass
3*	0.272	40.97	9.97	61.06	20.09	QP	L	Pass
3**	0.272	28.75	9.97	51.06	22.31	AV	L	Pass
4	0.708	37.94	9.95	56.00	18.06	Peak	L	Pass
4*	0.708	28.66	9.95	56.00	27.34	QP	L	Pass
4**	0.708	25.65	9.95	46.00	20.35	AV	L	Pass
5	1.306	29.93	9.84	56.00	26.07	Peak	L	Pass
5*	1.306	22.48	9.84	56.00	33.52	QP	L	Pass
5**	1.306	27.04	9.84	46.00	18.96	AV	L	Pass
6	29.038	39.30	8.96	60.00	20.70	Peak	L	Pass
6*	29.038	32.77	8.96	60.00	27.23	QP	L	Pass
6**	29.038	27.73	8.96	50.00	22.27	AV	L	Pass

Test standard	: FCC Part 15.207(a), RSS-Gen 8.8
Requirement	: ANSI C63.10-2013, Clause 6.2
Kind of test site	: Shielded room

Input Voltage	: which received AC 120V, 60Hz Power
Operation Mode	: A.1.a
Earthing	: Connected to GND
Ambient temperature	: 26°C
Relative humidity	: 49%

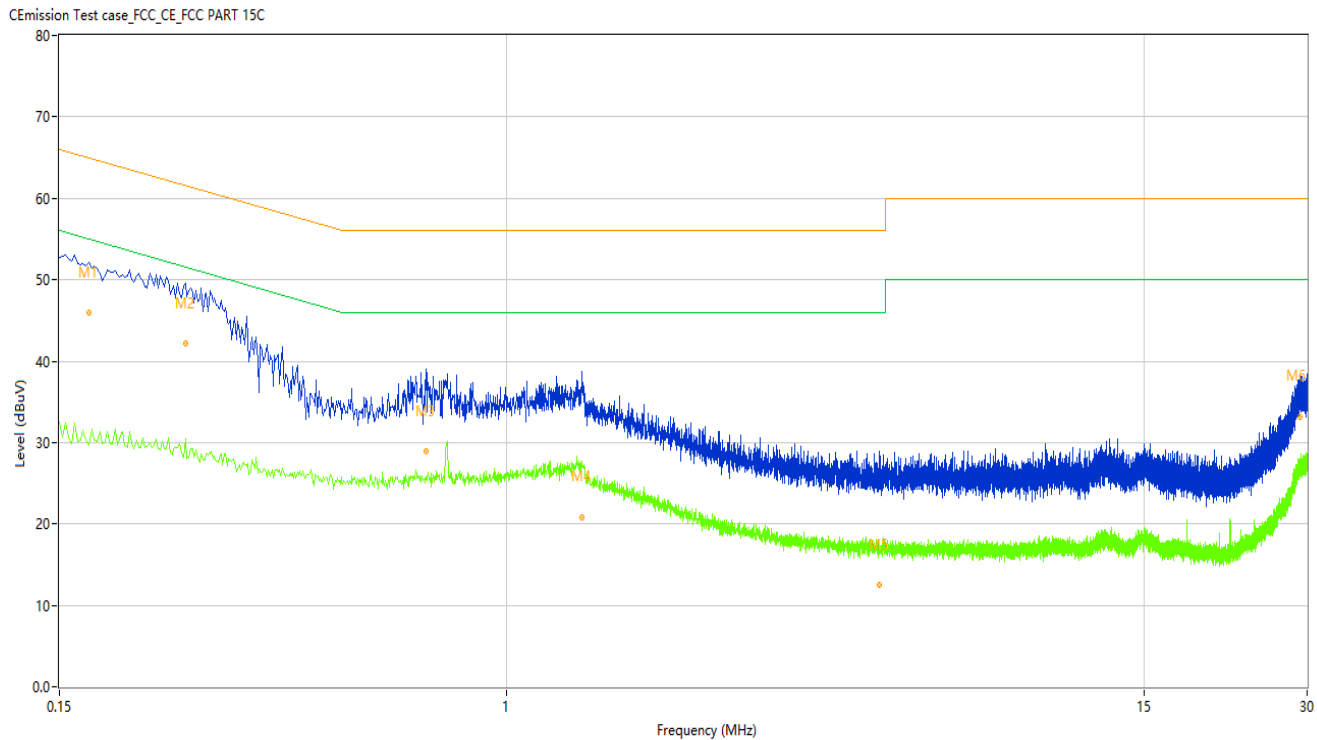
Figure 47: Conducted Emission on AC Mains, N Phase

No.	Frequency (MHz)	Results (dBuV)	Factor (dB)	Limit (dBuV)	Margin (dB)	Detector	Line	Verdict
1	0.170	52.10	10.03	64.96	12.86	Peak	N	Pass
1*	0.170	45.94	10.03	64.96	19.02	QP	N	Pass
1**	0.170	29.75	10.03	54.96	25.21	AV	N	Pass
2	0.256	49.26	10.06	61.56	12.30	Peak	N	Pass
2*	0.256	42.21	10.06	61.56	19.35	QP	N	Pass
2**	0.256	30.42	10.06	51.56	21.14	AV	N	Pass
3	0.712	38.14	10.04	56.00	17.86	Peak	N	Pass
3*	0.712	28.91	10.04	56.00	27.09	QP	N	Pass
3**	0.712	25.84	10.04	46.00	20.16	AV	N	Pass
4	1.378	28.66	9.94	56.00	27.34	Peak	N	Pass
4*	1.378	20.76	9.94	56.00	35.24	QP	N	Pass
4**	1.378	26.97	9.94	46.00	19.03	AV	N	Pass
5	4.878	20.23	9.74	56.00	35.77	Peak	N	Pass
5*	4.878	12.50	9.74	56.00	43.50	QP	N	Pass
5**	4.878	17.32	9.74	46.00	28.68	AV	N	Pass
6	29.050	39.70	9.05	60.00	20.30	Peak	N	Pass
6*	29.050	33.22	9.05	60.00	26.78	QP	N	Pass
6**	29.050	27.54	9.05	50.00	22.46	AV	N	Pass

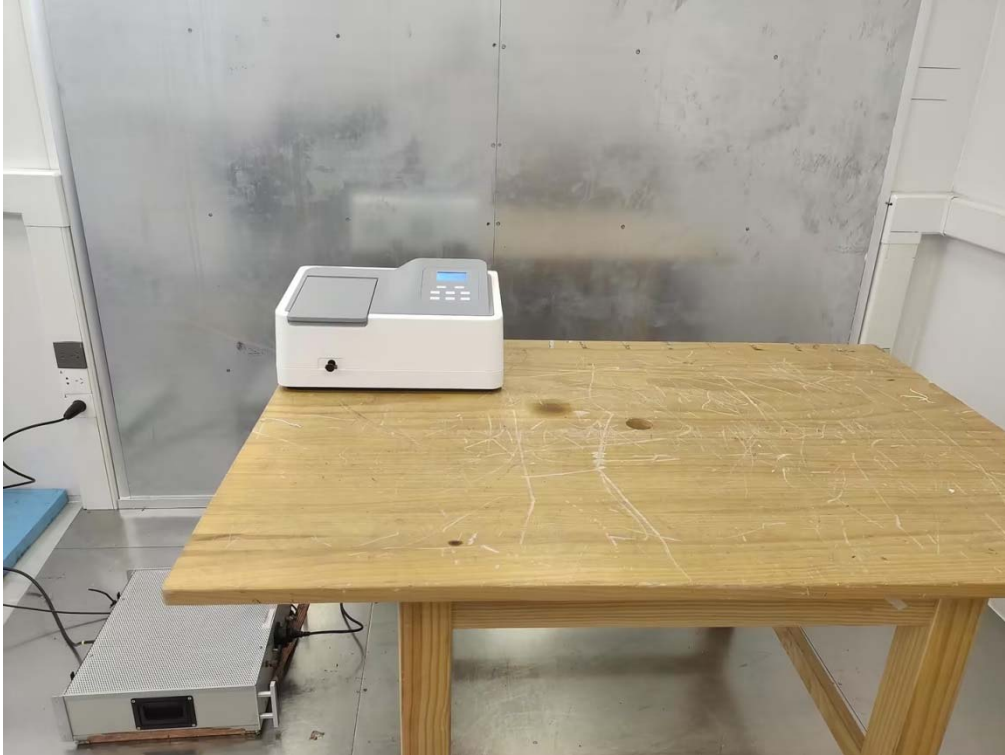
## 5.2 Set-up for Conducted Emission on AC Mains

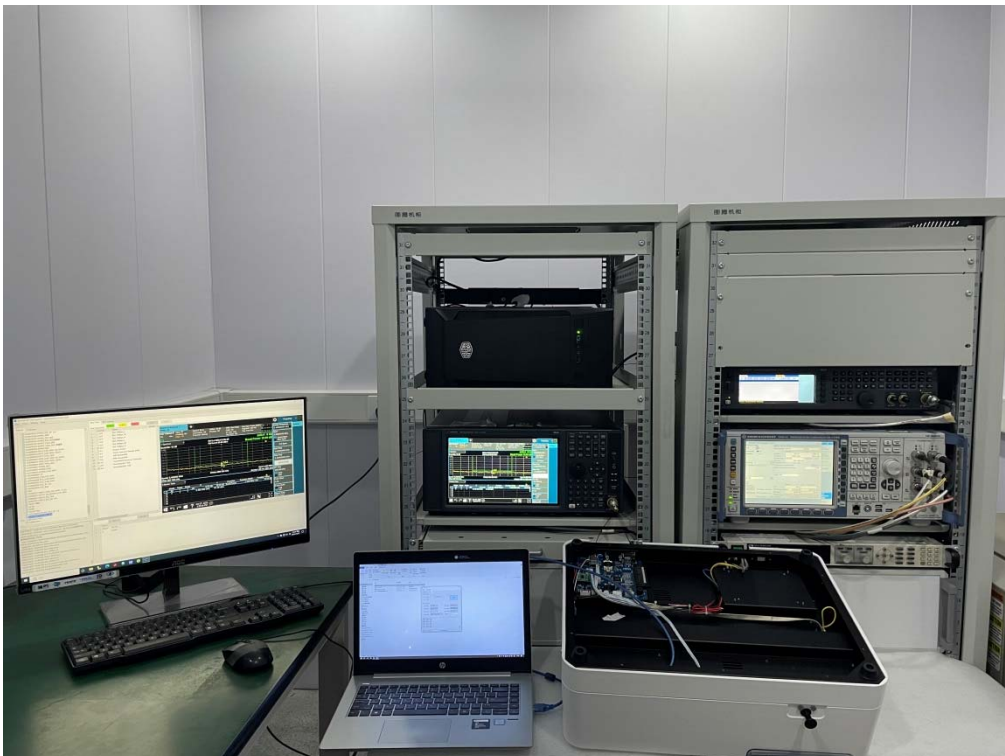
## 5.3 Set-up for Conducted RF test at Antenna Port

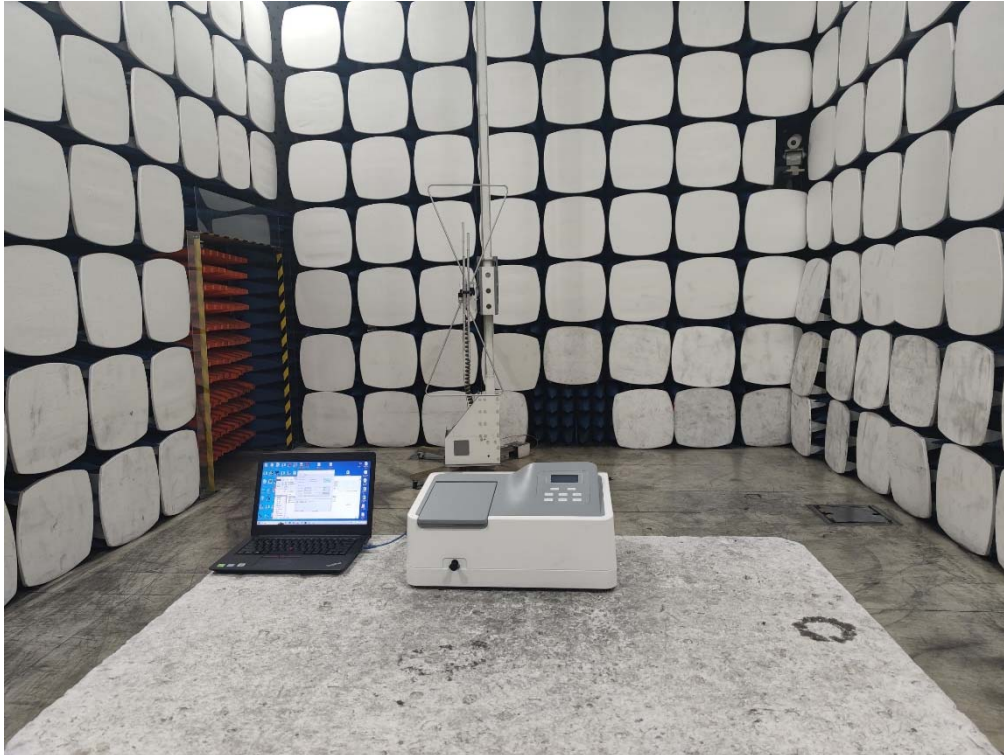
## 5.4 Set-up for Radiated Spurious Emissions below 1GHz

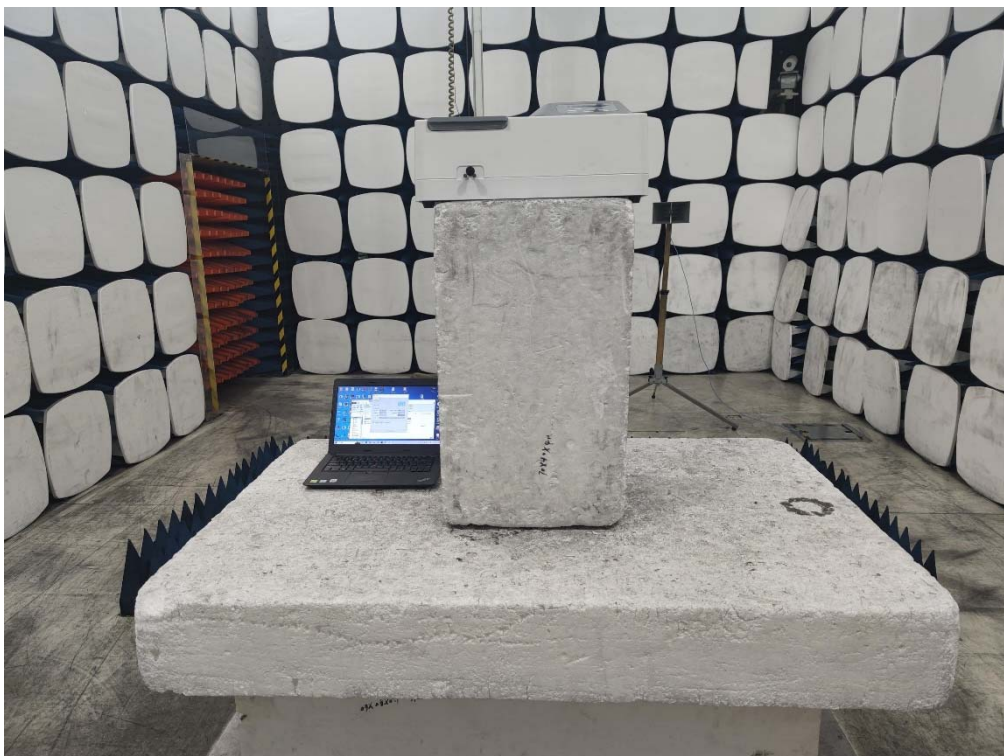
## 5.5 Set-up for Radiated Spurious Emissions above 1GHz
