## Conducted RF Spurious Emission

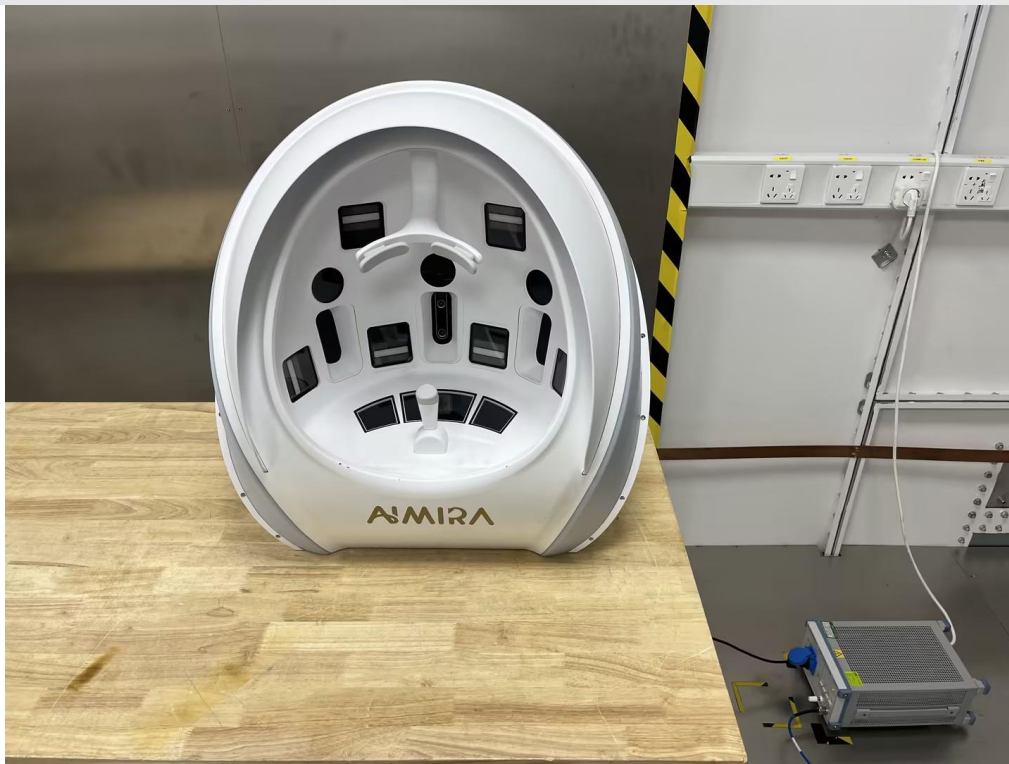
AC Power Line Conducted Emission

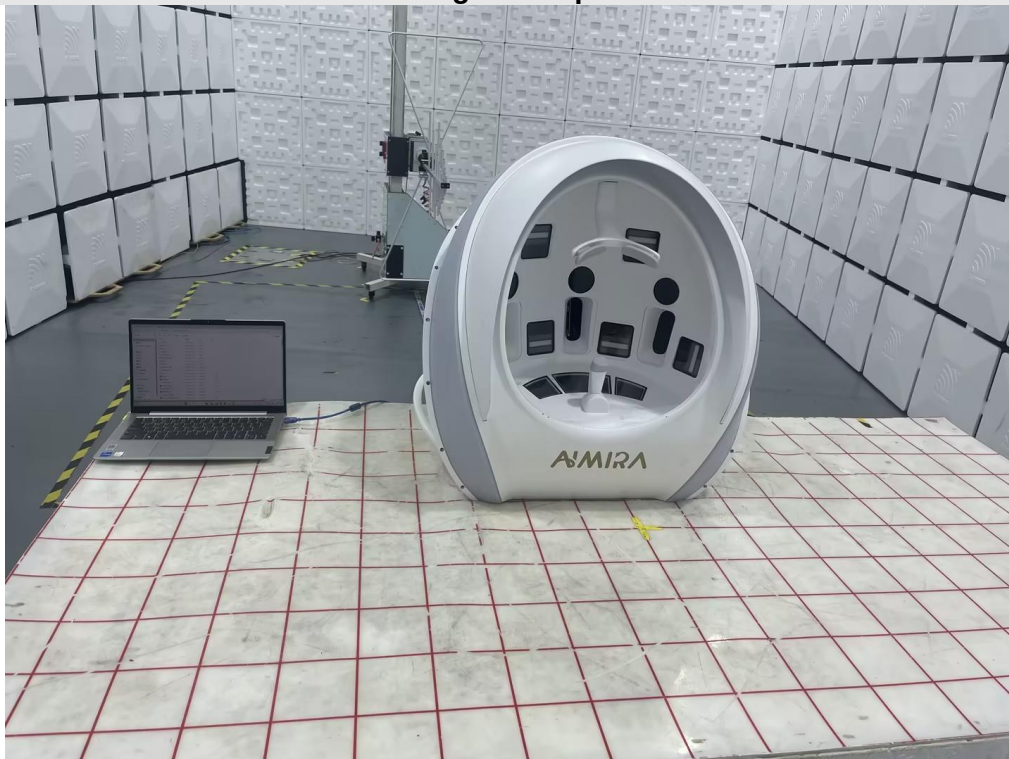
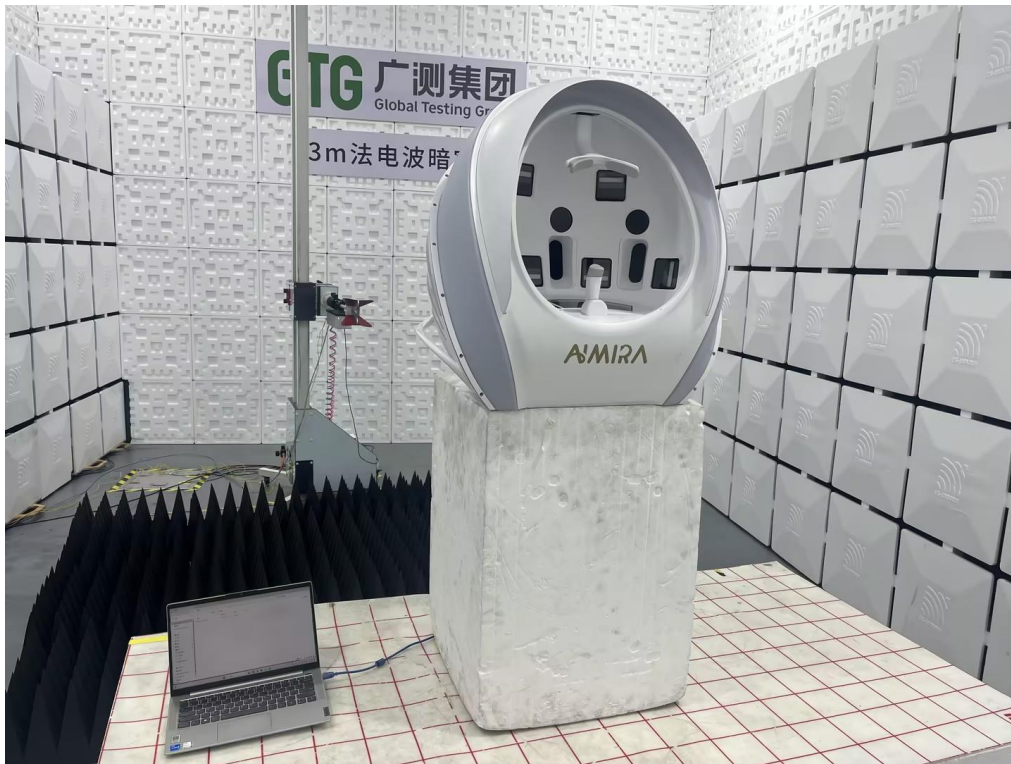
Radiated Band edge and Spurious Emission
